**Loss of Pitch Control on Takeoff
Emery Worldwide Airlines, Flight 17
McDonnell Douglas DC-8-71F, N8079U
Rancho Cordova, California
February 16, 2000**

Aircraft Accident Report
NTSB/AAR-03/02

**NTSB/AAR-03/02
PB2003-910402
Notation 7299A
Adopted August 5, 2003**

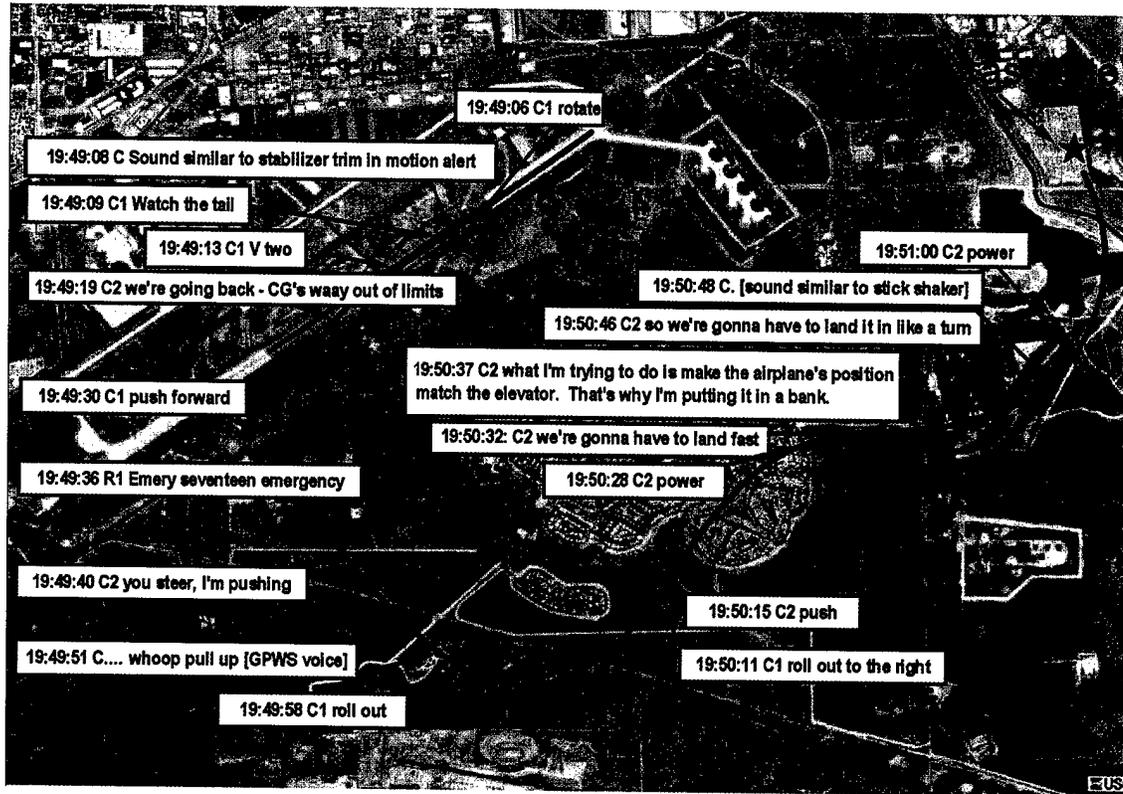
Figure 1. The airplane's ground track, with selected CVR comments, during the accident flight.

The airplane impacted the ground in a left-wing-low, slightly nose-up attitude in an automobile salvage yard, about 1 mile east of the departure runway. Figure 1 shows the airplane's ground track, with selected CVR comments, during the accident flight. (For additional information regarding CVR comments, see the CVR transcript in appendix B).

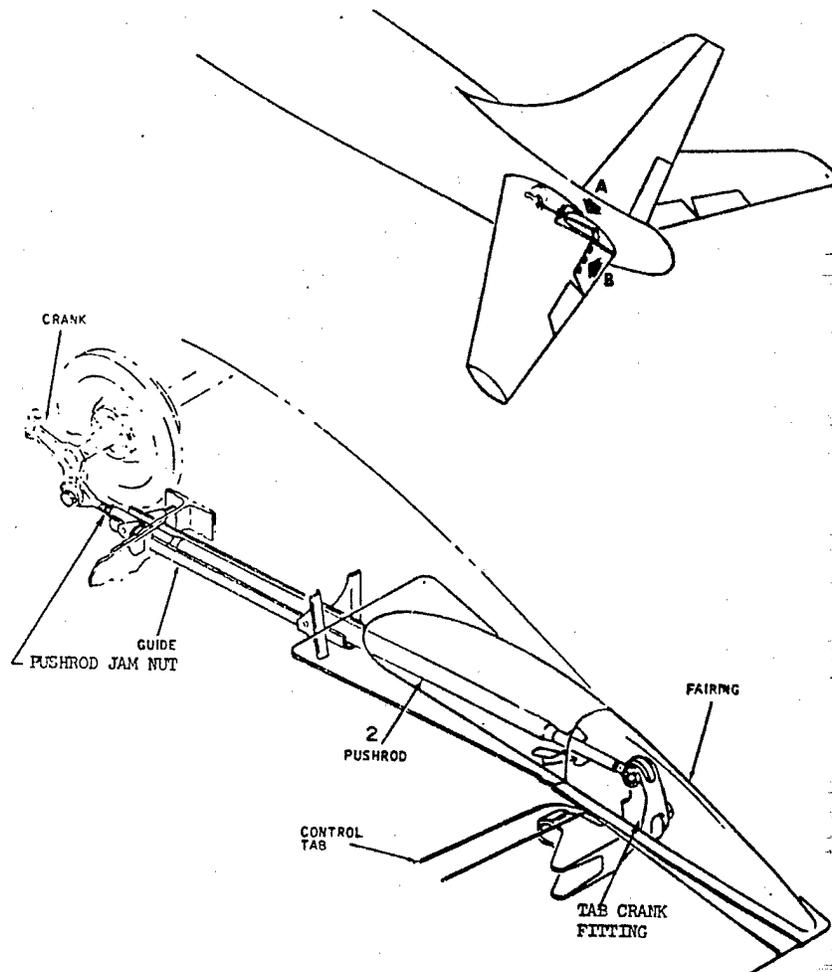
Figure 2. A diagram of the elevator control tab installation.

Each elevator control tab is hinged to the inboard trailing edge of the associated elevator surface, then connected by a mechanical linkage (including a crank fitting, pushrod, and bellcrank assembly) at the inboard edge of the tab to the flight control system on that side of the airplane. Figure 2 is a diagram of the elevator control tab installation. The elevator control tabs are in their neutral position when they are in line with the elevator surfaces and should have a maximum TEU deflection of $8.5^\circ \pm 0.5^\circ$ and a maximum TED deflection of $26.5^\circ \pm 0.5^\circ$ from that neutral position.

(See figure 2, in section 1.6.2, for a diagram of the elevator control tab installation.) The right control tab pushrod was recovered separately, with its aft rod end (which would normally have been bolted to the tab crank fitting) intact. Examination of the forward edges of the elevator control tab crank fitting lugs revealed evidence of repeated contact damage (including gouge marks and indentations). (Figure 9 is a photograph of damage to this area.) The internal surfaces of the pushrod aft rod end bearing and the bushings in the crank fitting lugs showed no visible signs of damage or deformation. The bolt and associated hardware that normally secures the right elevator control tab pushrod to the tab crank fitting⁶¹ was missing and not recovered.

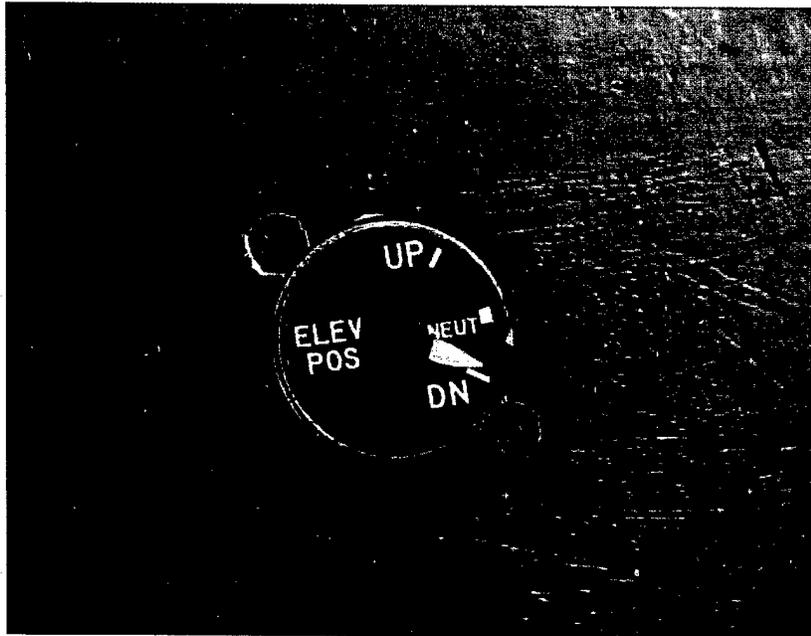
Figure 3. A photograph of an EPI gauge similar to the gauge installed on the accident airplane.

The DC-8 EPI is a 1-inch diameter circular cockpit gauge with a pointer needle and index markings for UP, DN (down), and NEUT (neutral) positions to indicate the position of the elevators. When the EPI is properly calibrated, the up index mark should correspond to the maximum TEU elevator surface position of 27° and the down index mark should correspond to the maximum TED elevator surface position of 16.5° TED. A narrow white band adjacent to the NEUT index mark indicates an elevator surface position between 0° and 5° TEU. Figure 3 is a photograph of an EPI gauge similar to that on the accident airplane.

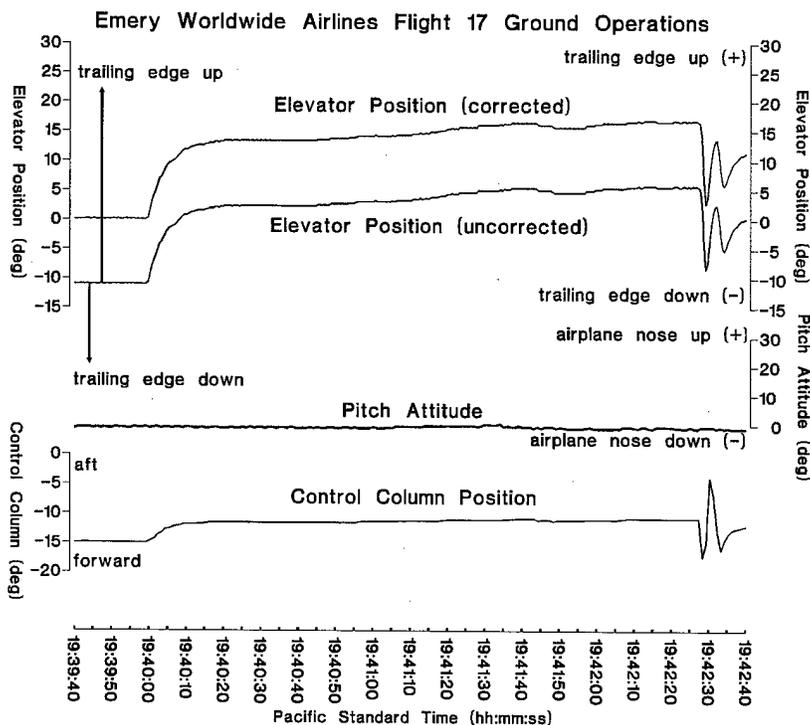
Figure 6 shows the elevator, pitch, and control column plots recorded by the accident airplane's FDR during ground operations before the accident flight. On this plot, the uncorrected data on the far left side of the plot shows an 11° TED elevator deflection when the gust lock was engaged (and the elevator was in its neutral, or 0°, position).

Figure 6. Elevator, pitch, and control column plots recorded by the accident airplane's FDR during ground operations before the accident flight. The first 20 seconds of data were recorded while the gust lock was engaged.

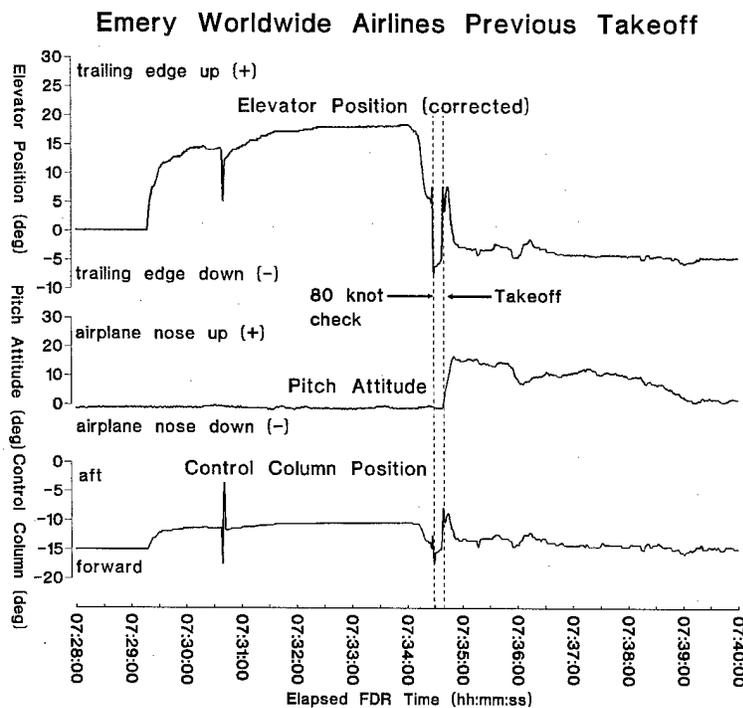
The Safety Board's examination of the corrected elevator position data revealed that the airplane's elevator never traveled below its neutral position to a TED deflection during the accident flight, although recorded forward control column inputs should have resulted in a TED elevator deflection. For example, although the FDR data indicated that, during the 80-knot elevator check at MHR, the control columns were moved to about 6° forward of their rigged neutral position, the elevators did not deflect below 2.2° TEU. In contrast, during the 80-knot elevator check on the previous takeoff (at RNO) the FDR recorded elevator movement to 8° TED, with less forward control column movement. Figure 7 shows plots of the pitch attitude, control column position, and elevator position FDR data for the accident flight. Elevator position is shown using the conversion that corrected for the 11° offset. Figure 7 also shows when the 80-knot elevator check and takeoff occurred. Figure 8 shows the same information for the takeoff from RNO.

Figure 8. Pitch attitude, control column position, and (corrected) elevator position FDR data for the previous takeoff from RNO. About the first 1 minute 20 seconds of data were recorded while the gust lock was engaged.
