**AEROPLANE AND ARMAMENT
EXPERIMENTAL ESTABLISHMENT**

SEA VENOM MK. 20 WK. 379
(GHOST 3)

RADIO ACCEPTANCE TRIALS

10th Part of Report No. AAEE/868/1.

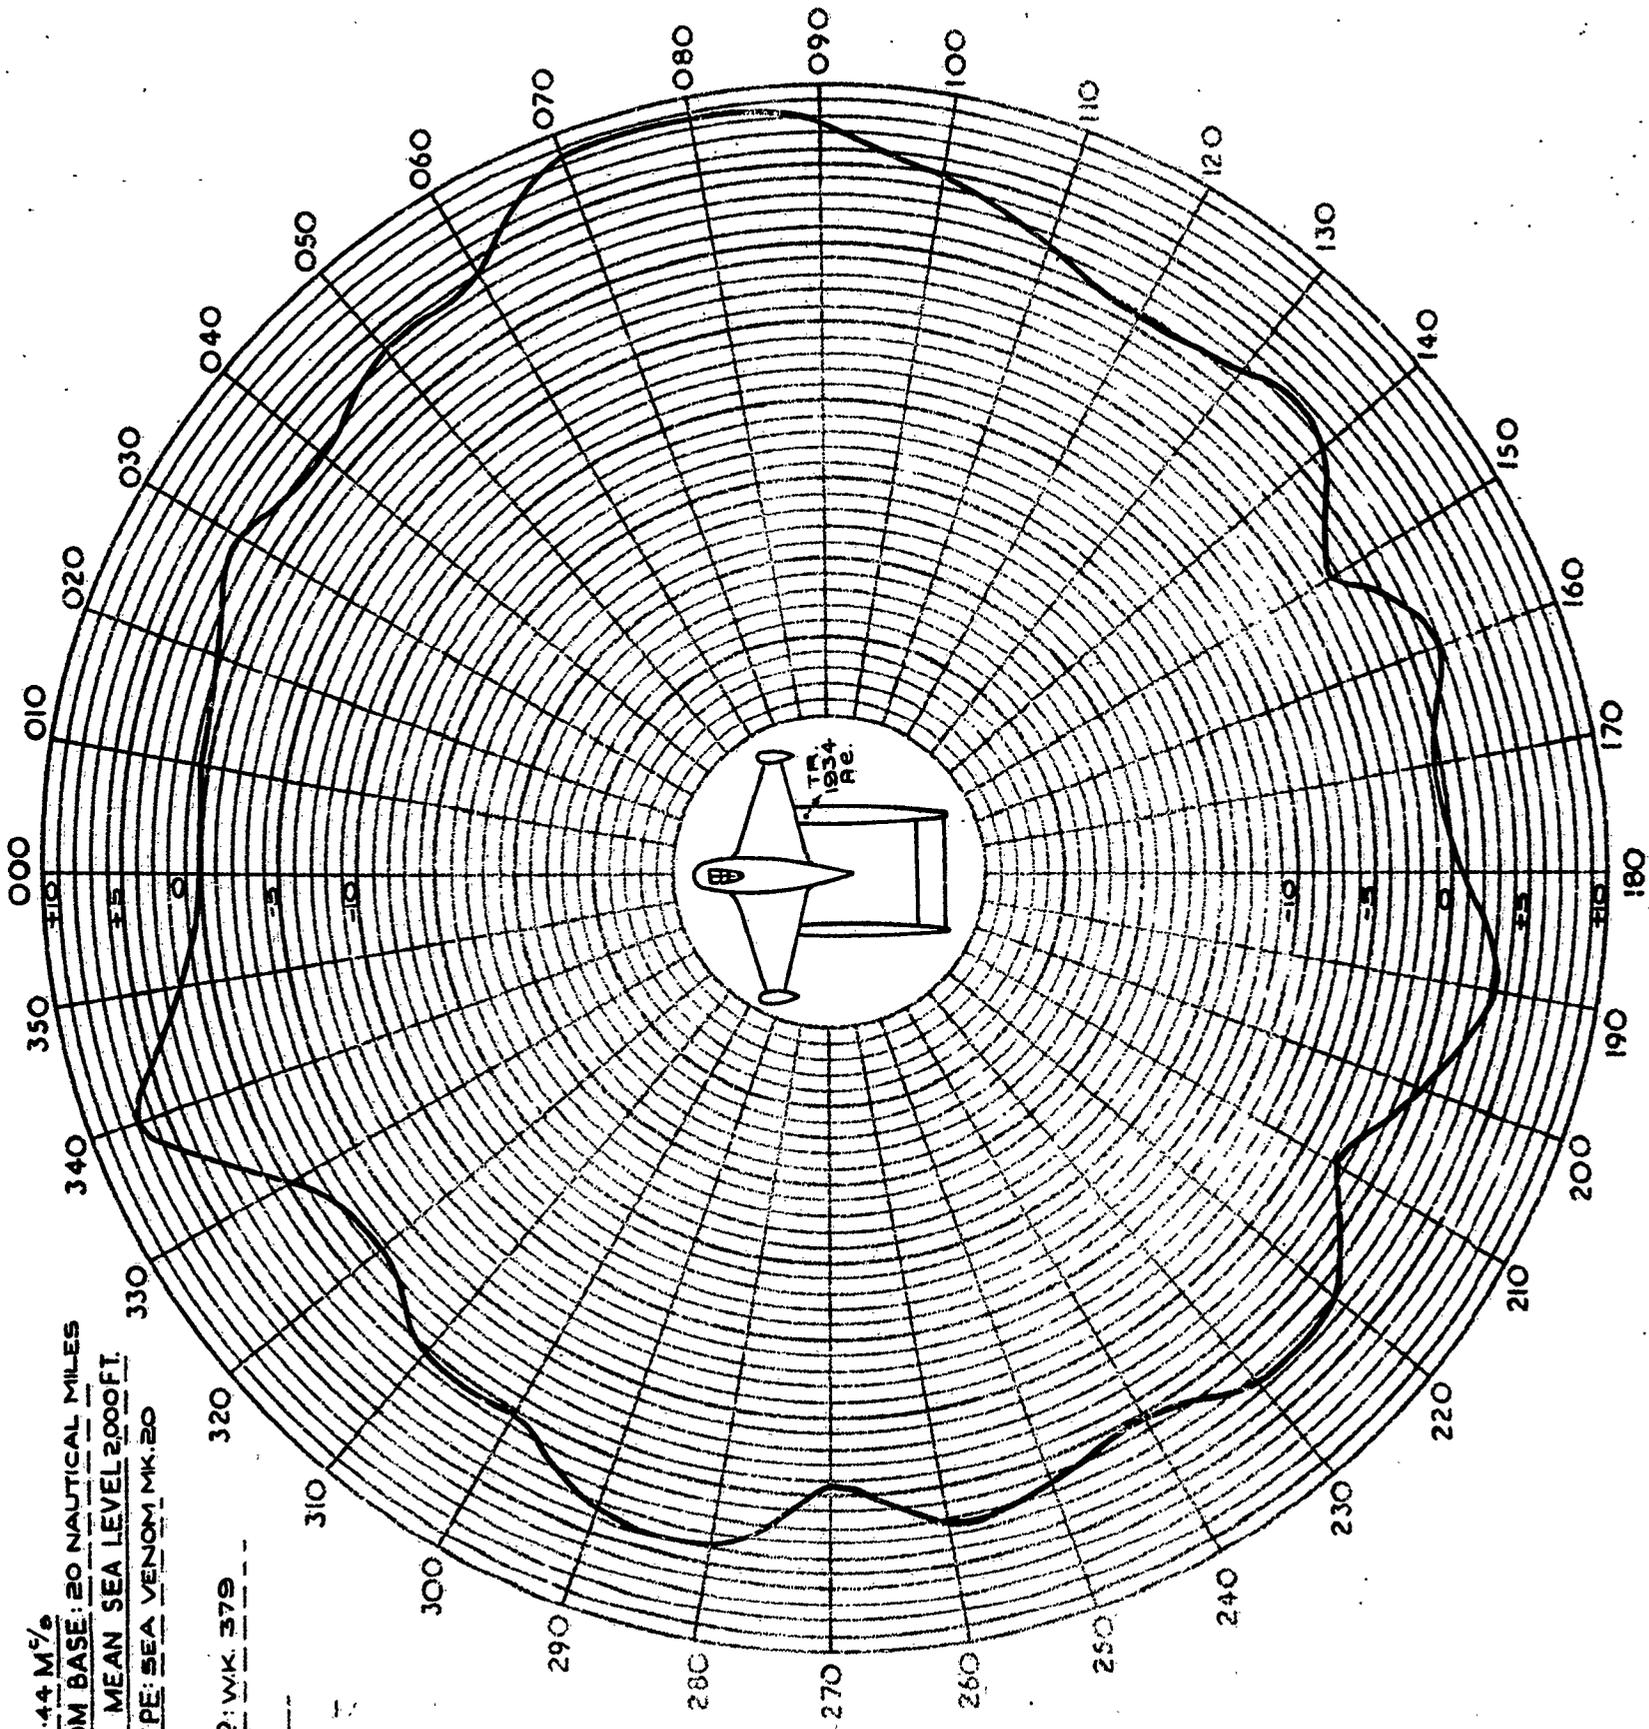
FIG. 9

7.3.1. Polar Diagrams. The results of the polar diagram runs are given in Figures 9 and 10 and are satisfactory.
