NAMC-AEL-1625 14 DEC 1959

CALIBRATION AND QUALIFICATION TESTS
OF McCULLOCH YO-100-4 ENGINE
FOR ROTORCYCLE USE

FINAL REPORT ON
BUAER PROJECT TED NAM-PP-2648.1
BY
C. W. SHEARER

Final Report NAMC-AEL-1625
on
BUAER Project TED NAM-PP-2648.1

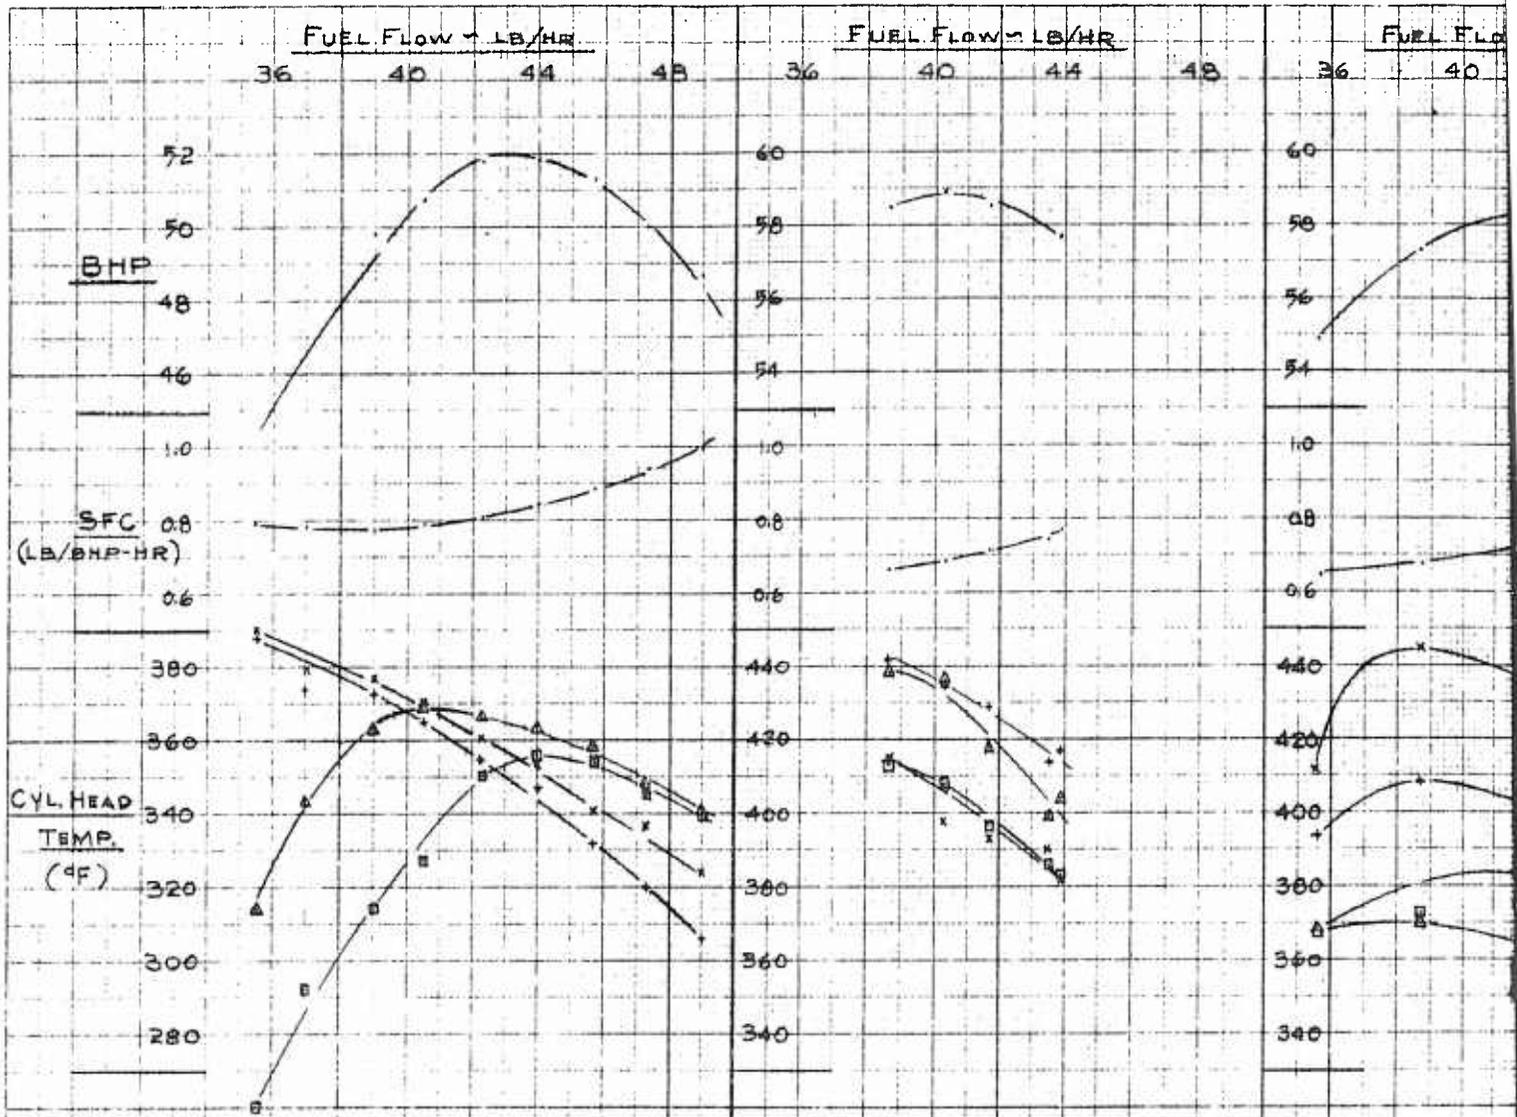
a. The calibration results, shown on plate 1, indicate that the engine does not meet the manufacturer's specified power rating of 60 bhp at 4000 rpm employing the regular exhaust manifold configuration. The results of mixture control runs, with all powers corrected to standard sea level conditions, are shown in the following table:

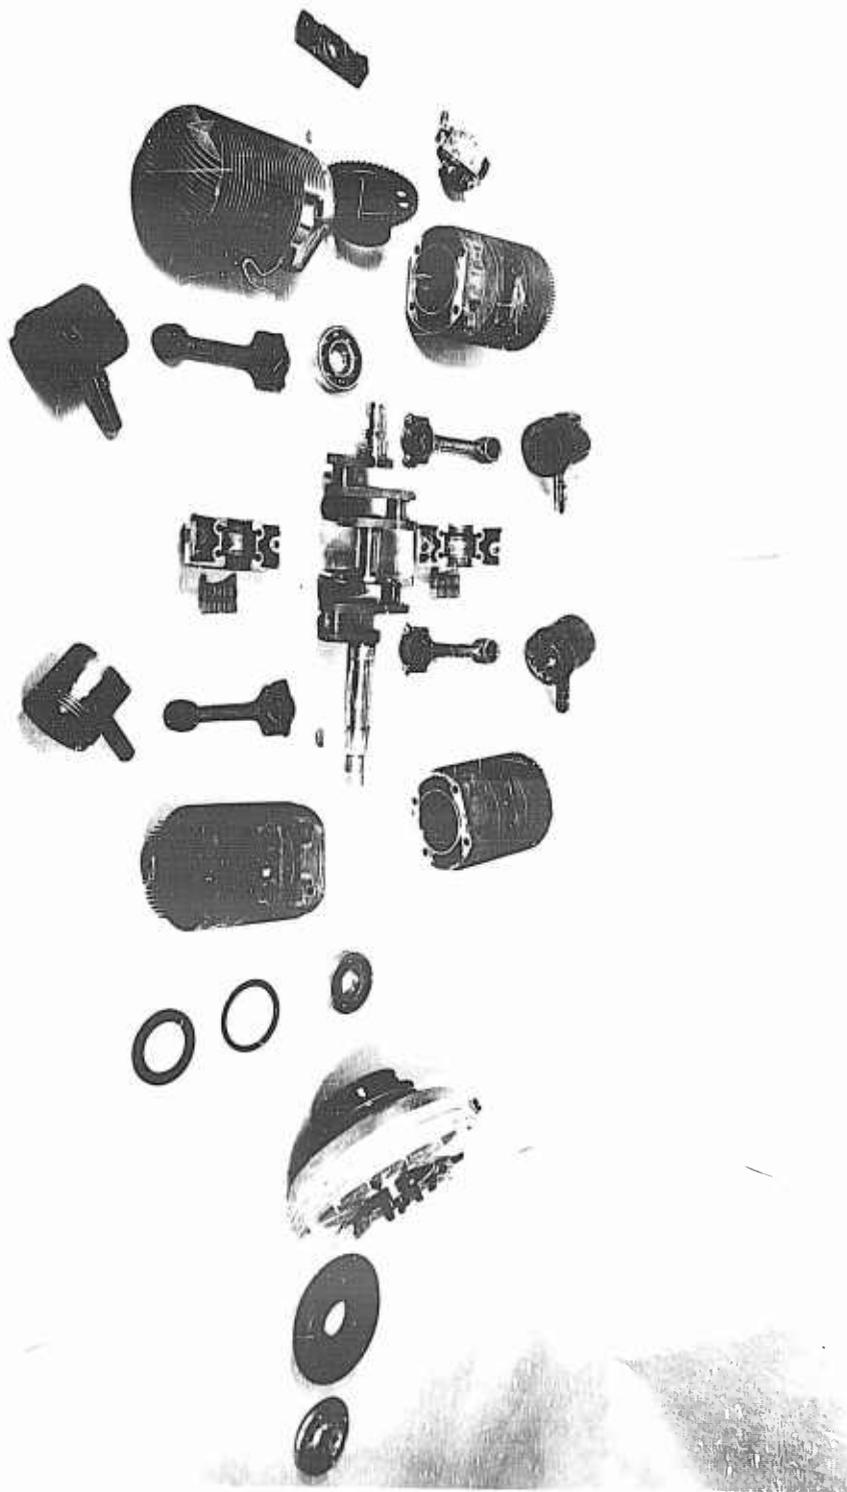
PLATE 14

e. Engine Serial No. 431-C-3 (rebuilt) was completely disassembled after the third cylinder retention failure. Visual inspection of the bearings, rods, cylinders, journals, etc. showed them to be in satisfactory condition. A Magnaflux inspection of the steel parts and a Zyglo inspection of the aluminum crankcase showed no incipient failures. Plates 14 and 15 are photographic views of the disassembled engine after the final teardown inspection.

McCULLOCH YO-100-4 ENGINE, EXPLODED VIEW OF POWER SECTION COMPONENTS

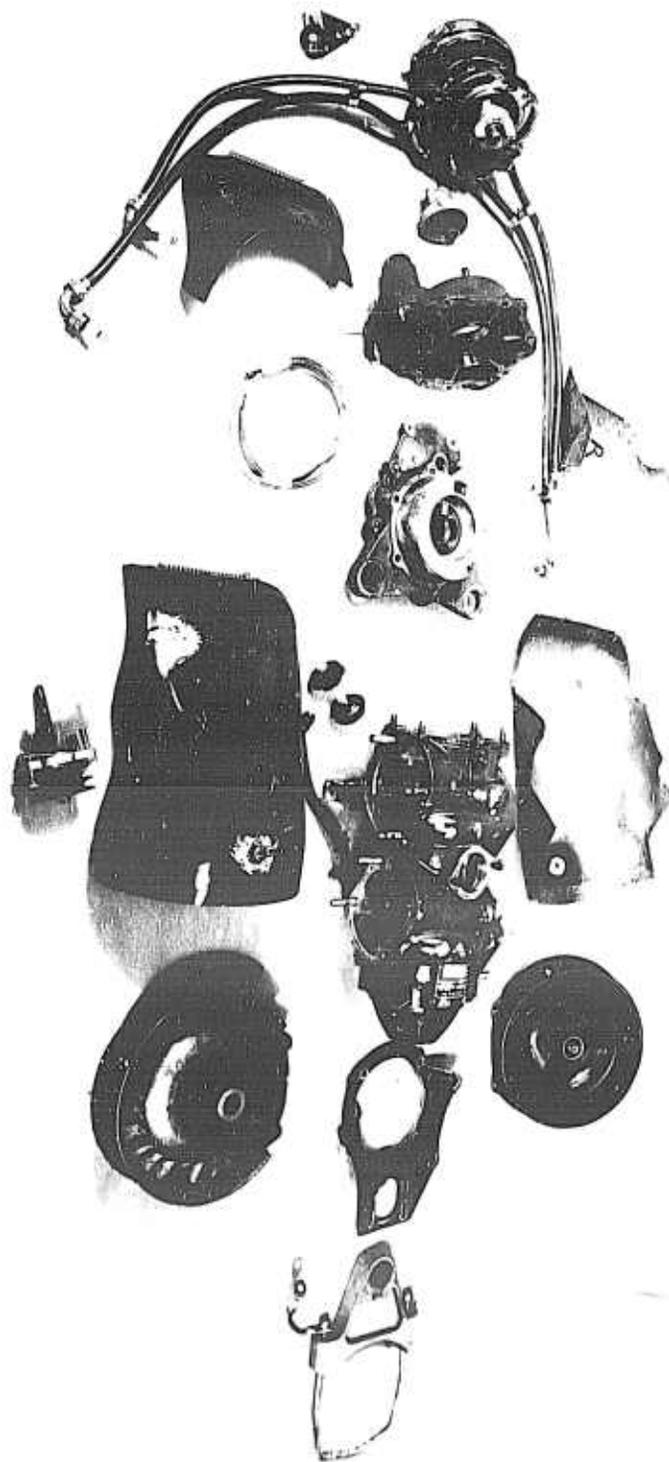
MCCULLOCH YO-100-4 ENGINE, EXPLODED VIEW OF COMPONENTS

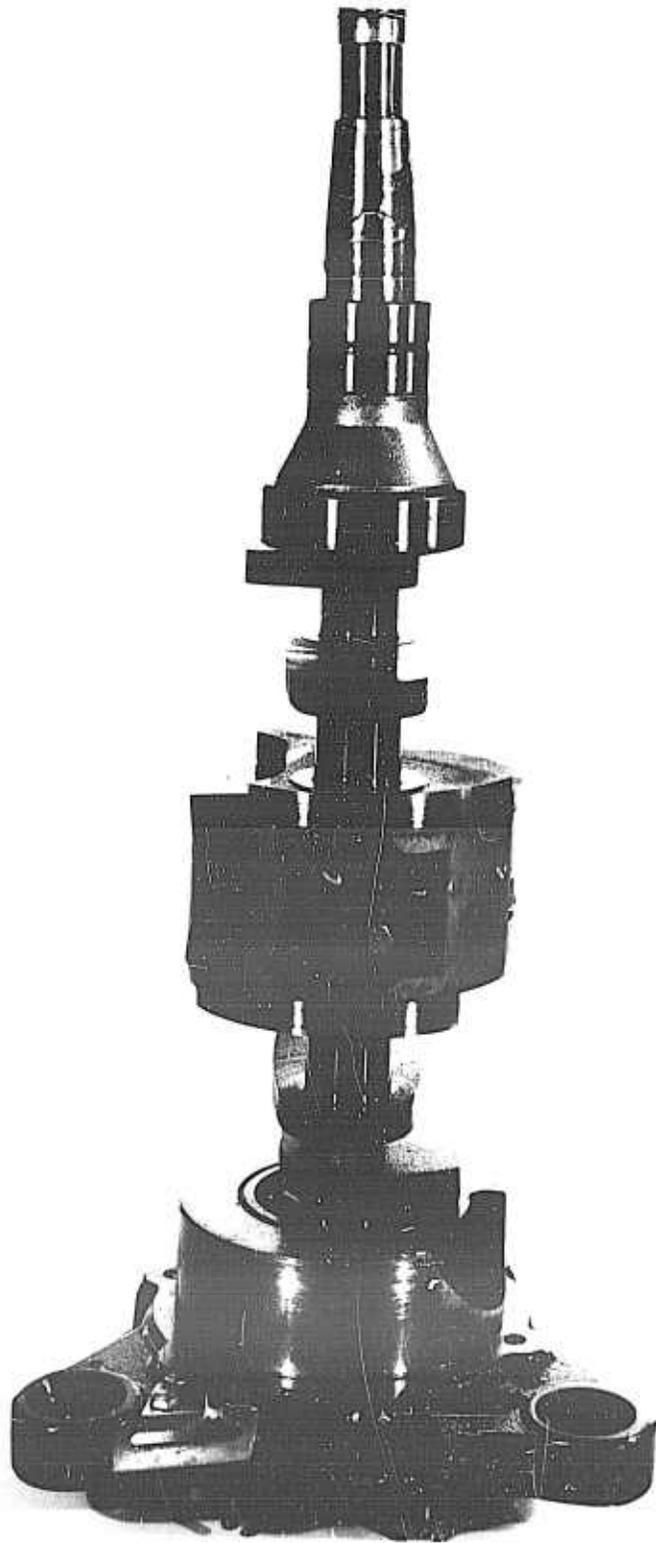
PHOTO NO: CAN-310127(L)-5-58

(1) Failure of the propeller shaft at 10.7 hours of total engine time. Investigation disclosed that the engine rear mounting spacers were too long for proper dynafocal pinch and thus allowed excessive engine movement. The spacers were manufactured by the Gyrodyne Co. to a McCulloch drawing dimension which was in error. Cutting 1/16 inch off the two spacers proved satisfactory. The fluid coupling adapter-propeller shaft taper fit was also unsuitable and the second propeller shaft taper was lapped to obtain a proper fit. A total of 113 hours of operation proved that the foregoing fixes were satisfactory.

CRANKSHAFT ASSEMBLY OF McCULLOCH 0-100-4 ENGINE

5. It is, therefore, recommended that the design, fabrication, and assembly of the engine and its components be reviewed with regard to the elimination of notch effects, proper bearing contacts, and misalignment.
