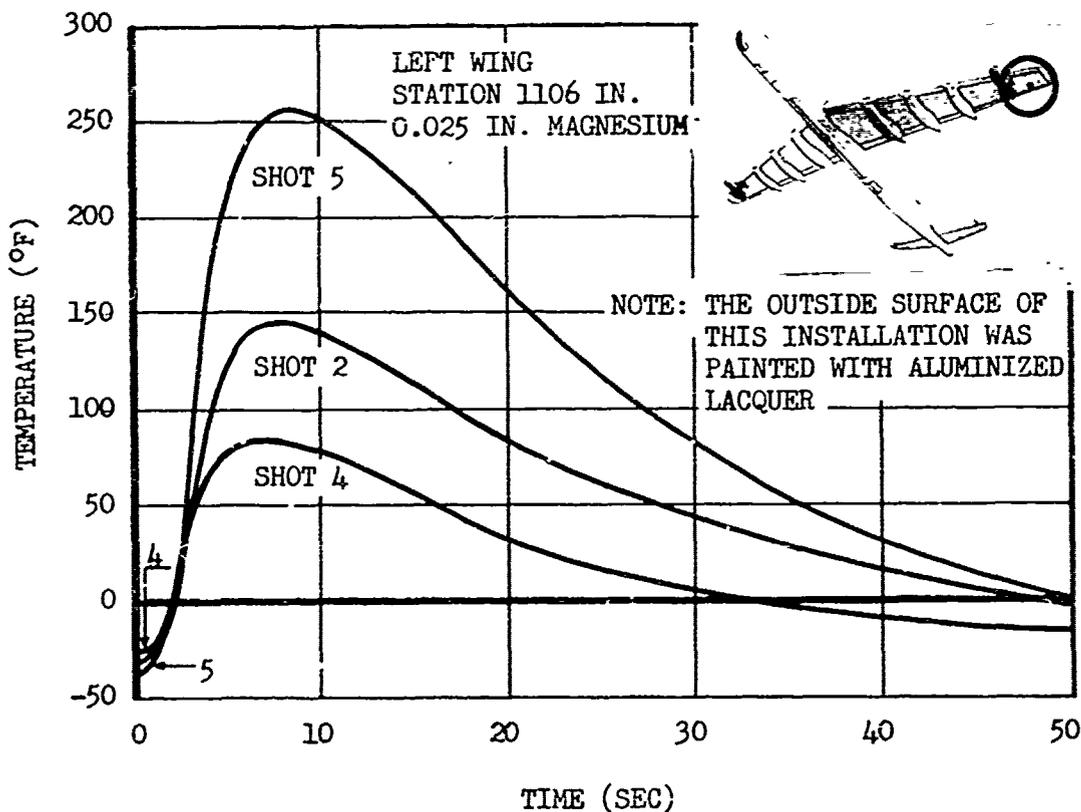
Fig. 4.8 Wing Skin Temperature vs Time

Figures 4.8, 4.10, 4.11, and 4.12 present the temperature curves for installations on Waffle panels of the left wing. Figure 4.9 shows the thermocouple arrangement that was utilized during Shots 2, 4, and 5 for wing waffle panel temperature measurements. The difference between the use of white enamel and aluminized lacquer can be studied by comparing the temperature rises of the skins at Stations 1068 and 1106 in. The data presented in Table 4.5, indicate that the absorptivity of the aluminized lacquer surface was slightly higher than the white enamel surface for Shots 2 and 5 and essentially equal for Shot 4.

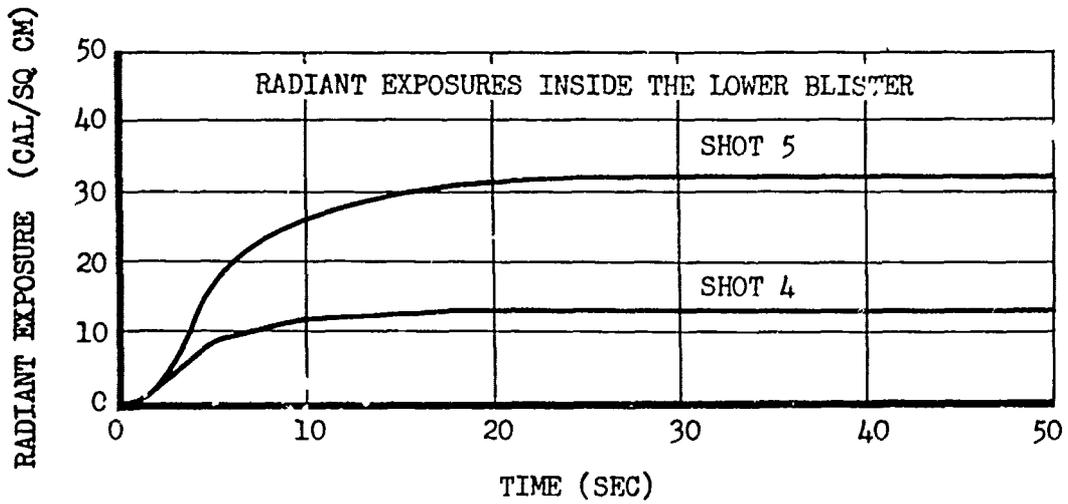
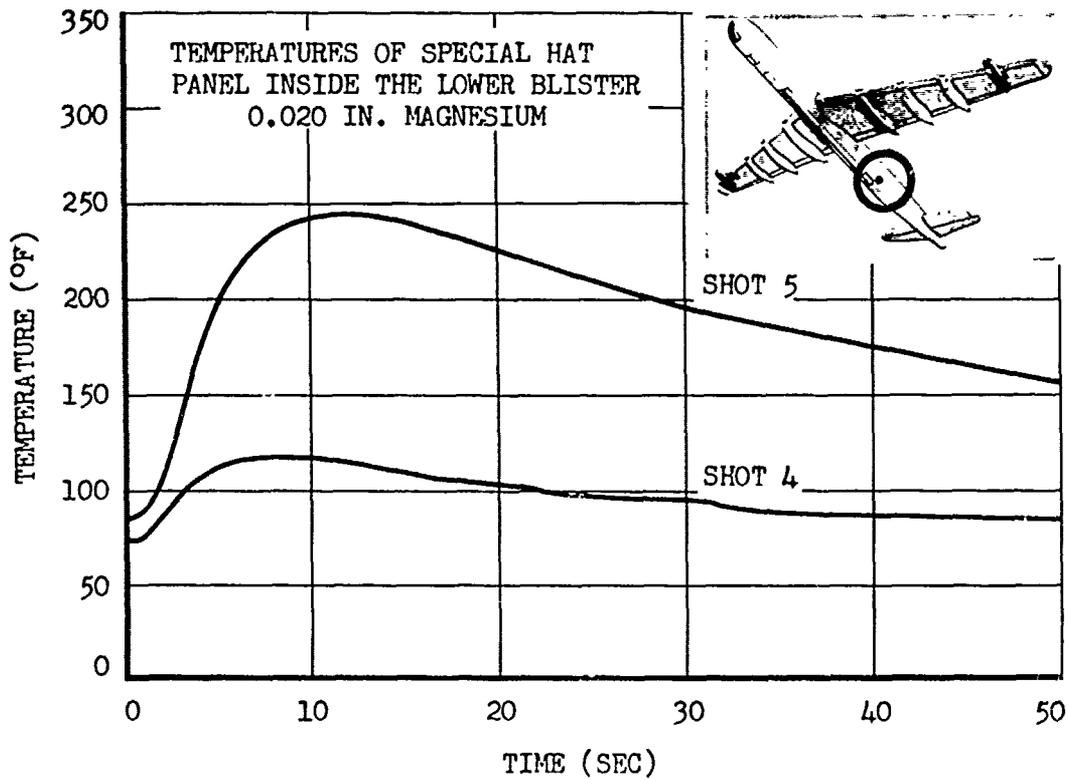
Fig. 4.13 Radiant Exposures and Skin Temperatures Inside the Lower Blister

Figure 4.13 presents the data obtained from the special instal-

lation located inside the aft lower left blister for shots 4 and 5. A comparison of the energies received inside the blister with those received outside (Fig. 4.1) for corresponding shots indicates that 76 and 71 per cents of the energies were received inside the blister for Shots 4 and 5, respectively. With this attenuation of the Plexiglas blister in mind, the hat panel skin temperature data can be analyzed to determine the cooling effect of the airstream over the external skin of the aircraft, in particular, that of the elevator since the installation was constructed from a section of an elevator hat panel and oriented so that the thermal energy would be received at approximately the same angle as that of the elevator.

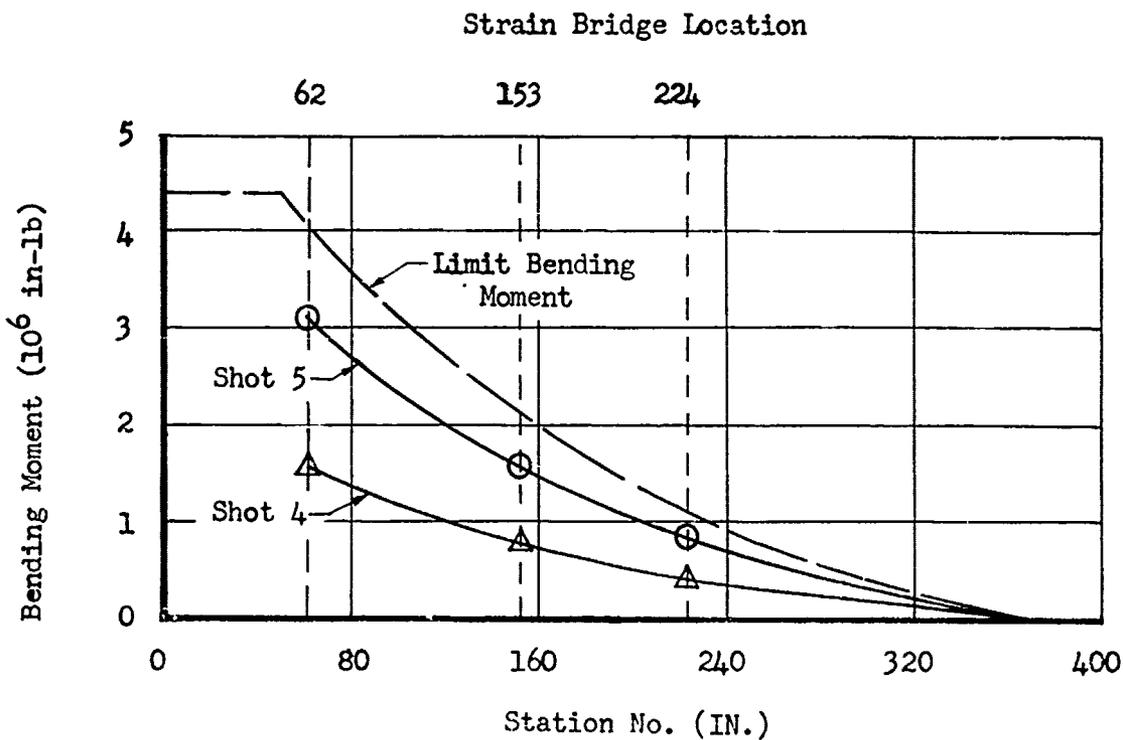
Fig. 5.4 Bending Moment Distribution Left Horizontal Stabilizer

The total bending moment values expressed in terms of the limit bending moments have been computed for the peak positive values obtained from the experimental data. The values pertaining to the horizontal stabilizer structure are contained in Table 5.4 and Fig. 5.4.

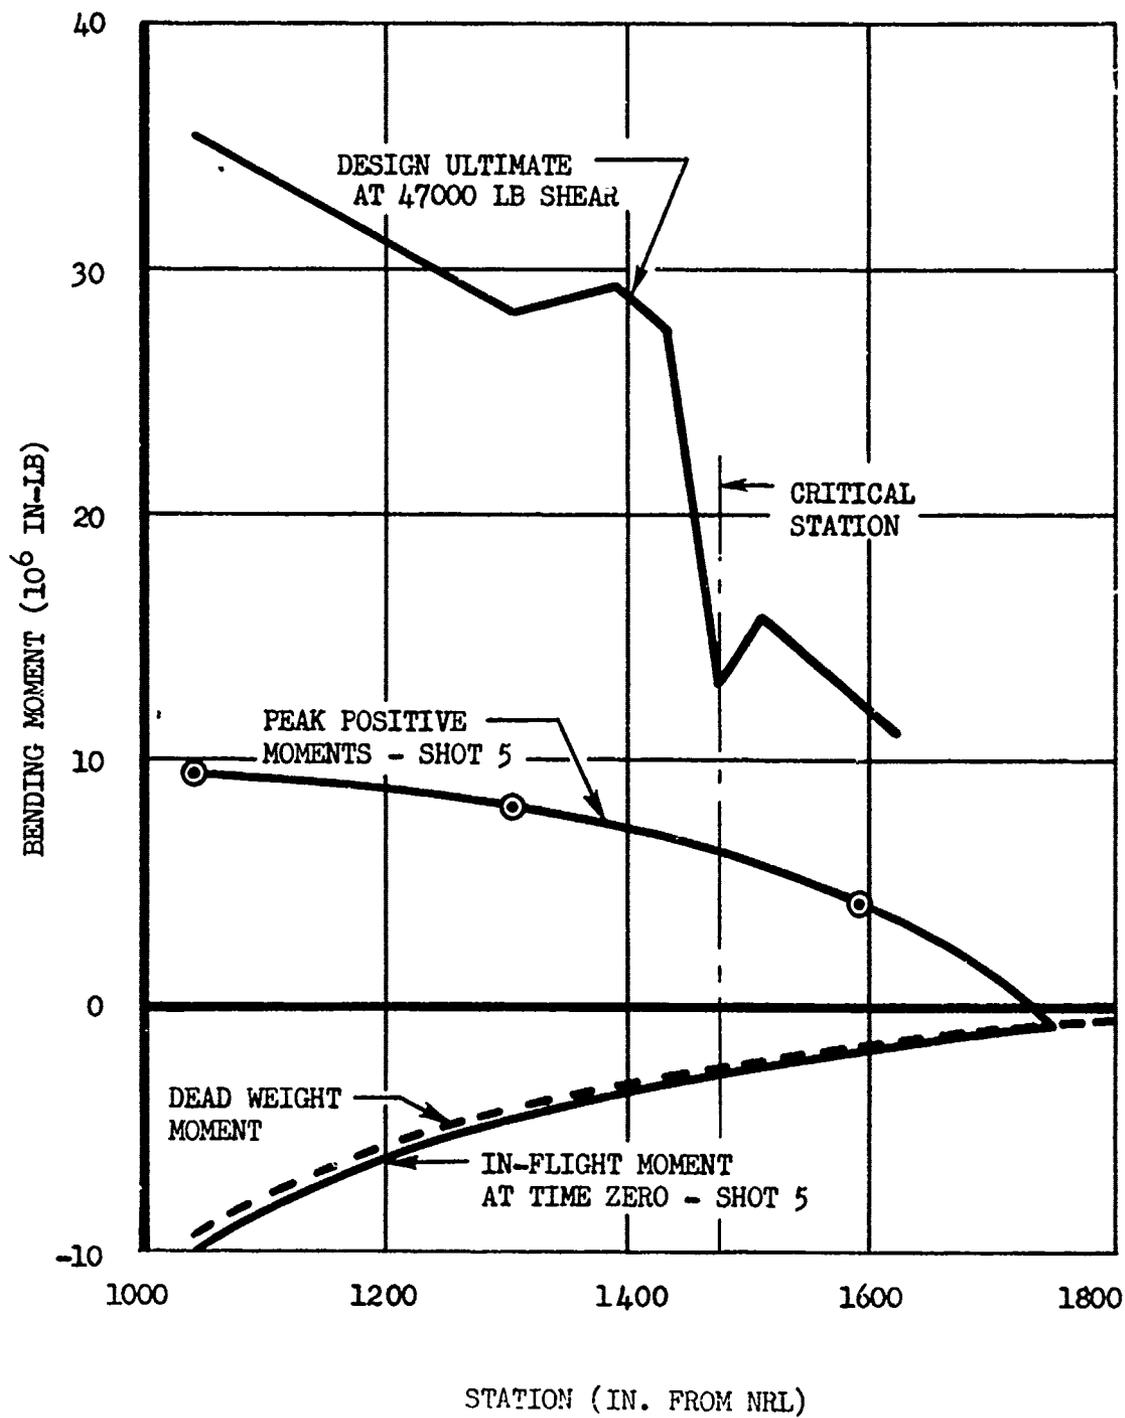
Fig. 5.5 Bending Moment Distribution Aft Fuselage Section, Shot 5

An analysis of this type is beyond the scope of this presentation; however, the change in magnitude of ultimate bending with a change in shear is not so large as to prohibit an approximation utilizing an ultimate curve established for a constant shear value. The curve presented in Fig. 5.5 is the ultimate bending moment distribution for a 47,000-lb. shear load, this load approximating the static load upon the horizontal stabilizer, at 90 per cent of limit bending of the stabilizer. From this curve it appears as if Stat' 1476 in. is the critical station, representing the aft bulkhead (No. 12) of the aft crew compartment. The use of the usual safety factor in order to define a limit moment at this station results in a limit moment of 8.65×10^6 in-lb, which is two-thirds of the ultimate value. The peak positive bending moments, that is, the peak moments above the strain-zero condition, define a moment distribution along the fuselage section. These peak positive moment values are the differences between the in-flight bending moments and the measured peak moments obtained from the experiment. In order to define the moment at the critical station, it is necessary to draw a curve through the three points obtained from the measured data. A fourth point may be utilized, the point where there is no change of bending moment due to the blast loading. Theoretically, this point occurs at the location of the effective loading, where the horizontal stabilizer transfers its load to the fuselage. The results may be seen as the smooth curve of Fig. 5.5. It is realized that this smooth curve may not represent the bending moment distribution; however, in order to define the percentages of limit attained during the experiment, it will be used as a first approximation.

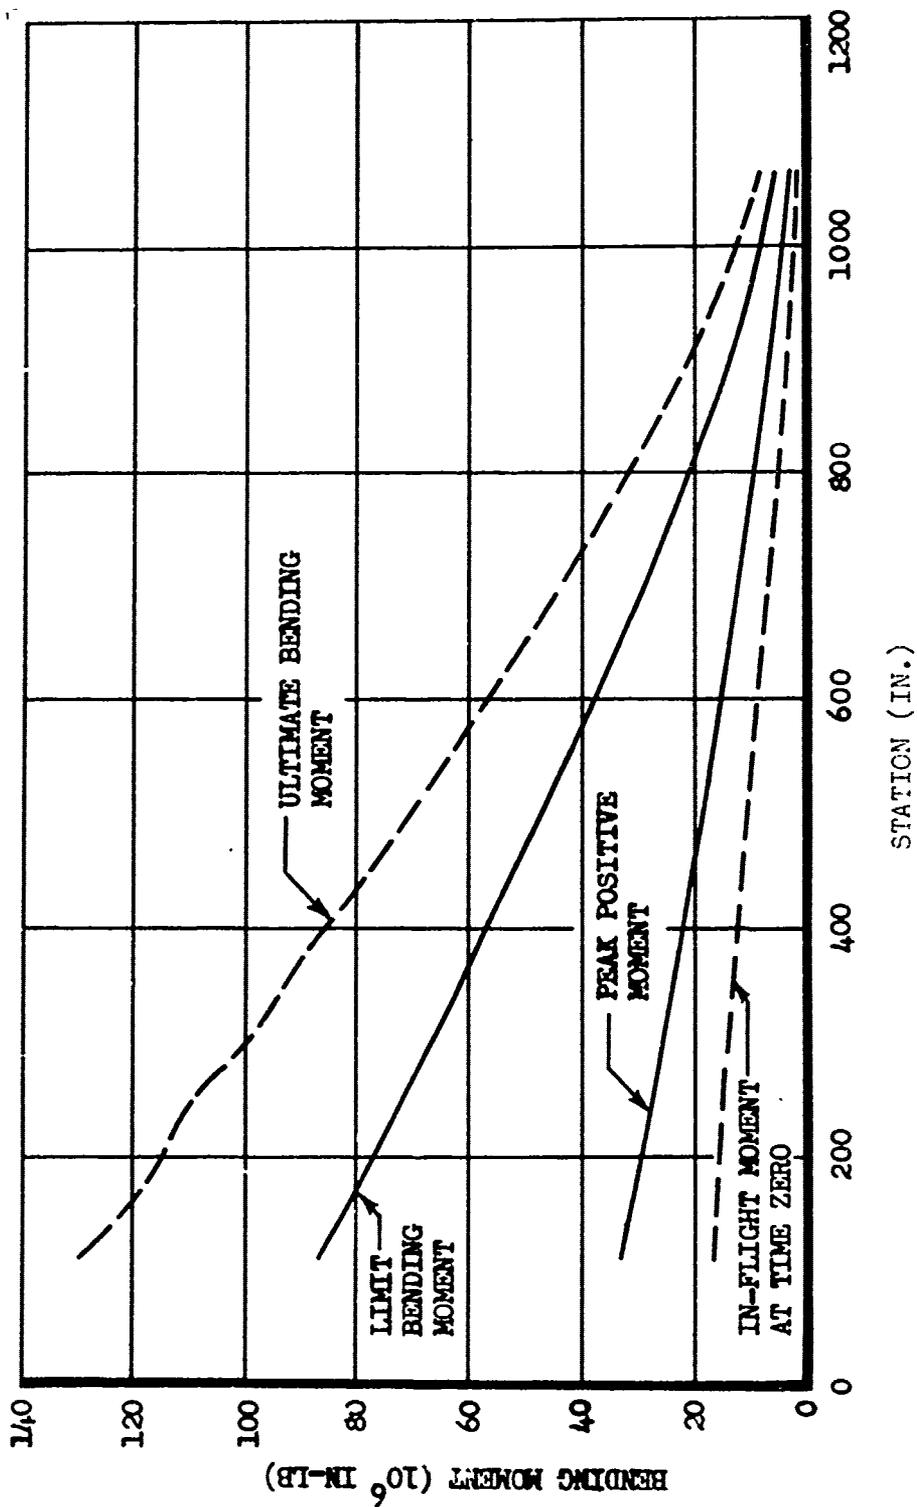
Fig. 5.6 Bending Moment Distribution Left Wing. Sheet 5

The wing bending moment distribution during Shot 5 is graphically represented by Fig. 5.6. The limit curve shown on this figure has been drawn as a smooth curve rather than following the small irregularities in the ultimate bending curve.

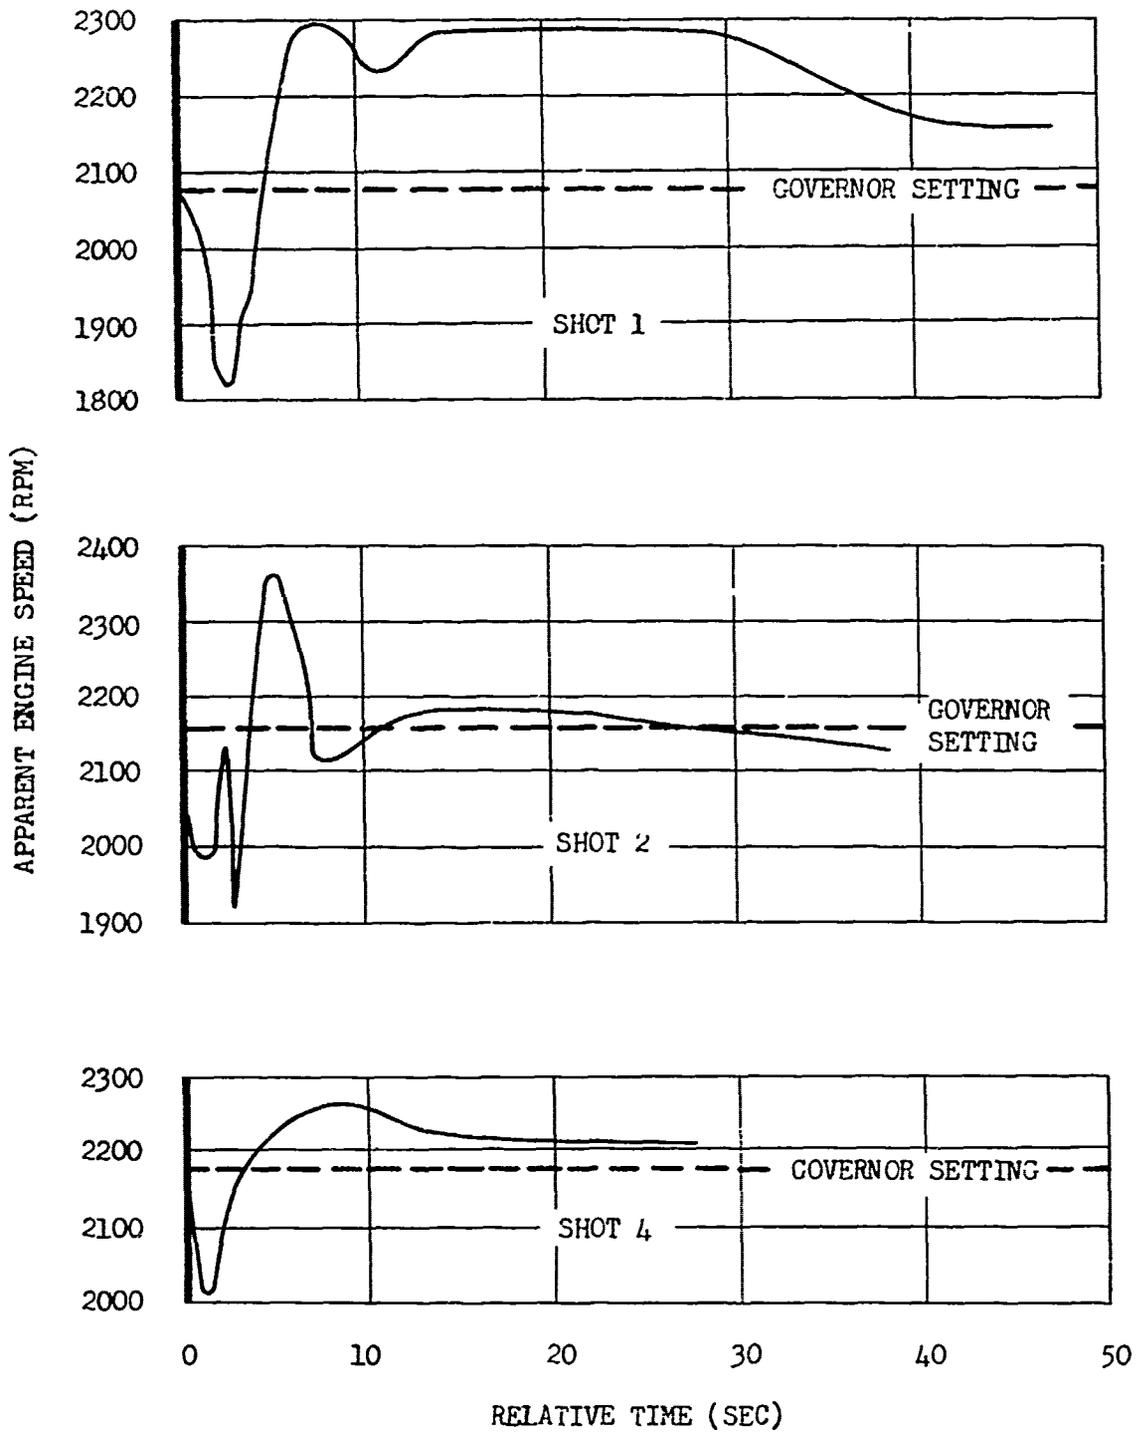
Fig. 5.7 Apparent Engine Speed Change, Shots 1, 2 and 4

- a. The two inboard engines (No. 4 and 5) are responsible for the stabilizer vibrations as their propellers are directly ahead of the stabilizer airfoil; therefore, the curves of Figs. 5.7 and 5.8 probably represent the speed variations of these two engines although some effects from the other engines may possibly appear on the record.
- b. The response characteristics of the horizontal stabilizer may limit the rate to which it can provide a reliable indication of engine speed for transient input conditions.
- c. Resolution of the time axis is limited to 0.2-sec increments by the method of data reduction.

The relative response of engine speed to the shock waves for fully-automatic and hand-governed operation may be seen by comparing the response curves for Shots 1 and 5 with Shot 2. It is apparent that the hand-controlled method minimizes the engine speed fluctuations, but this is then dependent upon the skill of the flight engineer where an error in judgment might produce a more detrimental effect than the blast itself. It appears that the engine speed variation is not of sufficient magnitude to cause damage to the engines or their associated equipment; however, because it would probably occur again under similar circumstances, flight crews of propeller-driven aircraft capable of participating in a nuclear strike should be acquainted with the phenomenon as part of a briefing in order to prevent undesirable crew reactions to an unexpected engine speed change.
