R.A.E. Report No. PBW.2

May, 1963

EXPLOSION OF A TITANIUM FURNACE
AT THE JESSOP-SAVILLE WORKS, SHEFFIELD

An investigation into the explosion of a titanium arc-furnace is briefly described, and photographs of the more important pieces of wreckage are given.

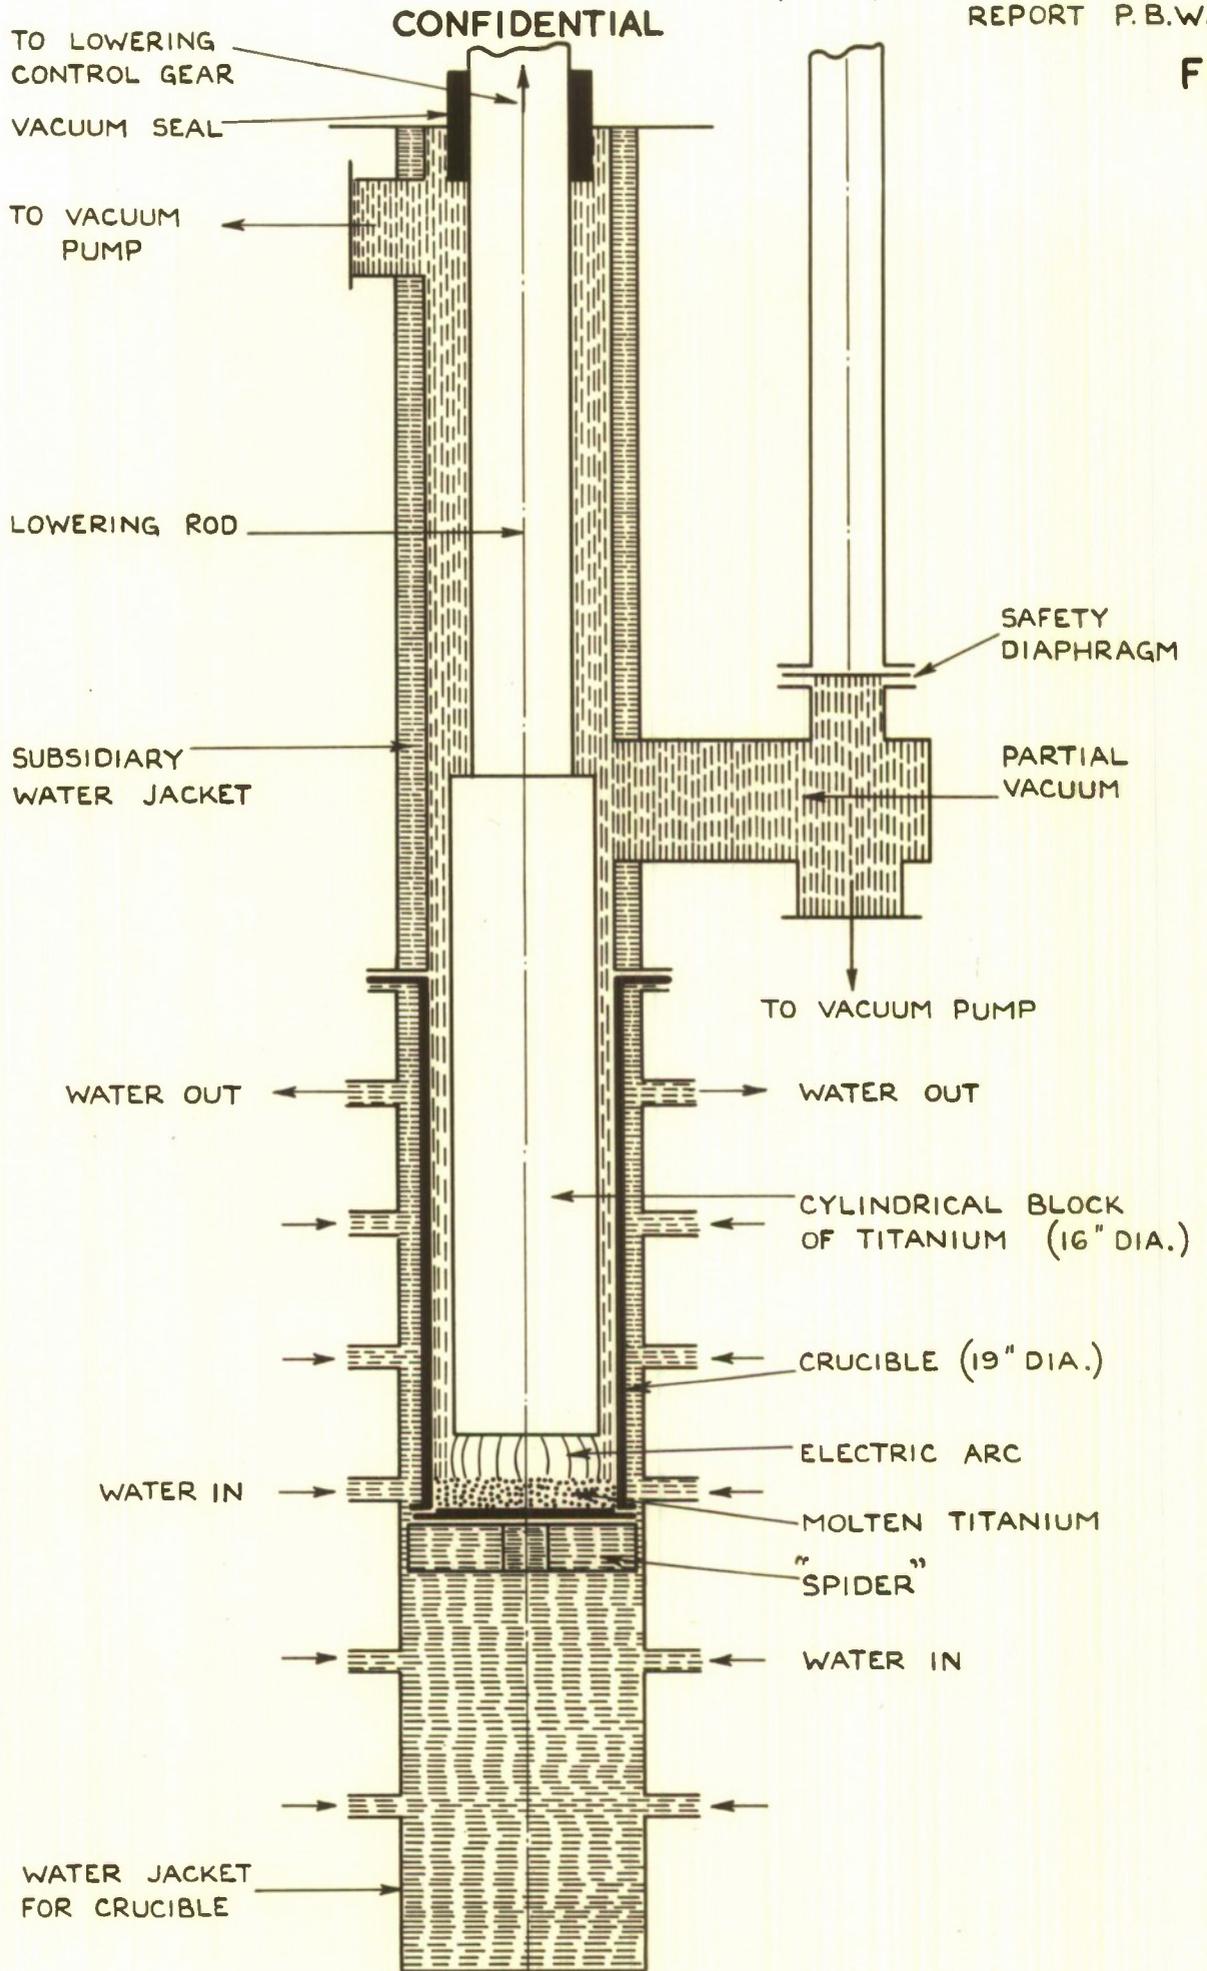
FIG.1. DIAGRAM OF TITANIUM MELTING FURNACE.

The furnace, which had seen many years service, operated on the principle of the electric arc at about 400 kilowatts of power. In this design, a cylindrical block of titanium, weighing initially about a ton, drips molten metal along a downward moving arc into a copper crucible. This crucible is cooled on the outside by a steady circulation of water enclosed in a steel jacket. The system is illustrated diagrammatically in Fig.1.
