WT-1132

The primary purpose of Project 5.1 of Operation TEAPOT was to determine the structural responses and progression of failure in the post-buckling range of aircraft structures when subjected to destructive gust loads produced by a nuclear explosion. Three QF-80 drones, chosen as the test vehicles, participated in full-scale field tests conducted at the Nevada Test Site during Shot 12.

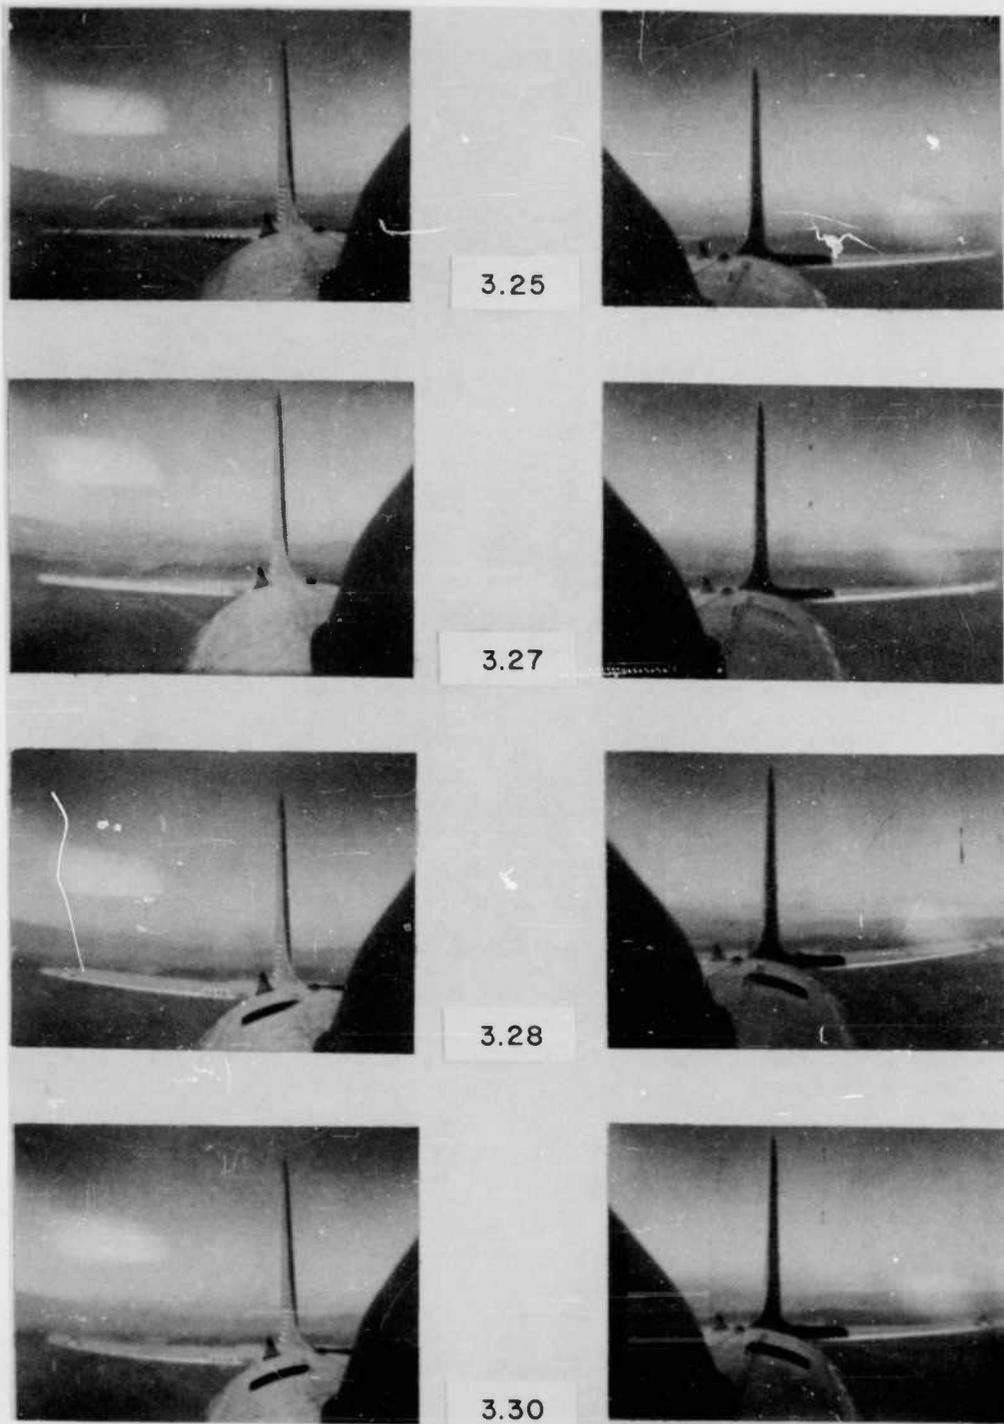
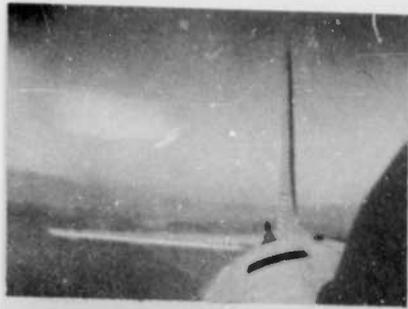
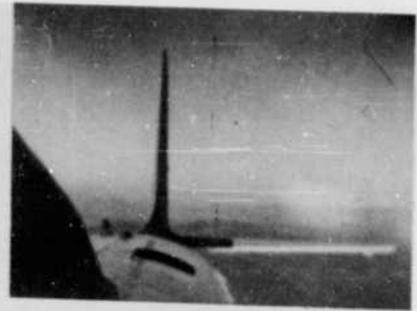
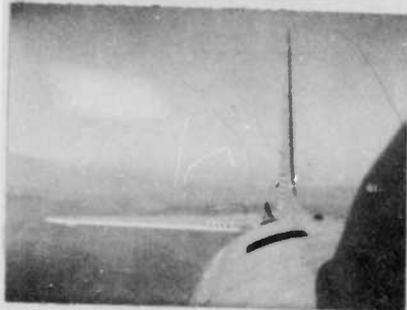
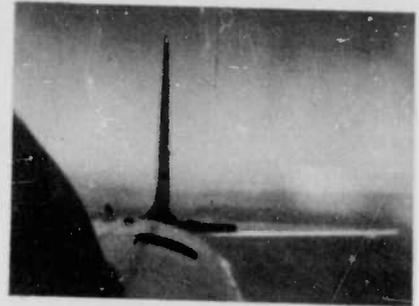
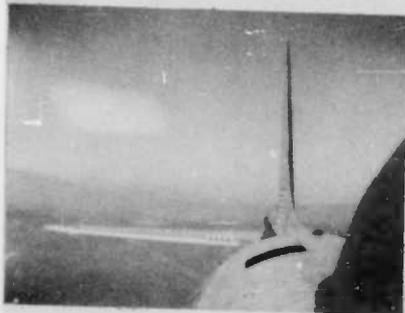
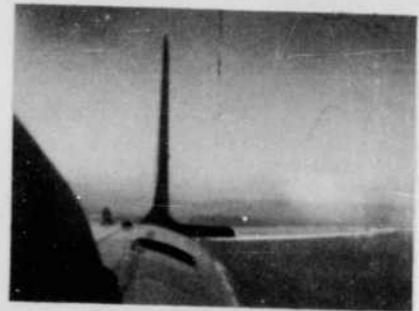
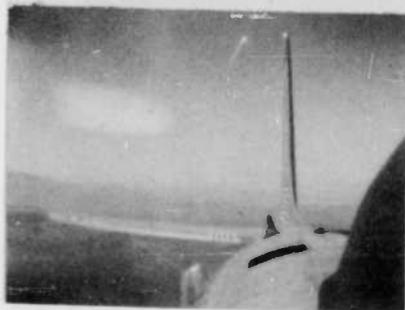
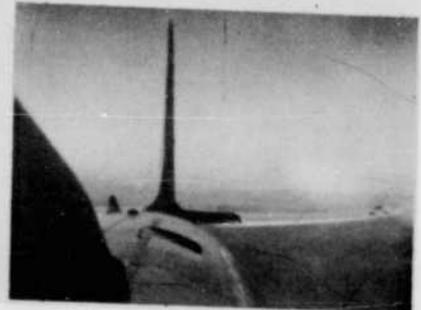
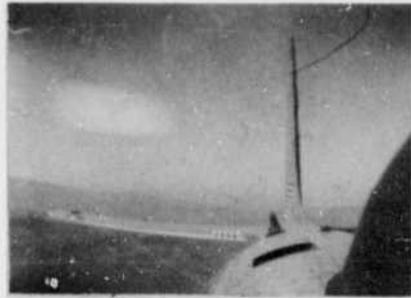
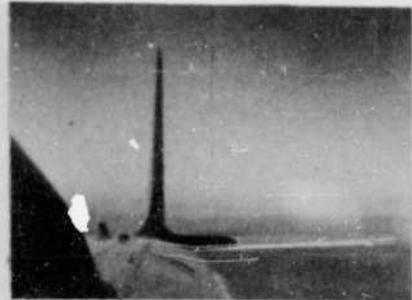
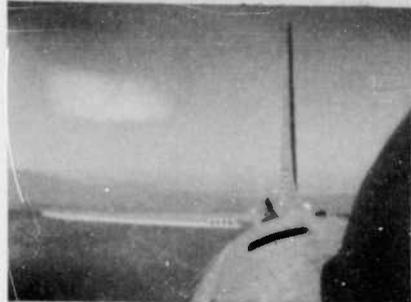
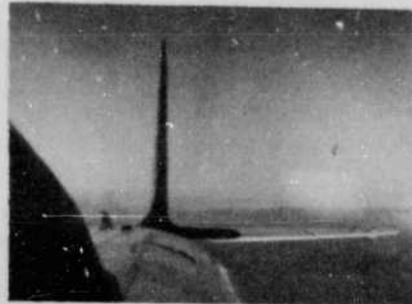
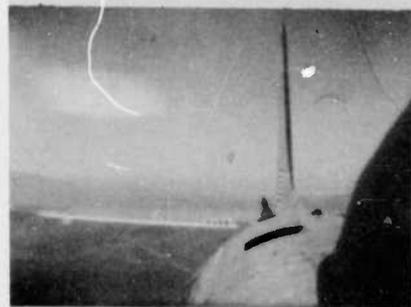
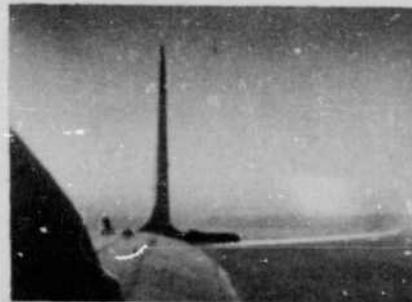
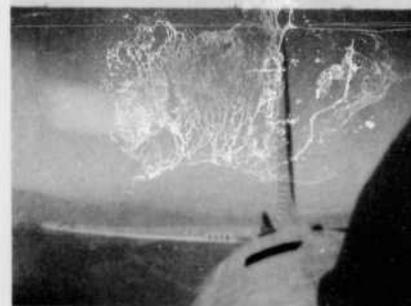
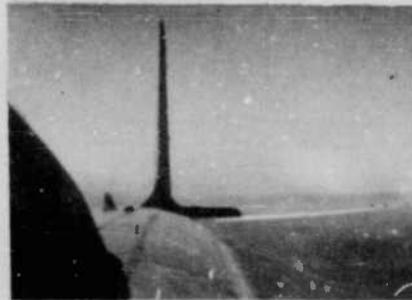
Figure 6.3 Horizontal Stabilizer Deflection at Shock Arrival, Drone 1. Numbers represent seconds after time zero.

Visual Damage. Close inspection of the recovered drone components in the field and in the laboratory revealed that the blast had very little permanent effect on Drone 1. The horizontal stabilizer was only slightly damaged by blast effects and to an even less degree by thermal effects. There were small permanent buckles, on the upper skin between Stations 40 and 50 on each side, which extended completely across the scab fix. There were also small permanent wrinkles in the elevator, particularly at the trailing edge. The ailerons and flaps had small wrinkles at the trailing edge, but the wing itself showed no indication of damage due to blast. Figure 5.16 shows the blast damage to the horizontal stabilizer and to the aileron. None of these effects would be likely to seriously affect the flight performance of the drone.

In Figure 6.3 is presented a portion of the sequence of photographs for Drone 1 which were used to measure the horizontal-stabilizer deflections presented in this report. These photographs cover the shock arrival and about the first 0.18 second after shock arrival, or past the two major peaks. Comparable illustrations are shown in Figures 6.4 and 6.5 for Drones 2 and 3.

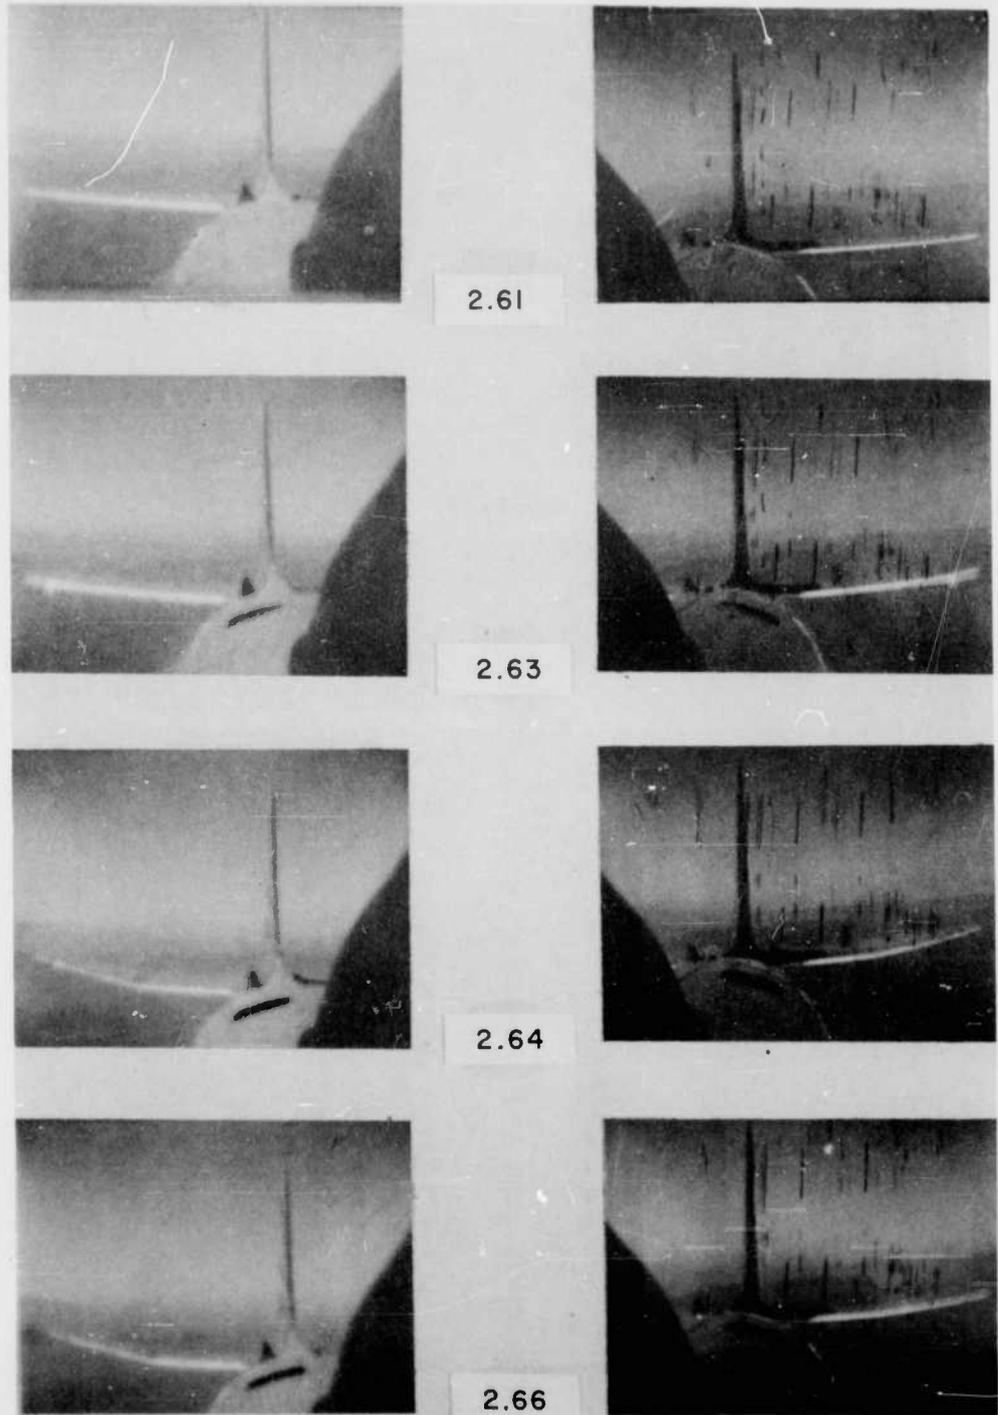
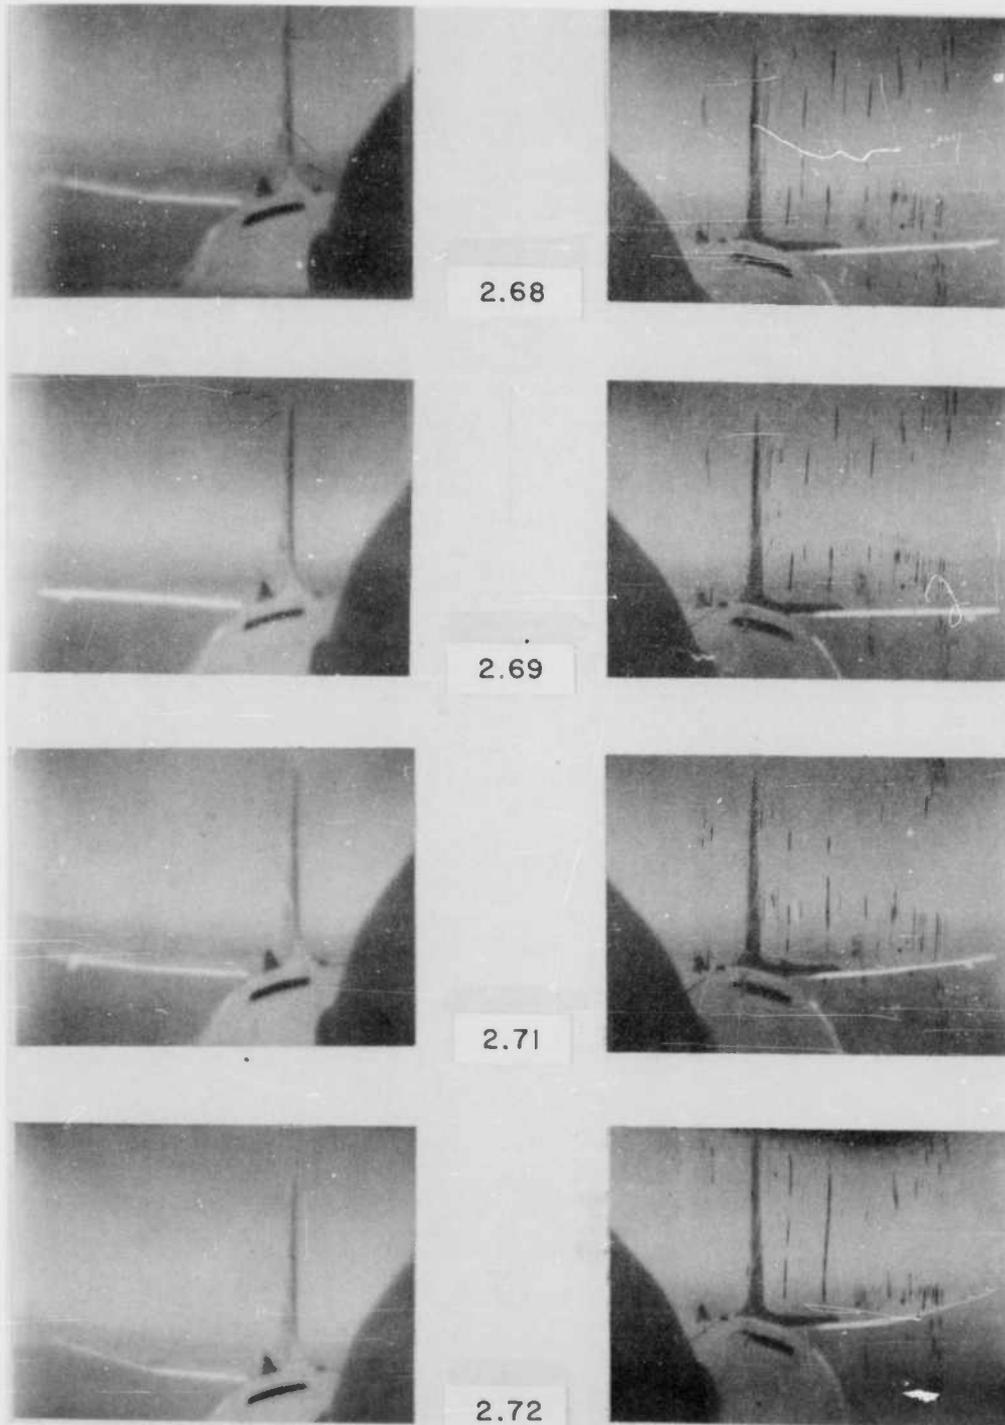
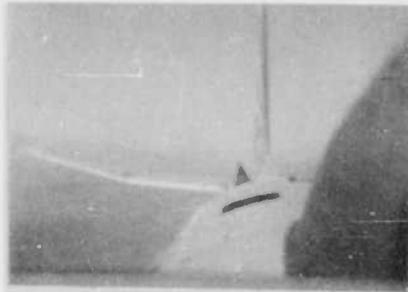
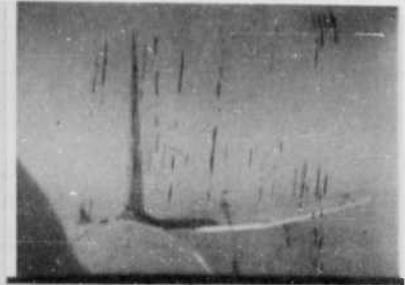
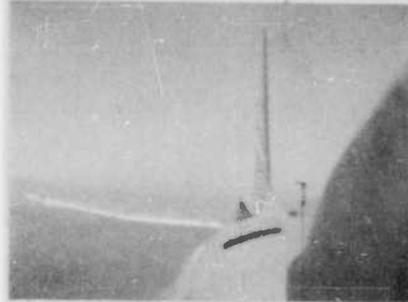
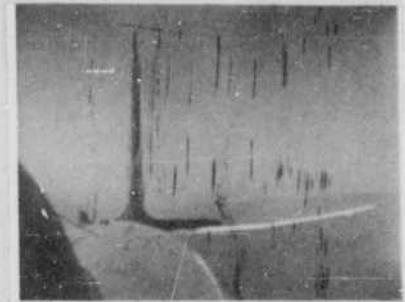
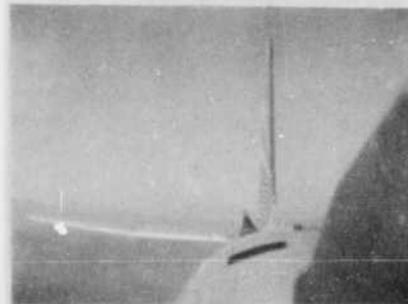
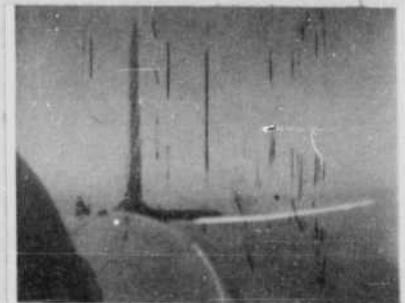
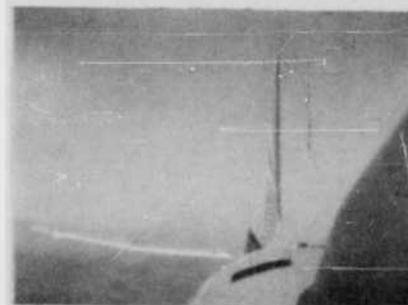
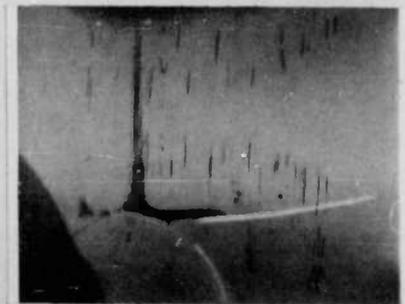
Figure 6.4 Horizontal Stabilizer Deflection at Shock Arrival, Drone 2. Numbers represent seconds after time zero.

Visual Damage. Close inspection of the recovered drone components in the field and in the laboratory revealed that the damage observed to Drone 2 was similar to that for Drone 1, only more severe (see Figure 5.17). The horizontal stabilizer was buckled between Stations 40 and 50 on both sides, and outboard of that point the stabilizer had a permanent set of about 3 degrees. The stabilizer buckled at about Station 48 at the leading edge, extended back to the vicinity of the main spar, and then moved diagonally inboard to about Station 42 at the trailing edge. There were several rivets popped on the upper skin. The elevators were movable but were binding slightly and showed evidence of rather severe rubbing at the outboard end.

Both the ailerons and flaps were wrinkled near the trailing edge, with the most severe damage at about the midspan of the aileron. Elevator control might possibly have been affected by the damaged elevator, but otherwise the flying capabilities should not have been seriously affected.

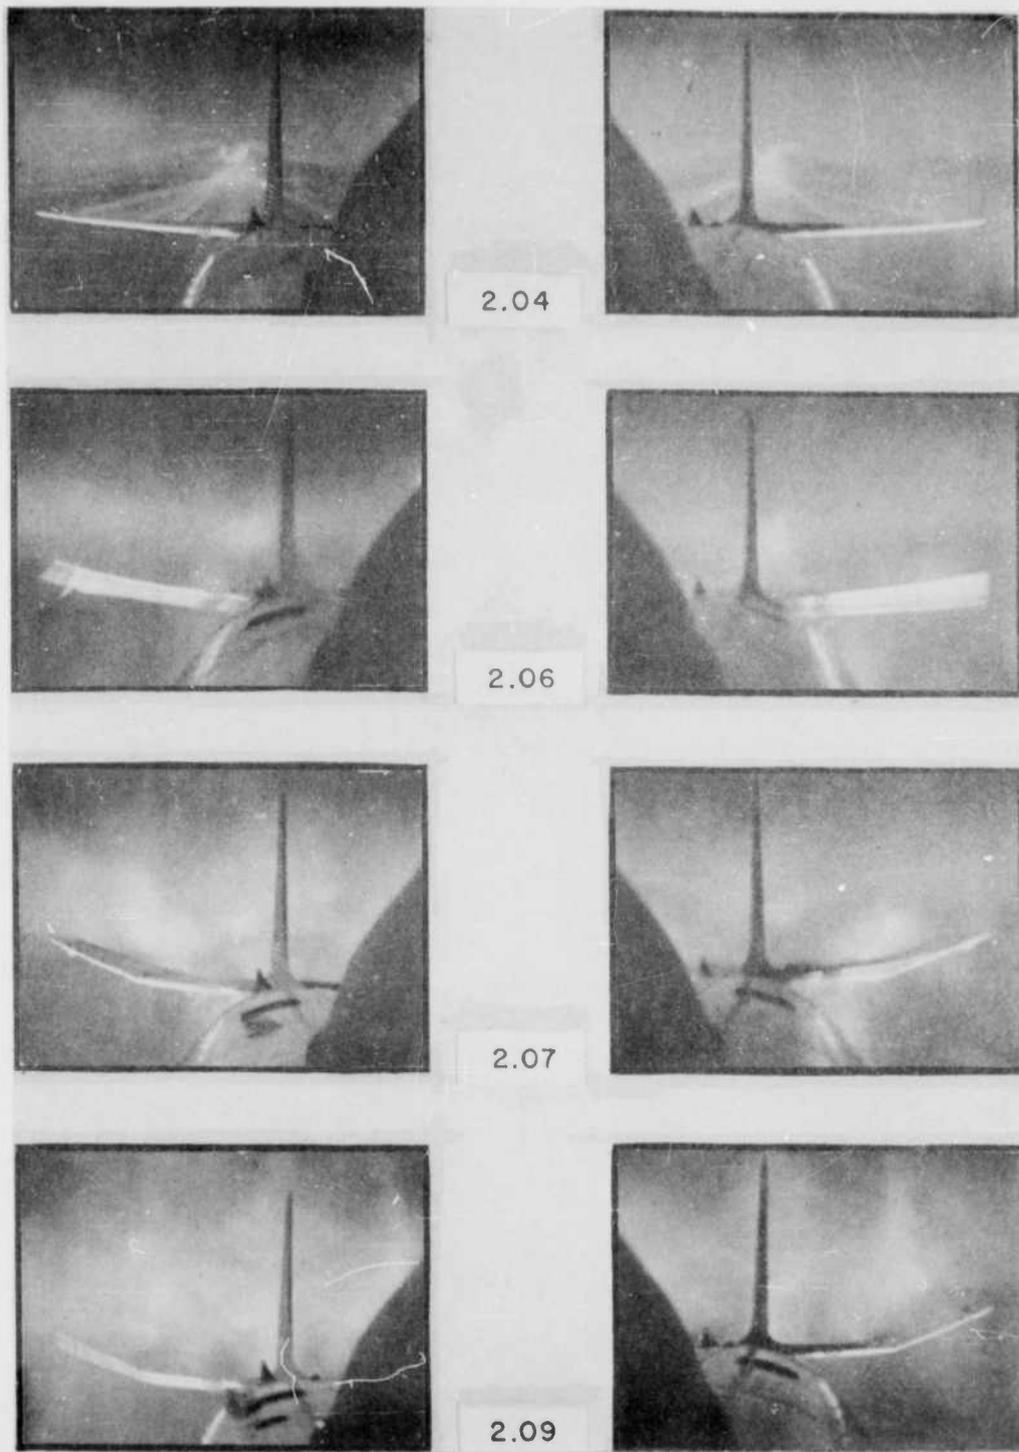
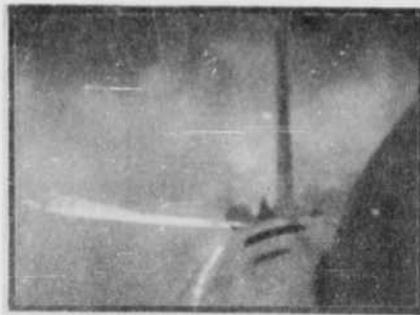
Figure 6.5 Horizontal Stabilizer Deflection at Shock Arrival, Drone 3. Numbers represent seconds after time zero.

Visual Damage. Close inspection of the recovered drone components in the field and in the laboratory revealed that Drone 3 was severely damaged by blast and thermal effects (see Figure 5.18). The horizontal stabilizer break was more severe than on Drone 2 and the permanent set was greater. The stabilizer broke at about Station 50 at the leading edge extending back to the main spar and then moved diagonally inboard to about Station 42 at the trailing edge. There were several rivets popped, and the skin was ruptured in several places. The elevators were also badly bent, with ruptures in the skin at about Station 42. From an inspection of the recovered stabilizer, it appears probable that the elevator could bind seriously and affect altitude control of the drone. Both ailerons were recovered and were considerably wrinkled and showed signs of thermal damage at the trailing edge.

Thermal damage on the horizontal stabilizer was extensive. Two large areas of paint were burned off from the leading edge to the trailing edge of the stabilizer. The burning started at the black deflection-calibration markers painted on the leading edge of the stabilizers. Although there was some scattered scorching and blistering of the lower surface in general, the thermal damage was primarily confined to areas which did not have clean white paint. Since no severe thermal damage occurred near the failure station, it seems unlikely that these burned areas seriously affected the failure due to gust.

An interesting photograph is shown in Figure 6.5, Sheet 1, at 2.07 seconds on the right side of the page. In this picture the camera caught two images of the left side of the horizontal stabilizer, one just before failure was reached and the other just after. Since the exposure time of

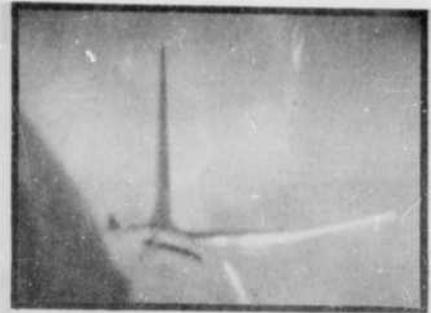
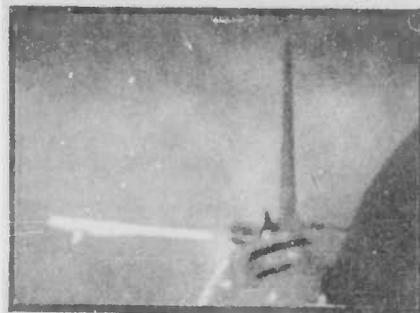
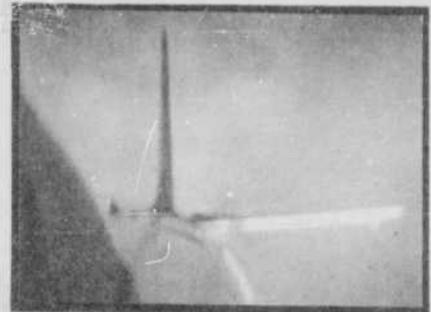
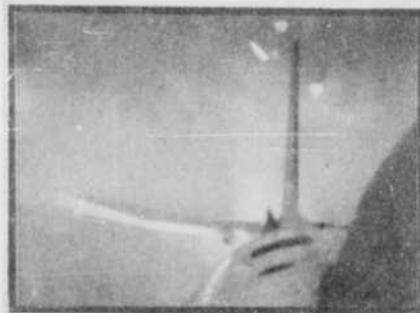
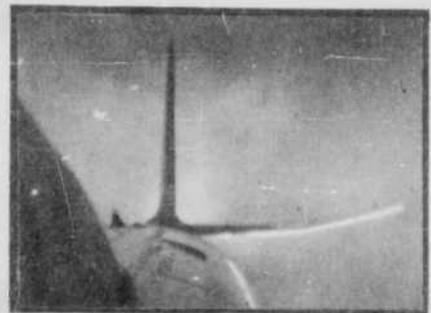
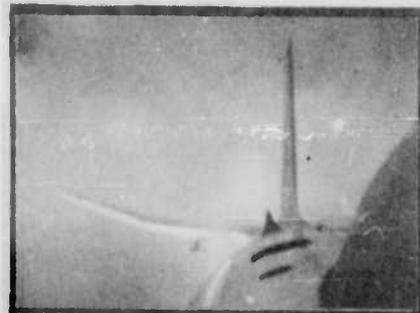
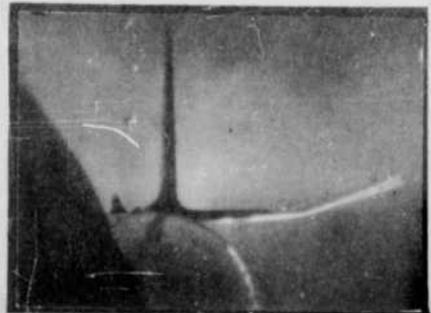
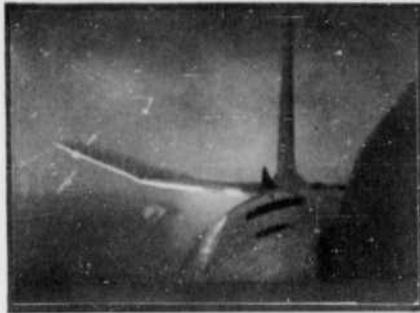
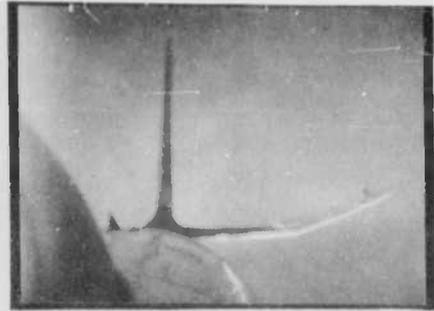
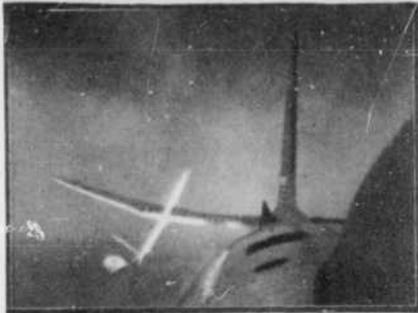
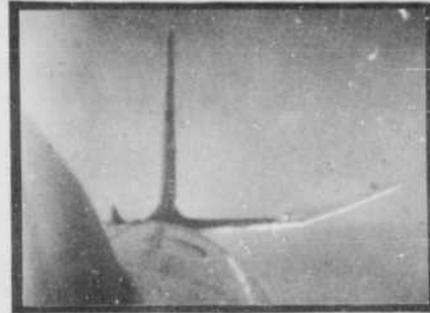
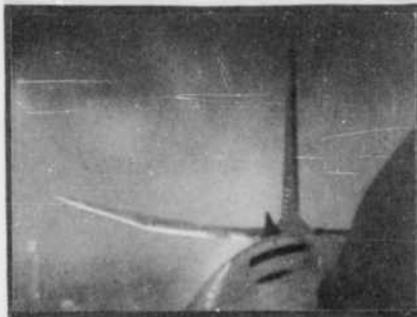
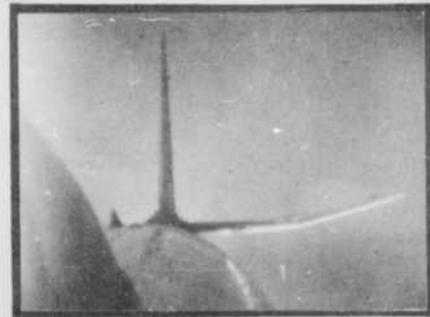
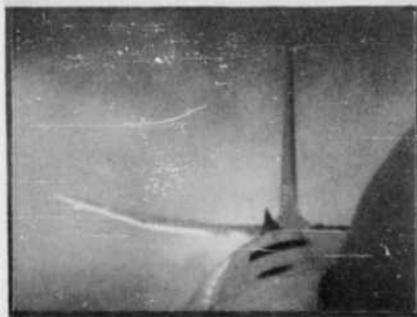
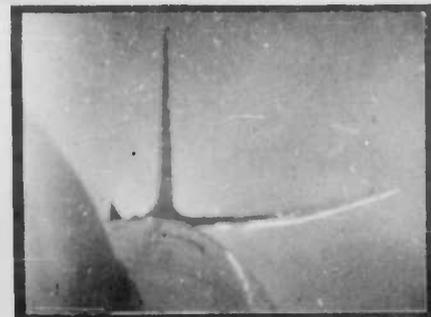
Figure 6.5 Continued.

this frame is less than 0.008 second, the picture clearly shows the rapidity of stabilizer movement and the wide range of position covered by a single frame.

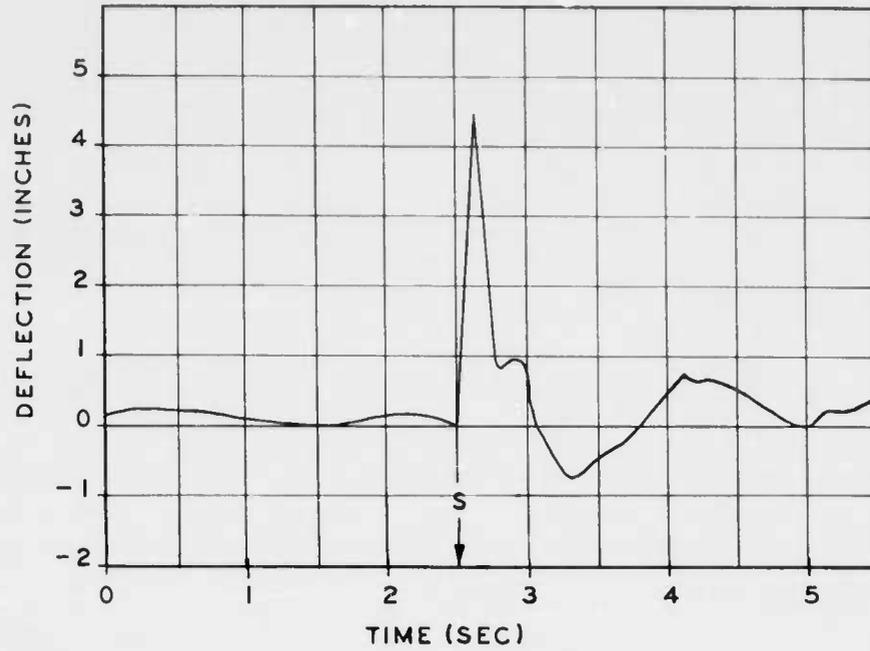
Fuselage. Fuselage deflection was obtained from airborne Cameras 2 and 5 and was measured at Station 373. Reference marks were painted on the vertical stabilizer a little aft of the leading edge. The change in position of these marks was measured and multiplied by the calibration factor to obtain deflection in inches. The accuracy of the individual data points is ± 0.54 inches. A typical fuselage deflection-versus-time history is presented in Figure 6.6.

Figure 6.6 Fuselage Deflection versus Time After T_0 , Station 373, Drone 2

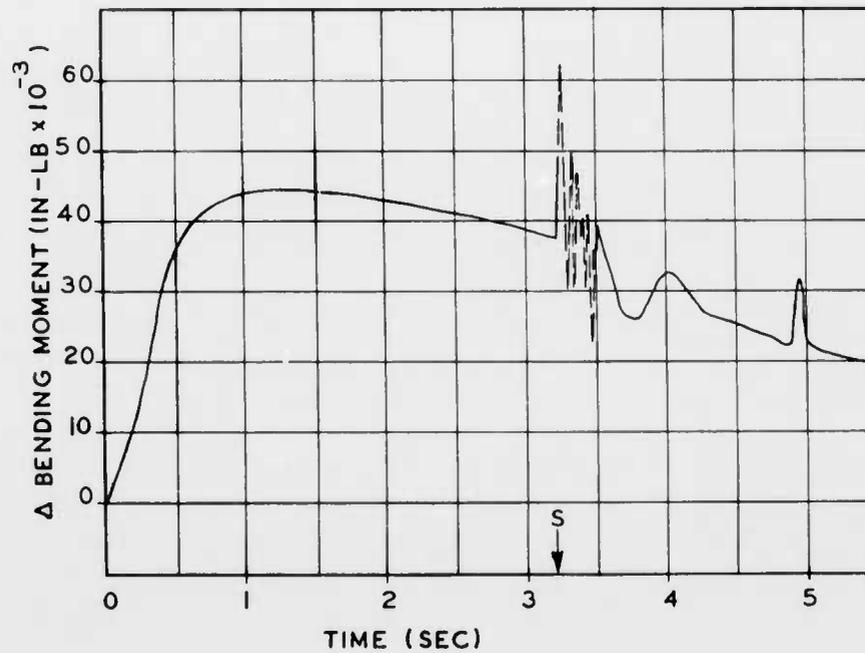
A typical bending-moment curve is presented in Figure 6.7, with the dashed line representing that portion of the curve which was not clearly legible on the record. In this figure the strain-gage response is termed "apparent" bending moment, because it includes the thermal effects at time zero which are not actually bending moment.

Figure 6.7 Horizontal Stabilizer Apparent Bending Moment, Station 43 Left, Drone 1

cameras between time zero and shock arrival and shown in the deflection figures of Chapter 5. This was also shown by the large deflections of the bending moment curves between time zero and shock arrival (see Figure 6.7).

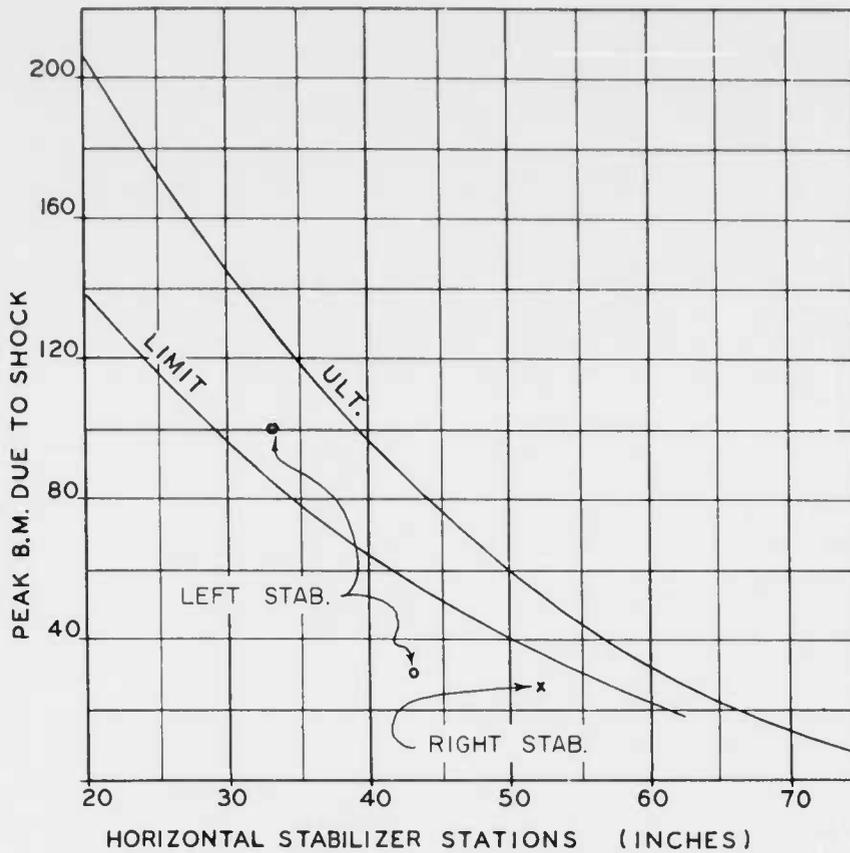
The peak values of bending moment obtained at all measuring stations are presented in Table 5.3. In Figure 6.8 the peak bending moments measured

Figure 6.8 Comparison Between Peak Bending Moments and Limit Loads, Drone 1

are plotted against horizontal-stabilizer station and compared with limit load. This graph shows that the measurement at Station 43 does not form a smooth curve with Stations 33 and 52 and is far below limit load. It is therefore assumed to be in error. This is possibly due in part to the proximity of the bending moment measuring station to the actual break station.

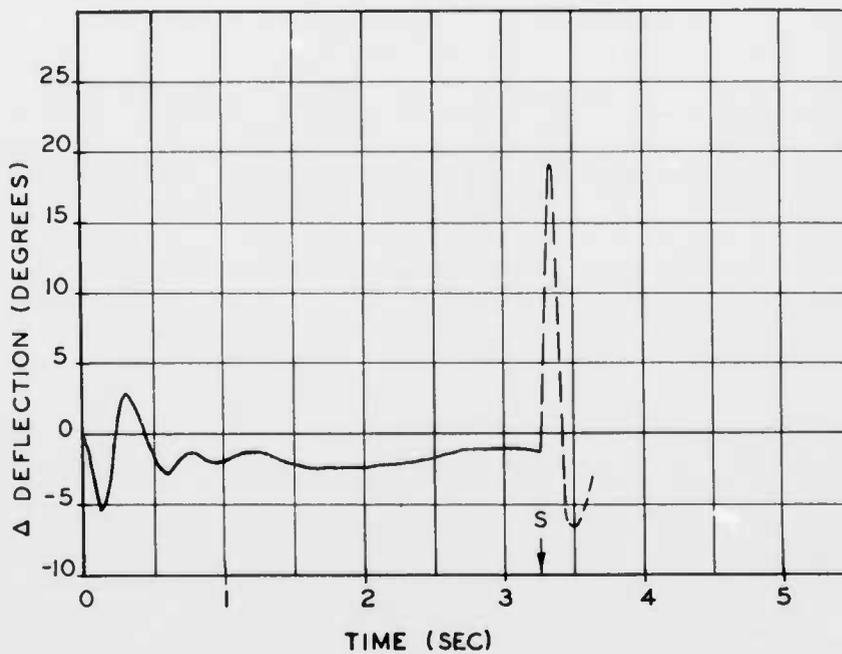
Figure 6.9 Elevator Deflection. Station Zero, Drone 1

6.2.5 Elevator Deflection. In Figure 6.9 is presented the elevator deflections at Station 0 on Drone 1. The elevator deflection for Drone 1 was obtained from the local recorder records and for Drones 2 and 3 from the telemeter records. The values of elevator deflection at shock arrival are obtained in the same manner as the bending moments discussed in the previous section and should be treated accordingly.

Except for the deflection at shock arrival, the curve of Figure 6.9 is typical of all three drones. For Drones 2 and 3 no deflections were measured after shock arrival. Although the amount of deflection varied from -5° on Drone 1 to -9° on Drone 3, it was generally the same for all stations on a given drone. The oscillation immediately following time zero was observed to have the same approximate period for all drones. The amplitude, however, varied inversely with the distance from the blast. This oscillation was also observed on all drone instrument-panel cameras as control-stick motion. No explanation of this phenomenon can be advanced at this time, however.

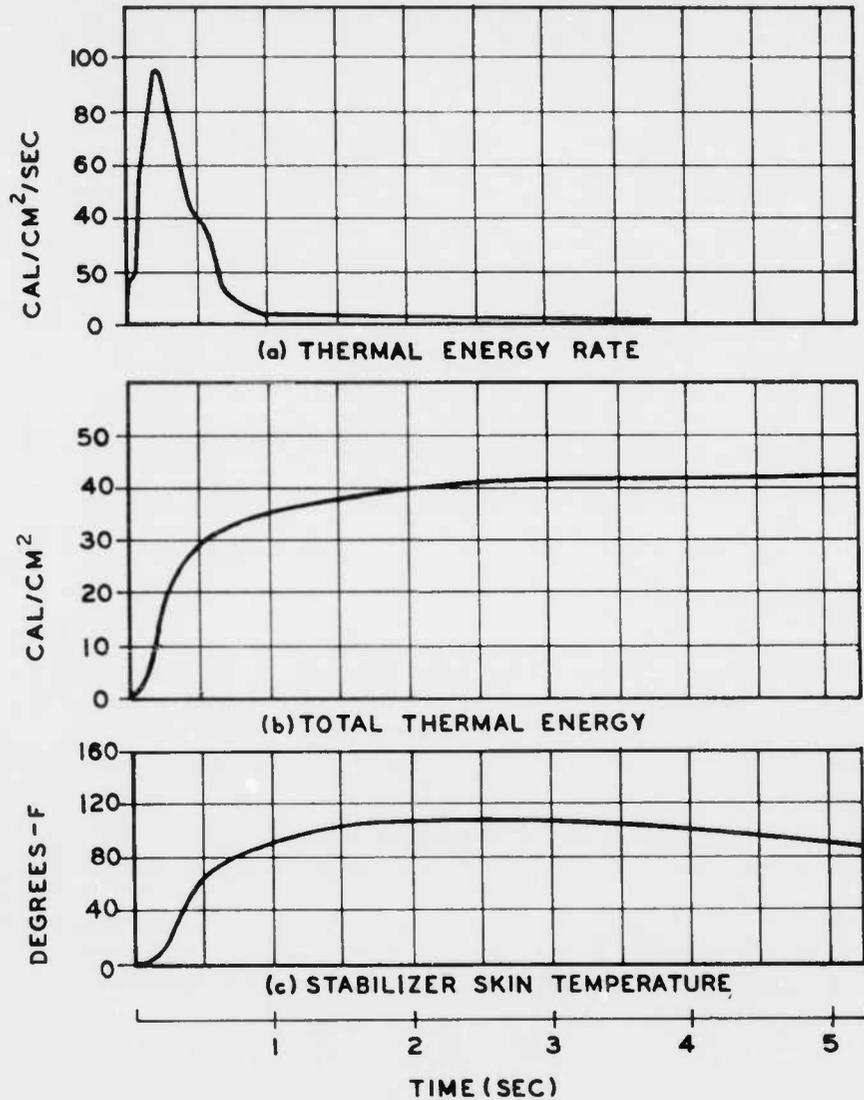
Time-history curves of thermal-energy rate, total thermal energy and horizontal-stabilizer skin temperature are given in Figure 6.10. These curves are typical of all drones, except for peak values obtained. As expected, the decline of thermal energy rate between 0.2 and 0.7 second was slower for Drone 3 and faster for Drone 1 than that shown for Drone 2. The total thermal energy leveled off at 5 to 6 seconds, and skin temperature reached a maximum at 2 to 3 seconds. The maximum values measured for all drones are given in Table 5.3.

Figure 6.10 Thermal Curves, Drone 1

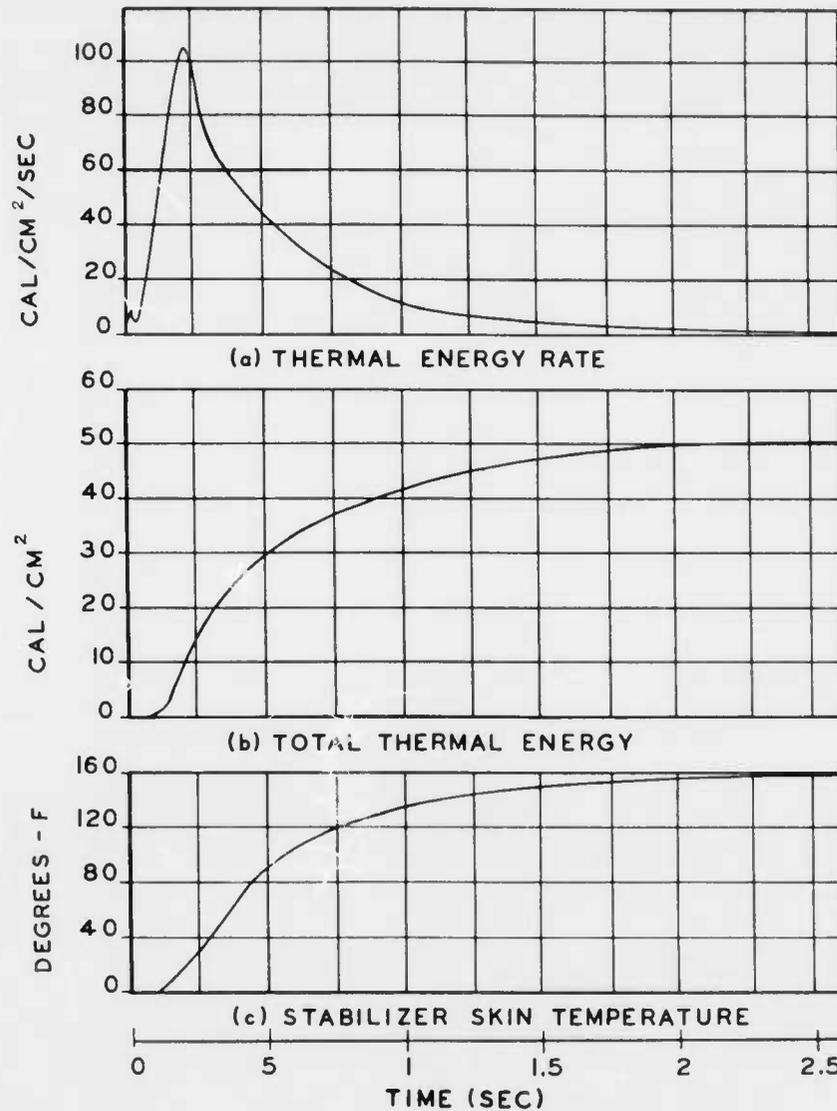
* This is not maximum value for Drones 2 and 3, since thermal energy was still increasing when the record was lost at shock arrival. See Figures 6.11 and 6.12.

Figure 6.11 Thermal Curves, Drone 2

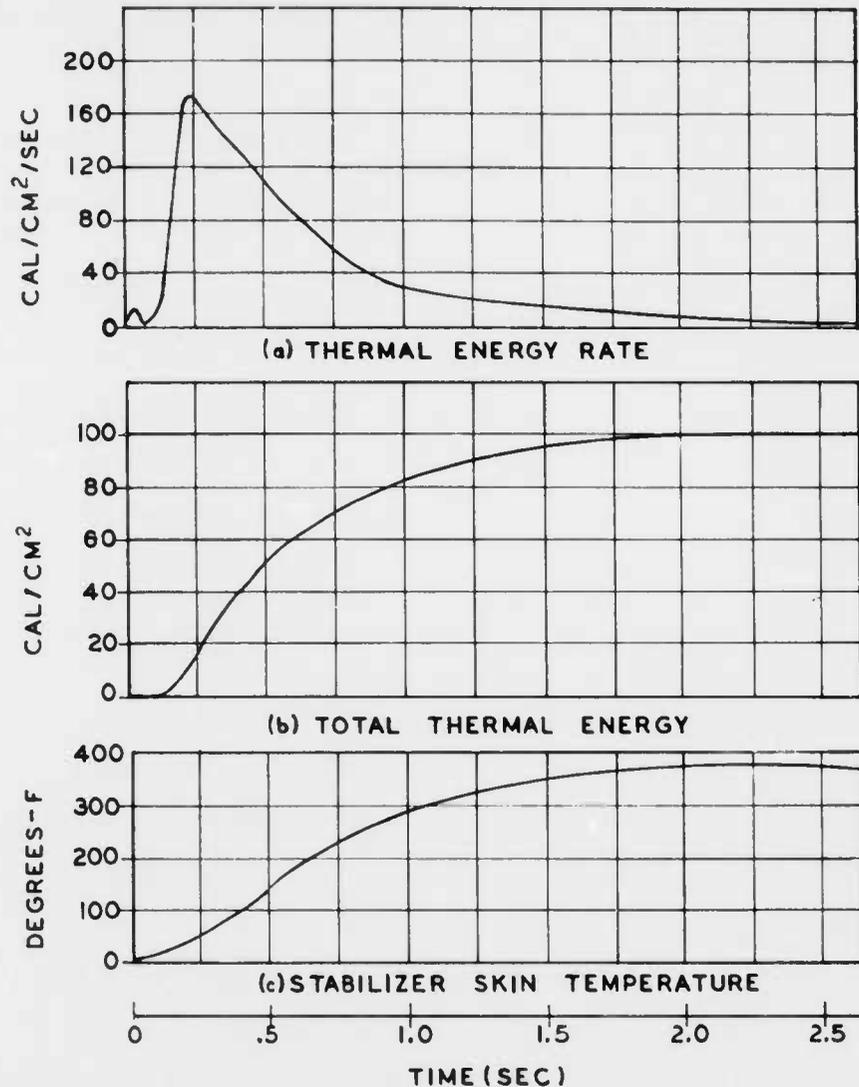
Figure 6.12 Thermal Curves, Drone 3
