(9) BUREAU OF SHIPS GROUP
TECHNICAL INSPECTION REPORT

(6) OPERATION CROSSROADS,
U.S.S. GENEVA (APA86).
TEST ABLE [U.S.]

USS GENEVA (APA86)

TECHNICAL INSPECTION REPORT

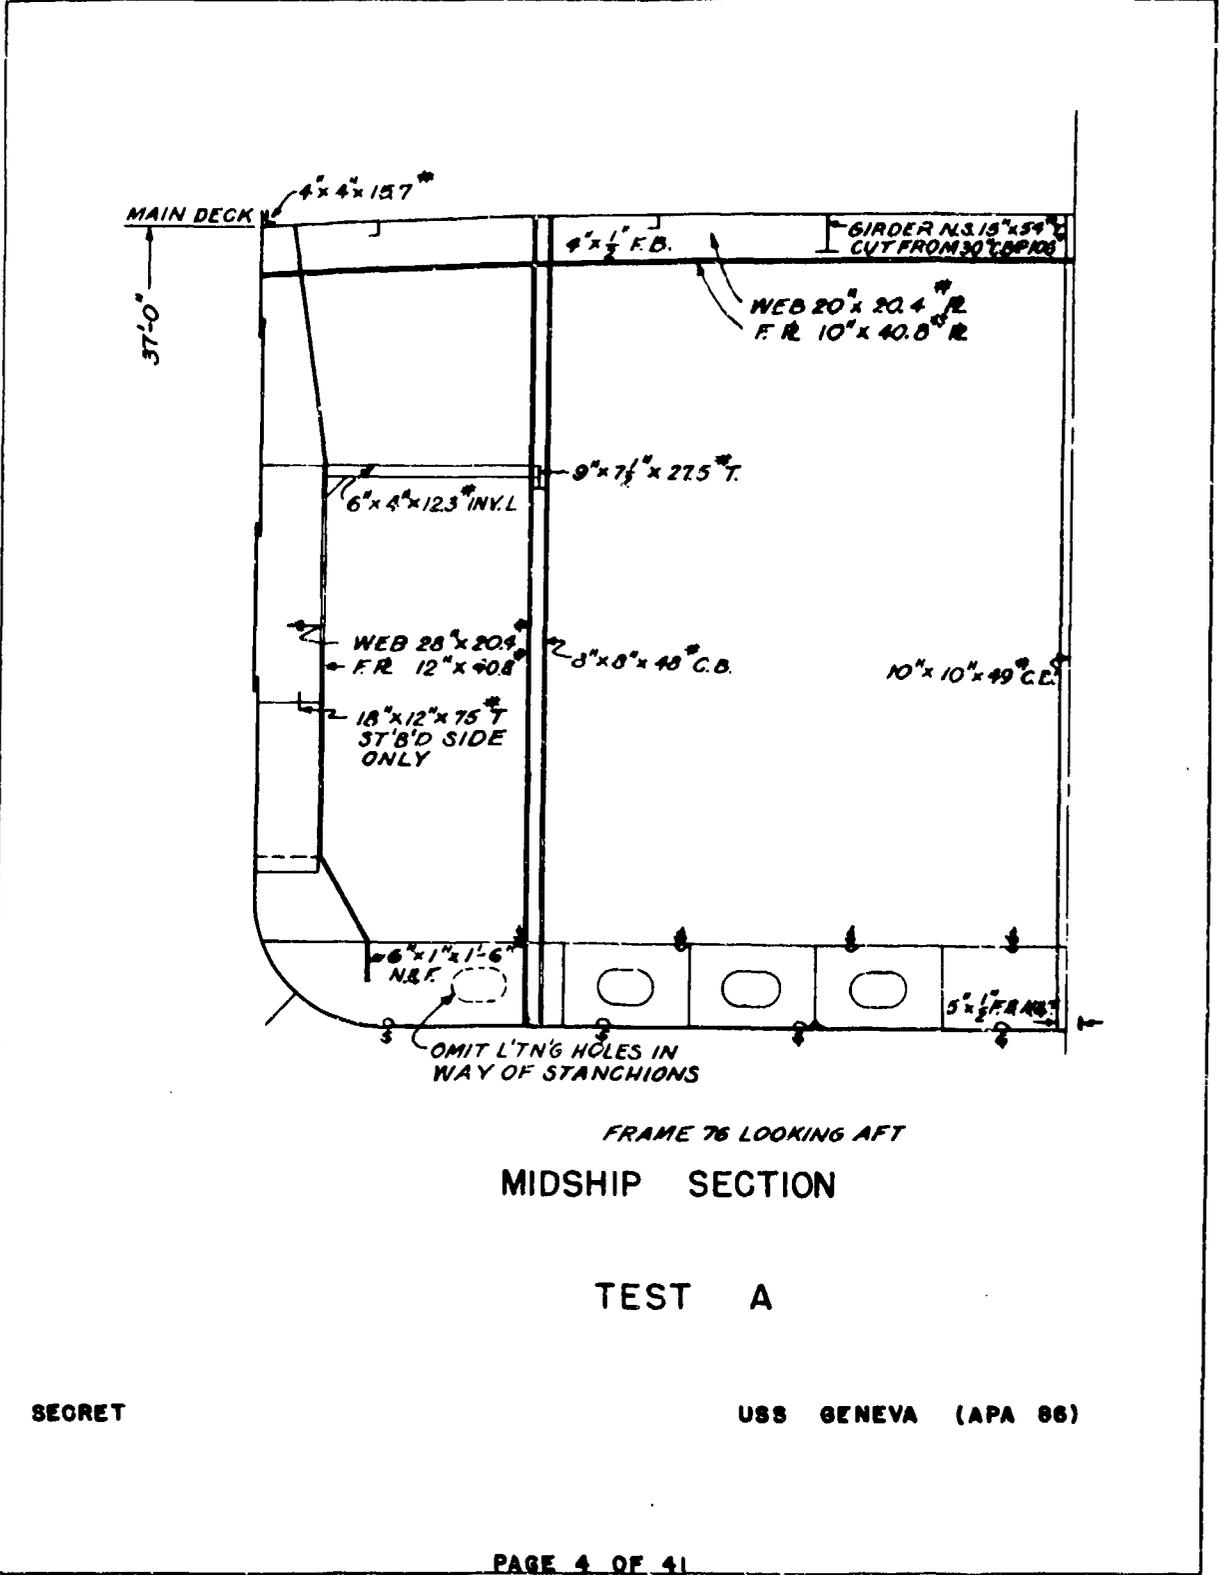
FRAME 76 LOOKING AFT
 MIDSHIP SECTION
 TEST A

There is no structural damage, however exposed sheet metal is slightly damaged.
