Technical Note N-622

TSUNAMI DAMAGE AT KODIAK, ALASKA, AND CRESCENT CITY,  
CALIFORNIA, FROM ALASKAN EARTHQUAKE OF 27 MARCH 1964

W. J. Tudor

November 1964

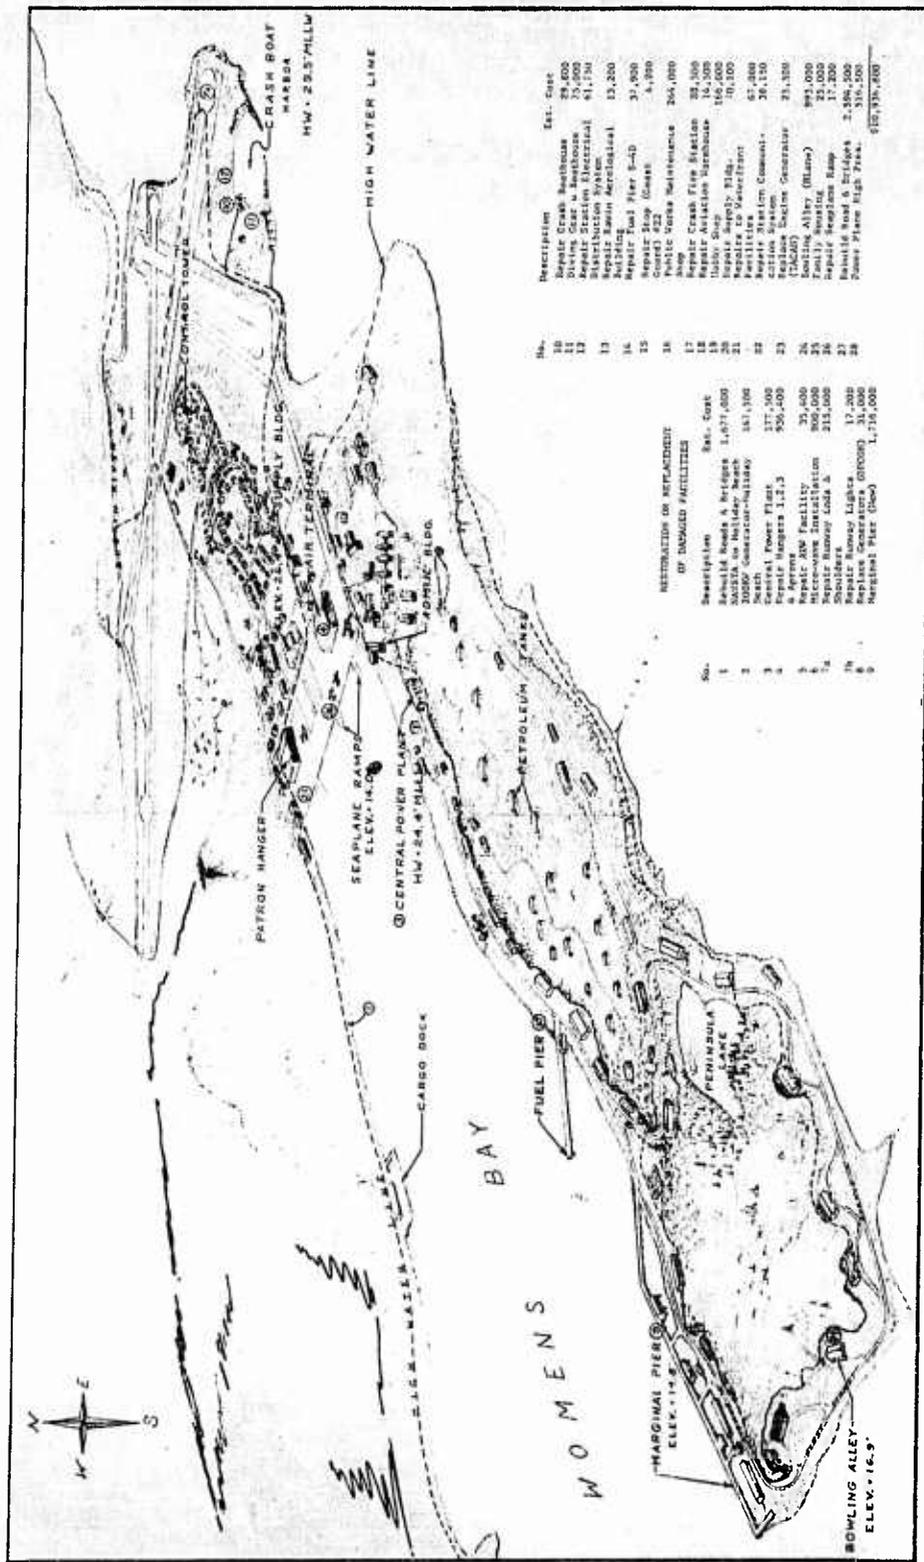
The waves were incredibly high, almost silent tides stealing into low-lying areas of Naval Station Kodiak, inundating buildings and inflicting over six million dollars in damages to structures, materials and equipment (see Figure 3). The main power station was flooded and all electrical power and steam to the centrally-heated station buildings and quarters were lost. Breaks occurred in the water mains which necessitated a shut down of the water system.

Figure 3. Map of U. S. Naval Station, Kodiak, Alaska (Sketch and Estimates by Public Works, Kodiak NAVSTA)

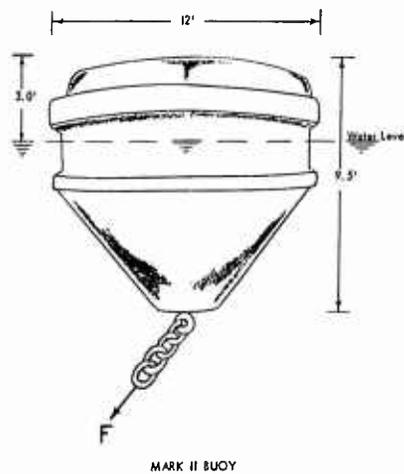
Near the Crash Boat Harbor, sea shells brought in from the harbor by the tsunami were found deposited on land 10 to 15 feet above MLLW. Adjacent to the supply building a 16-foot-diameter mooring buoy (Figure 17A) was washed ashore after being torn from its offshore anchorage. The magnitude of the force on the buoy when submerged is estimated in Figure 17B. This estimate indicates that where the buoy is fully submerged, as it was by the tsunami, the added load is approximately 36 times the load from an assumed mooring chain while neutrally floating. This would seem enough to tear the mooring from its anchorage.

Problem: Force to tear out ring from bottom of mooring buoy.

Assume: Total buoy vol. = 789.7 cf  
 Vol. below water = 450.6 cf  
 Reserve displacement = 789.7 - 450.6 = 339.1 cf  
 Wt. of mooring chain = 20 lbs/ft  
 Neglect current and wind.

Figure 17B. Mooring Buoy action under tsunami waves.

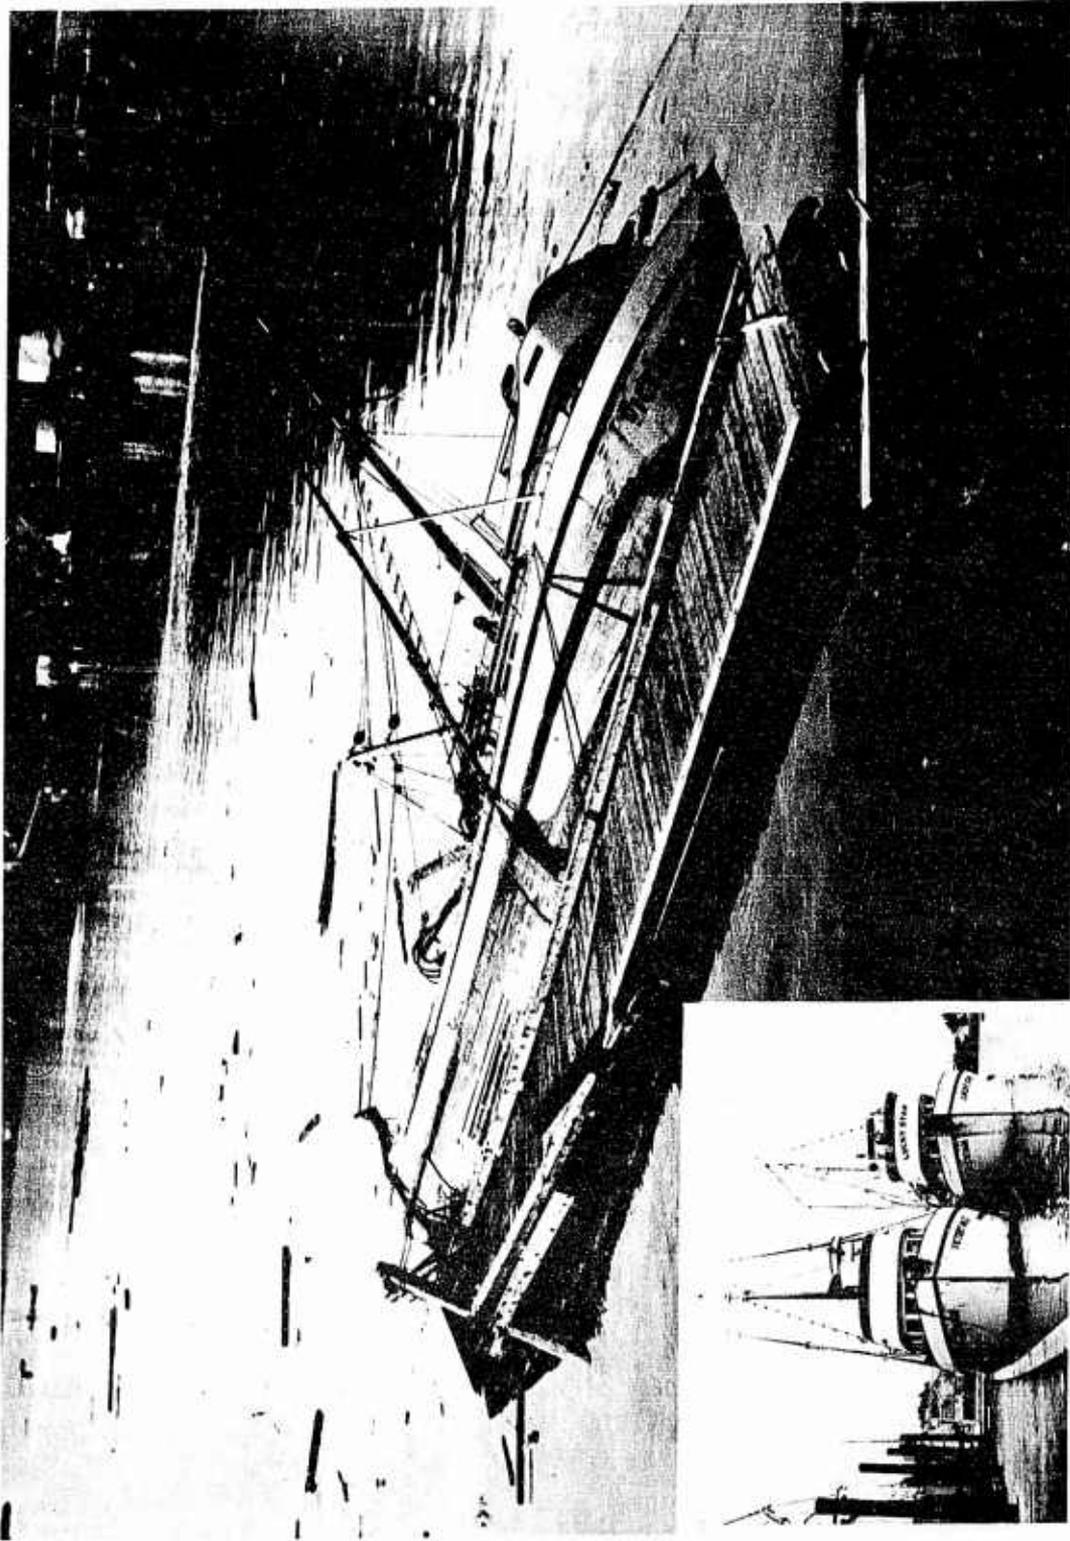
Seventy-seven of the total of 160 crab and salmon boats were missing or fearfully mauled (Table I), two of the canneries were swept away, and the others were unable to operate for 1 or 2 months. An example of boat damage is shown in Figure 23 which also shows a ruined portion of the harbor dock shown in Figure 24.

Figure 23. The view in the lower photo insert shows the Victory Maid and the Lucky Star of the Kodiak's fishing fleet resting serenely hours before the earthquake. The Lucky Star, which was declared a complete loss was not as lucky as her companion the Victory Maid, which is lying to port following the Alaskan Good Friday tsunami. (Photos by PIO, Kodiak NAVSTA)

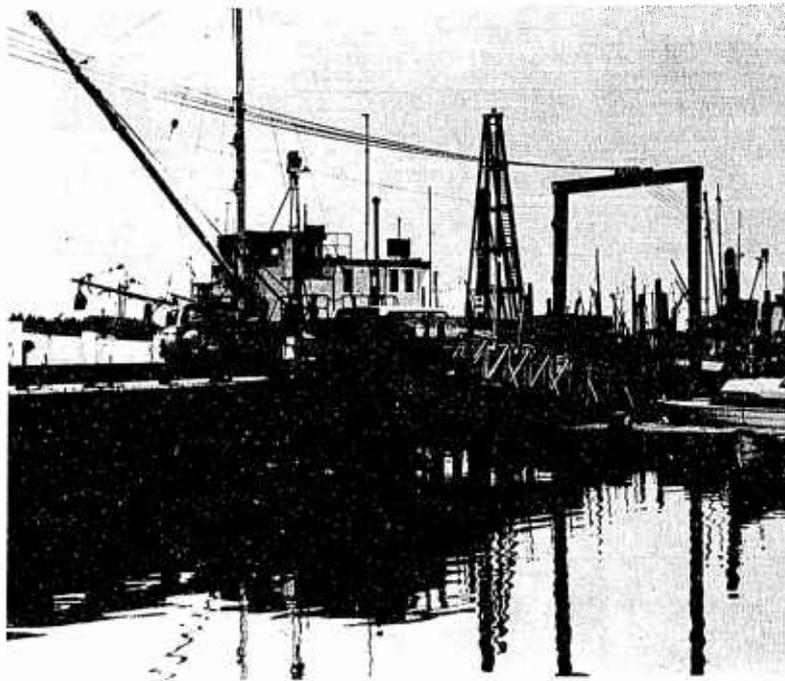
Figure 24. Fishing fleet two hours before the quake. Some boats were maneuvered to safer coves by their owners, while those unmanned rammed into the business section of the city. (PIO, Kodiak NAVSTA)

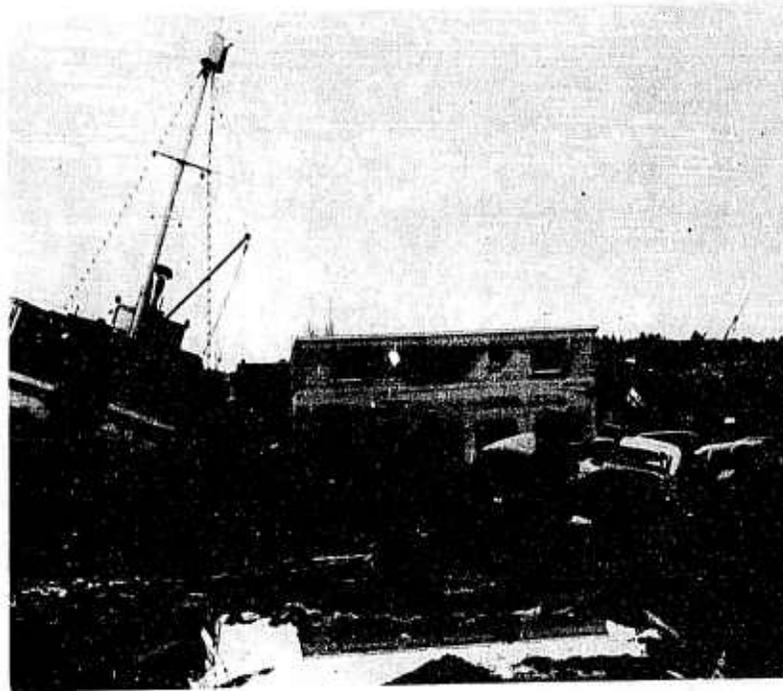
Vehicles in the flooded area were ruined. Furnishings and equipment of homes and offices were damaged when water poured in through broken windows and doors (Figure 28 and 29). Most boat owners and vehicle owners with comprehensive insurance can collect on damages. Interviews with townspeople revealed that the home and business owners did not carry seismic sea wave insurance because of its nonavailability or prohibitive cost.

Figure 28. Vehicle and boat owners with insurance can collect on damages. Business and home owners did not carry "tidal-wave insurance".

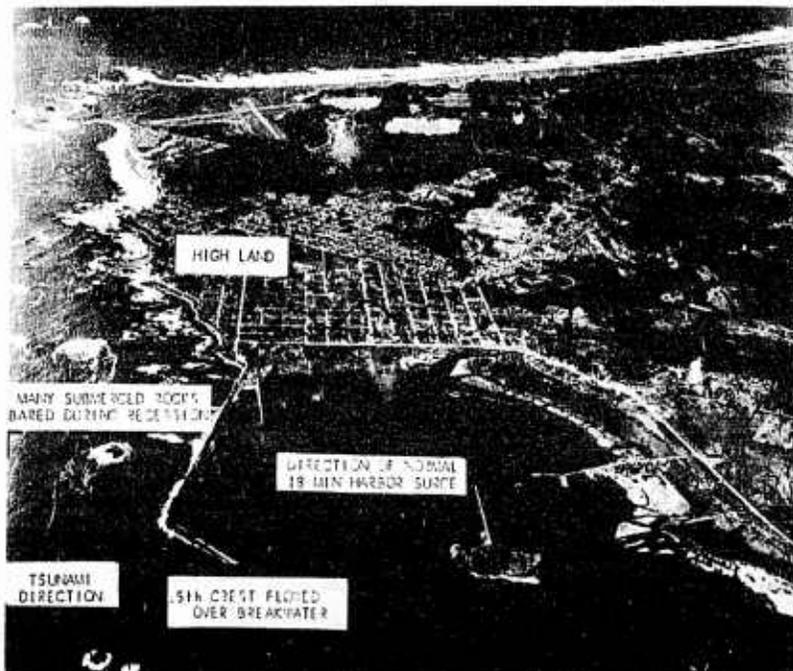
Figure 36. Crescent City's harbor has breakwater protection from storm waves but not from tsunami waves. Dashed lines show high water marks.

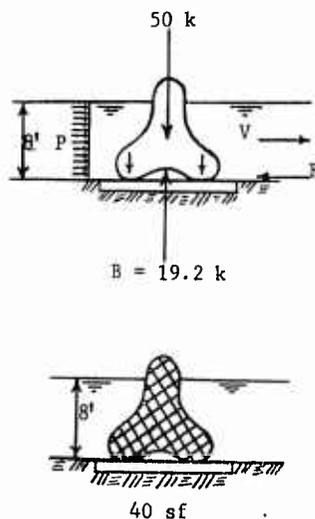
Calculation to find water velocity to slide large tetrapod off base:

$$\begin{aligned}
 \text{Wt.} &= 25 \text{ T; Coef. of Frict.} = 0.65 & \text{Total vol.} &= 325 \\
 \text{Vol.} &= 325 \text{ cf; Drag coef.} = 1.2 & \text{Vol. in air} &= 25 \\
 B &= 300 \text{ cf} \times 64 \text{ pcf} = 19.2 \text{ K} & \text{Subm. vol.} &= 300 \\
 N &= 50 - 19.2 = 30.8 \text{ K} \\
 F &= 0.65 \times 30.8 = 20 \text{ K} \\
 P &= 20/40 \text{ sf} = 500 \text{ psf.} \\
 V &= \frac{500 \times 32.2 \times 2}{1.2 \times 64} = 20 \text{ fps} = 14 \text{ MPH}
 \end{aligned}$$

Figure 37B. Unit pressure and approximate velocity required to slide 25 ton tetrapod.

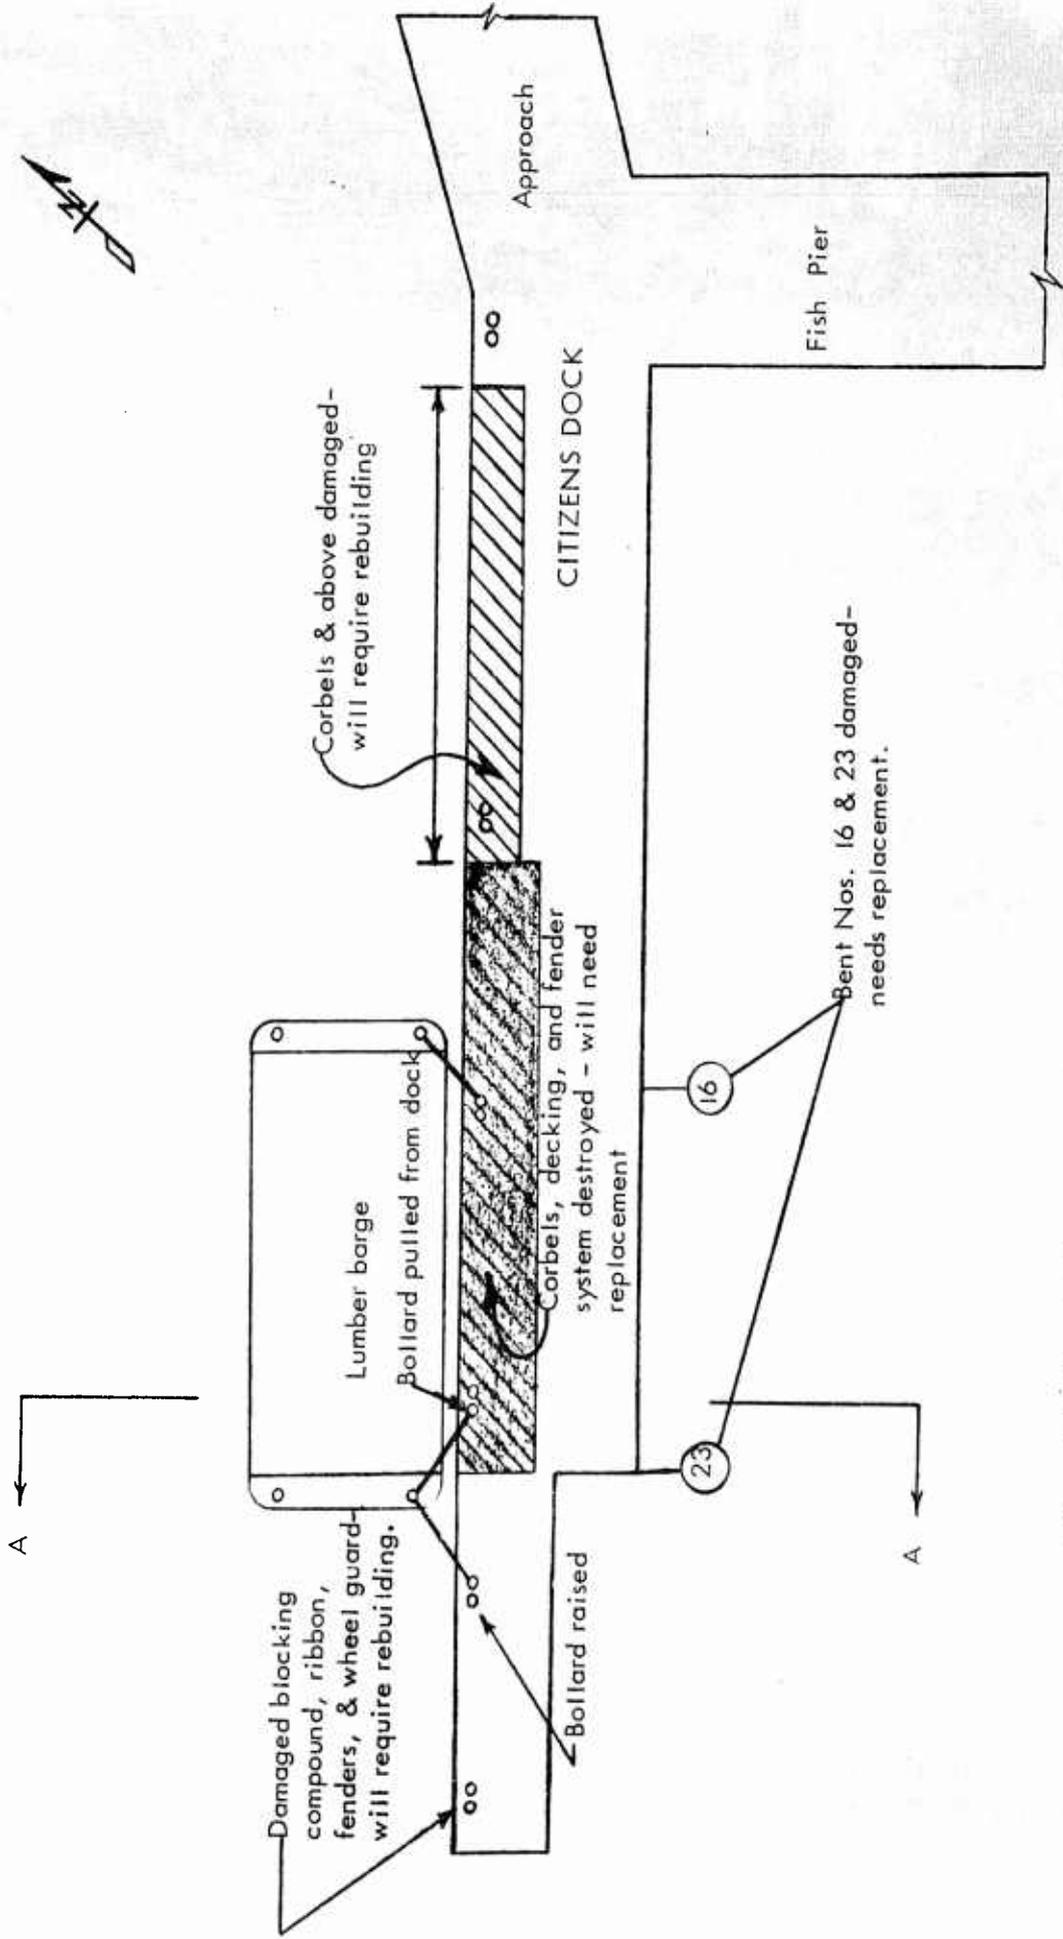
The only damage to the fish pier on Citizen's Dock was along the centerline where the deck raised about six inches. This was due to lack of steel straps between pile caps and stringers. The commercial fish shacks on the pier were displaced (Figure 45).

Figure 45. Plan of Citizens Dock showing moored lumber barge and pier.

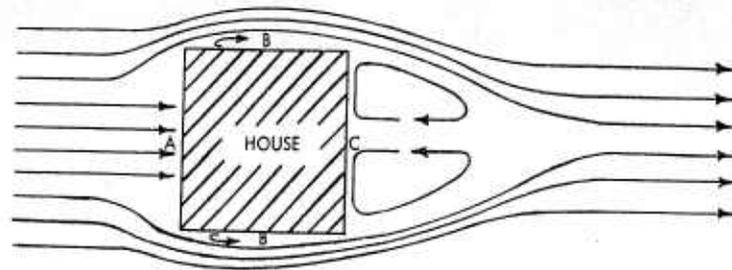
Figure 61A. Flow around typical house.

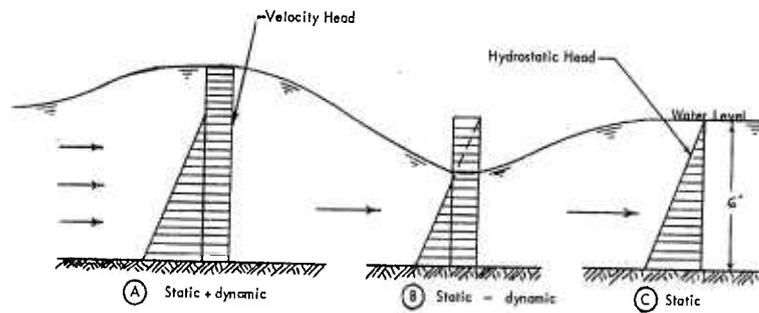
$V = 5 \text{ fps} \rightarrow$	$384 + 24 = 408 \text{ lbs/sf}$	$384 - 24 = 360 \text{ lbs/sf}$	$384 \text{ lbs/sf}$
$V = 10 \text{ fps} \rightarrow$	$384 + 100 = 484 \text{ lbs/sf}$	$384 - 100 = 284 \text{ lbs/sf}$	$384 \text{ lbs/sf}$
$V = 15 \text{ fps} \rightarrow$	$384 + 225 = 609 \text{ lbs/sf}$	$384 - 225 = 159 \text{ lbs/sf}$	$384 \text{ lbs/sf}$

Figure 61B. Fluid pressure diagram around typical house.

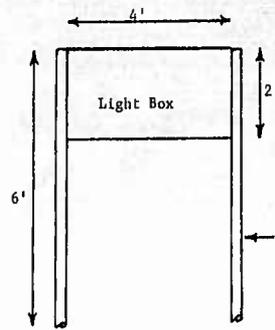
Prob: Find load per in<sup>2</sup> which will produce yielding of post at base.

Assume:  $S = 30 \text{ KSI}$   
 $I_{\text{post}} = 1.18 \text{ in}^4$   
 $ID = 2.468$   
 $OD = 2.375$   
 $C = 1.437$   
 $C_D = 0.35$   
 $\bar{y} = \frac{\sum \Delta y}{\sum A} = \frac{82,080}{1,512} = 54.2''$
