OCTOBER 1964

# QUARTERLY TECHNICAL PROGRESS REPORT No.

XV-5A LIFT FAN  
FLIGHT RESEARCH AIRCRAFT.

5 GENERAL ELECTRIC COMPANY  
Cincinnati, Ohio.

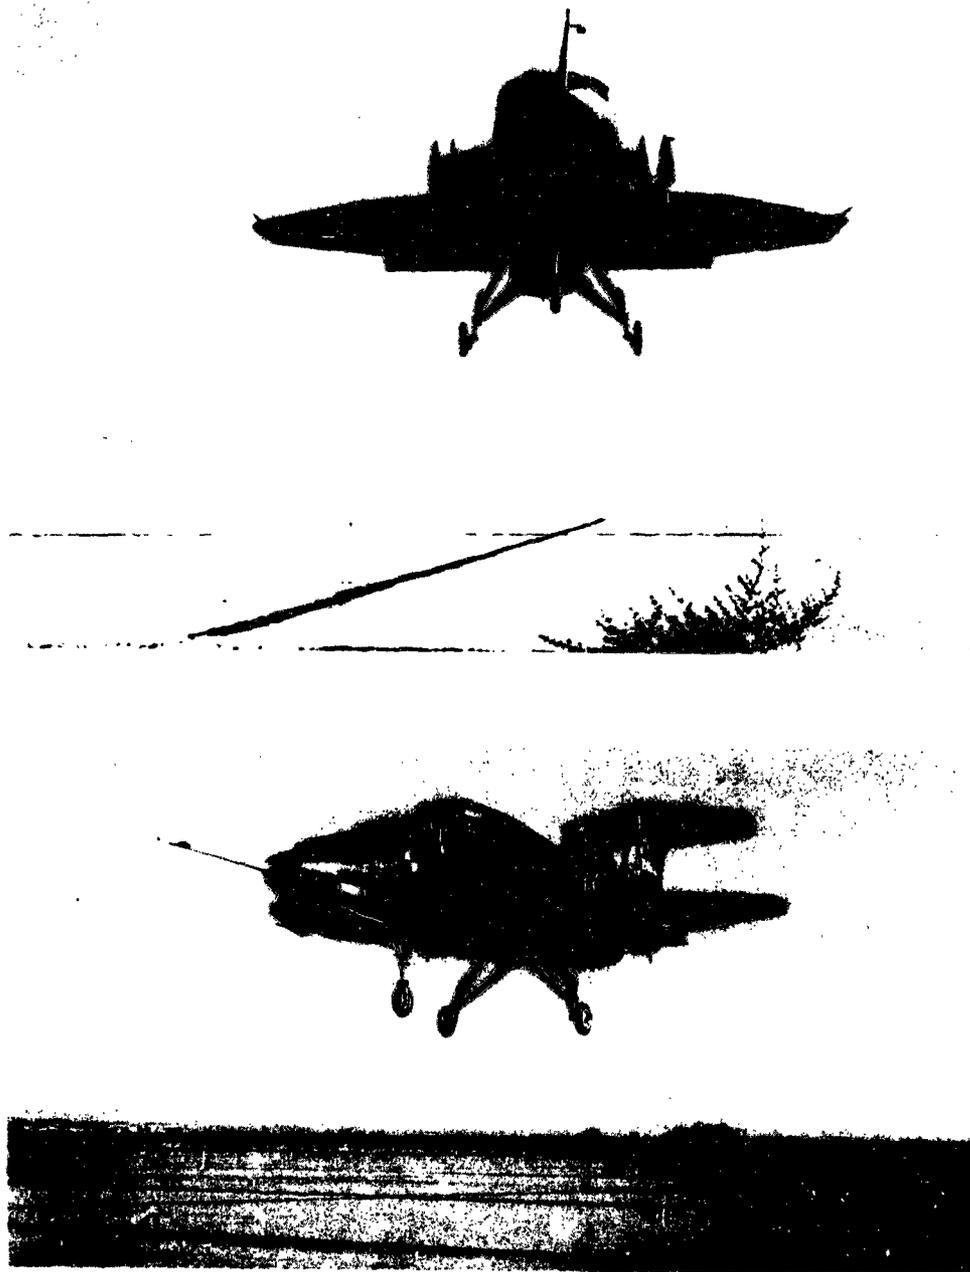
Figure 35. XV-5A During Hovering Test Flights.

9. Flight 9F, on July 16, 1964, was the first hover attempt since March 31, 1964, when the first attempt was aborted due to low roll control power. Figure 35 shows the XV-5A during the first hover flight.

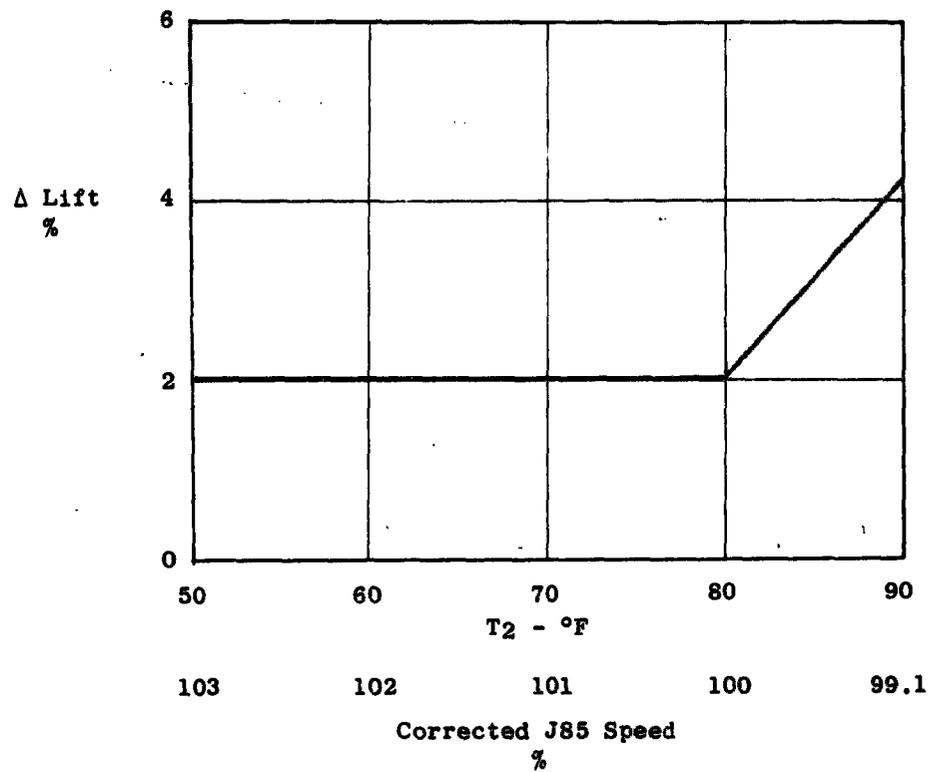
Figure 43. VG Adjustment - Effect on Performance - Predicted Decrement Based on SAED Engine 100-A.  
 $T_5 = 680^\circ\text{C}$  - Max. Power.

- 1) Engine trim at 102% - - -
- 2) Variable geometry adjustment -2.0%\*
- 3) Ejector for compressor case cooling  $\frac{-0.2\%}{-2.2\%}$

\*Below 80°F  $T_t$  - See Figure 43.

- 4) Adjusted variable geometry for 5% open bleeds or more during all operations, plus adjusted bleed valve schedule for cold drag response (see Figures 42 and 43).
