FOAMGLAS INSULATION FOR
BURIED HOT PIPES

NAVAL FACILITIES ENGINEERING COMMAND

U. S. NAVAL CIVIL ENGINEERING LABORATORY

Technical Report R-451

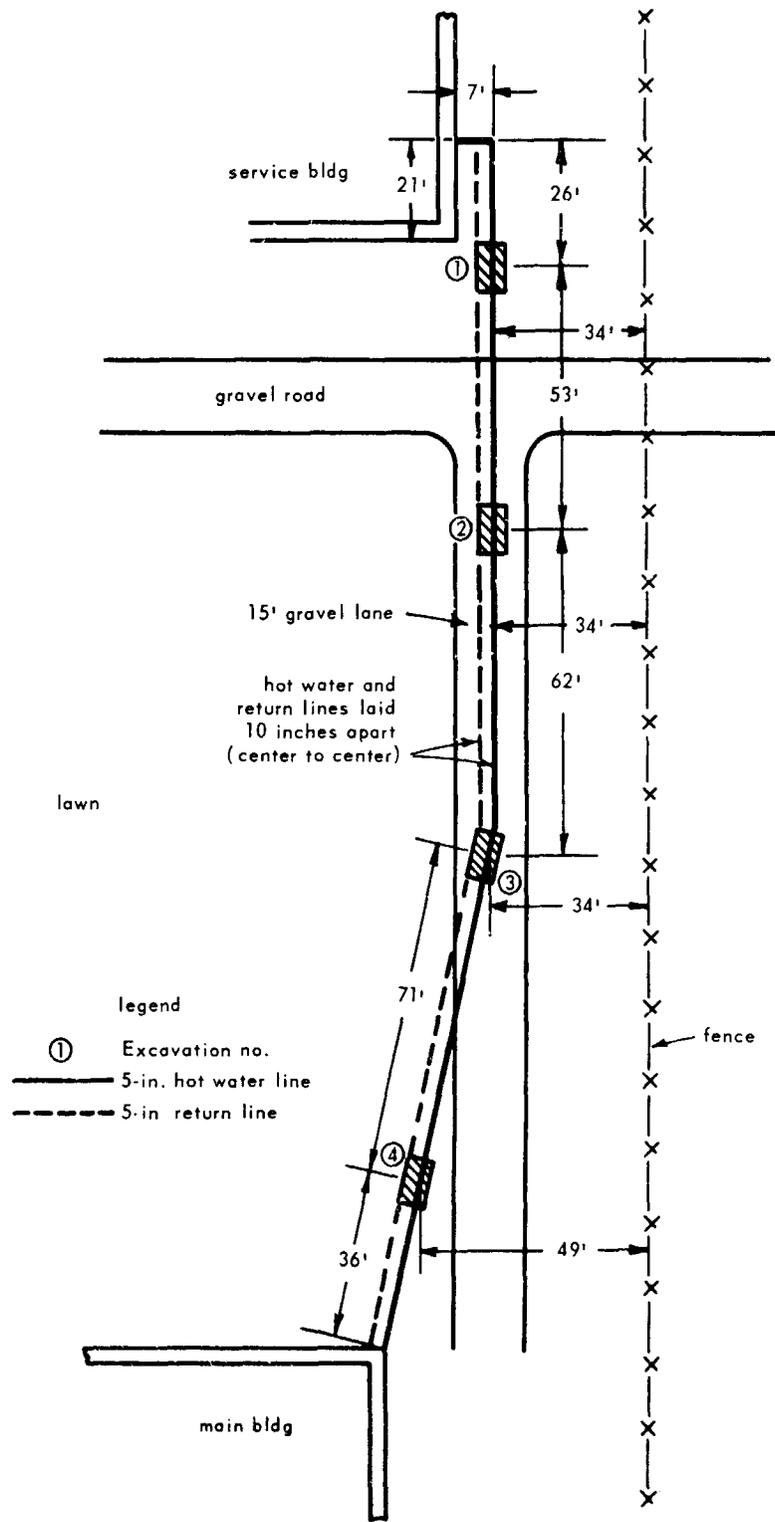
Figure D-1. Plan view: location of underground hot water pipes, Lake City Sewage Plant, Municipality of Metropolitan Seattle, Washington.

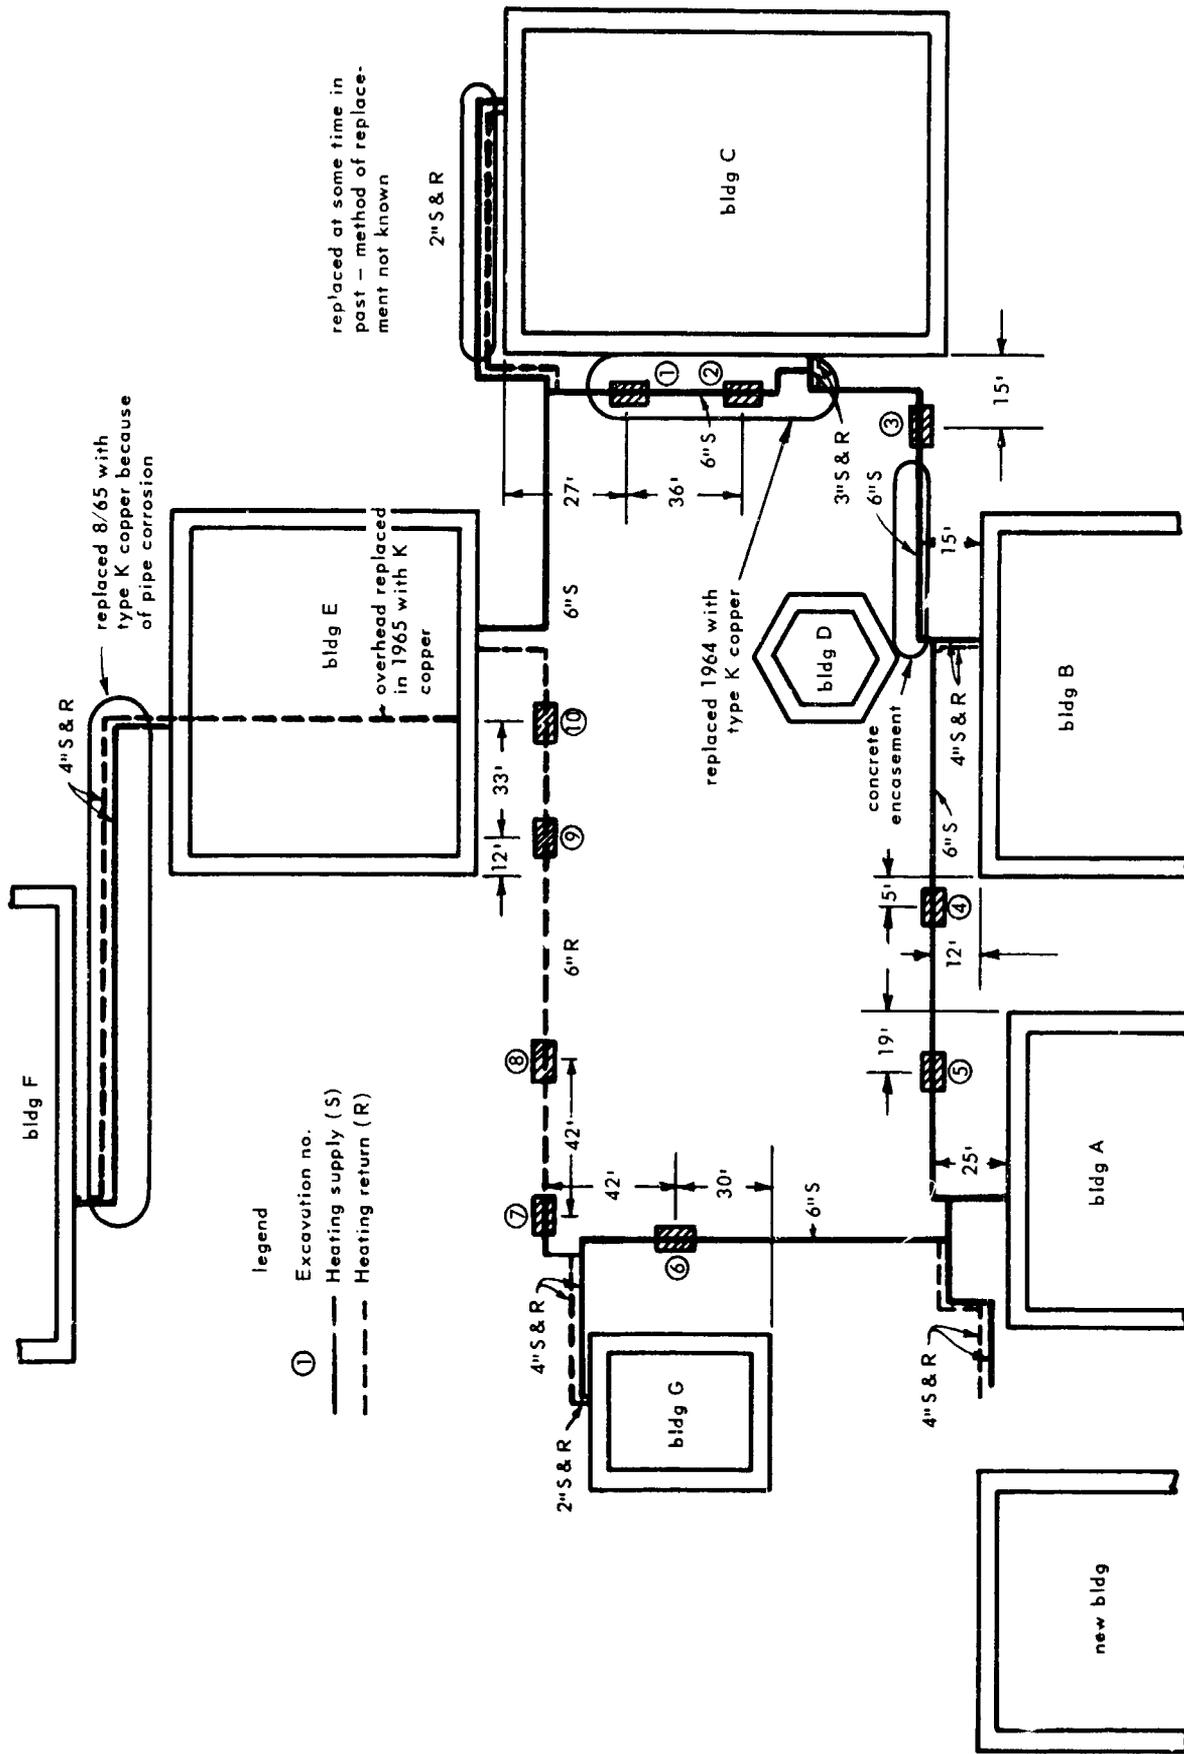
Figure D-2. Plan view: location of underground hot water heating system, St. Thomas Aquinas High School, St. Louis, Missouri.

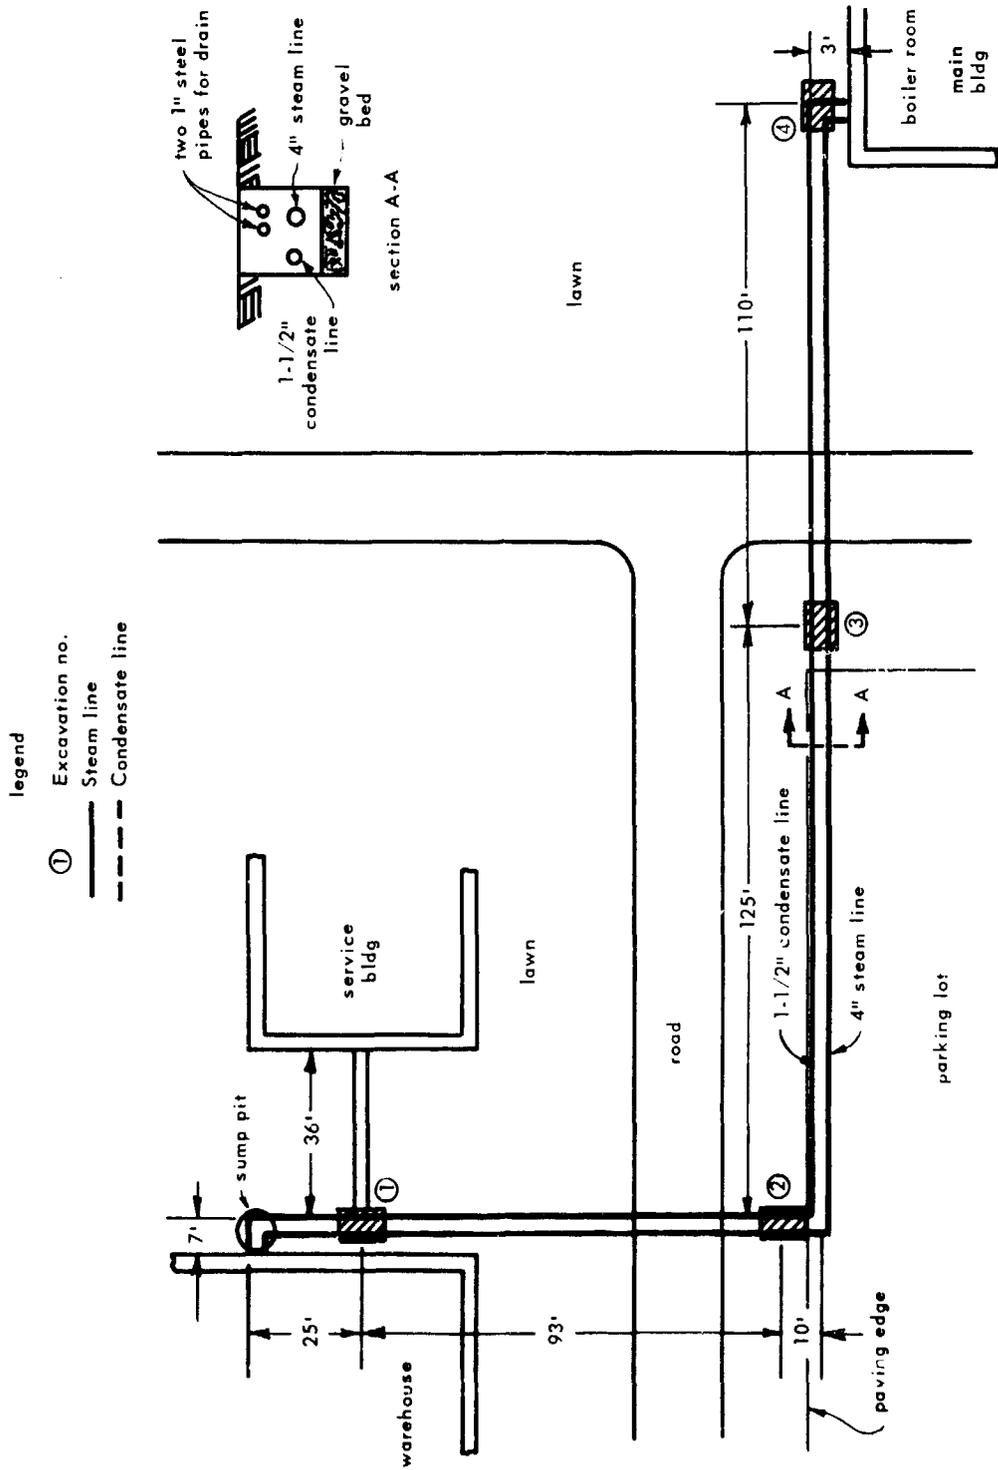
Figure D-3. Plan view: location of underground steam and condensate pipes, Ochsner Foundation Hospital, New Orleans, Louisiana.
