AM 66-18

Evaluation of Head and Face Injury Potential of Current Airline Seats During Crash Decelerations

June 1966

OFFICE OF AVIATION MEDICINE
FEDERAL AVIATION AGENCY

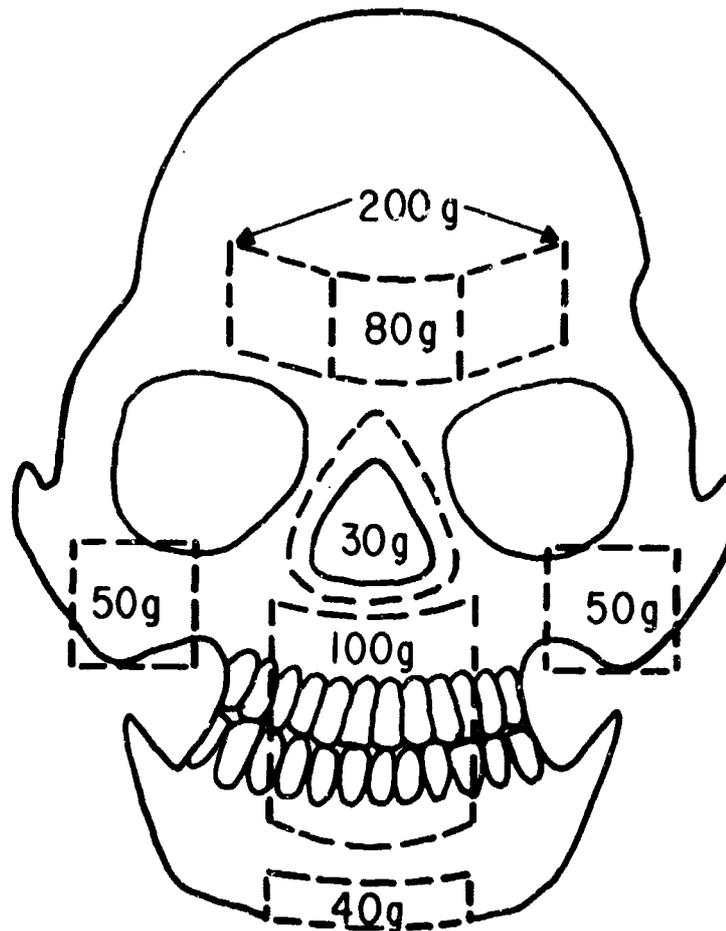
Figure 1 reproduces summary data² showing the tolerances of the human face and head to

FIGURE 1. Summary of maximum tolerable impact forces on a padded deformable surface.
