**Final Report of the  
Pre- and Postshot  
Structural Survey**

D. M. Harvey/M. W. Jackson/F. A. Linville  
HOLMES AND NARVER, INC

FINAL REPORT OF THE  
PRE- AND PCSTSHOT STRUCTURAL SURVEY  
PROJECT DRIBBLE  
SALMON EVENT

UNITED STATES ATOMIC ENERGY COMMISSION  
NEVADA OPERATIONS OFFICE

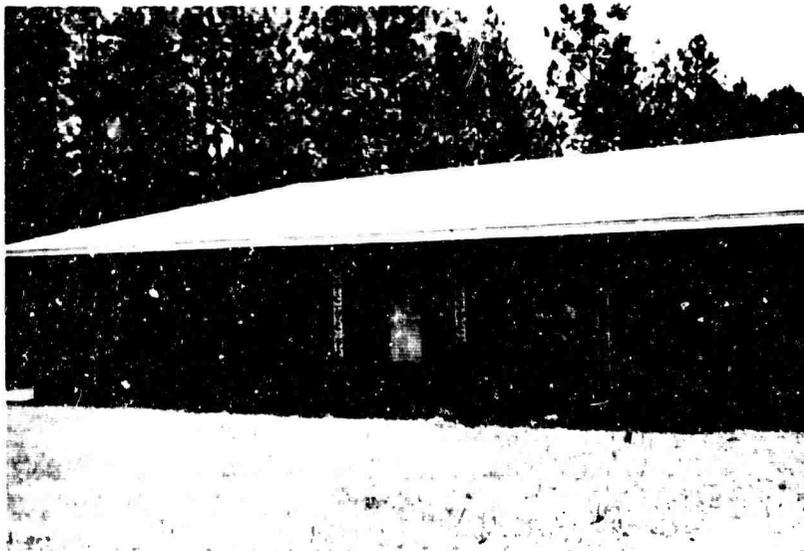
Photo No. 1 - Pre-Shot of H&N No. 47

A new one-story brick veneer house on a concrete slab (H&N 47) was located 3,505 meters from SZ (photo no. 1). The peak ground motion was predicted to be 11.5 cm/sec. No bracing was recommended and no damage was evident in the postshot survey of the structure.

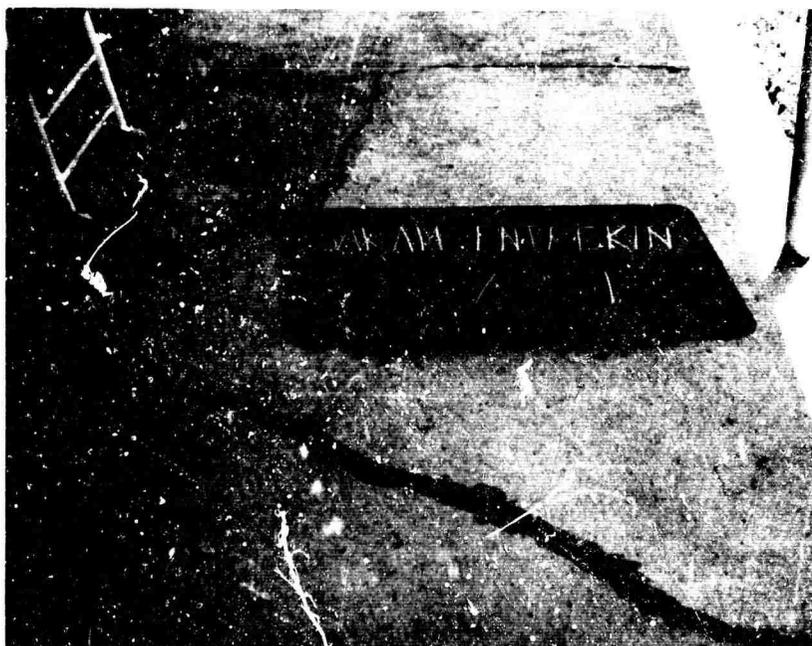
Photo No. 2 - Pre-Shot Front Porch Slab - H&N No. 73

A concrete block house at 4,480 meters (H&N 257), and another at 5,000 meters (H&N 73) were surveyed. All were similar in construction and size with numerous cracks in the walls and floor slabs prior to the event (photos no. 2 and 3). The houses were supported on concrete slabs and had wood frame and asphalt shingle roofs. The peak ground motion was predicted to be 8 cm/sec and no precautionary bracing was recommended. After the event many of the cracks appeared to be aggravated (photos no. 4 and 5), and several new cracks in the mortar joints developed (photo no. 6). Some interior sheetrock partitions appear to have developed hairline cracks also.

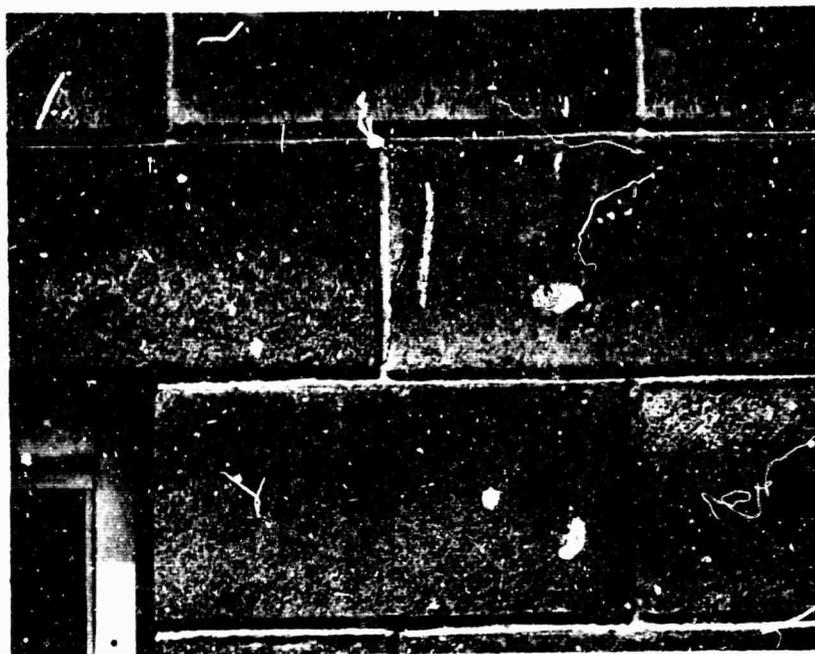
A new block house (H&N 83) under construction 5,060 meters from SZ revealed the type of construction practices followed in the area. No lintels were used over the openings as illustrated in photo no. 7. Very little reinforcing steel was used in the structure (photo no. 8). The peak ground motion was predicted to be 8 cm/sec. No observed new cracks were present in the concrete blocks of this structure (H&N 83) after the event, but some old cracks were aggravated and new cracks were evident in the brick chimney.

Photo No. 7 - Pre-Shot Window Construction, H&N No. 83

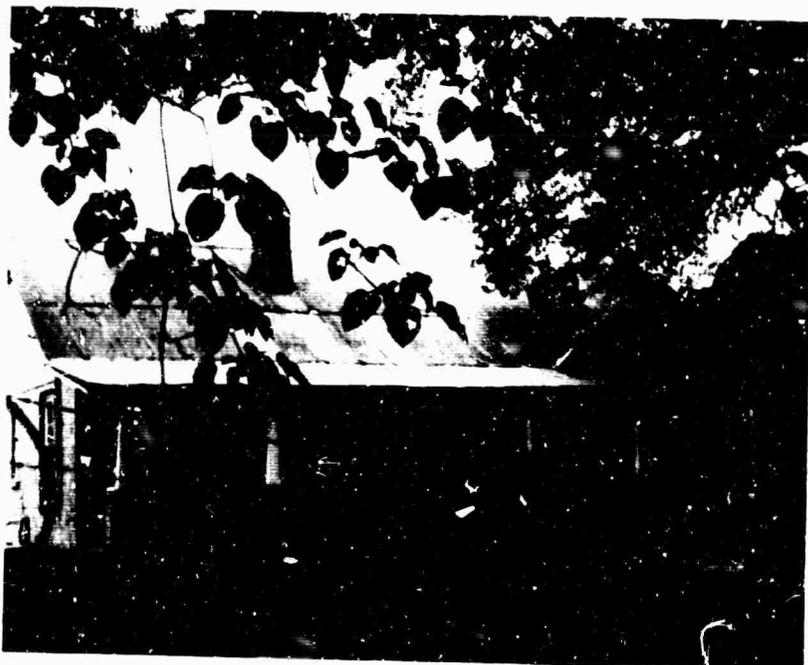
A house constructed of solid brick walls (H&N 190-1) was surveyed at 5,210 meters distance from SZ (photo no. 9). The brickwork was in good condition with few cracks in the mortar joints and through the bricks (photos no. 10 and 11). The house was supported on a continuous concrete footing with frame gables and galvanized iron roofing. The concrete front porch floor was supported on a continuous concrete block footing. This block footing had several mortar joint cracks (photos no. 12 and 13). The interior walls were either exposed brick, wood paneled, or taped sheetrock on wood studs. The central chimney appeared substantial in the Pre-shot survey. The predicted ground velocity was 7.6 cm/sec at this location and no bracing was recommended or installed. The postshot survey of this structure indicated that the old cracks noted in the pre-shot survey were aggravated (photo no. 14).

Photo No. 9 - Pre-Shot - Solid Brick House, H&N No. 190

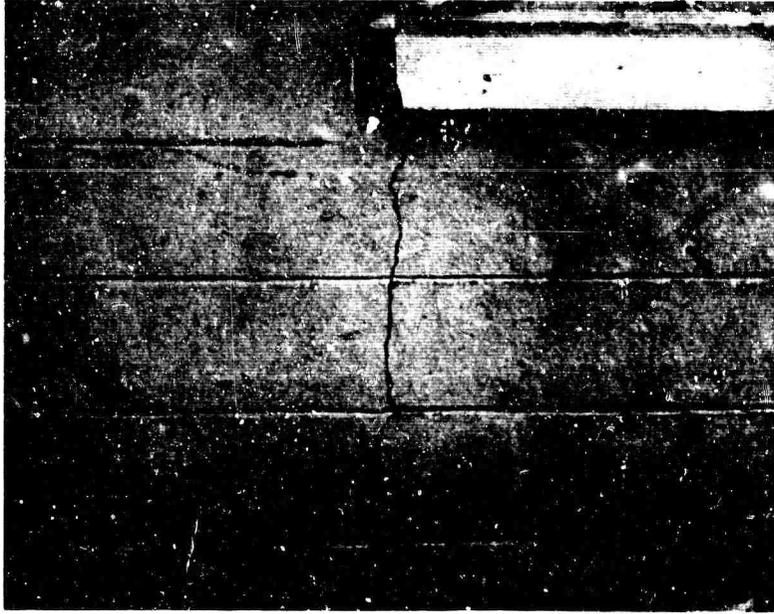
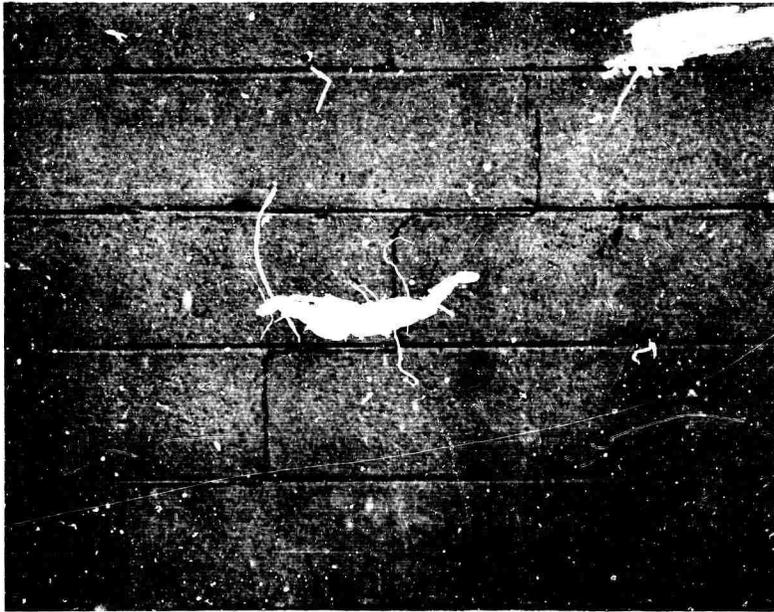
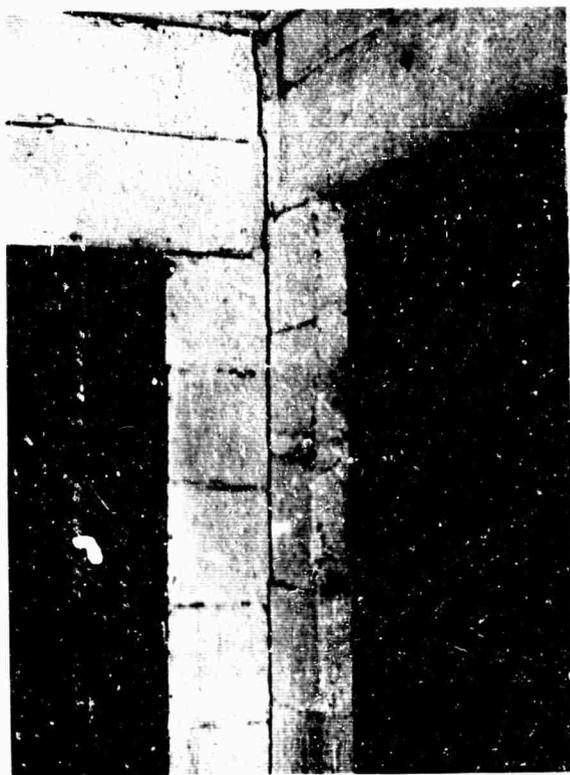
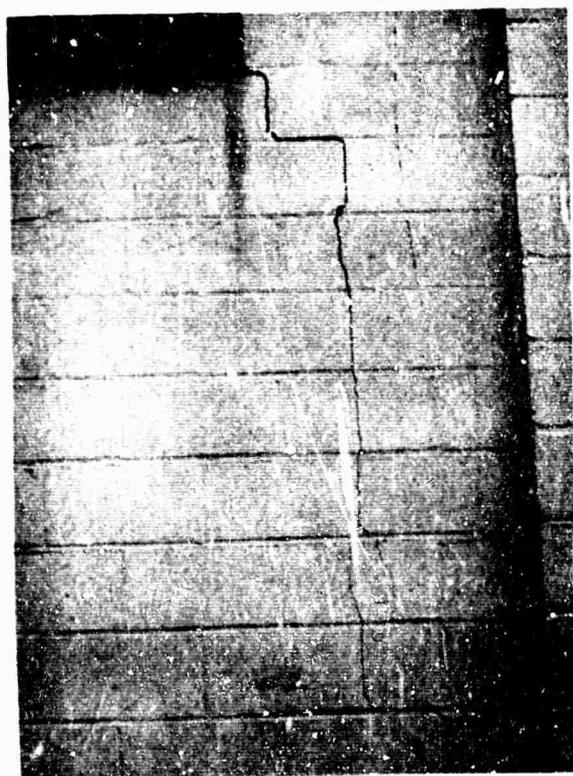
A group of concrete block structures, the Baxterville School (H&N 116), were surveyed 6,950 meters from SZ. The ground motion was predicted to be 4 cm/sec. A large number of cracks were documented in the pre-shot survey (photos no. 19 to 22). The postshot survey indicated only possible minor aggravation. The engineer's report states, "It is remotely possible that some of the hairline cracks in the masonry have been aggravated". Photo no. 23 is a postshot picture of the crack illustrated in photo no. 22 taken immediately after the event. To determine the increase in the cracks with time, photo no. 24 was also taken of the same crack ten months after the event. It is apparent that there was only a small increase in the size of the crack.

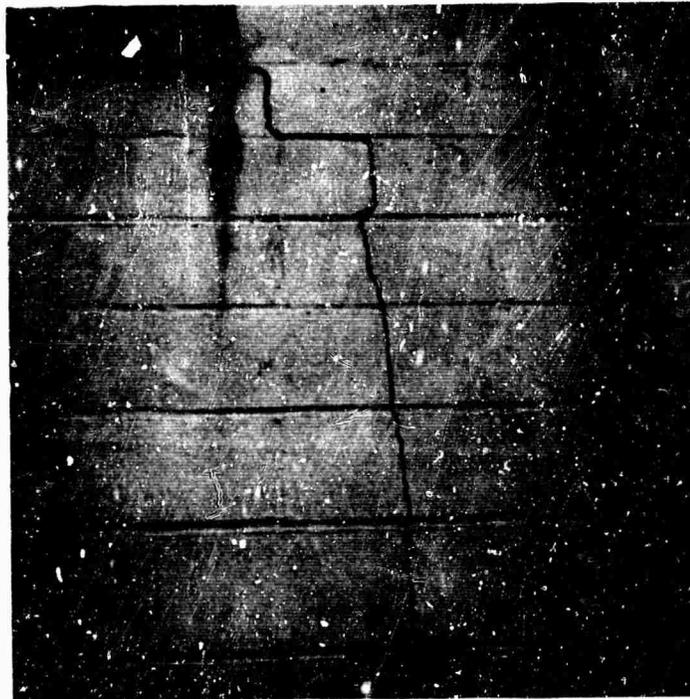
Photo No. 24 - Postshot of H&N No. 116, Ten Months After Event

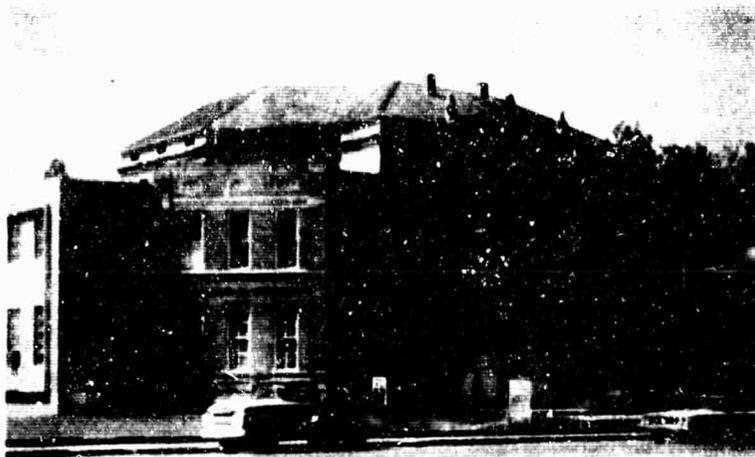
An old (1906) two-story brick building, the Lamar County Courthouse and Jail (H&N S-3) was surveyed 15,300 meters from SZ, where ground motion was about 1 cm/sec. The structure was in relatively good condition prior to the event with no noticeable cracks in the exterior brick walls or interior plaster walls and ceilings (photo no. 25). The postshot survey of the courthouse and jail identified one crack on both sides of the southwest corner of the basement wall (photo no. 26). The postshot survey also revealed hairline cracks in the interior plaster walls and ceilings of 12 rooms.

Photo No. 25 - Pre-Shot of Lamar County Courthouse

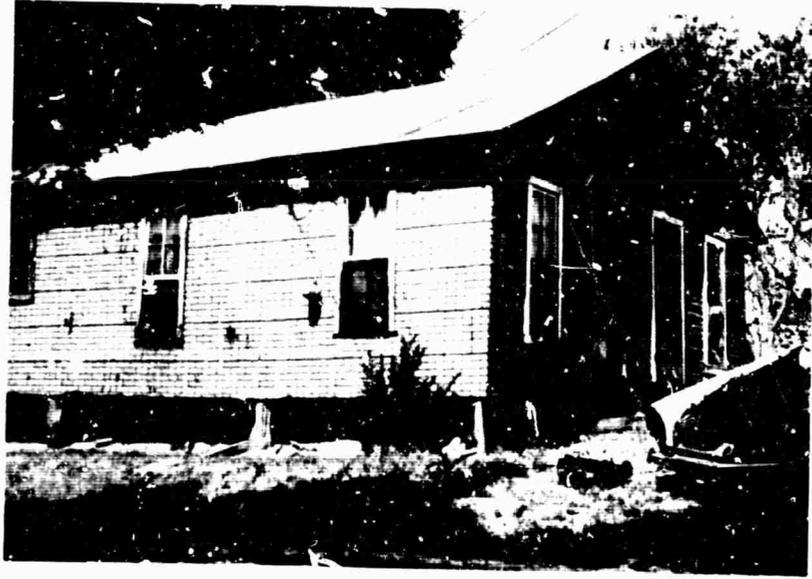
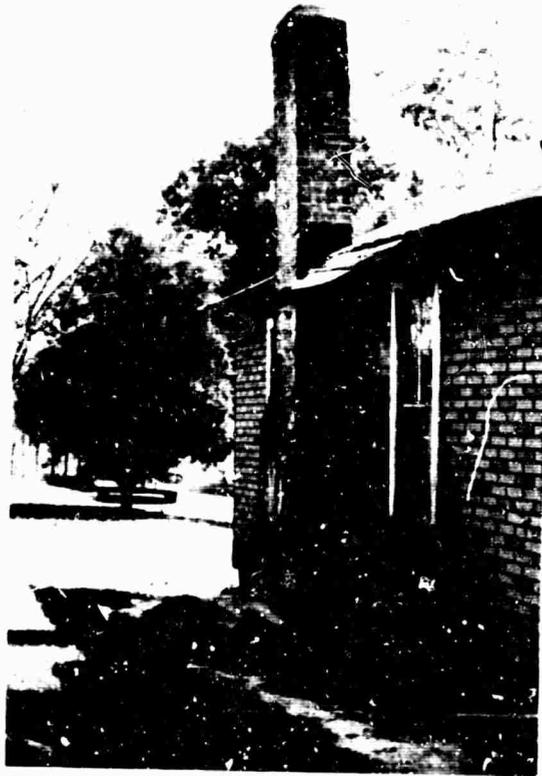
A wood frame house (H&N 56) at 1,650 meters was supported on wood posts (photo no. 27). A chimney and fireplace (photo no. 28) were braced prior to the event, in accordance with the established standards, see sketch no. 8, of Appendix C. The predicted peak ground motion at this location was 35 cm/sec. After the event when the bracing was removed, the chimney was found to be demolished (photo no. 29). Floor beams and timber piers had been installed as a precautionary measure prior to the event. No other damage was evident in the postshot survey.

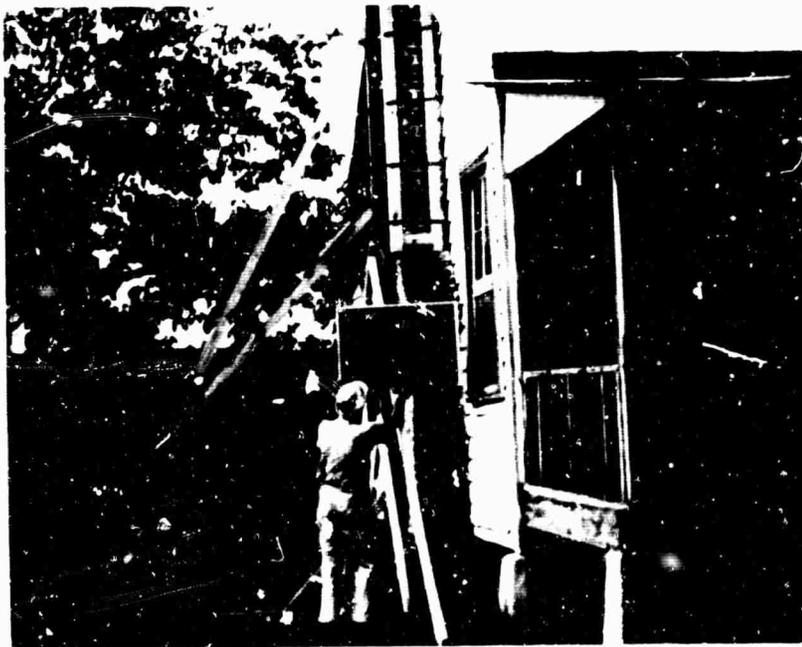
Photo No. 30 - Postshot of H&N No. 9 - Chimney Bracing

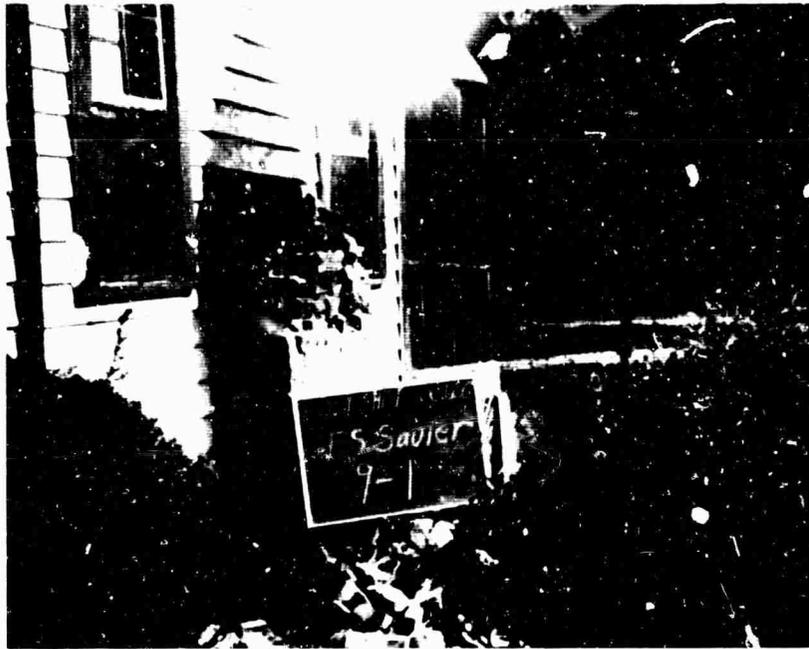
Photo No. 31 - Postshot of H&N 9 - After Removal of Bracing

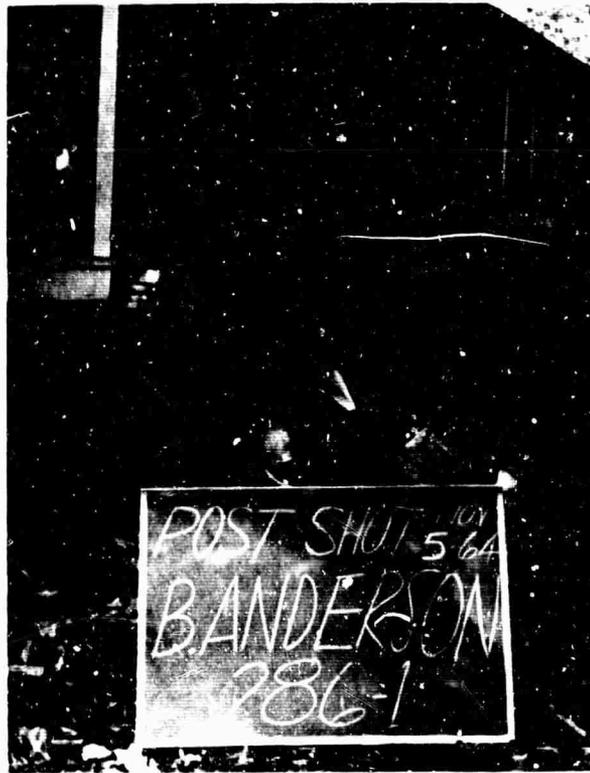
Photo No. 39 - Postshot of H&N No. 286 - Chimney

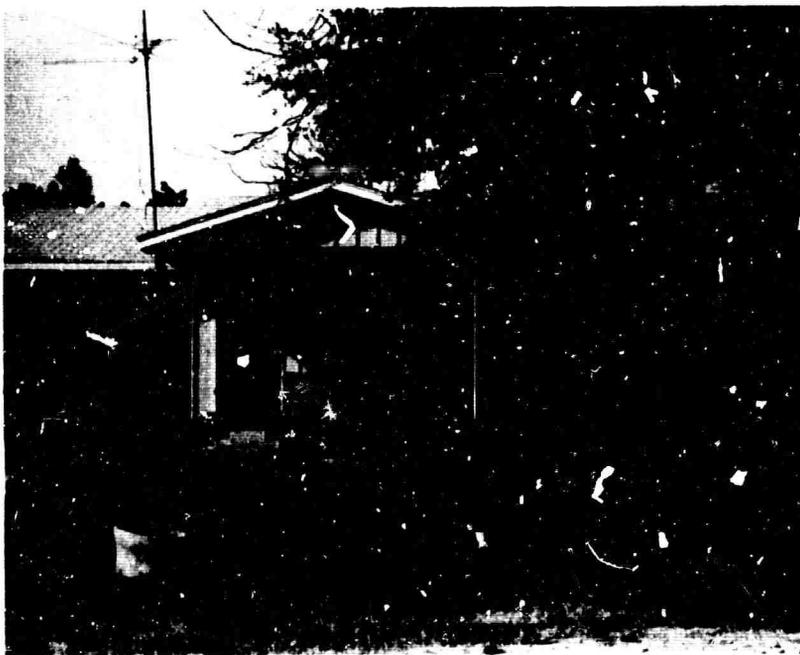
A frame house on low concrete block piers, 6,800 meters from SZ (H&N 105) had a 1 meter high, face-brick veneer across the front and one side (photos no. 46 and 47). The predicted ground motion was 4 cm/sec and no bracing was recommended. The brick facing appears to have suffered some minor damage in the mortar joints, as shown in postshot photo no. 48.

Photo No. 46 - Pre-Shot of H&N No. 105-Facing Brick

Photo No. 47 - Pre-Shot of H&N No. 105-Facing Brick

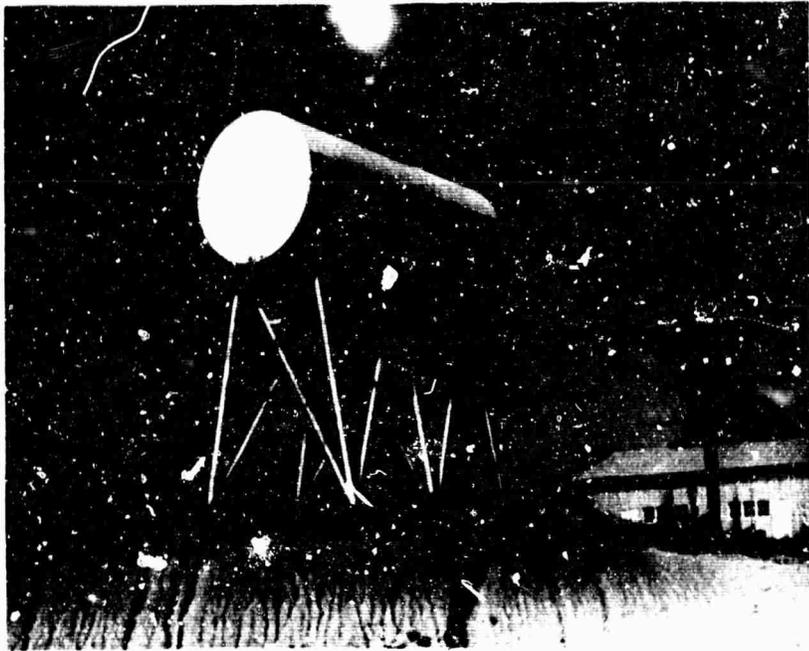
The Patrick Harrisor water tower (T-16) consisted of a steel water tank,  $4\frac{1}{2}$  meters long and 2 meters in diameter, supported horizontally on a steel frame. The tank was 4 meters above the ground and the frame was anchored to concrete foundation pads (photos no. 53 and 54). The water tank was located 543 meters from SZ and the peak ground motion was predicted to be 125 cm/sec velocity. It was recommended the tank be emptied, and on shot day it contained only a small amount of water. The postshot survey revealed no damage to the water tank or support; however, two of the three concrete foundation pads were cracked, as shown in sketch no. 4.

Photo No. 53 - Pre-Shot of T-16 Water Tower

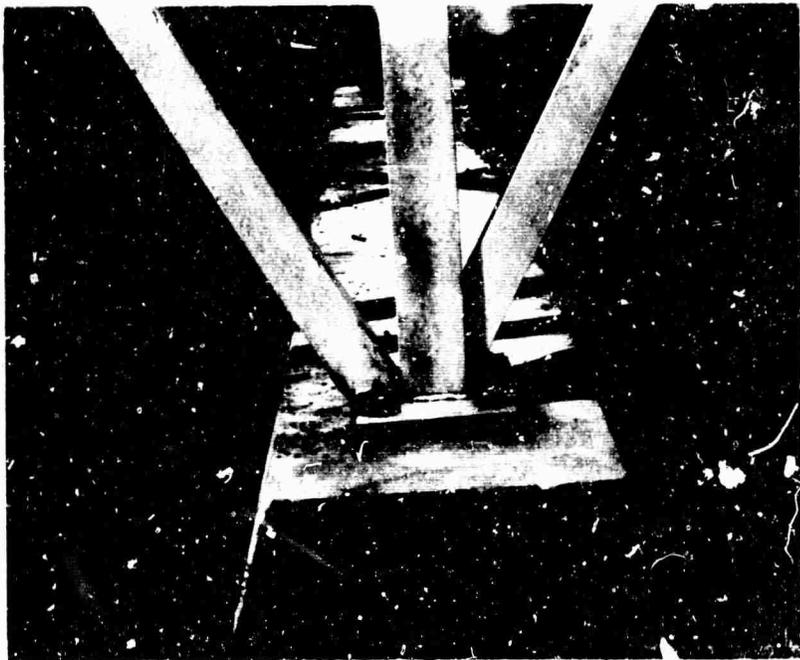
Photo No. 54 - Pre-Shot of T-16 Footing

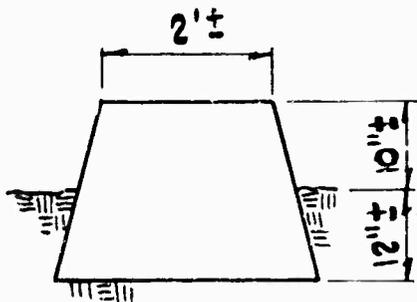
SKETCH N<sup>o</sup> 4

NOTE: NO DAMAGE TO THE STRUCTURAL STEEL WAS OBSERVED.

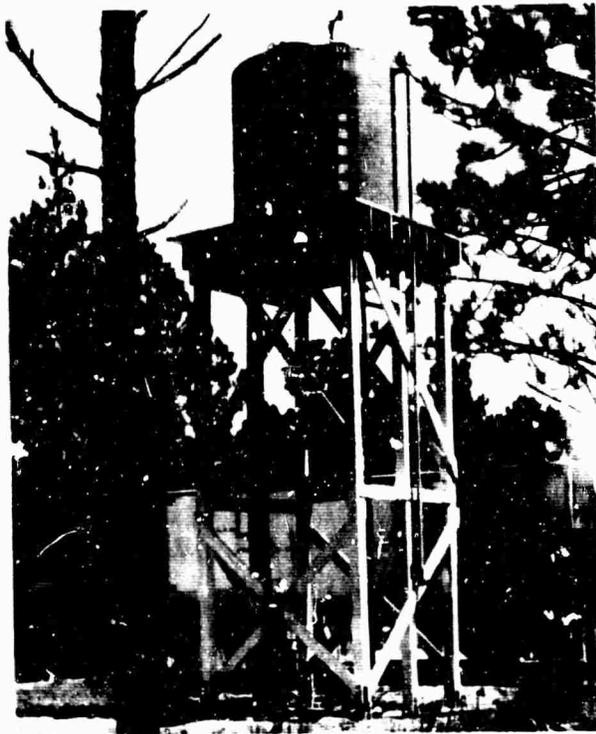
A water tank and tower (T-19) were located 610 meters from SZ. The steel tank, 2 meters high and 2 meters in diameter, was mounted vertically 4 meters above the ground on a wood platform (photo no. 55). The tower was constructed of six 15 x 15 cm posts braced with planks bolted diagonally as illustrated. The peak ground motion velocity was predicted to be 112 cm/sec at the tower, and it was almost empty on shot day. No damage was observed after the event.

Photo No. 55 - Pre-Shot of Water Tank and Tower  
at First Aid Station

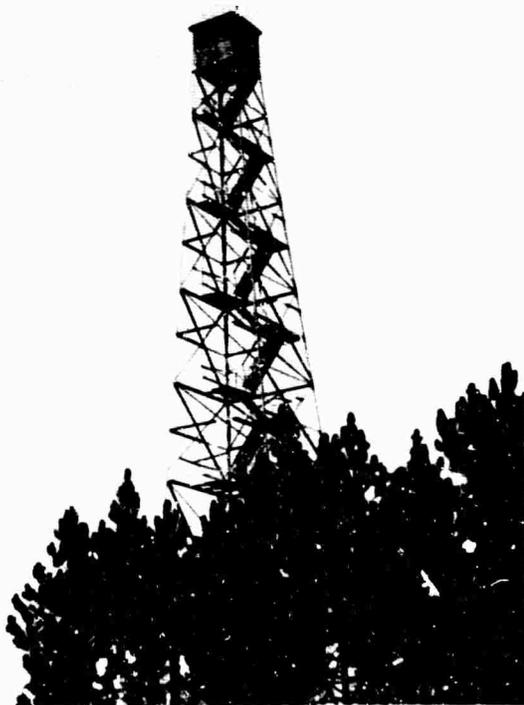
A fire tower (S-4) occupied by the Mississippi State Forestry Service was surveyed 9.3 km from SZ. The steel frame, wood panelled cabin was supported on 10 x 10 cm angle columns, approximately 33.5 meters above the ground (photo no. 56). The columns were braced diagonally and horizontally with steel angles (photo no. 57). The tower is supported on individual concrete footings (photo no. 58) and anchored with two bolts through each base plate bracket. The predicted ground motion was 2 cm/sec. No damage was noted in the postshot survey of the tower.

Photo No. 56 - Pre-Shot of Mississippi State  
Forestry Service Fire Tower

Photo No. 57 - Pre-Shot of Fire Tower Columns  
Braced with Steel Angles

Photo No. 58 - Pre-Shot of Fire Tower Footing

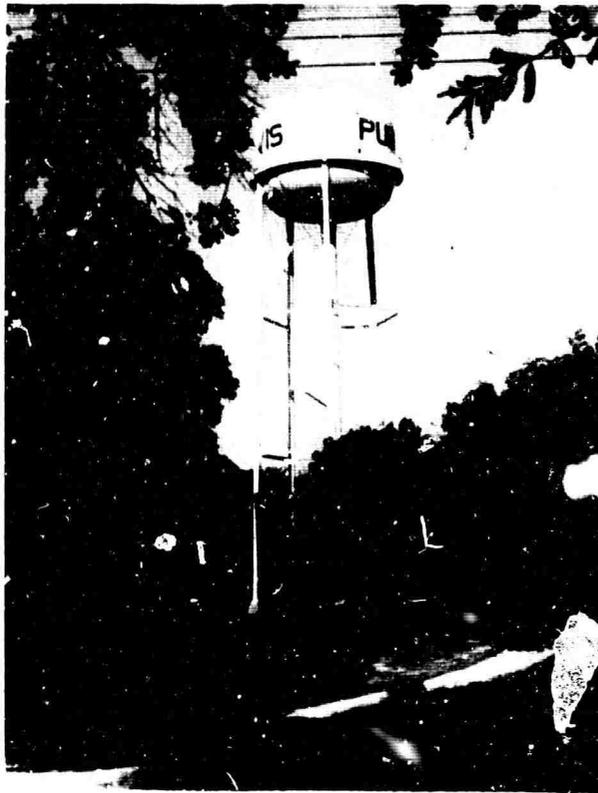
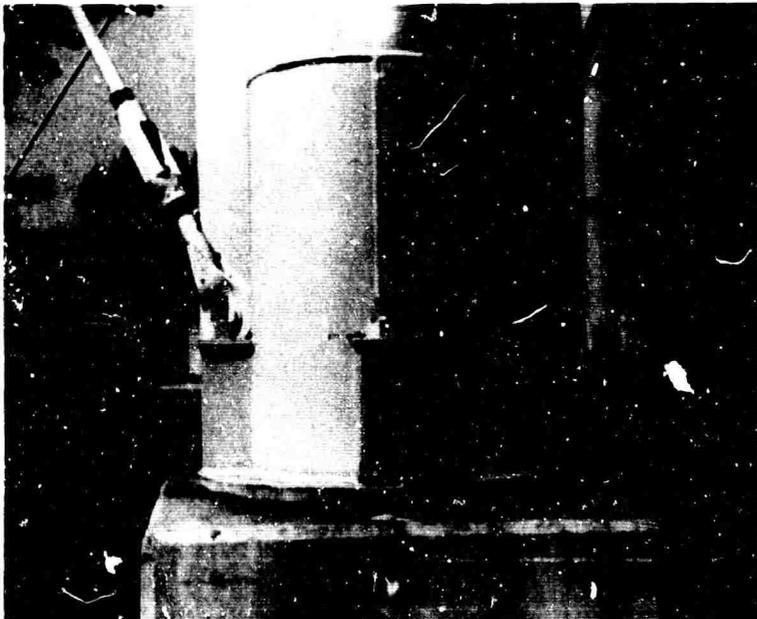
Farther out from SZ, the Purvis City water tank (S-2) was surveyed. This elevated 946,000 liter steel tank was located 15.2 km from SZ (photo no. 59), where the ground motion was predicted to be 1 cm/sec. The tank was estimated to be about 37 meters above the ground and was supported on five 61 cm diameter steel pipe columns. The columns were cross-braced. The exterior columns were anchored to concrete foundation pads with four steel anchor bolts for each column (photo no. 60). An interior 122 cm diameter steel pipe extended down from the center of the bottom of the tank.

Photo No. 59 - Pre-Shot of Purvis Water Tower

Photo No. 60 - Purvis Water Tower Footing

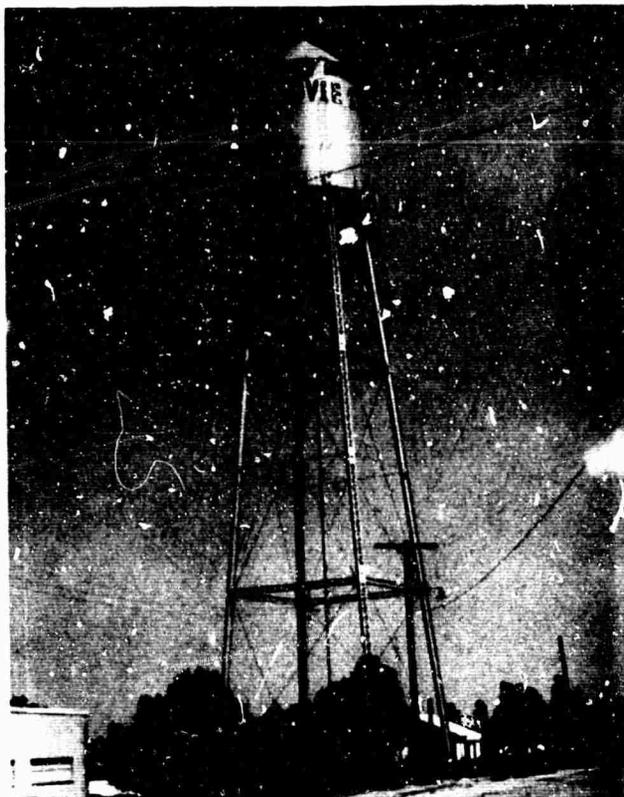
Another water tower, the Movie Star of Purvis Corp. water tank (S-1) was surveyed also at a distance of 16.1 km from SZ. This is also a steel tank mounted approximately 30 meters above the ground on a steel tower (photo no. 61). The four tower legs, consisted of channel sections, with steel bars for diagonal bracing. Each column base plate was mounted to a concrete pad by one anchor bolt, as shown in photos no. 62 and 63. The ground motion at this location was also estimated to be 1 cm/sec.

The two Purvis water tanks were not expected to be damaged, and no pre-cautionary measures were taken prior to the shot. Only the Movie Star of Purvis Corporation tank sustained any apparent damage from the Salmon Event, and this was only a small leak in the fill pipe. Since the postshot survey indicated only a small dripping, it is possible that the leak was aggravated by the ground motion from the event.

Photo No. 61 - Movie Star of Purvis Water Tower

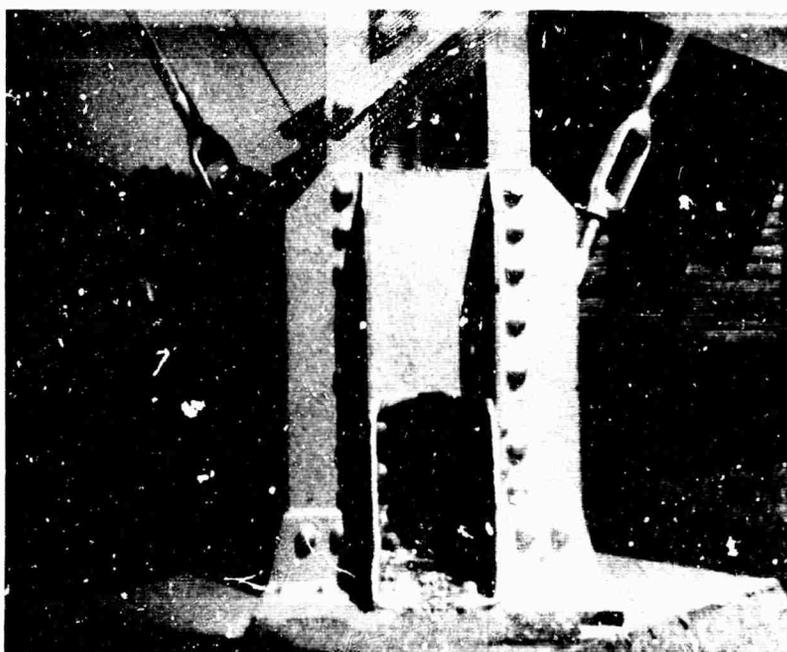
Photo No. 62 - Movie Star of Purvis Water Tower Footing

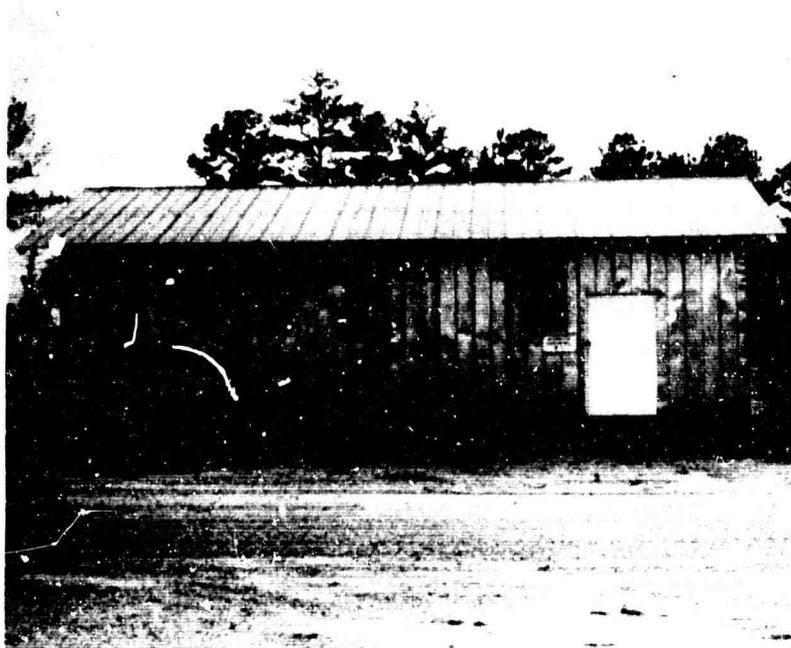
The compressor house on the Dribble Site, designated T-4, was a prefabricated building with aluminum siding (photos no. 64, 65, and 66). It had a continuous concrete slab around the compressor foundation pad. The structure was located 550 meters from SZ and the predicted peak ground velocity was 125 cm/sec at this distance. Numerous cracks developed in the concrete floor slab after the Salmon Event. The cracks extended radially out from the massive compressor foundation pads; however, no cracks appeared in the compressor foundation pads. The slab also indicated about 1 cm of settlement more than the compressor pad. Probably due to compaction of the fill under the slab. The postshot condition is shown in sketch no. 5 and in photo no. 67.

Photo No. 64 - Pre-Shot of Compressor House - Front View

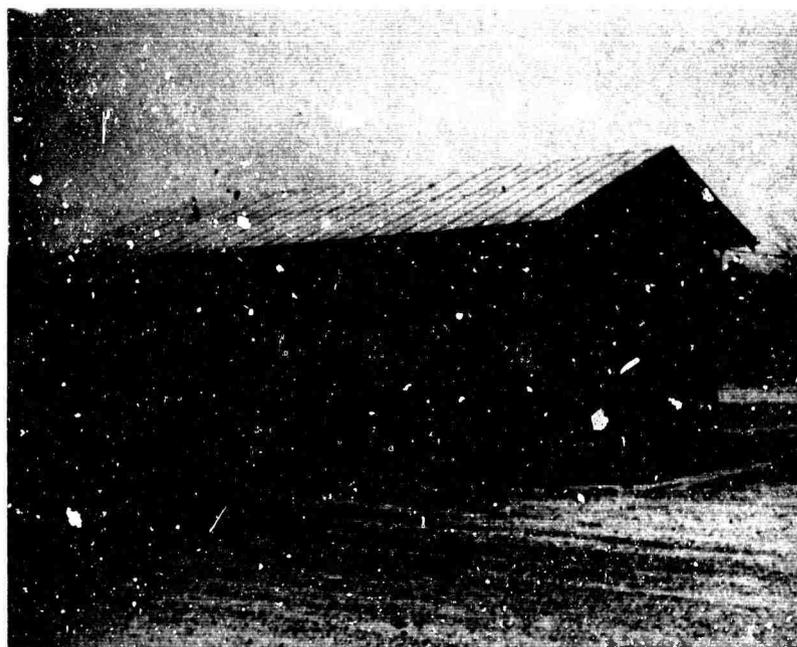
Hoists were housed in two structures on the Dribble Site. The hoist houses were prefabricated structures with aluminum siding and a continuous concrete floor slab around a large hoist pad foundation (photos no. 68 and 69). Both were located approximately 565 meters from SZ where the predicted peak ground motion velocity was 120 cm/sec. After the event, cracks were evident in the floor slabs of both structures; and approximately 1 cm of settlement of the floor slabs was also indicated after the event, however, no cracks appeared in the hoist foundation pads (sketches no. 6 and 7).

Photo No. 69 - Pre-Shot of Hoist House No. 2

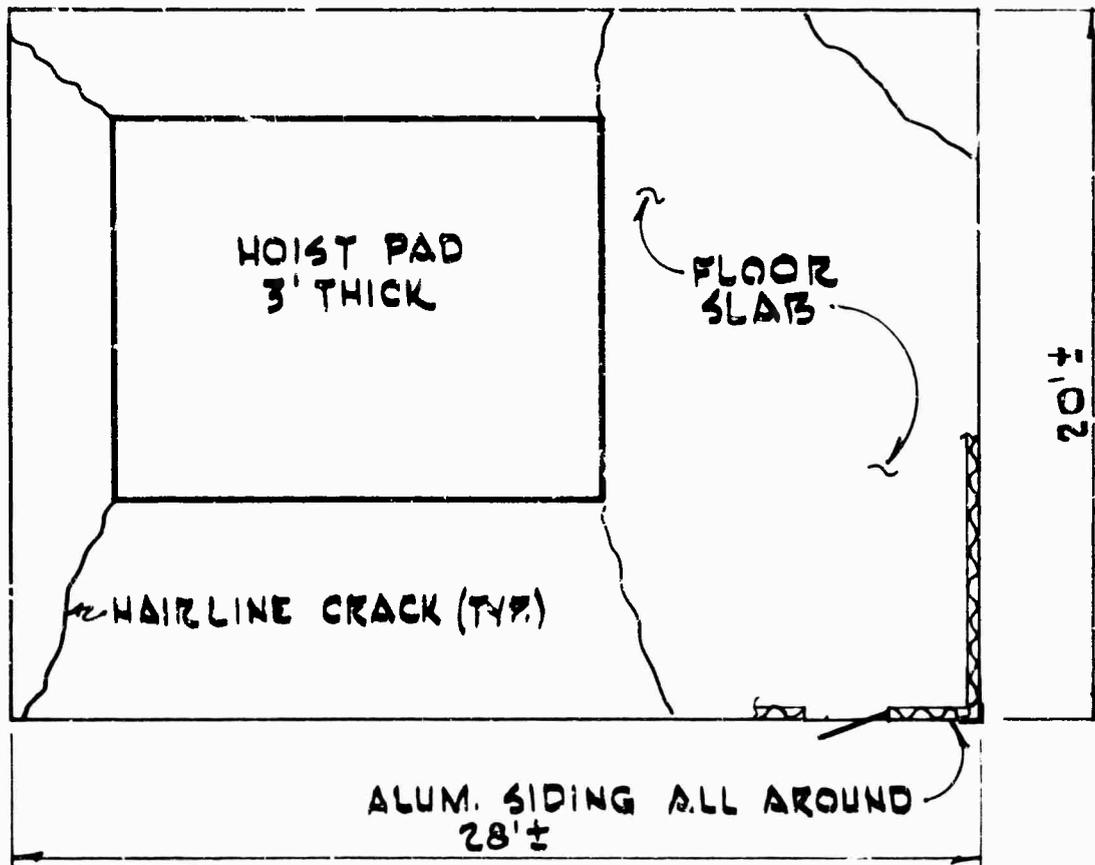
HOIST HOUSE N°2 FLOOR PLAN

POSTSHOT CRACKS IN HOIST HOUSE  
N°2 SLAB.

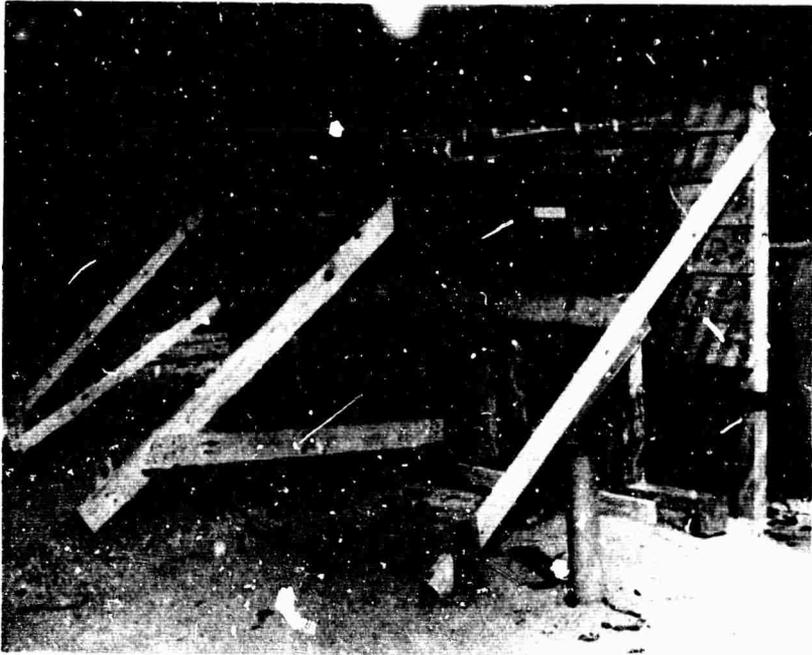
Photo No. 72 - Pre-Shot of Transformers and Oil Fuse Cut-Out Panel at Sta. 1-A After Bracing

Two electrical transformers and equipment boxes and two oil fuse cut-out panels (T-13) were located 107 meters from SZ (photos no. 70 and 71). The oil fuse cut-out panels were bolted to a wood frame. The transformers and other equipment had not been bolted down prior to the phase 3 survey, and with the predicated peak ground motion velocity at this location of approximately 227 cm/sec, it was recommended that bracing and guy cables be installed (photo no. 72). No damage was observed to the equipment during the postshot survey.

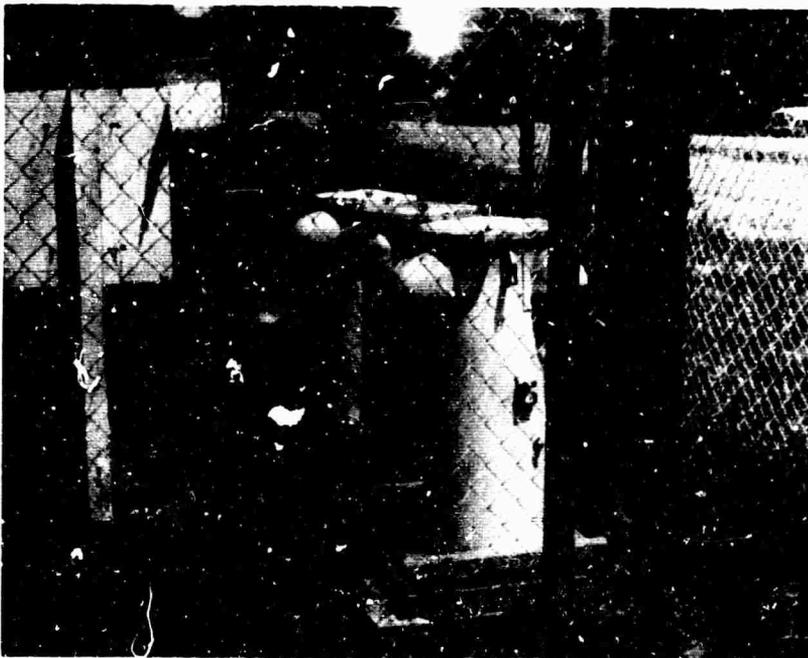
Three electrical transformers (T-12) were located at a substation 381 meters from SZ. The transformers were supported by blocking as indicated on (photo no. 73) and the predicted peak ground motion velocity at this location was 170 cm/sec. H&N recommended guy cables which were installed as indicated on photo no. 74. The postshot survey revealed no damage to the equipment.

Photo No. 73 - Pre-Shot of Transformers Near Entrance to Sta. 1-A (T-12) Prior to Installing Guy Wires

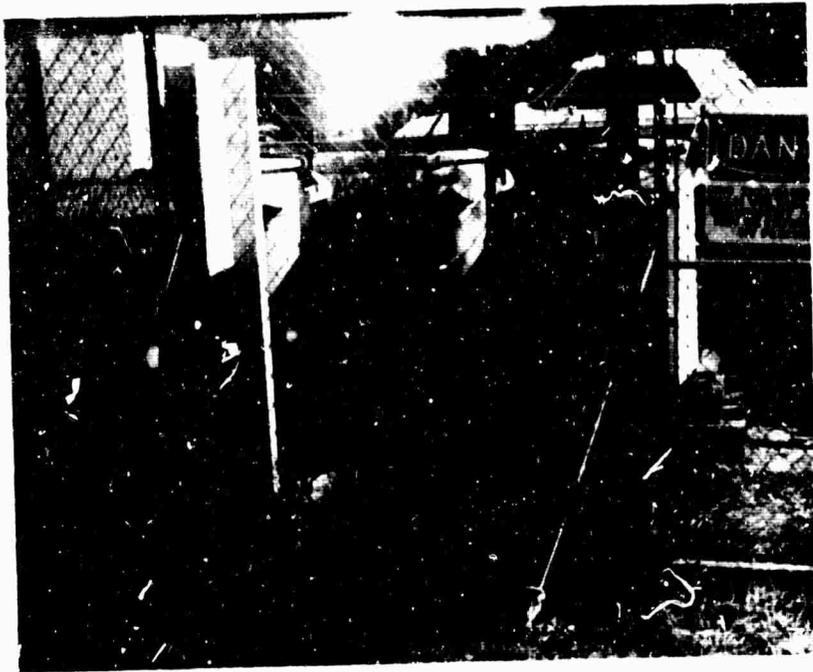
Photo No. 74 - Pre-Shot of T-12 After Installing Guy Wires

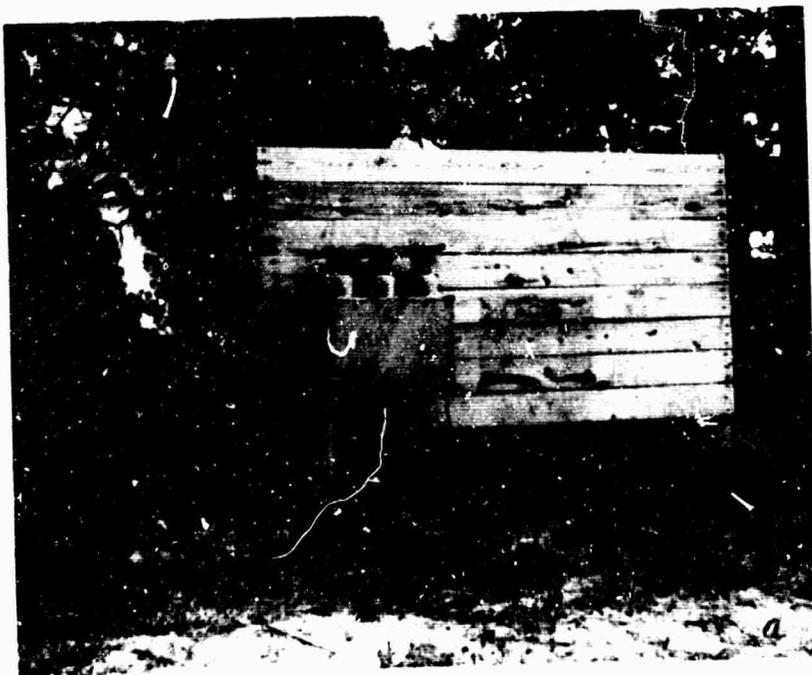
The oil fuse panel at 427 meters was the only one requiring guy cabling. No damage was observed to any of this electrical equipment during the postshot survey.

Photo No. 75 - Pre-Shot of Oil Fuse Cut-Out Panel (T-14)

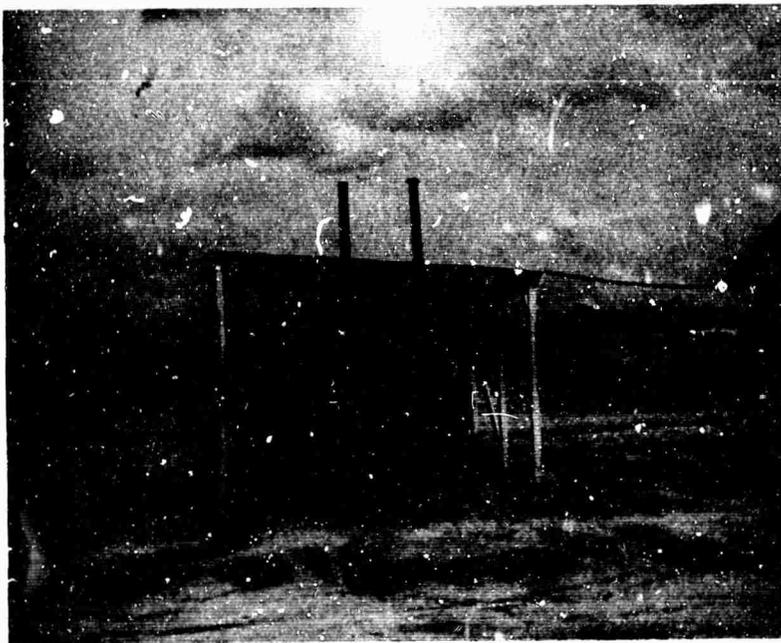
An electrical generated unit with a Caterpillar D-8 motor (T-6) was located in an open shed 565 meters from SZ (photo no. 79). The equipment was supported on wood beams. The predicted peak ground motion velocity at this distance was 120 cm/sec and no bracing was recommended. The postshot survey revealed no damage.

Photo No. 79 - Pre-Shot of Motor and Generator (T-6)

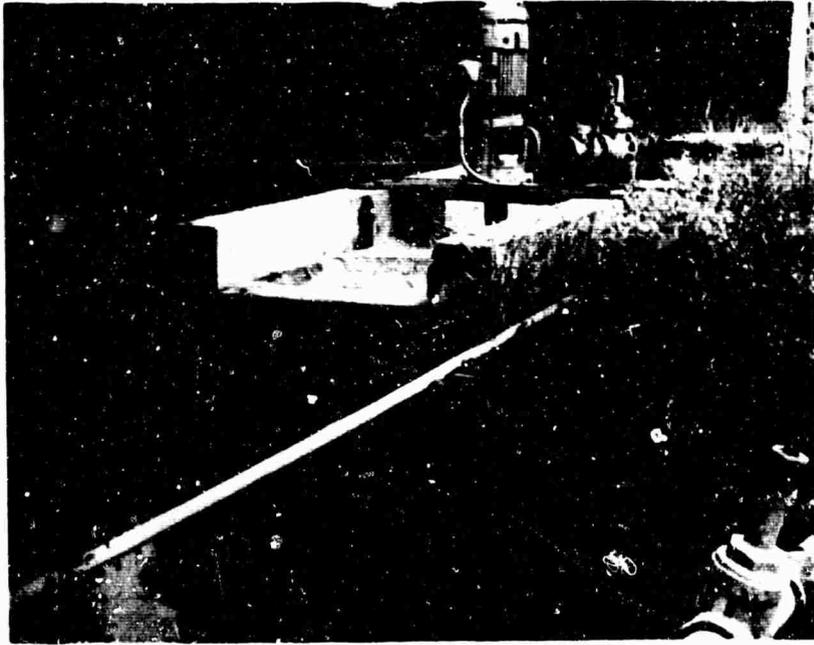
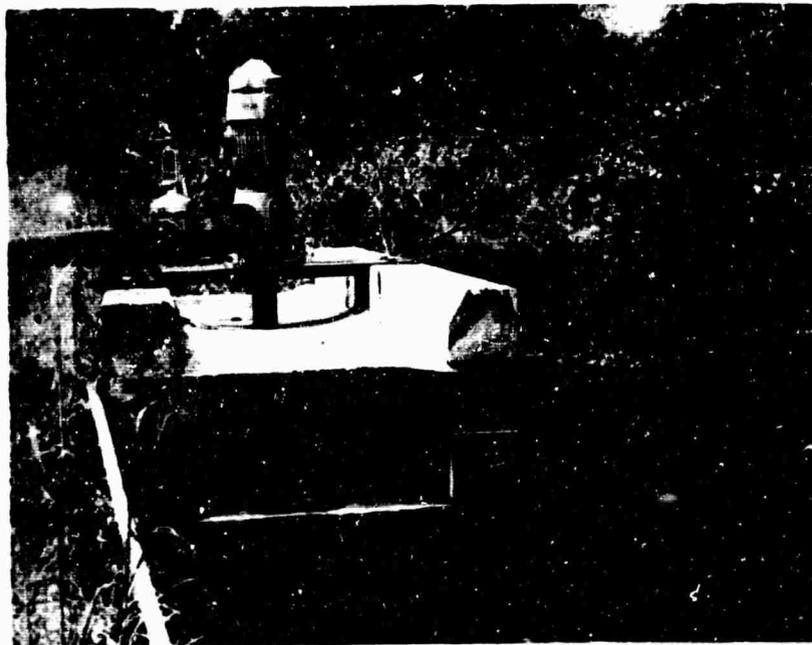
A pump (T-9) for the bleed-down plant was located on a timber crib structure 183 meters from SZ (photos no. 80 and 81). The crib was approximately 5 meters long, and 4 meters high, and was constructed of 30 x 30 cm timbers filled with rock ballast. Although the predicted peak ground motion velocity at this location was 220 cm/sec, only minor damage was predicted, therefore, no precautionary measures were taken. The postshot survey revealed no damage to the equipment or structure.

Photo No. 80 - Pre-Shot of Pump Crib for Bleed-Down Plant

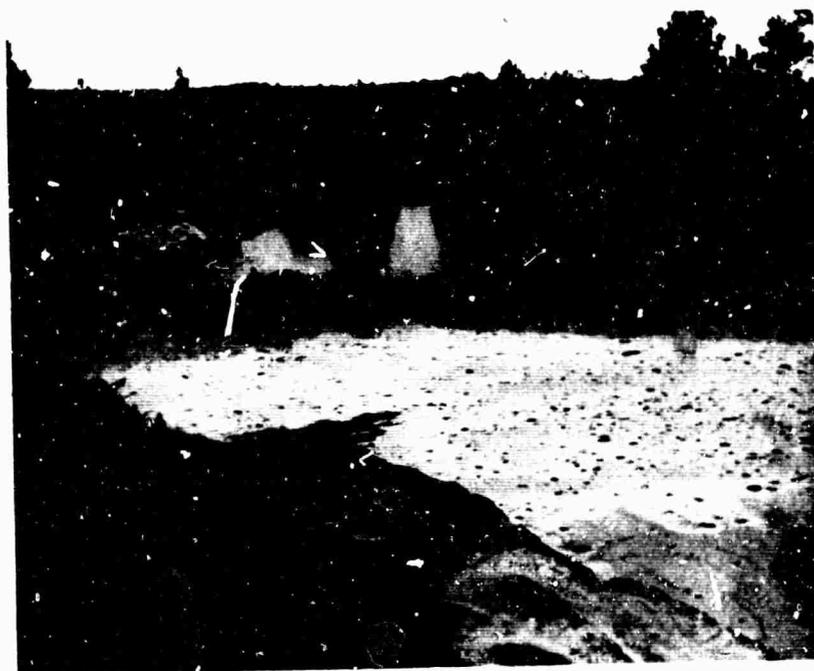
Pit no. 2 - This pit was also filled to full capacity of about 1,760,000 liters and a liquid depth of  $1\frac{1}{2}$  meters. There was evident of seepage through the roadside dike prior to the test, as shown in photo no. 87. After the test longitudinal cracks developed on the berm of the dike (photo no. 88).

Photo No. 87 - Pre-Shot of Disposal Pit No. 2 (Background)  
and Disposal Pit No. 3 (Foreground) on  
September 30, 1964)

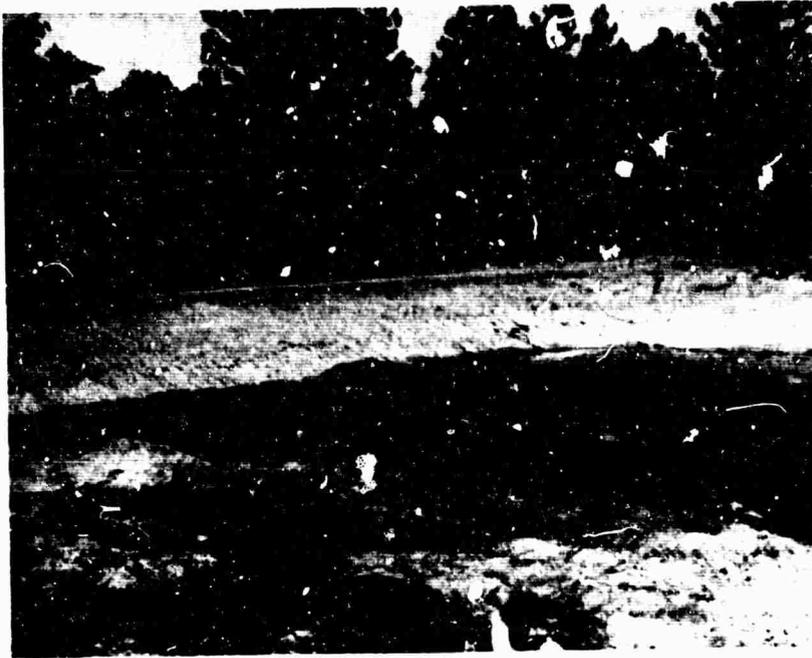
Pit no. 5 - This pit was similar in height to no. 4, however, it was only partially filled and it was recommended that several of the other pits be reduced in quantity of liquid by pumping into no. 5. Prior to the event "mud" was pumped from no. 2 into no. 5 until the level of no. 5 was 2 meters (photo no. 92) from the top. After the event, many longitudinal cracks developed in the berm, and sloughing was evident on both the upstream and downstream faces (photo no. 93).

Photo No. 92 - Pre-Shot of Disposal Pit No. 5  
(August 12, 1964)
