Technical Note N-1130

IMPROVED TECHNIQUES FOR THE NON-DESTRUCTIVE TESTING
OF DIESEL ENGINE PISTONS

October 1970

NAVAL CIVIL ENGINEERING LABORATORY
Port Hueneme, California 93041

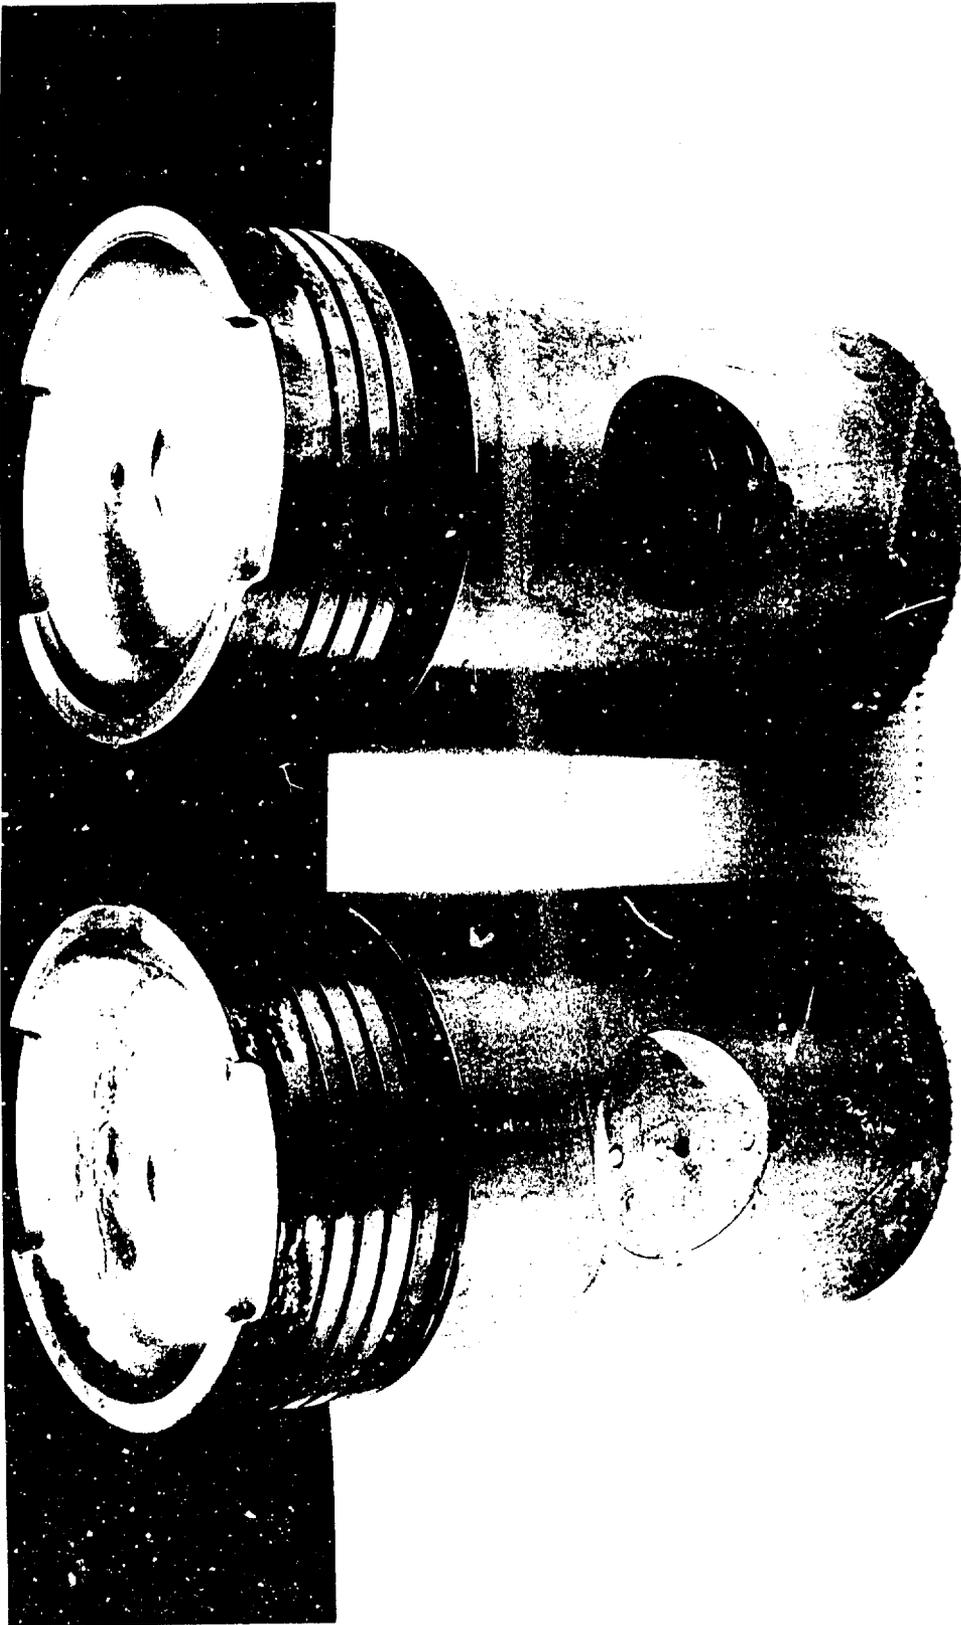
Figure 1. Enterprise Pistons. Part No. G-6924.

The first step in the development of the improved, non-destructive inspection technique was to conduct a thorough investigation and diagnosis of in-service piston failures. This involved an inspection and analysis of all defective pistons returned from Vietnam. See Figure 1 for an illustration of typical pistons as received. These pistons, manufacturer's part no. G-6924, are from Model DSG Enterprise diesel engines. The pistons are approximately 12 inches in diameter, by 20-3/8 inches high, and weigh between 185 and 188 pounds each. They are of one-piece construction, are machined from a ductile, nodular cast iron, and have a vertical-section configuration as indicated in Figure 2. Nodular cast iron is a relatively recent development in engineering materials. It is similar in some respects to gray (flake) iron, but is distinguished from it primarily because of the spheroidal shape of its graphite particles. The spheroidal graphite, in turn, results in improved mechanical properties in nodular cast iron, as compared to those of gray iron.

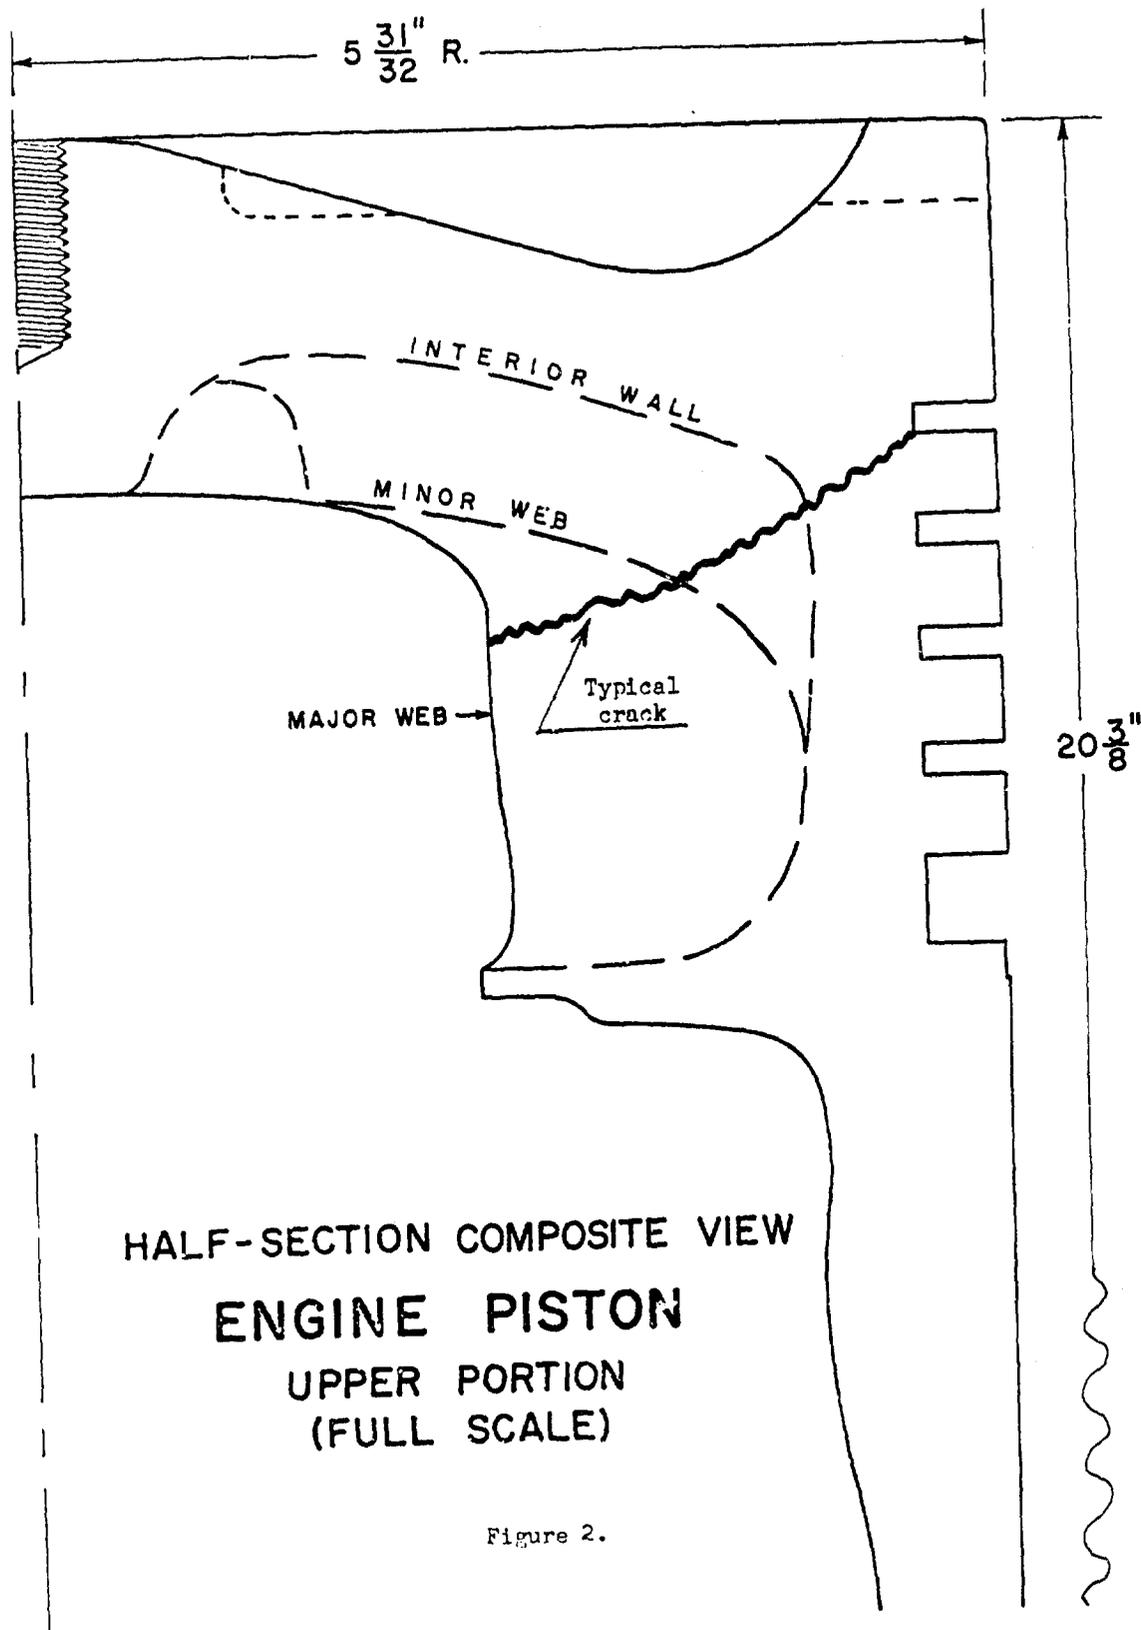
Figure 2.

Initially two new, unused pistons were supplied for examination, and for use as a basis of comparison. Subsequent examination of all available defective and suspected pistons indicated that the cracking, and ultimate failure, originated along the inner major radius profile of any of the four major webs inside the piston, and propagated radially outward toward either of the two upper ring grooves (as illustrated in Figure 2). As the engine continues to operate, this cracking continues to develop circumferentially around the piston, until finally the top portion, or crown, separates from the piston body with disastrous results to the engine.

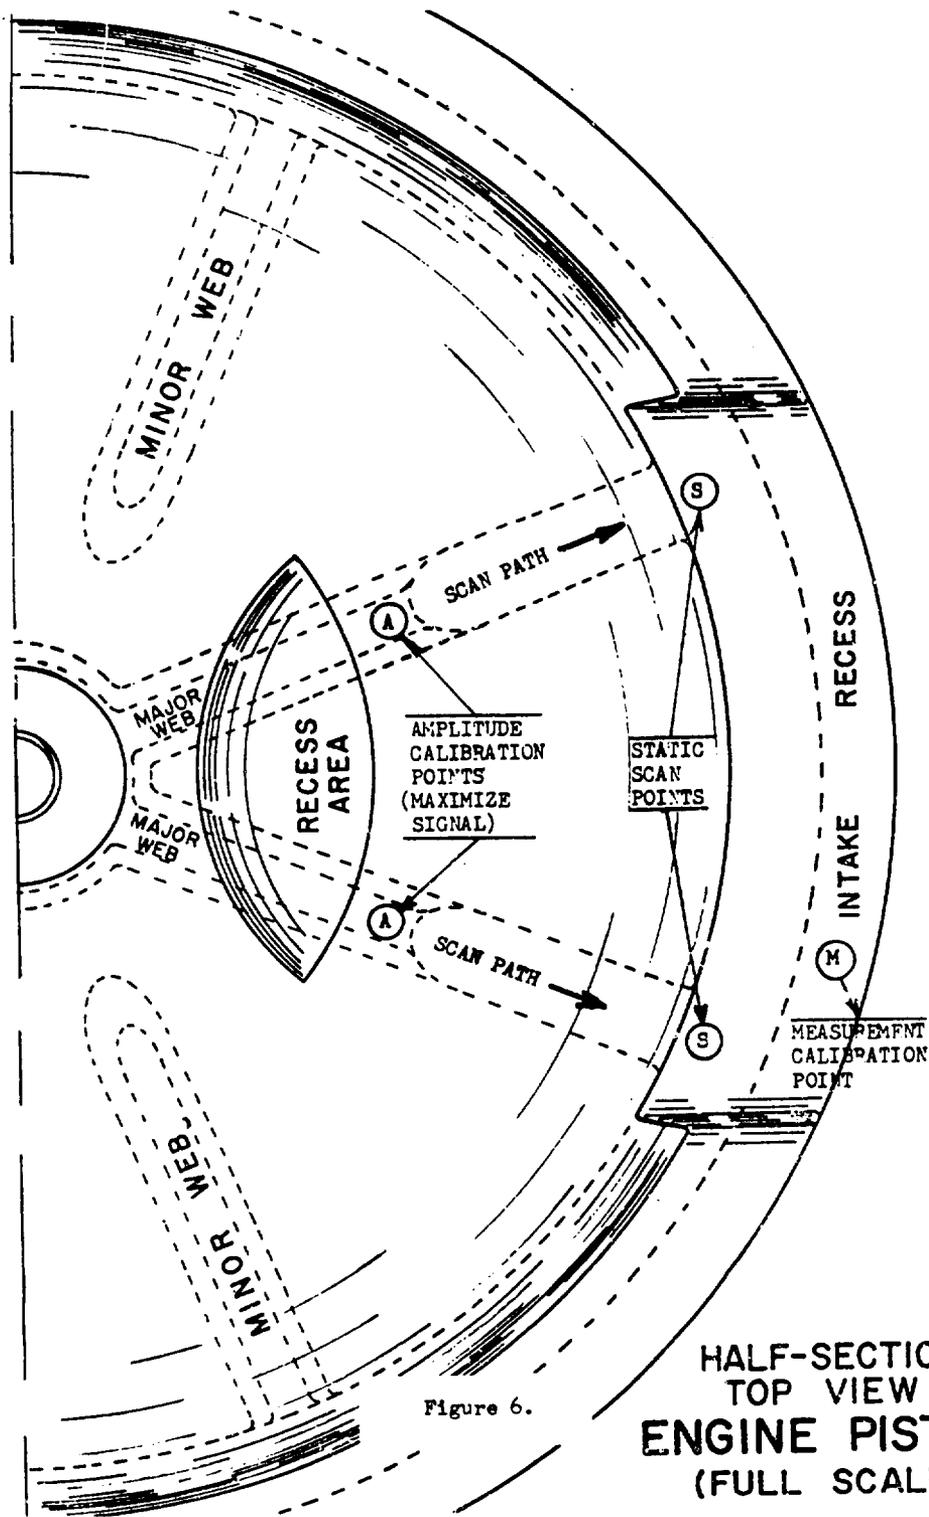
Figure 6.

The outer section of the piston top, located between the valve rim recess and the uppermost ring groove (see point "M" on Figures 6 and 7), provides a material reference calibration dimension of 1-1/4 inches.

For sensitivity (vertical) calibration, the search unit is "coupled" to the piston head in position "A" as illustrated in Figures 6 and 7. After obtaining an indication from the far edge of the major web (the major web at this point is identified as a double image at approximately 1-7/8 inches in depth), this signal is maximized by carefully scanning the transducer in each direction across the web. The instrument gain control is then adjusted so that the peaked indication is set at 80% of full screen height. During this maximizing process, any indication occurring on the screen at 7/8 inch depth, represents the interior wall of the piston head, and is evidence that the transducer is not correctly positioned over the deep center line of the major web.

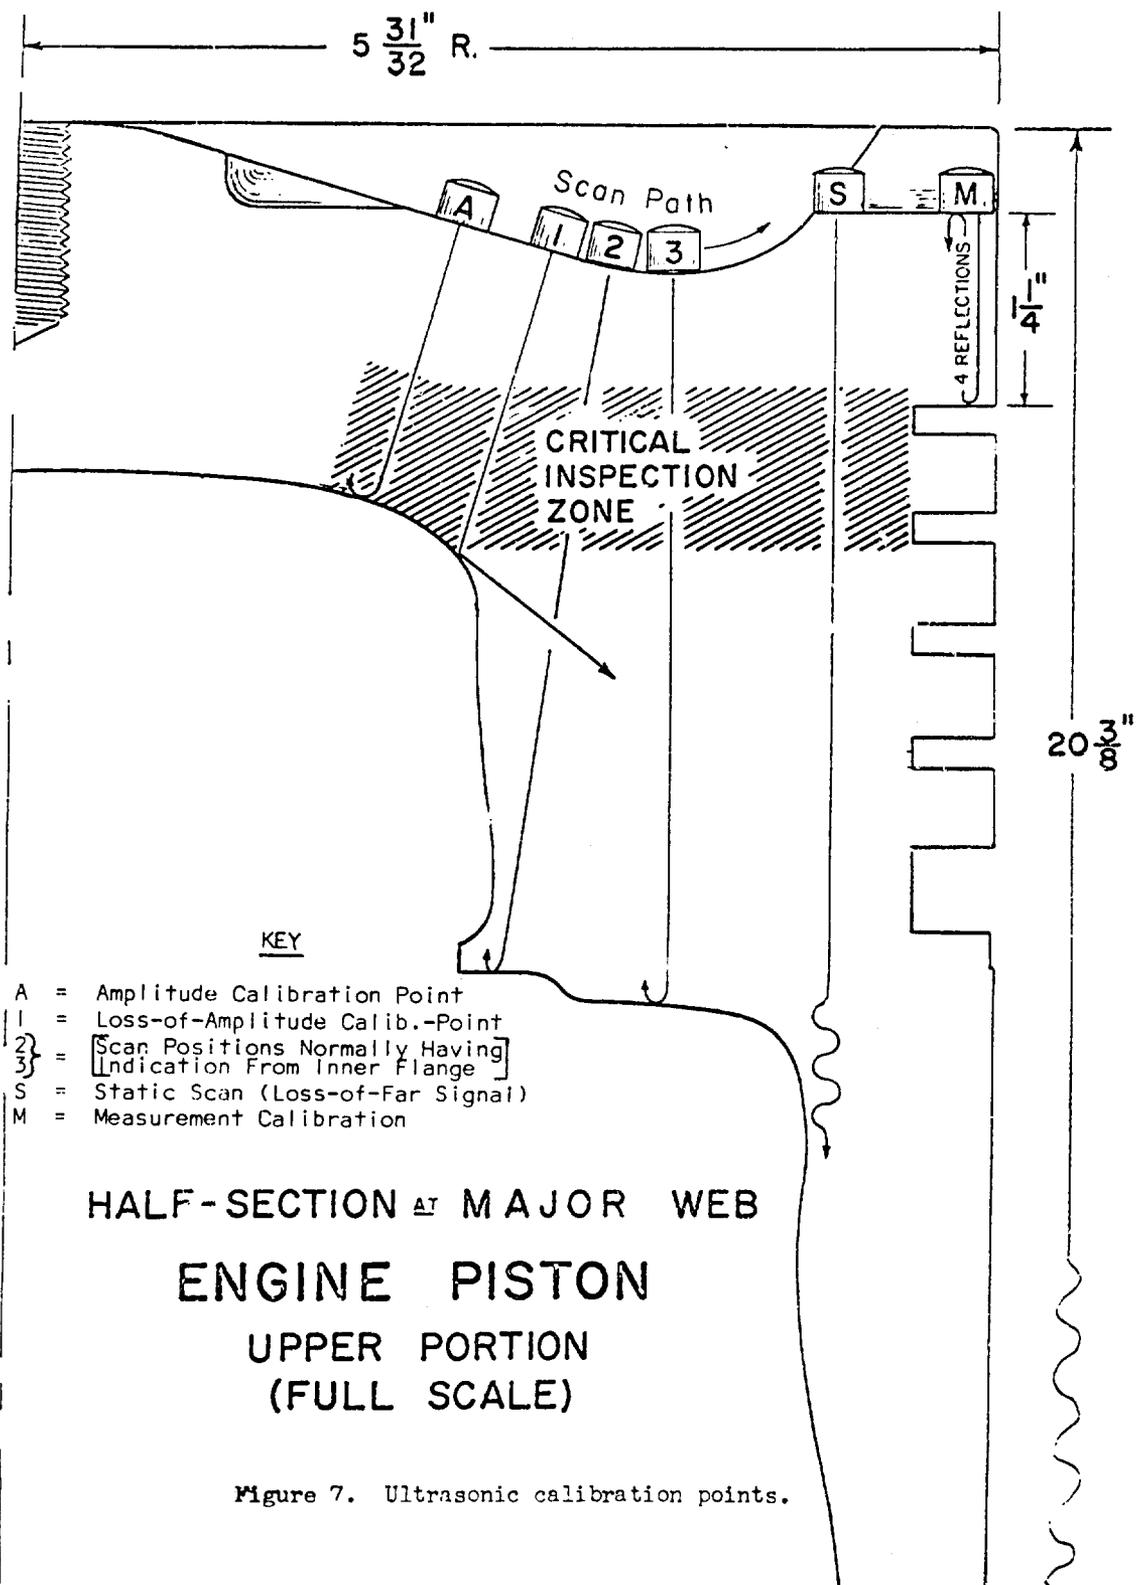
Figure 7. Ultrasonic calibration points.

A transducer of the proper type is finally connected to the instrument and "coupled" to the piston at the outer edge of the valve rim recess area of the piston top rim, where the thickness to the first ring groove is 1-1/4 inches. (Point "M" on Figure 7). The instrument controls are adjusted so as to display four multiple reflections from the uppermost ring groove. By refining the sweep delay and sweep range control settings, the leading edge of the first, second, third, and fourth multiple reflections are now aligned with the 1-1/4 inch, 2-1/2 inch, 3-3/4 inch, and 5 inch markings, respectively, on the scope base line, thus completing the horizontal calibration (see Figure 8). Should it be impossible to satisfactorily distinguish the four multiple reflections on the scope (as illustrated in Figure 9), it may be assumed that the piston material is flake type cast iron, and is therefore not suitable for the inspection via this process.
