FIRE TESTING OF INDEPENDENT FIBERGLASS  
FUEL TANKS WITH AND WITHOUT PROTECTIVE  
COATING OF FIRE RETARDANT PAINT

UNITED STATES COAST GUARD  
OFFICE OF RESEARCH AND DEVELOPMENT  
APPLIED TECHNOLOGY DIVISION

LTJG J. D. RICHART, USCG  
MERCHANT MARINE TECHNICAL DIVISION  
OFFICE OF MERCHANT MARINE SAFETY

Date: 2 July 1971

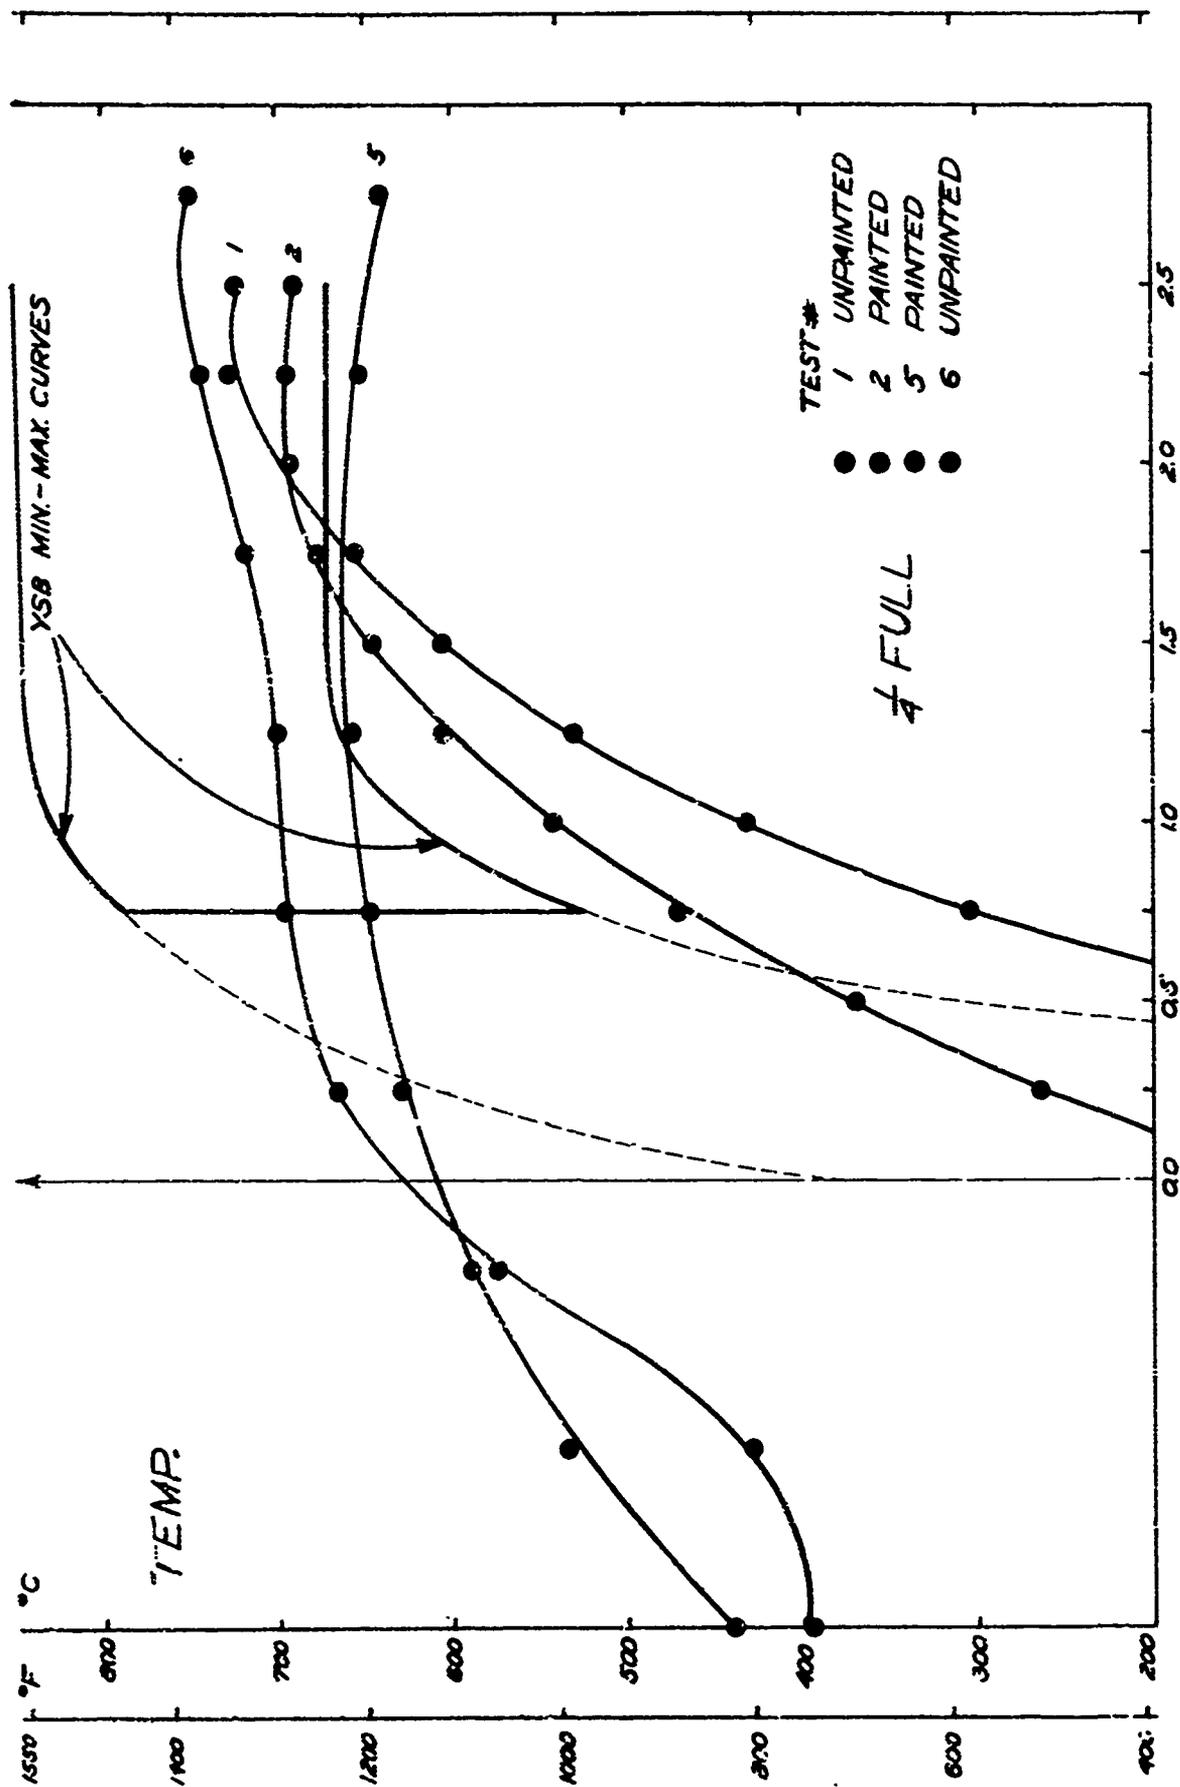
FIG. 1 RESULTS VS. Y.S.B. CRITERIA

Results of tests conducted on the eight independent fiberglass fuel tanks are summarized in Table I. Tests #1 and #2 were both for 2m30s and the time-temperature data were close to the YSB criteria for the 2m30s gasoline fire test (see FIG. 1, reference (1)). Photographs (3) and (4) show the internal appearance to be very good for both tanks. The unpainted tank has charred somewhat, causing some degradation of wall soundness, but both tanks could withstand several minutes more fire exposure before failure.

FIG. 1 shows that Test #6 on the unpainted tank had temperatures which fell easily between the YSB's min.-max. curves for the 2m30s independent fuel tank fire test. Test #5 did not cross over the minimum curve, due to variables beyond control. As can be seen in FIG. 5, the unpainted tank was subjected to a fire about 150°F hotter than the painted tank. However, the painted tank lasted two minutes longer and still presented a better internal appearance. The internal temperatures depicted on FIG. 7 show the temperature in Test #6 to rise sharply after two minutes. The dip in the curve can be explained as follows: the thermocouple was positioned in the vapor space and when the fuel began to boil, a droplet of fuel hit the nickel bead, causing a sharp drop in temperature reading. As the liquid vaporized, the temperature again climbed rapidly.

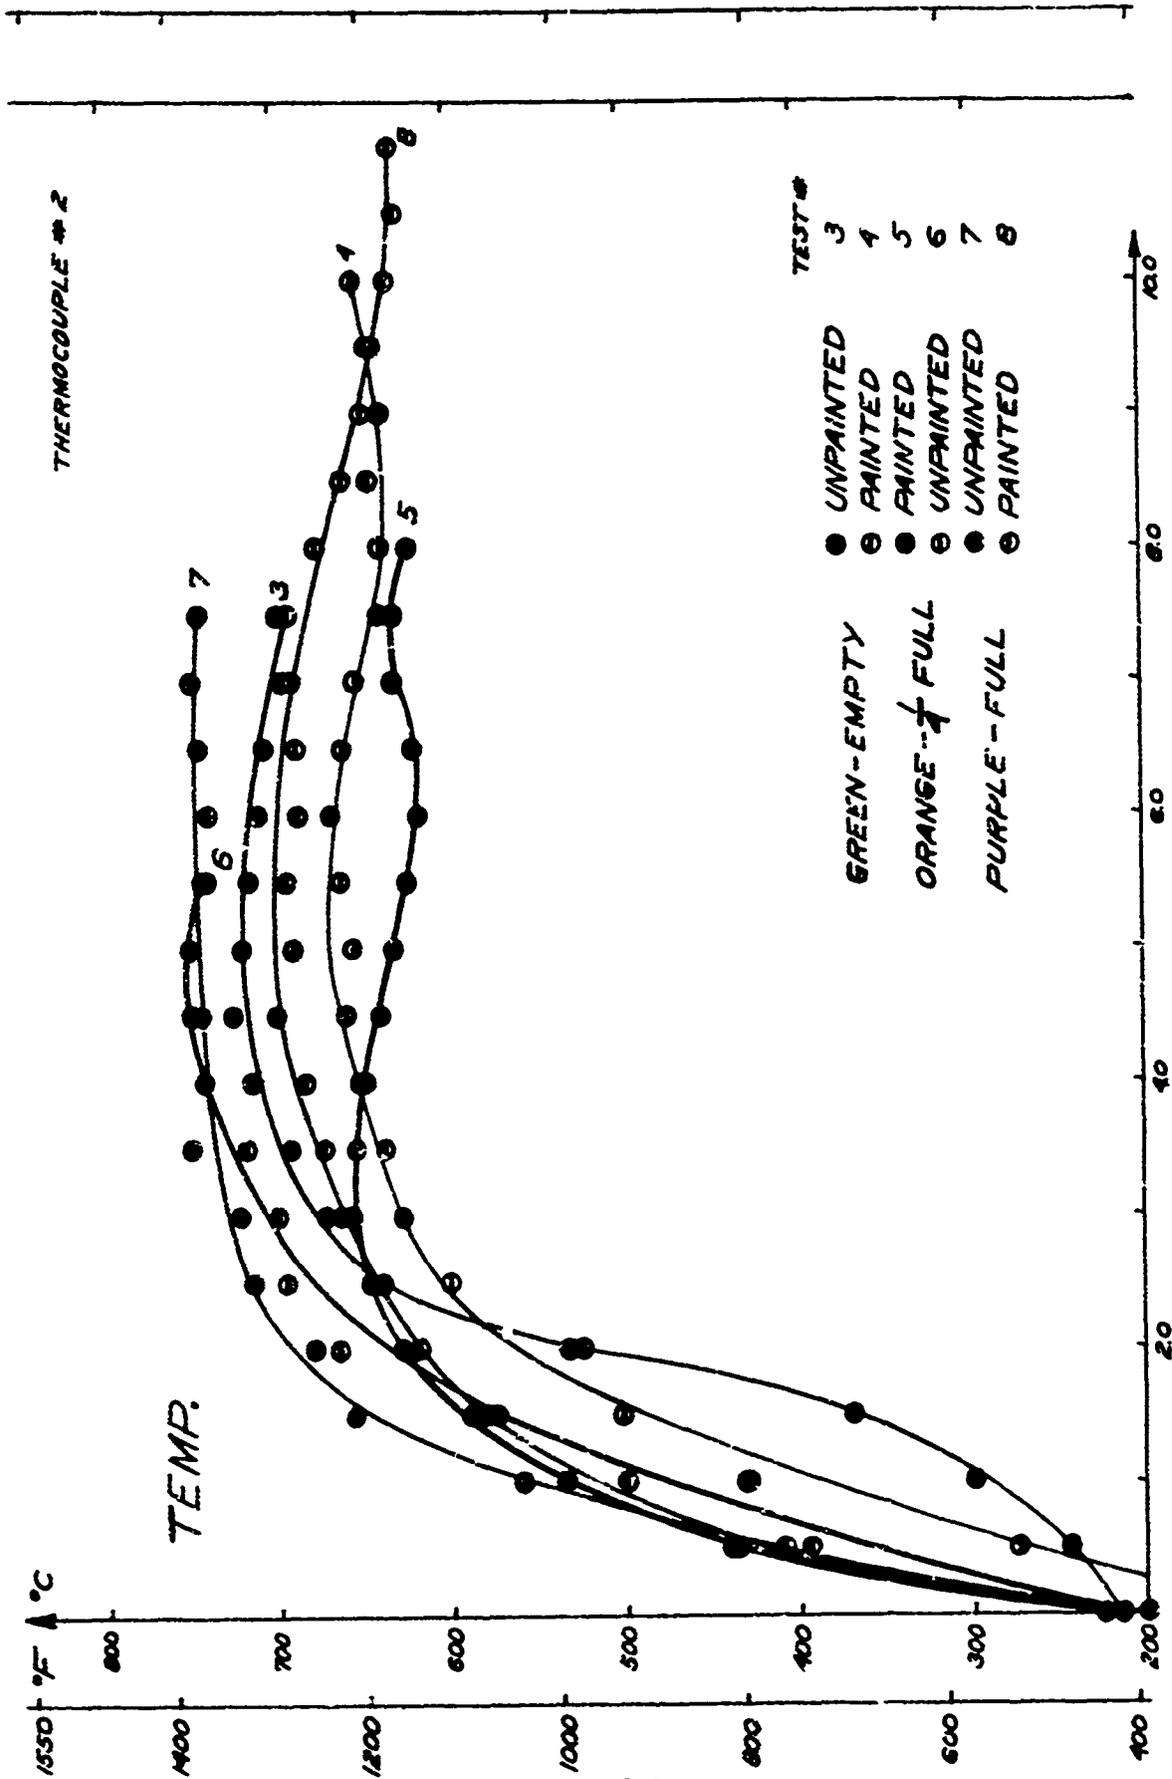
FIG. 3 TANK FIRE PROFILES

A brief overall view of the time-temperature data yields some interesting observations. The scatter in the data was much wider at thermocouple #1 (nearer the two-part door) than at thermocouple #2, indicating that wind conditions were locally affected by the door behind the test set-up (see FIGS. 2 and 3). The test temperature range was about  $440^{\circ}\text{F}$  ( $980^{\circ}\text{F}$ - $1420^{\circ}\text{F}$ ) at thermocouple #1, whereas the difference between fires varied only  $225^{\circ}\text{F}$  ( $1150^{\circ}\text{F}$ - $1375^{\circ}\text{F}$ ) at thermocouple #2. A look at FIG. 7 shows that all the painted tanks were insulated significantly better than the unpainted ones. In tests #7 and #8 the fires were very similar, eliminating the difficulty in comparing results from differing exposures, and the painted tank took two minutes longer to reach the  $200^{\circ}\text{F}$  internal temperature mark than did the unpainted tank. The tanks which were  $\frac{1}{4}$  full of fuel, providing the most severe fuel conditions for a fire, had four minutes separating their internal behavior. The empty tanks cannot be compared realistically, because of the difference in fire intensity.
