Report No. FAA-RD-72-25

# SONIC BOOM AND NATURAL DETERIORATION EFFECTS ON BUILDINGS: WHITE SANDS, N.M. STRUCTURE RESURVEY

FEBRUARY 1972  
FINAL REPORT

(A SUPPLEMENT REPORT TO REPORTS SST 65-15 (VOLS. 1 AND 2) AND SST 65-18)

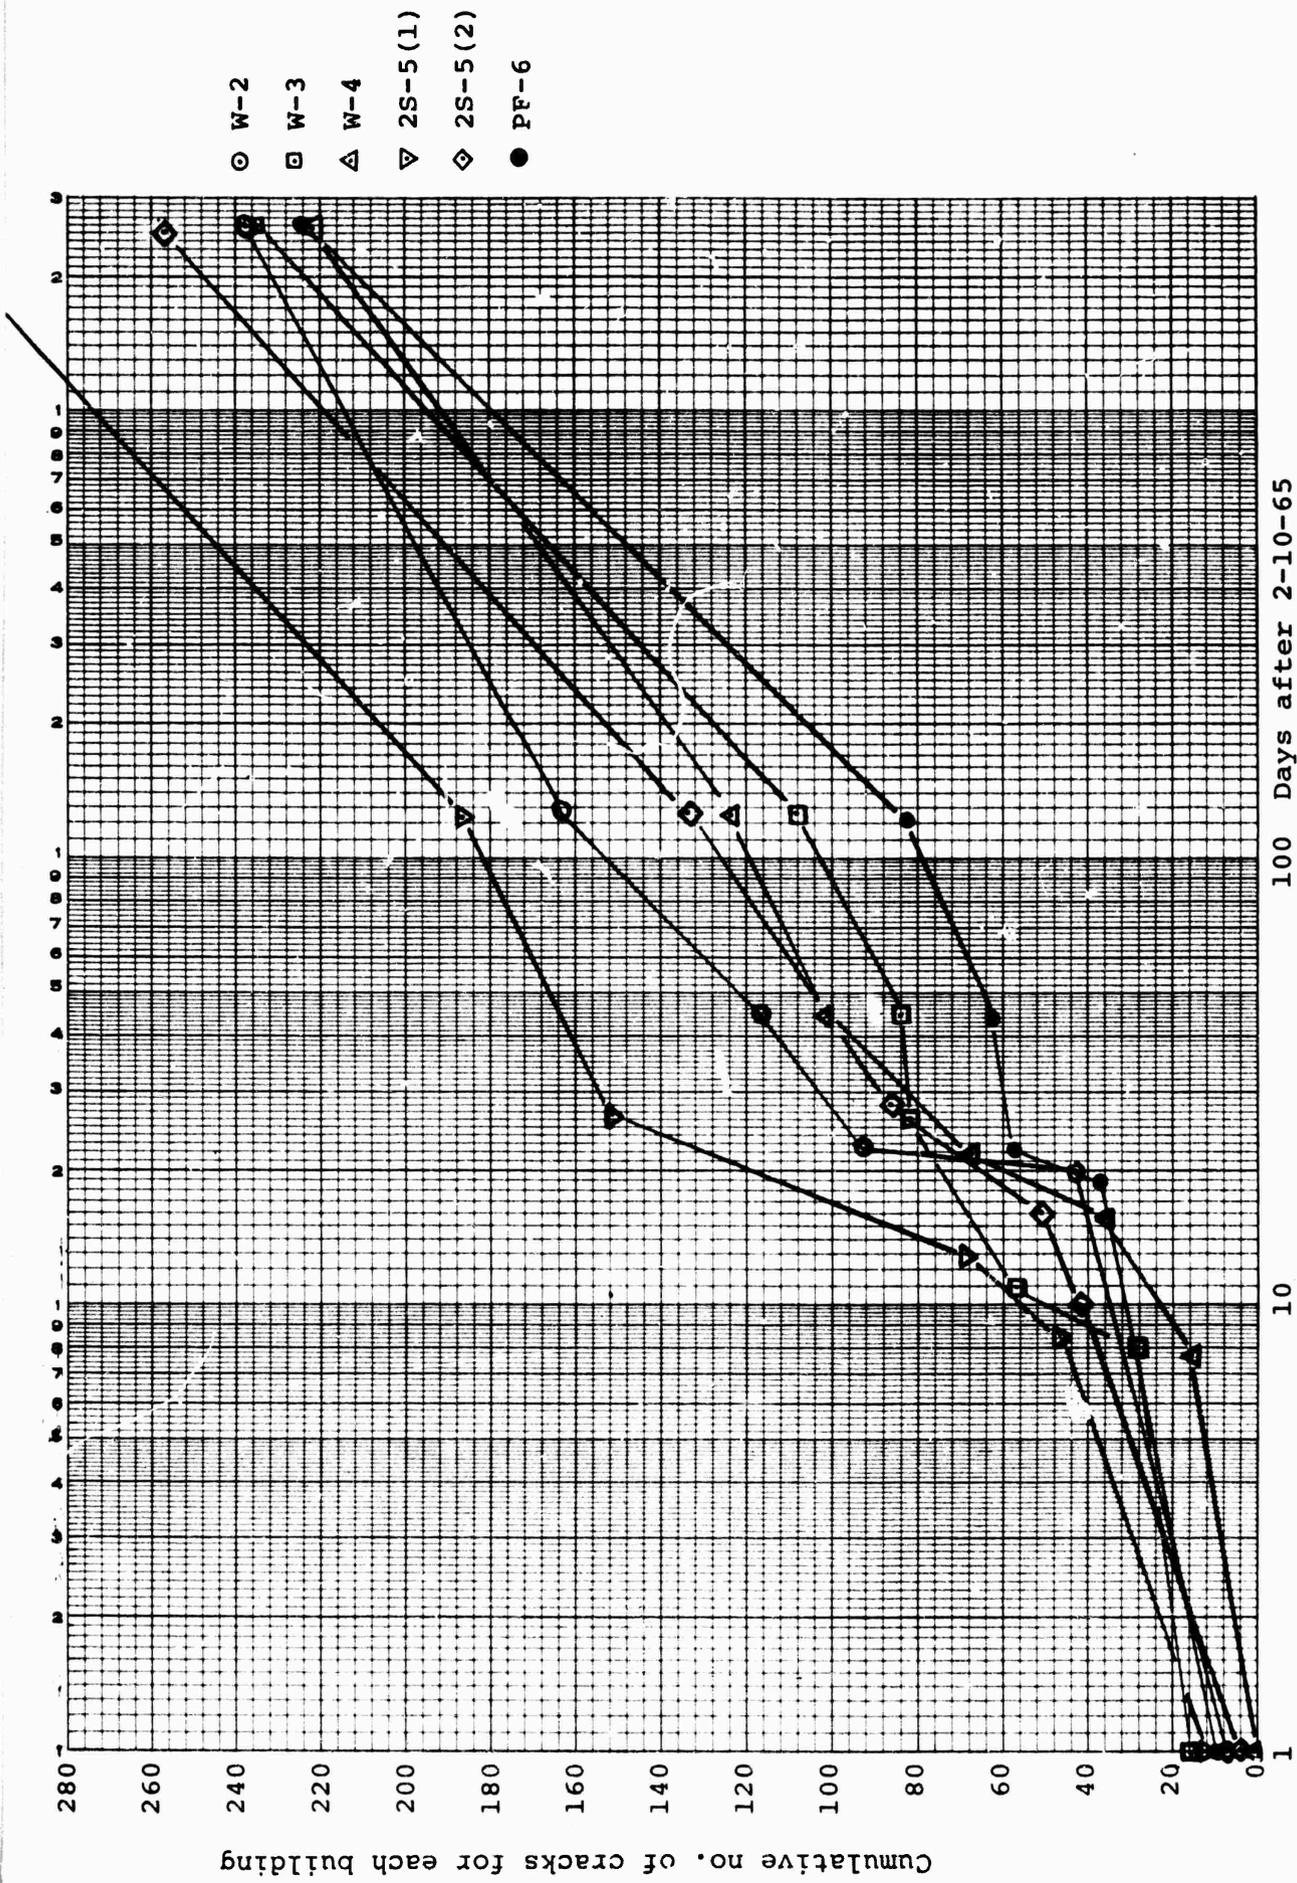
Fig. 53 Cumulative Damage Plotted only for Inflection Points

For the shrinkage type of process it has been found that  $\lambda(t) = \lambda/t$  is a good model. Based on this expression one would expect the rate,  $\lambda(t)$ , to plot as a straight line on log-log paper and the cumulative crack number to plot as a straight line on semi-log paper. This was demonstrated in SST 65-15 (Vol. 1). Figure 53 illustrates the data in Table 5.

cause further damage, one would expect at some over-pressure level the slope increase over and above that caused by the drying and settlement processes. This slope increase is obvious for each of the "buildings". However, in order to identify any real effects we plotted the average cumulative number of cracks for all the buildings along with temperature differential (Fig. 54). Slope increase is obvious on days of increasing temperature differential as well as over-pressure increase. These data infer that cumulative damage is indeed difficult to identify as a function of boom strength and number. However, the greater slope of the curve in the post-boom periods suggests strongly that natural deterioration conditions far outweigh boom influences regarding cumulative damage.
