MISCELLANEOUS PAPER S-72-22

CONDITION SURVEY, FORNEY ARMY AIRFIELD FORT LEONARD WOOD, MISSOURI

June 1972

Conducted by U. S. Army Engineer Waterways Experiment Station

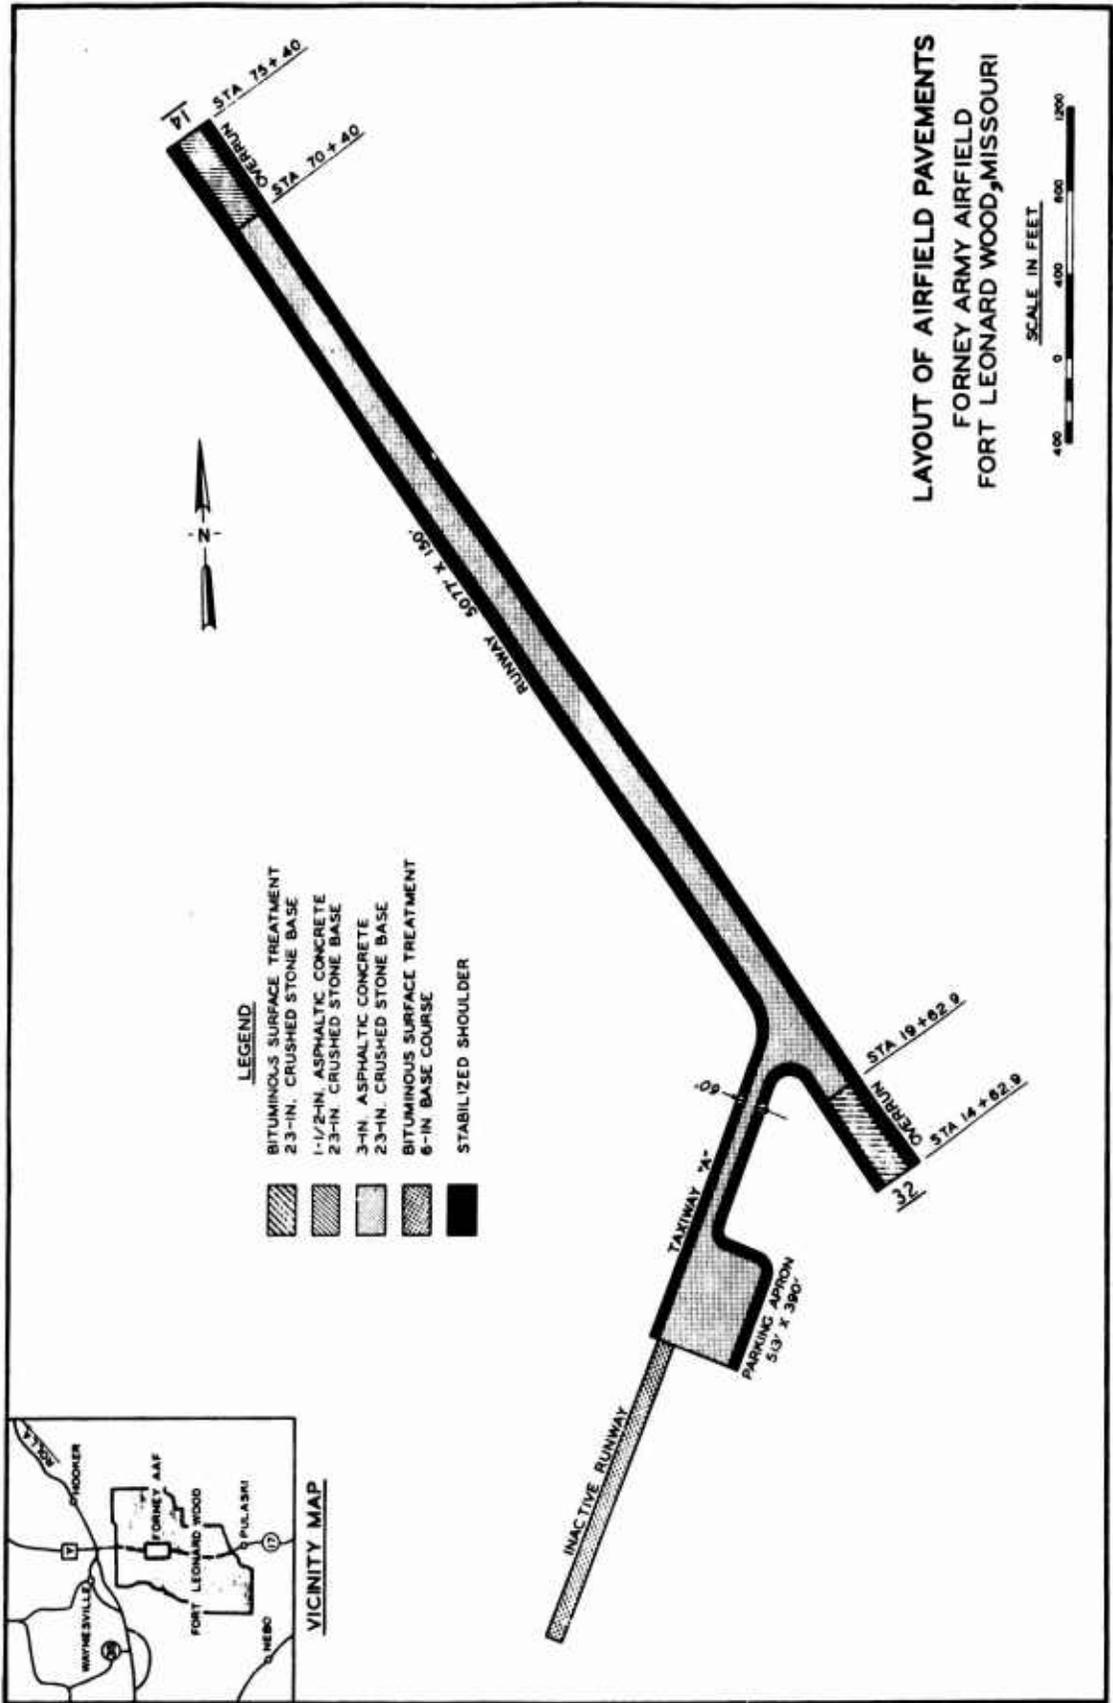
9. The taxiway and apron contained numerous cracks. Views of typical pavements of the taxiway and apron are shown in photographs 4 and 5, respectively. The cracks in the taxiway were approximately 25 ft apart in each direction and appeared to be contraction cracks. Neither the taxiway nor the apron showed any structural distress.

Photograph 5. Typical condition of apron area
