Marine Corrosion Studies

The Effects of Dissimilar Metal Couples and Toxicants from Antifouling Paints on the Corrosion of 5086 and 6061 Aluminum Alloys and Their Response to Cathodic Protection

(Fourteenth Interim Report of Progress)

NAVAL RESEARCH LABORATORY
Washington, D.C.

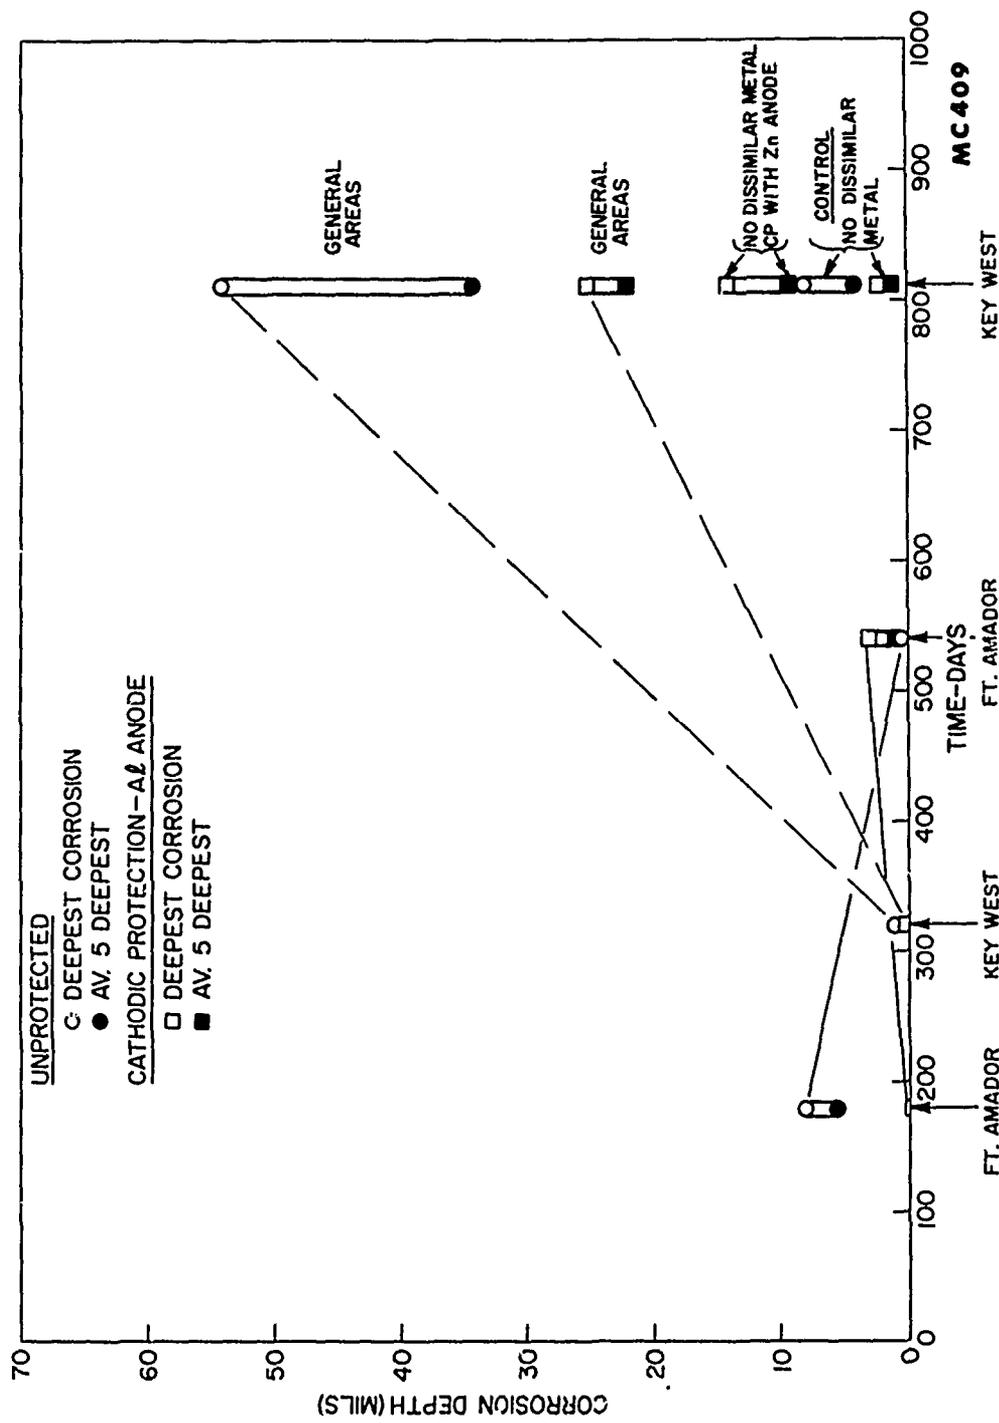
Comparative data showing the depth of corrosion on 5086-H32 aluminum and the effectiveness of cathodic protection in counteracting the detrimental effects of the dissimilar metals are shown in Figs. 20 thru 23. These data were obtained for two time periods from exposures at Key West, and two time periods from exposures at Ft. Amador, Canal Zone. The depth of corrosion on unprotected specimens was generally greater at Key West than at Ft. Amador. This was evident except when copper nickel was the dissimilar metal and the exposure time at Key West was relatively short.

Fig. 20 - 5086-H32 aluminum coupled to copper nickel, 10%; with and without cathodic protection (CP). Data from various exposure times in seawater at Key West, Florida and Ft. Amador, Canal Zone.

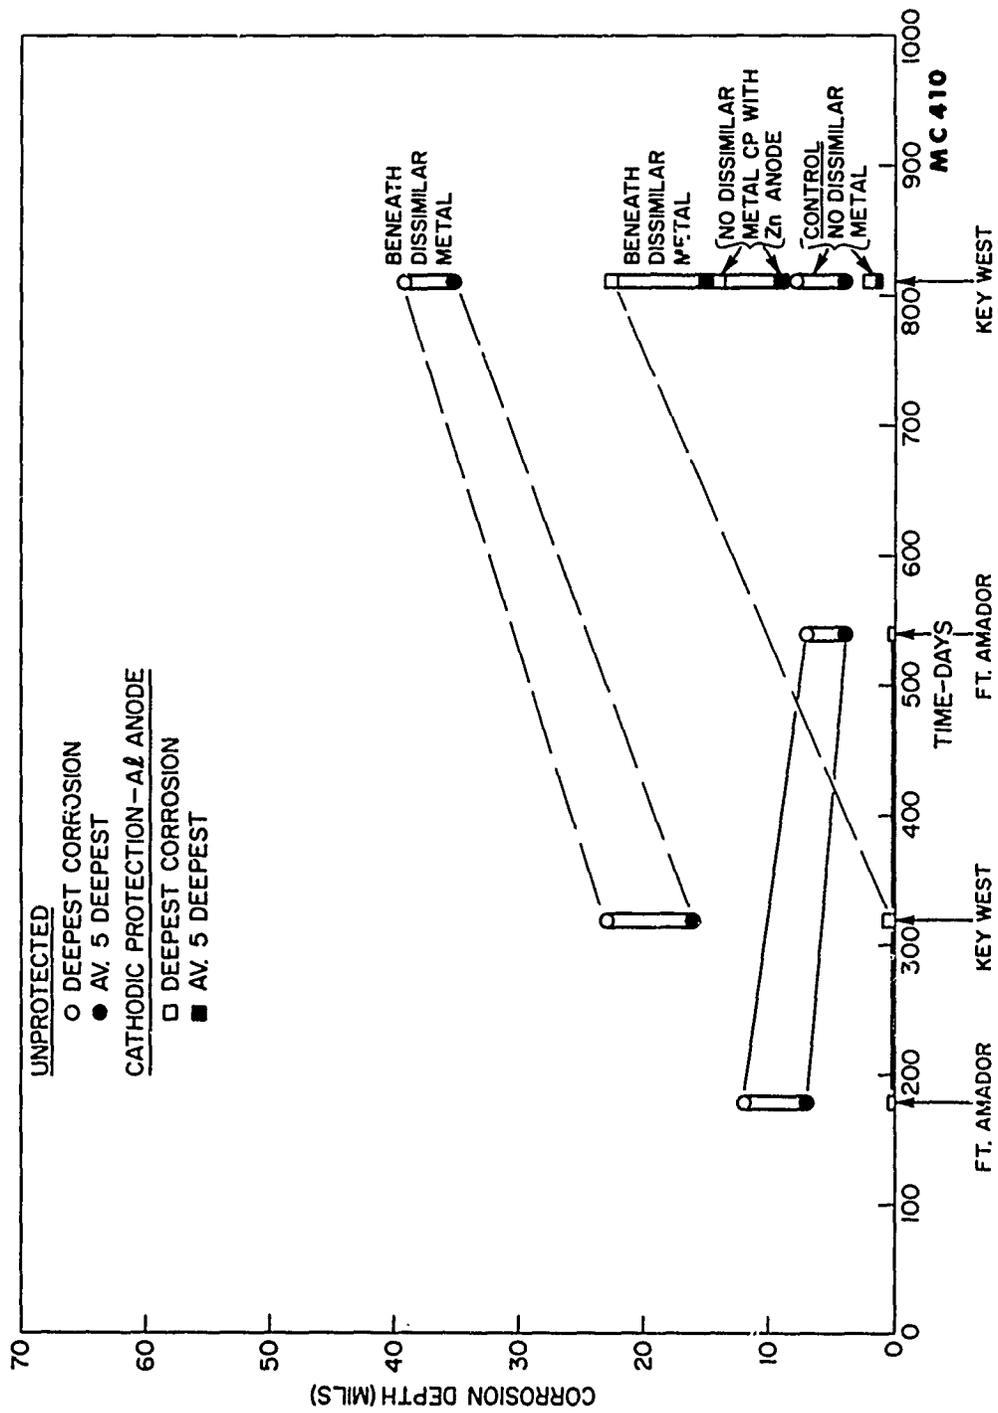
Fig. 21 - 5086-H32 aluminum coupled to yellow brass; with and without cathodic protection (CP). Data from various exposure times in seawater at Key West, Florida and Ft Amador, Canal Zone.

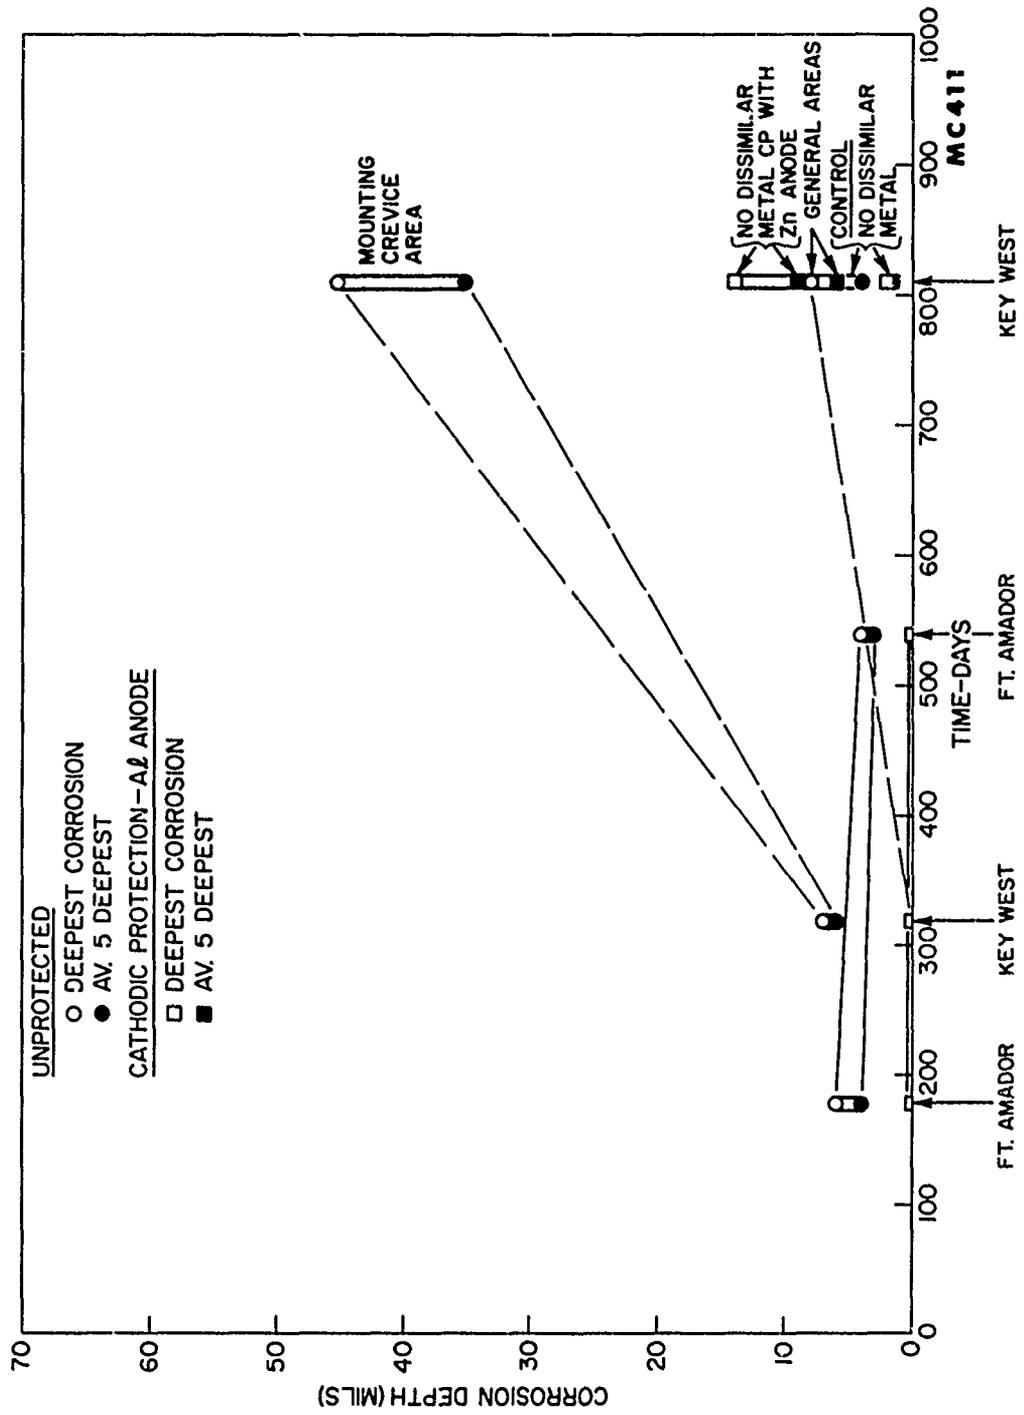
Fig. 22 - 5086-H32 aluminum coupled to 304 stainless steel; with and without cathodic protection (CP). Data from various exposure times in seawater at Key West, Florida and Ft. Amador, Canal Zone.

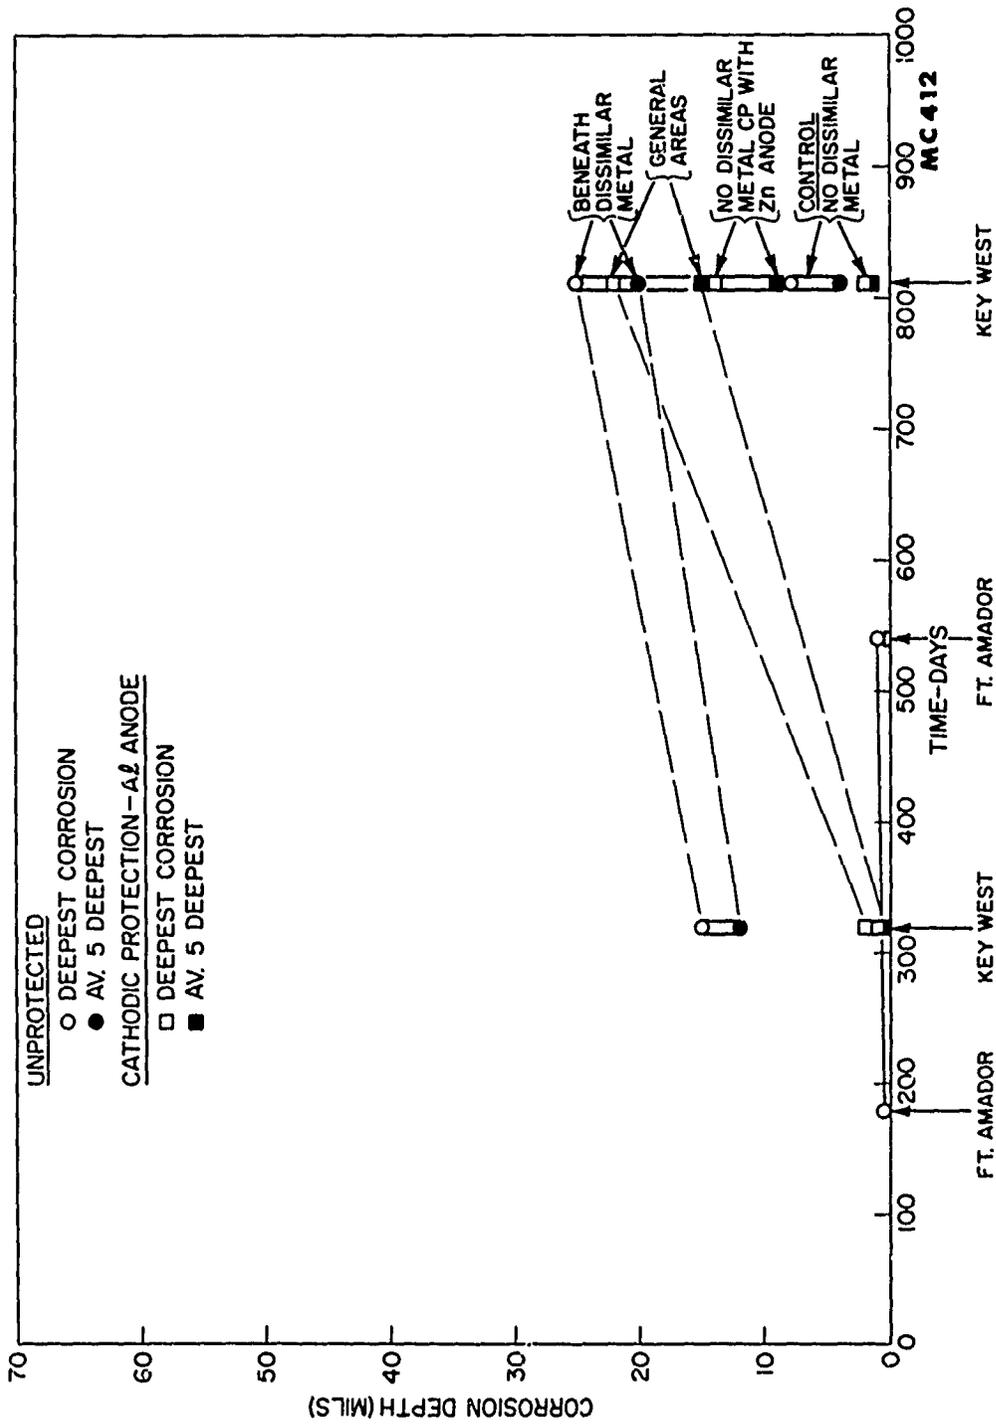
The Ft. Amador experiments did not indicate an increase of corrosion depth with time. The 540 days Ft. Amador data and the 319 days Key West data also indicated that cathodic protection from an aluminum anode was completely effective in preventing corrosion caused by the dissimilar metals. The longer term (809 days) Key West data indicated, however, that a prolonged incubation period existed before the detrimental effects of the dissimilar metals copper nickel, 10% and 304 stainless steel became evident (Figs. 20 and 22). The longer term Key West data also showed that cathodic protection was not completely effective in counteracting the detrimental effects on the aluminum caused by any of the dissimilar metals studied.

Fig. 23 - 5086-H32 aluminum coupled to mild steel; with and without cathodic protection (CP). Data from various exposure times in seawater at Key West, Florida and Ft. Amador, Canal Zone.

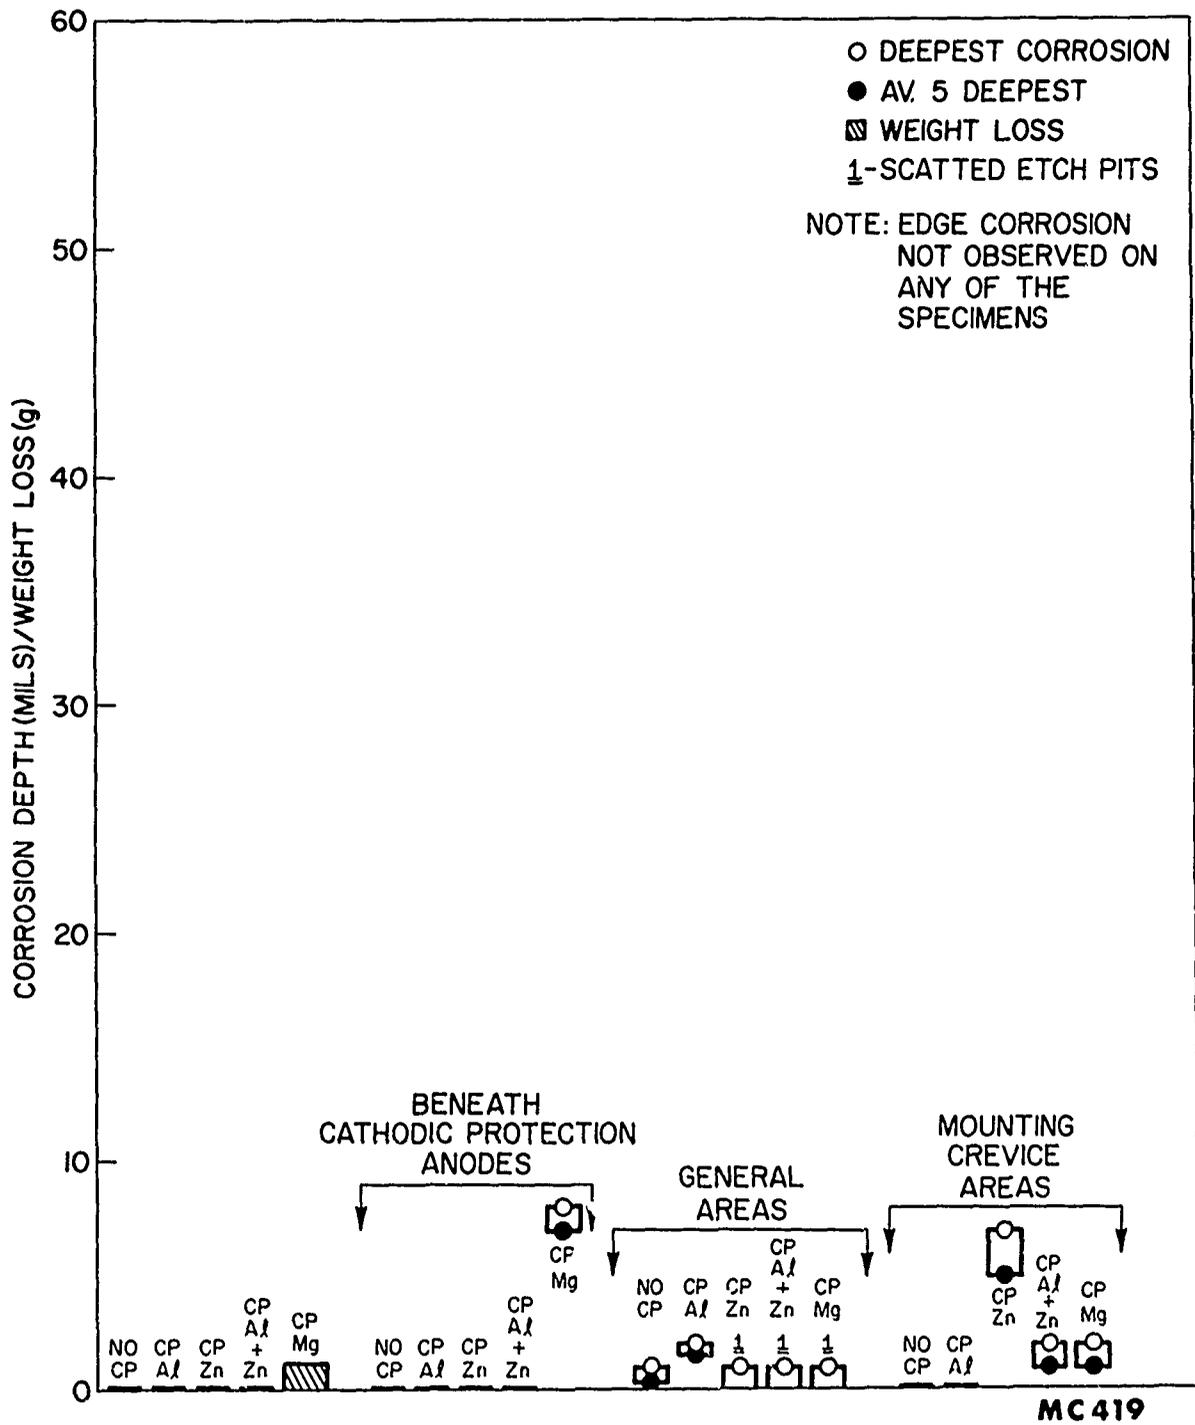
Figure 41 shows the area on 5086-H32 aluminum beneath a magnesium anode used for cathodic protection in the Potomac River. This photograph and the data in Fig. 30 indicate that the magnesium anode caused some corrosion on the 5086-H32 aluminum, but it was much less severe than the accelerated corrosion observed in seawater (compare Figs. 9 and 30).

Fig. 30 - 5086-H32 aluminum; with and without cathodic protection (CP), 675 days in the Potomac River.

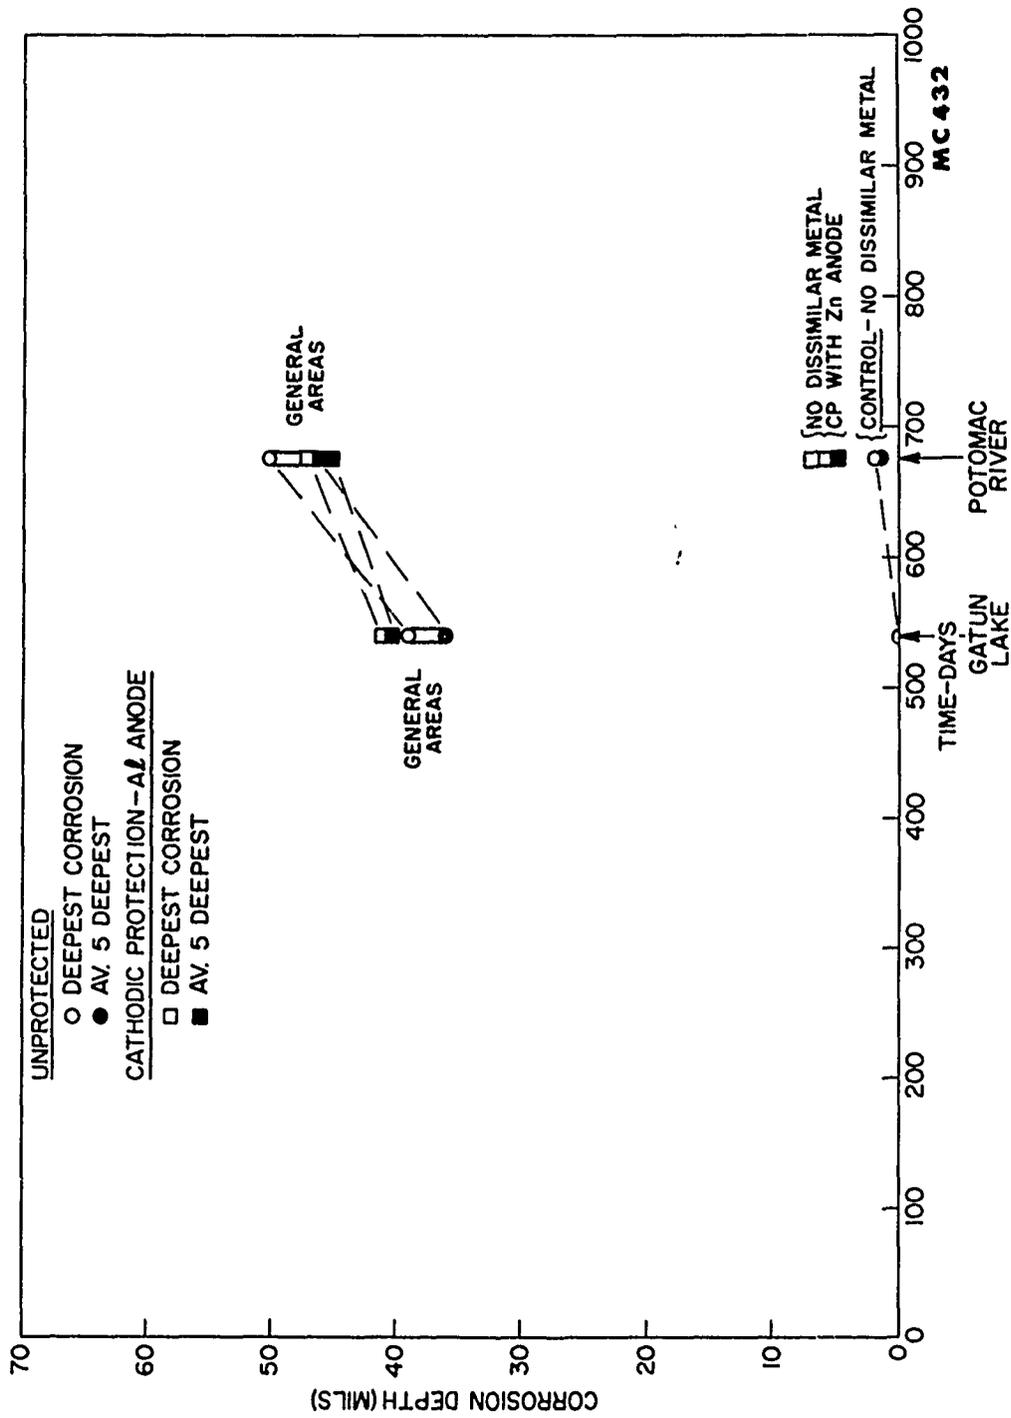
Figures 42 through 45 compare the depth of corrosion after 540 days in Gatun Lake, Canal Zone and after 675 days in the Potomac River. The depth of corrosion data from specimens at these two locations indicate the severe detrimental effects caused by the copper nickel, 10%; yellow brass; and 304 stainless steel at both sites, and the ineffectiveness of cathodic protection from an aluminum anode in counteracting this corrosion, Figs. 42 thru 44. The detrimental effect of the mild steel couple was not significantly reduced by cathodic protection in the Gatun Lake although cathodic protection was effective in the Potomac River, Fig. 45.

Fig. 43 - 5086-H32 aluminum coupled to yellow brass; with and without cathodic protection (CP). Data from Gatun Lake and the Potomac River exposures.

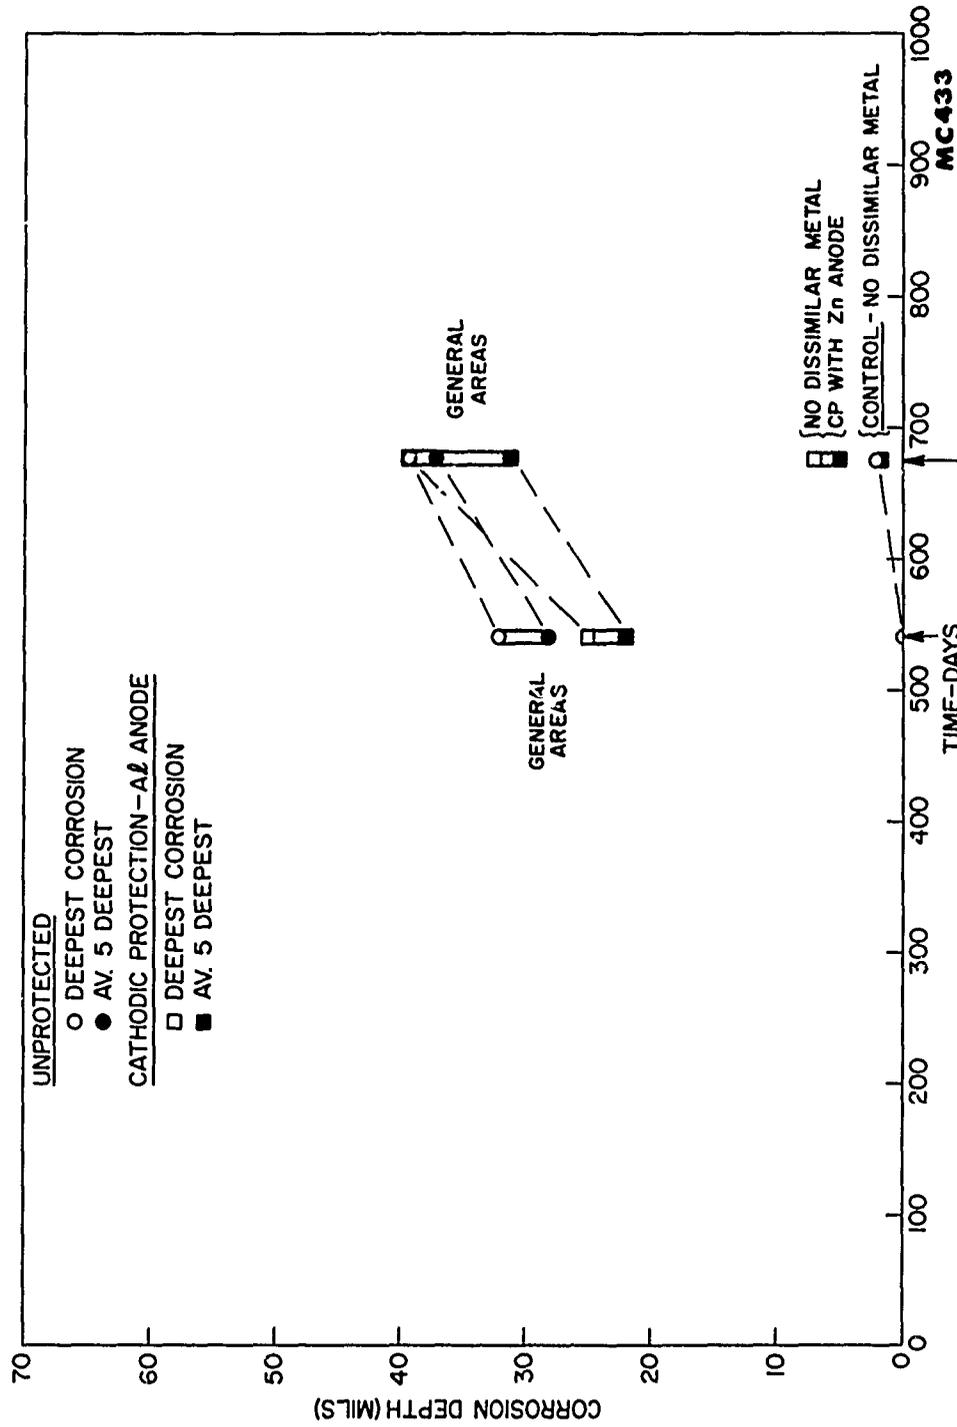
Fig. 44 - 5086-H32 aluminum coupled to 304 stainless steel; with and without cathodic protection (CP). Data from Gatun Lake and the Potomac River exposures.

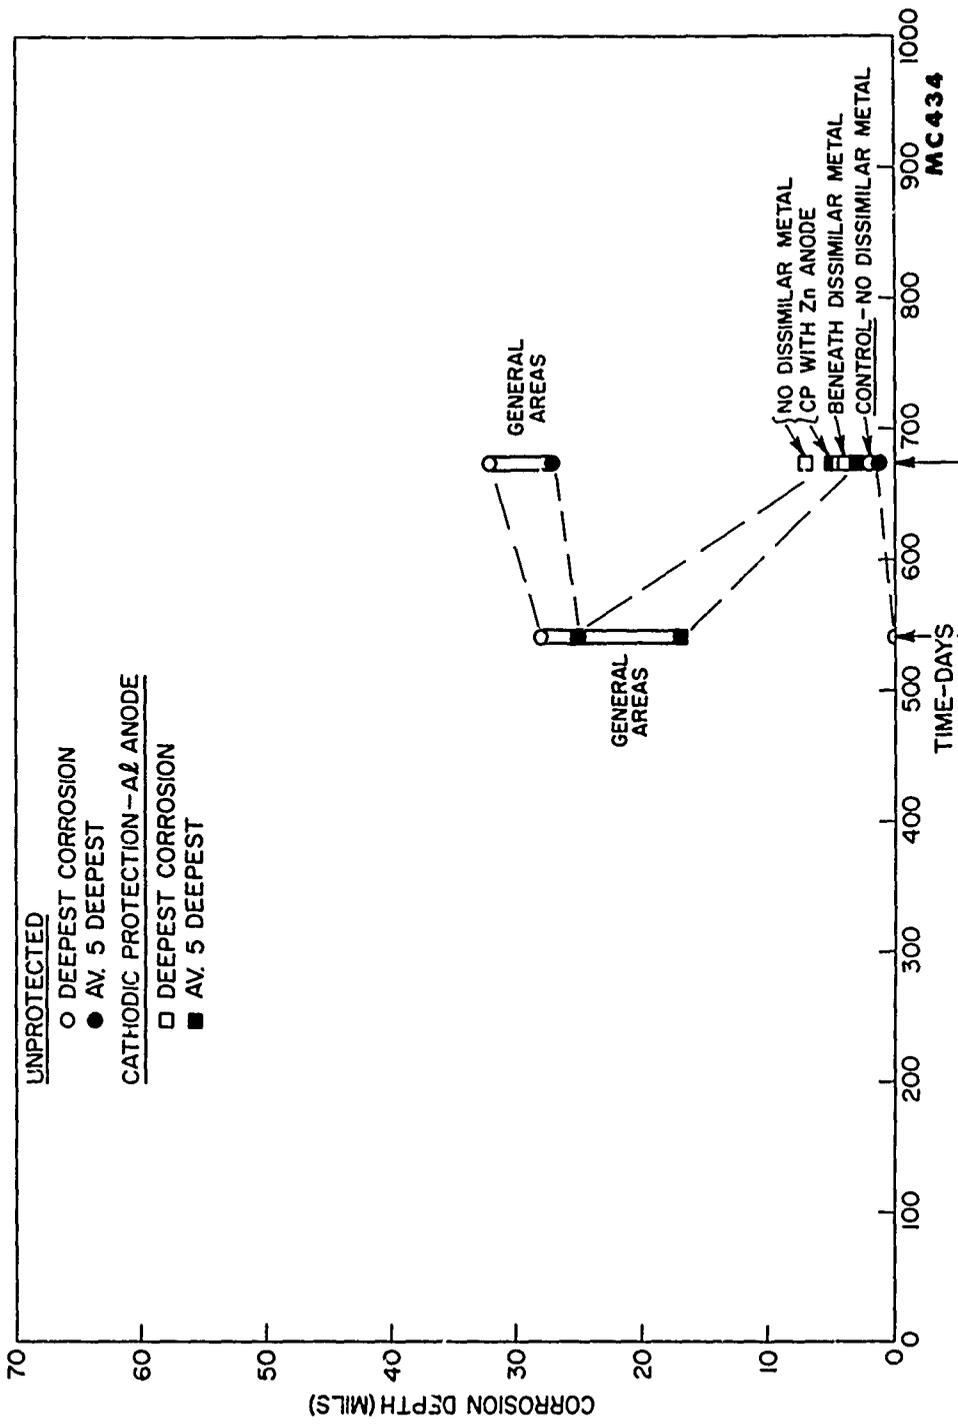
Fig. 45 - 5086-H32 aluminum coupled to mild steel; with and without cathodic protection (CP). Data from Gatun Lake and the Potomac River exposures.

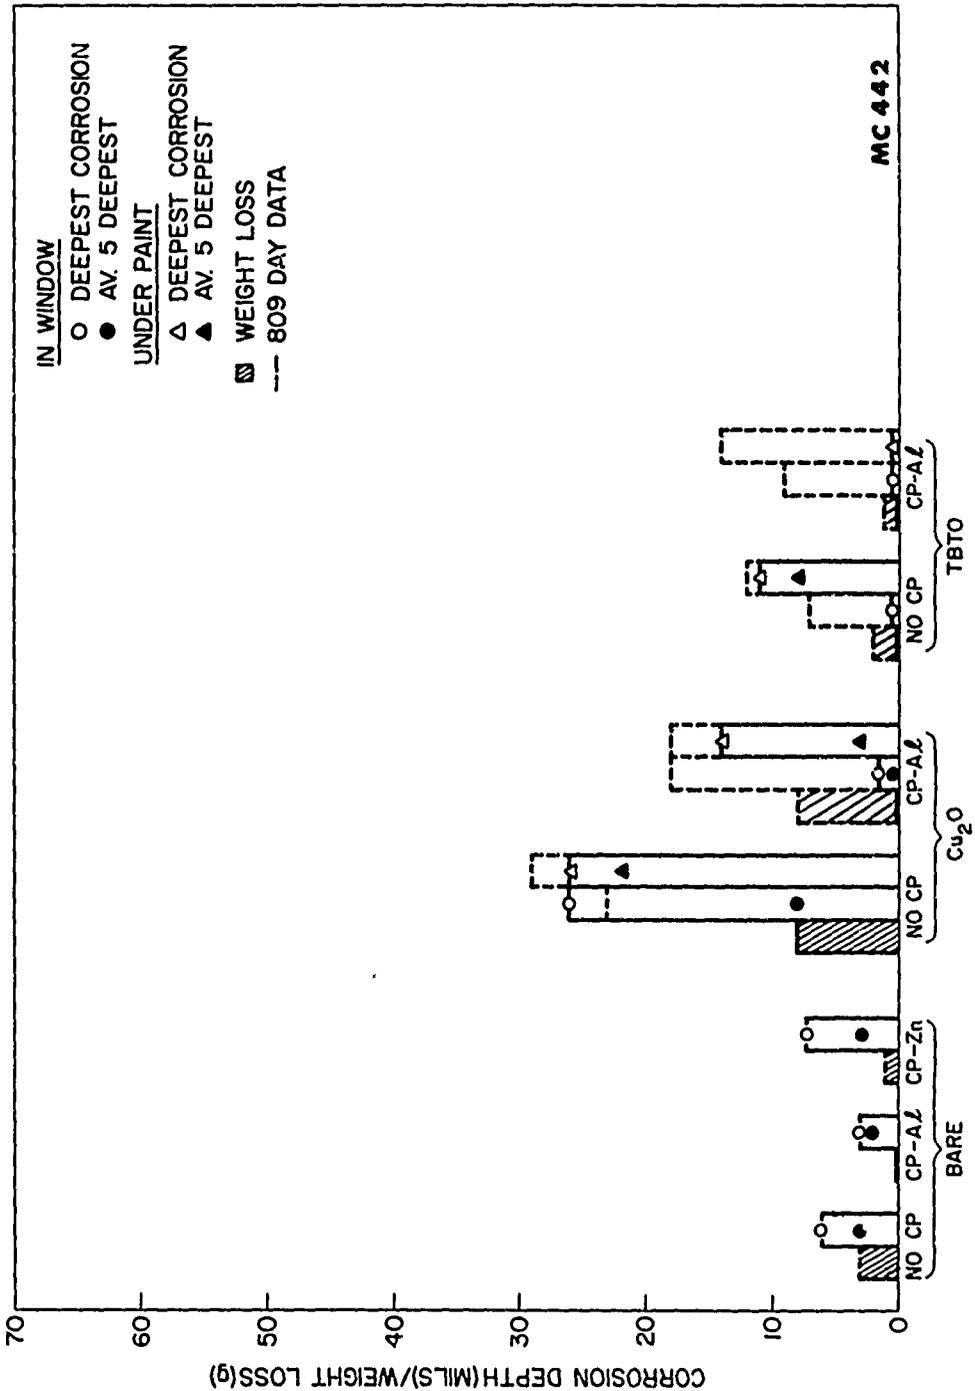
Fig. 49 - 5086-H32 aluminum coated with the Standard Navy Vinyl Anticorrosive Barrier and Cu₂O or TBTO Antifouling Toxicants; with and without cathodic protection (CP), 1264 in seawater at Key West, Florida.

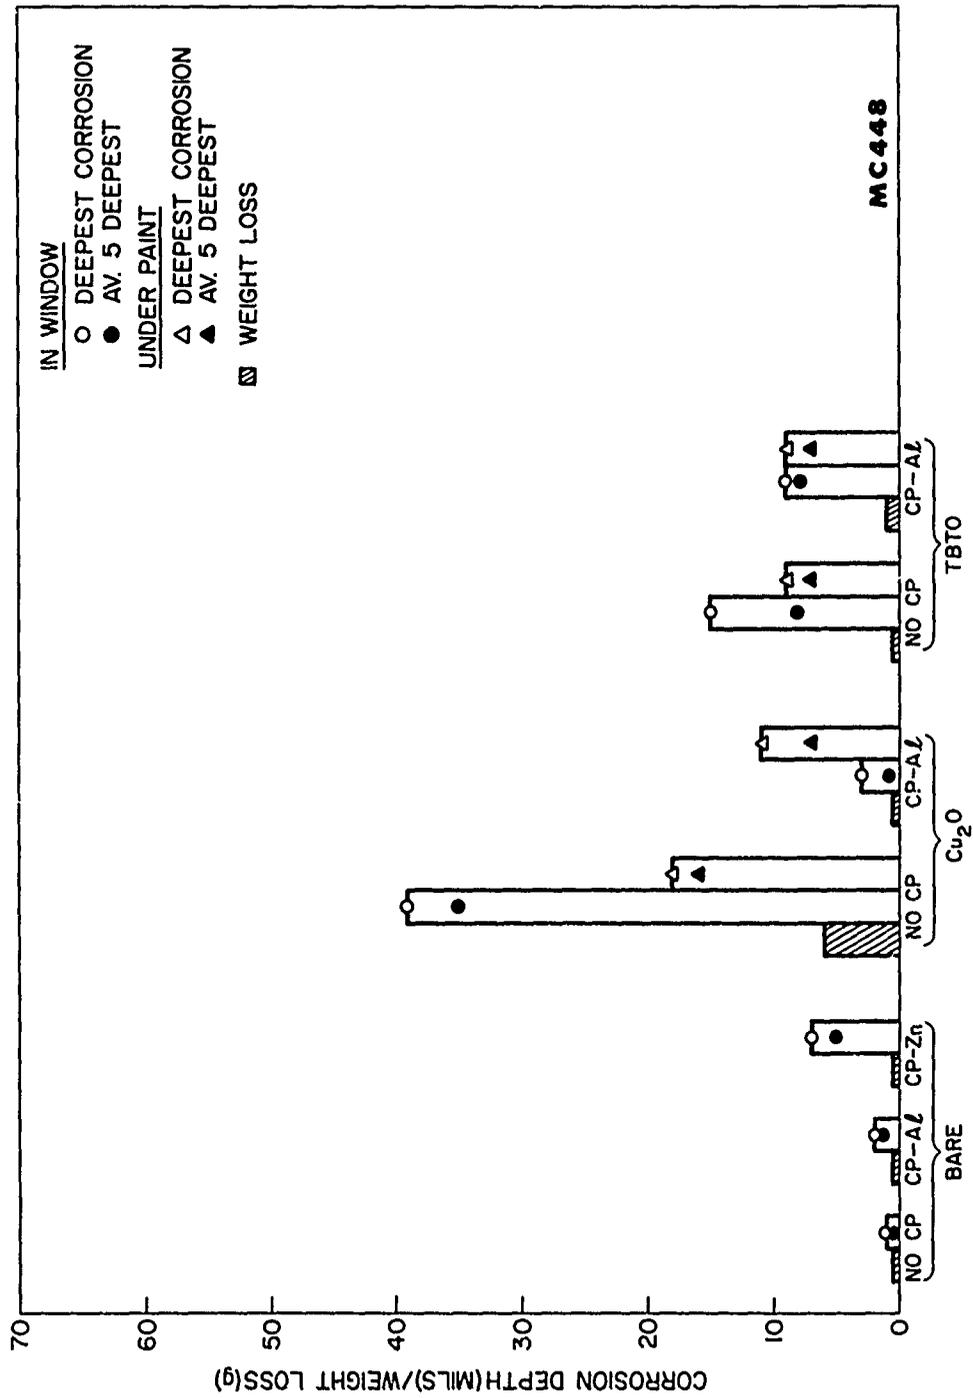
Fig. 52 - 5086-H32 aluminum coated with the Standard Navy Vinyl Anti-corrosive Barrier and Cu₂O or TBTO Antifouling Toxicants; with and without cathodic protection (CP), 675 days in the Potomac River.

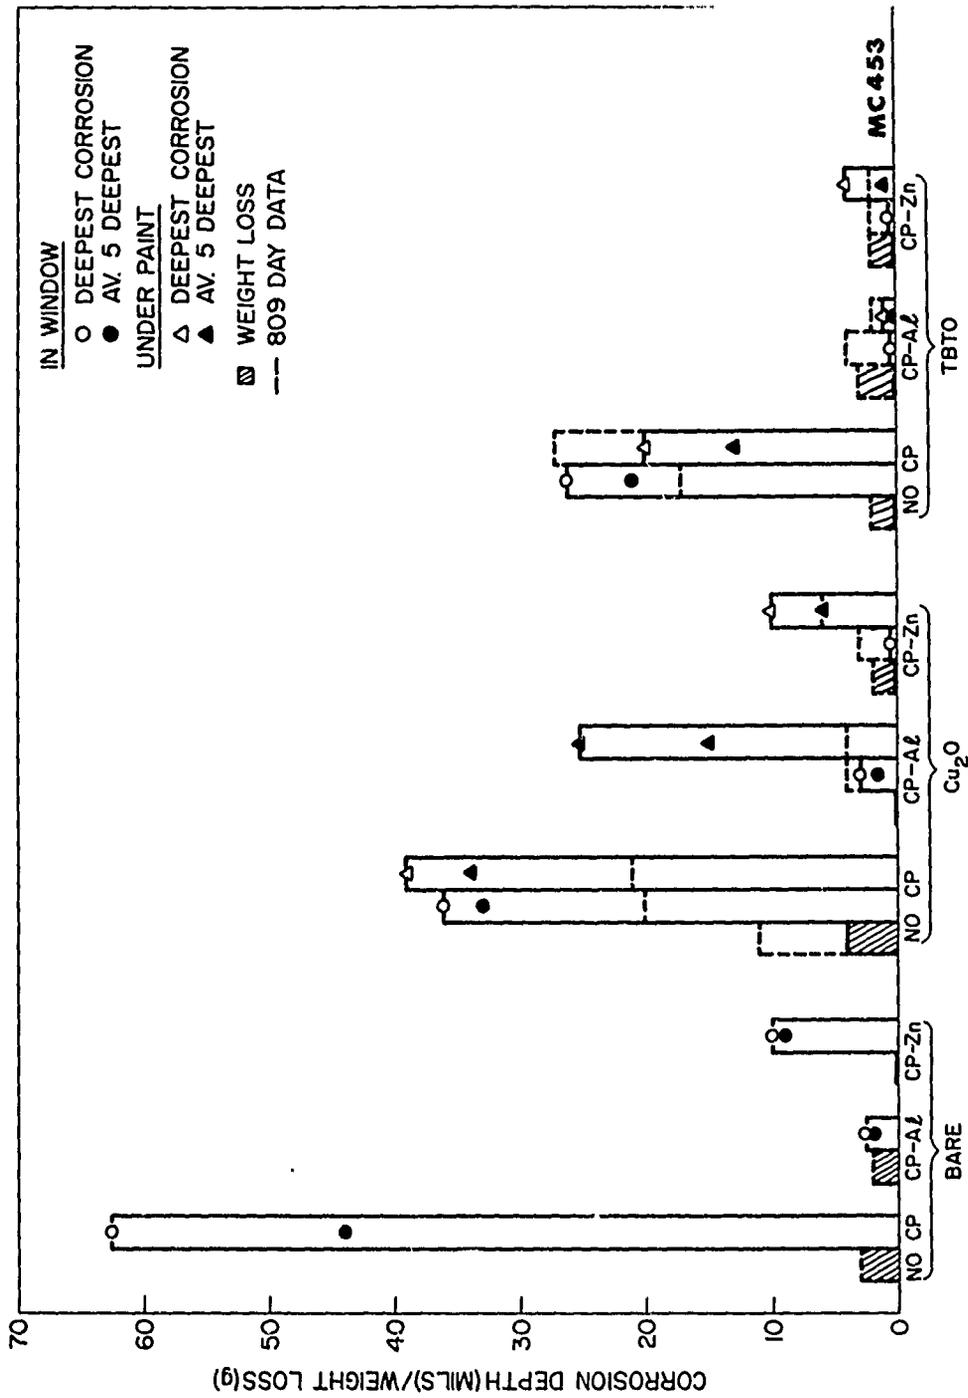
Fig. 57 - 6061-T6 aluminum coated with the Standard Navy Vinyl Anticorrosive Barrier and Cu₂O or TBTO Antifouling Toxicants; with and without cathodic protection (CP), 1264 days in seawater at Key West, Florida.

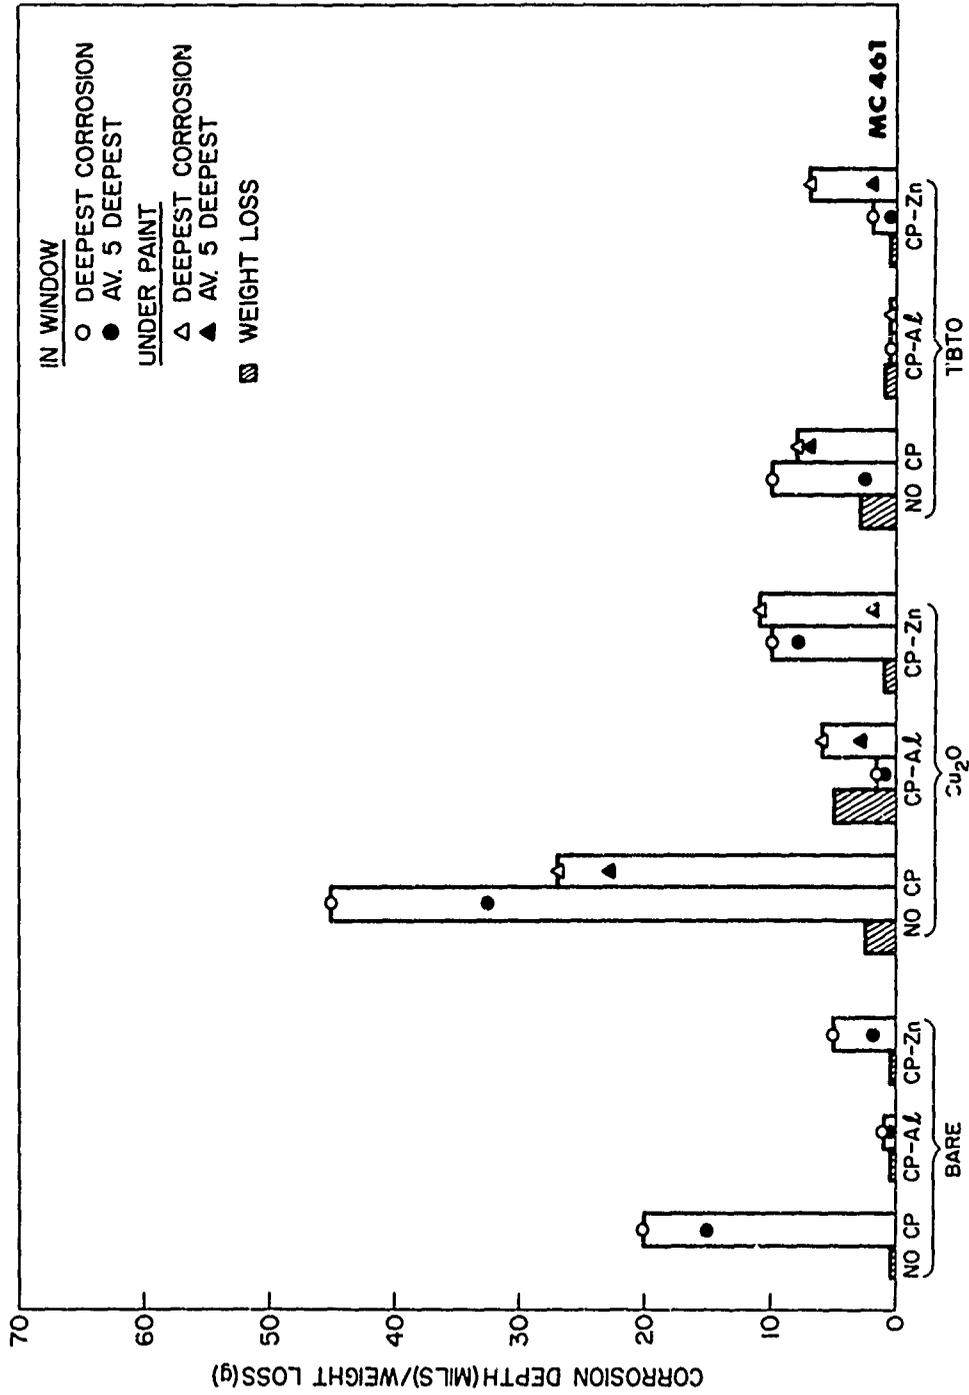
Fig. 60 - 6061T6 aluminum coated with the Standard Navy Vinyl Anticorrosive Barrier and Cu₂O or TBTO Antifouling Toxicants; with and without cathodic protection (CP), 675 days in the Potomac River.
