RADC-TR-72-148
Technical Report
July 1972

ELECTRICAL OVERSTRESS FAILURES IN SILICON DEVICES

Rome Air Development Center
Air Force Systems Command
Griffiss Air Force Base, New York

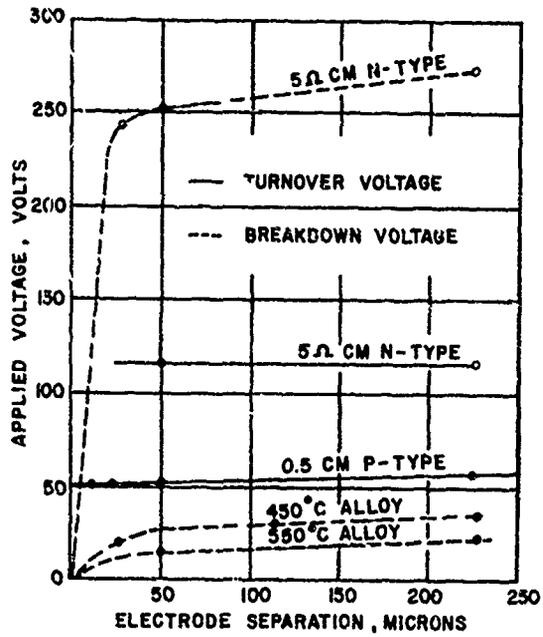
Two volts per micron equal a field strength of 2×10^4 volts per centimeter. Peak field across the junction is about 1×10^6 volts/cm, assuming a depletion region of 1×10^{-5} centimeters. The junction, however, is ill defined and any comparison with theoretical breakdown is of marginal value. More care was taken with Pattern D tests to note voltages and currents at critical points. The first group which was oxidized at 1150°C , alloyed at 450°C , overstressed and then alloyed again at 550°C , showed voltage versus electrode spacing variations depicted in Figure 16. For n-type material there was normal breakdown, microplasma formation and a continued increase in voltage and current until finally the zap occurred. The turnover voltage is the initial breakdown while the breakdown voltage is the voltage recorded when the zap occurred. Curves for n-type material were unaffected by the higher subsequent alloying. Contacts to the p-type material had very different I-V characteristics on the oscillograph display. Figure 17 gives a plot of power dissipation versus electrode spacing for the four combinations of conditions. Apparently there was a lower contact

Figure 16
Variation in Turnover and Breakdown Voltages as Function of Electrode Separation for Aluminum Contacts

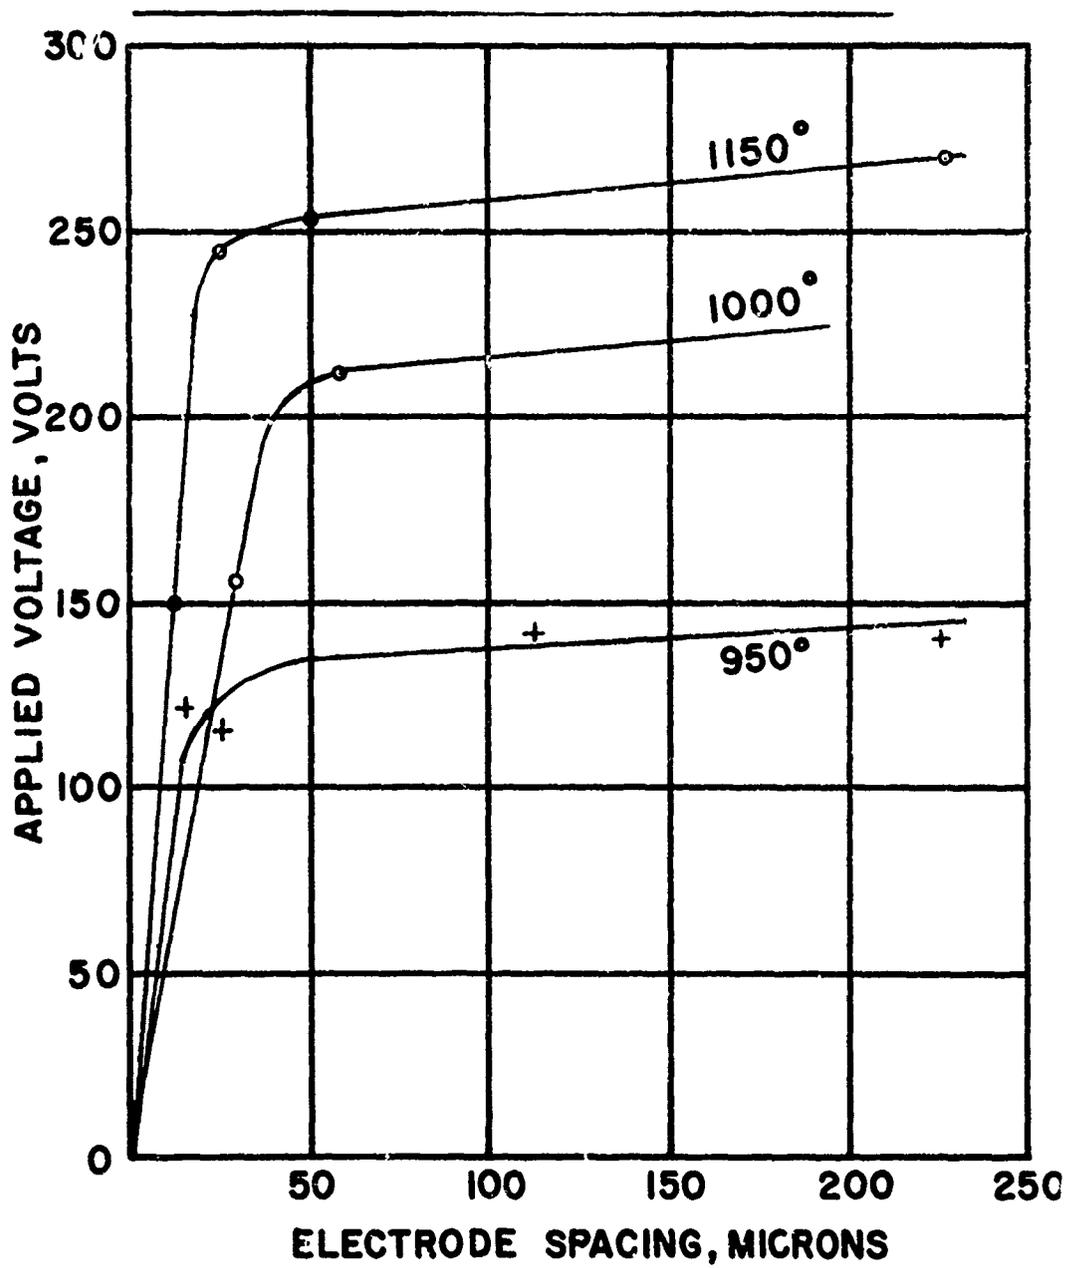
Only a faint hairline remained of the original aluminum path. This is due to a very narrow initial path which subsequently diffused away, or alloyed in because of the high temperature generated. It was also noted that when aluminum (in a zap path) melts back as a result of a second zap nearby, a black hazy line is left. This explains the double paths often seen in earlier work and shown in Figure 12. Perhaps the most important new information revealed by the lower oxidation temperature wafers was that the sensitivity to zap failures is increased by the lower oxidation temperature, particularly for 5 ohm - cm n-type wafers. This may seem surprising at first but the existence of more interface states at the Si-SiO₂ interface⁽⁶⁾ when the oxide is grown at lower temperatures may explain why the surface zap susceptibility is increased. The graph of Figure 25 compares the zap voltage with electrode separation for aluminum metallization to 5 ohm - cm n-type wafers oxidized at various temperatures.

Figure 25
 Variation in Breakdown Voltage
 With Electrode Separation
 For Three Oxidation Temperatures
