THERMAL AGING OF SILVER-PLATED COPPER AIRCRAFT
ELECTRICAL WIRE

AIR FORCE MATERIALS LABORATORY

MAY 1973

AFML-TR-73-113

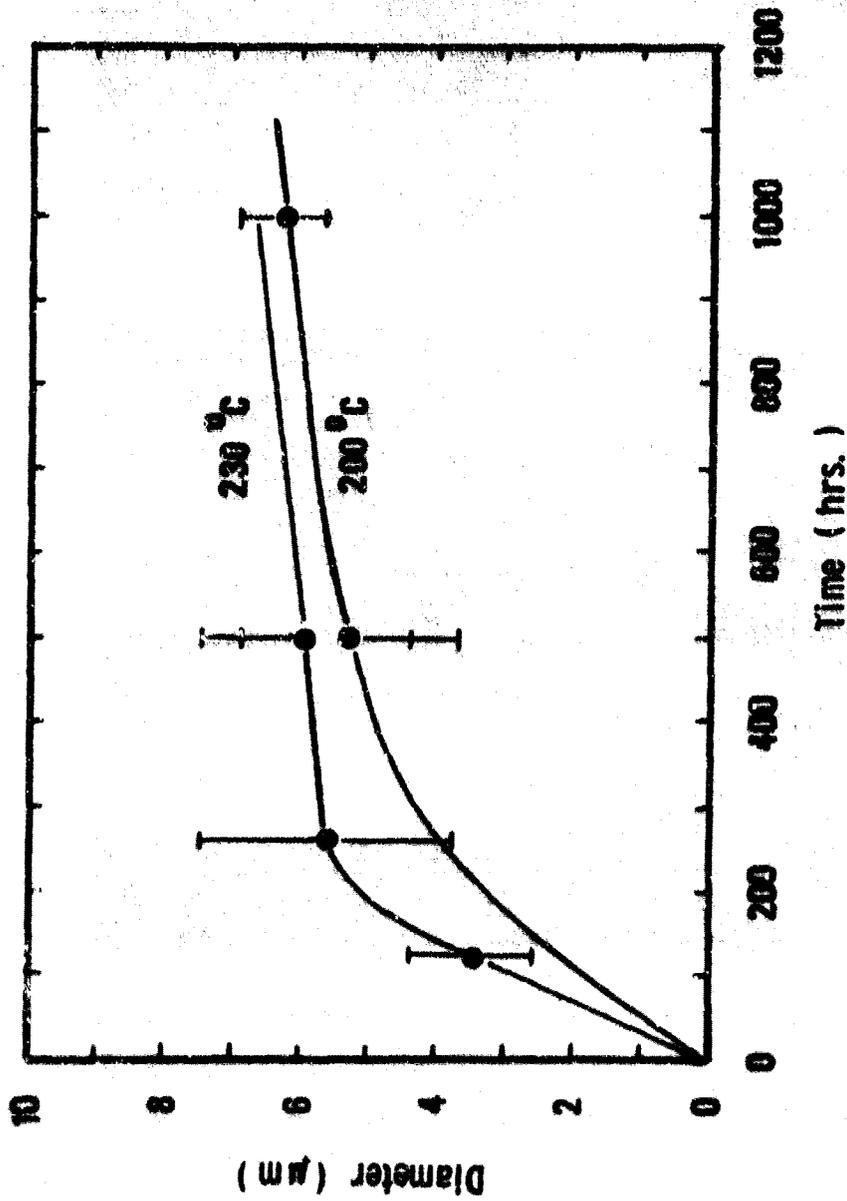
Figure 12. Diameter of larger silver globules on No. 20 (19/32) Rapton insulated unilay wire as a function of time and temperature.

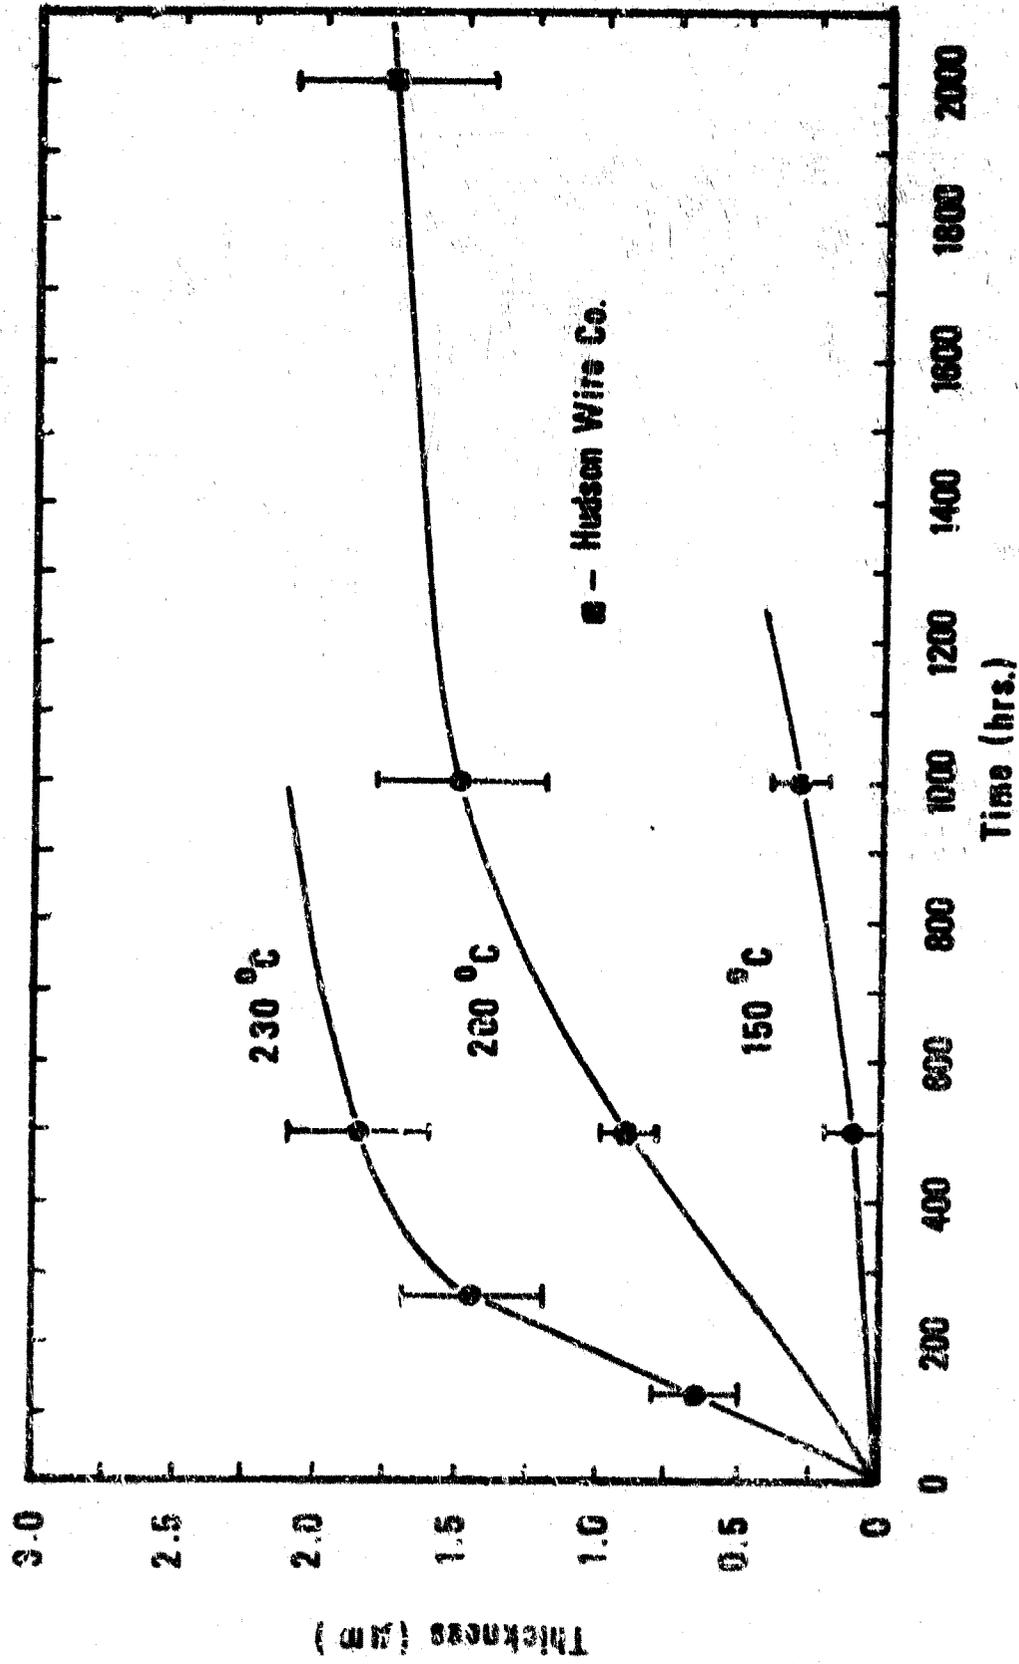
seen in Fig. 21, which shows the oxide film thickness as a function of time and temperature. It is obvious that the importance of the loss in conductivity resulting from oxidation will increase with decreasing wire size. If, for No. 26 wire (which for added strength employs a copper alloy containing small amounts of cadmium and chromium rather than pure copper), the continuity of the silver is completely lost and the rate of oxidation is comparable to that for pure copper (Fig. 21), an 8% loss in conductivity would occur in 500 hrs. at 200°C. For No. 24 wire, the loss would reach approximately 6.5%. These estimates actually represent upper bounds since they do not take into account the fact that substantial continuity of the silver appears to be retained in the interstrand contact regions. As can be seen from Fig. 21, the rate of oxidation decreases with time, indicating that the oxide layer is protective. While both the oxidation and the conductivity loss will increase with time, therefore, it will do so at a continuously decreasing rate.

Figure 21. Thickness of cuprous oxide layer on No. 20 (19/32) Kapton insulated unilay wire as a function of time and temperature.
