FINAL REPORT ON  
PRODUCT IMPROVEMENT TEST  
OF  
TRUCK, UTILITY, 1/4-TON, 4X4, M151, MODIFIED  
WITH SOLID REAR AXLE  
BY  
C. M. BRYZEK, JR.  
MARCH 1967

USATECOM PROJECT NO. 1-6-4030-12

12 APRIL THROUGH 30 DECEMBER 1966

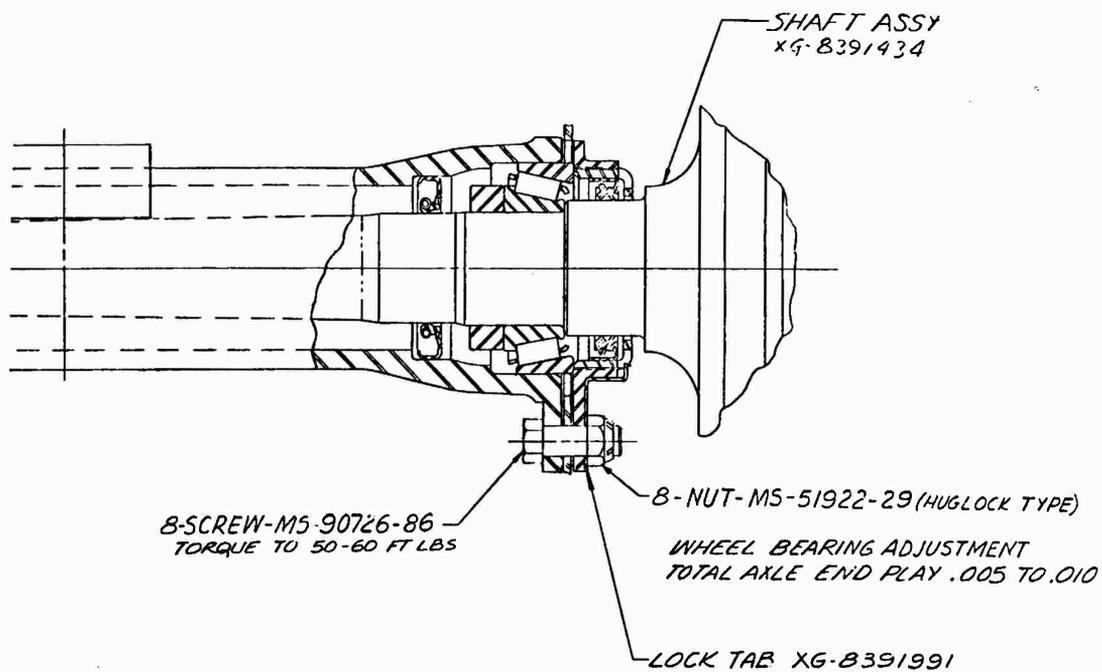
Figure 2.11-5: Axle-Shaft Assembly.

2.11.3.5 Group 11, Rear Axle. During operation, the rear differential lost lubricant through the differential carrier vent, at the rivets which attach the brake tube bracket to the carrier. After replacement of the vent at 6004 test miles, loss of lubricant through the vent was reduced. However, after 400 miles of operation, it was found that gear oil had been forced past the axle shaft inner seals and was contaminating the lubricant of the rear wheel bearings.

In accordance with directions from ANICPM-GP-TI (Appendix III), rear wheel bearings were not repacked at the normal 12,000 mile interval. However, after 17,801 test miles, rear-differential lubricant was leaking past the left and right rear-axle seals and wheel-bearing outer seals into the brake cavities. Replacement of the rear-axle wheel-bearing outer seals or repacking the bearings required an excessive amount of maintenance time, since the retaining collar must be broken and then the bearing must be pressed off the shaft (Figure 2.11-5). Extreme care must be exercised when pressing the bearing off and on the shaft to prevent bearing damage.
