Technical Note N-1044

PROTECTION OF FLOATING PONTOONS FROM CORROSION -- PART III.
CONDITION OF TEST FLOATS AFTER THREE YEARS

August 1969

NAVAL CIVIL ENGINEERING LABORATORY
Port Hueneme, California 93041

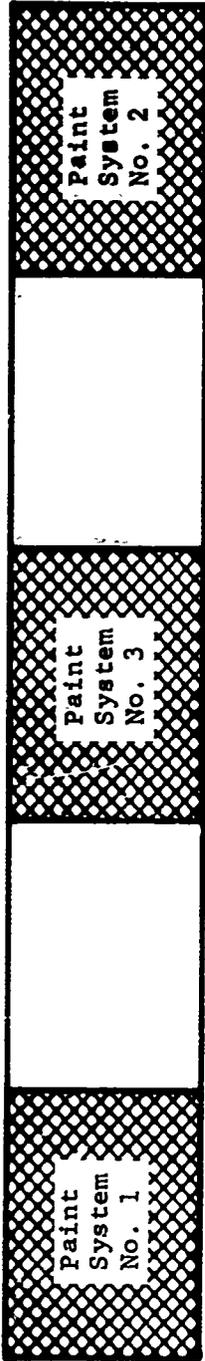
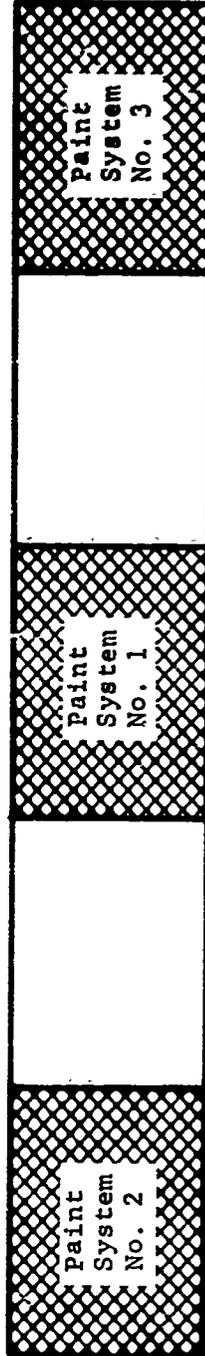
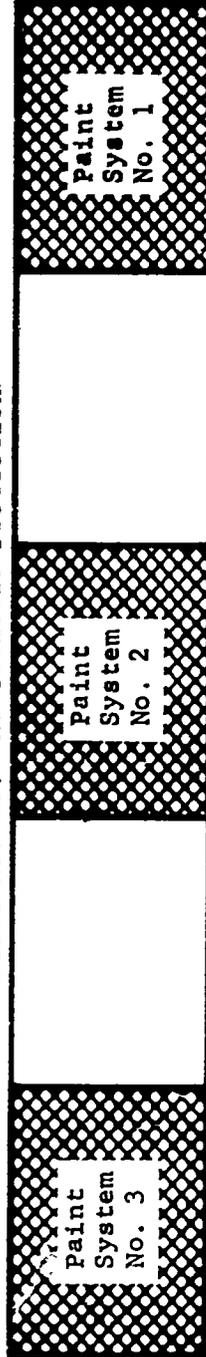
Figure 3. Design of pontoon float test.

Each test float consisted of three pontoons spaced a pontoon length apart and secured together with steel angle-iron bracing. They are commonly called 1 x 5's, because they have a width of one and a length of five pontoons. The test design for the three floats is shown in Figure 3. Each of three paint systems investigated was applied to one of the three pontoons in each test float. The pontoons in each float were arranged randomly as shown in Figure 3, so that each coating system would have the same magnitude of exposure to impact and abrasion damage. The design also permitted a study of the effect of each cathodic protection system on each of the three coating systems.

Float No. 01: Cathodically Protected With Zinc Anodes:

Float No. 02: Cathodically Protected With Aluminum Anodes:

Float No. 03: No Cathodic Protection.
