**USAAVLABS TECHNICAL REPORT 70-71A  
ANALYSIS OF HELICOPTER STRUCTURAL CRASHWORTHINESS  
VOLUME I**

**MATHEMATICAL SIMULATION AND EXPERIMENTAL  
VERIFICATION FOR HELICOPTER CRASHWORTHINESS**

January 1971

CONTRACT DAAJ02-69-C-0030

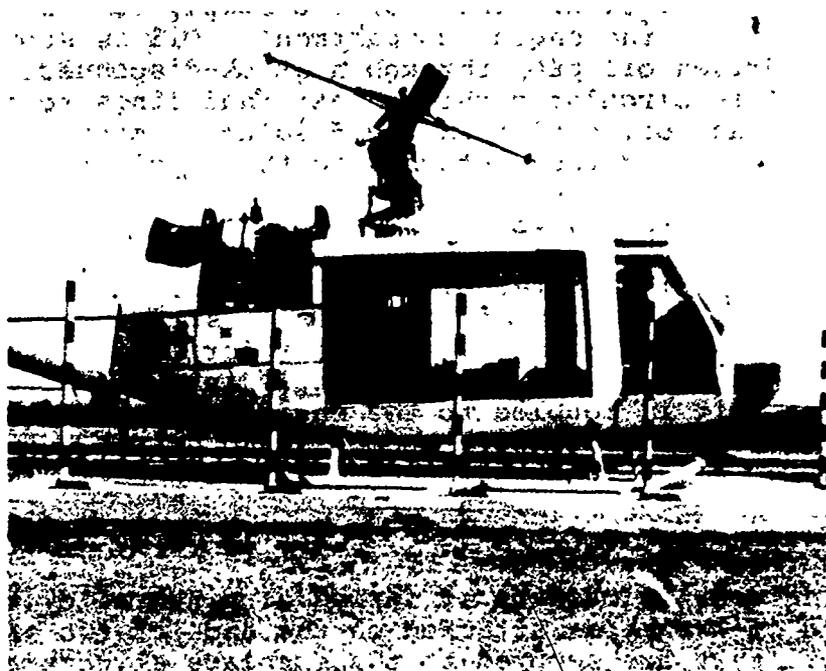
The UH-1D used as a test vehicle was modified and equipped to satisfy the test requirement as described in the following paragraphs. Figure 46 shows the test vehicle prior to the test drop, Army Test Number 34 (T-34).

Figure 46. Modified UH-1D Test Vehicle.

The UH-1D used as the drop vehicle had previously sustained damage to the right rear fuselage structure. This damaged section was removed and replaced with an undamaged portion from another UH-1D. The helicopter structure was returned to as near an original configuration and strength as possible. A tail boom for a UH-1D was not available; therefore, a UH-1A tail boom was adapted to the UH-1D fuselage. Ballast was added to duplicate the mass of a UH-1D tail boom and tail rotor assembly.

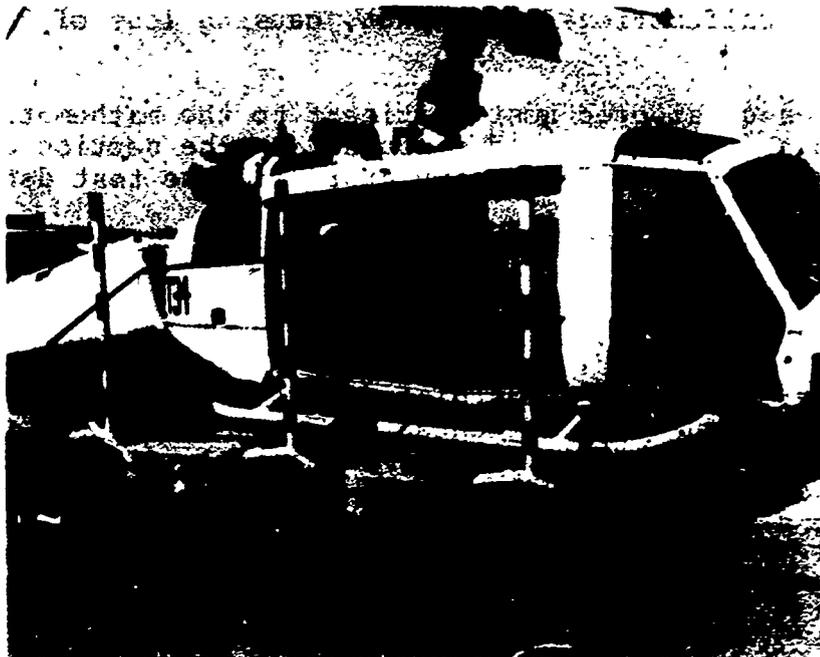
The landing gear cross tubes distorted outward and upward, permitting the fuselage to contact the concrete pad. The cross tubes did not fail but were permanently distorted, permitting the fuselage to rest on the concrete pad (Figure 58). The fuselage remained within 1 inch of the pad after all simulated fuel was drained from the tanks. The lowest point of the loaded fuselage prior to the drop was slightly over 14 inches.

Figure 58. Three-Quarter Posttest View.

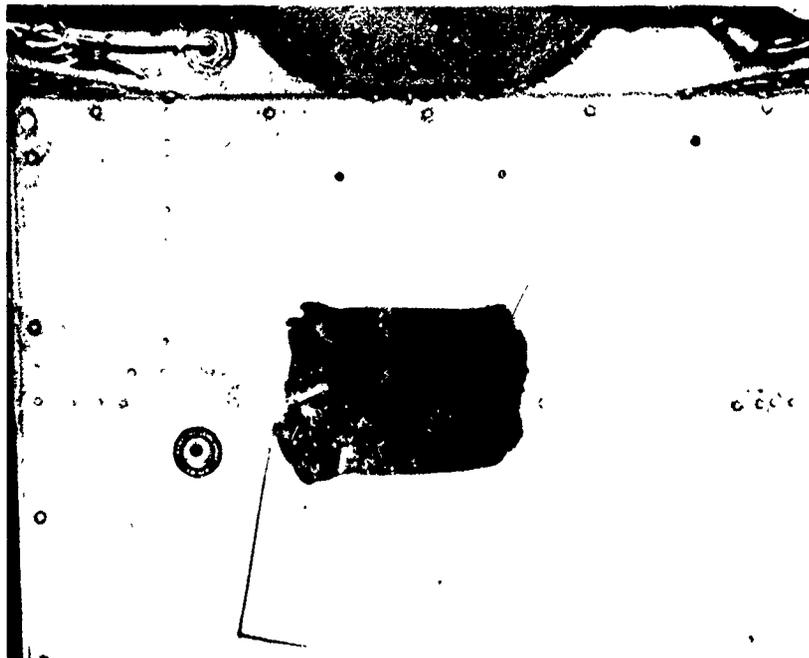
cargo area was held by only the two lower snaps following the impact (Figure 85; the two arrows indicate the two upper snap mount posts).

Figure 85. Posttest View of First-Aid Kit Installed in Rear of Cargo Compartment.
