**COATINGS FOR LIGHTING PROTECTION OF  
STRUCTURAL REINFORCED PLASTICS**

**TECHNICAL REPORT AFML-TR-70-303 Pt. I**

March 1971

Air Force Materials Laboratory  
Nonmetallic Materials Division  
Air Force System Command  
Wright-Patterson Air Force Base, Ohio

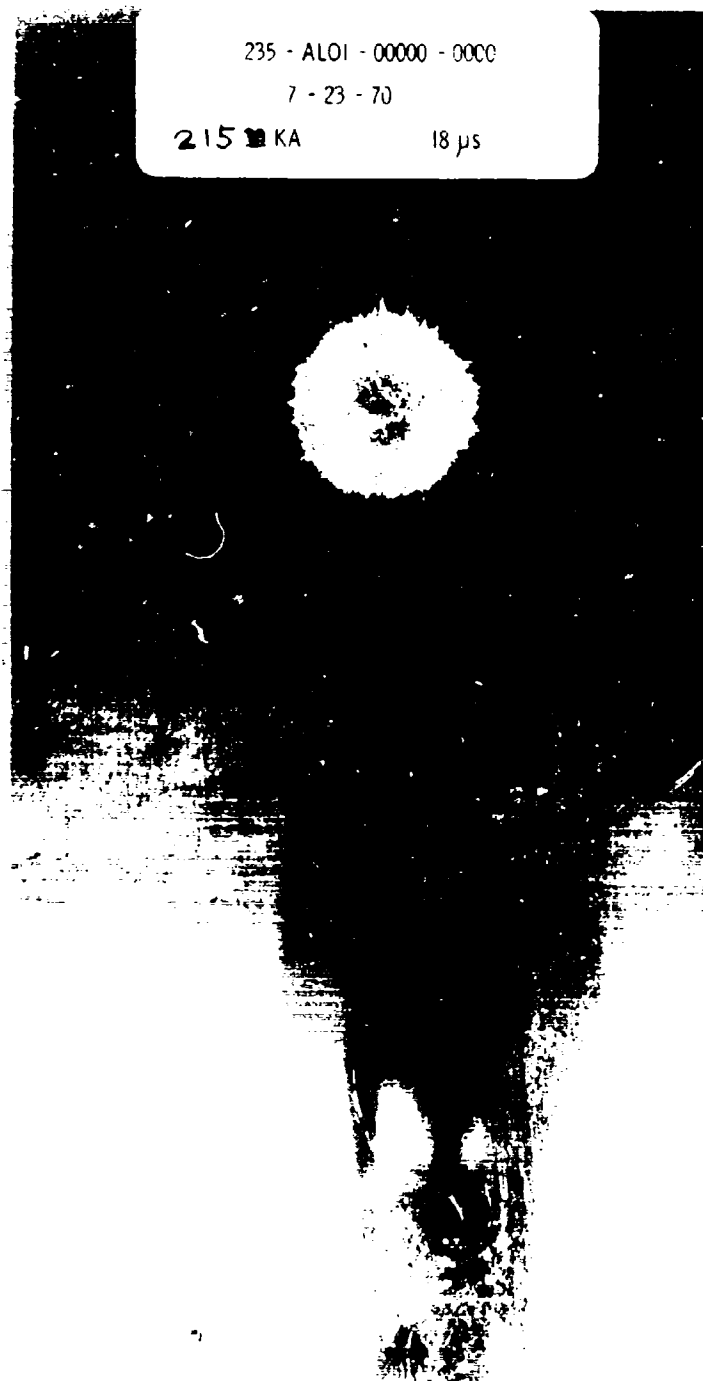
Figure 12 HIGH CURRENT DAMAGE TO ALUMINUM SHEET

For comparable lightning discharge currents the progression of damage is: boron > graphite > aluminum. This is shown in Figures 10, 11 and 12. Whereas the boron panel was completely shattered, the graphite panel was only punctured. The aluminum sheet was dented and noticeably mauled at the test zone. It should be noted also that the impedance of a boron/epoxy composite is almost 50 percent higher than that of a graphite/epoxy composite.

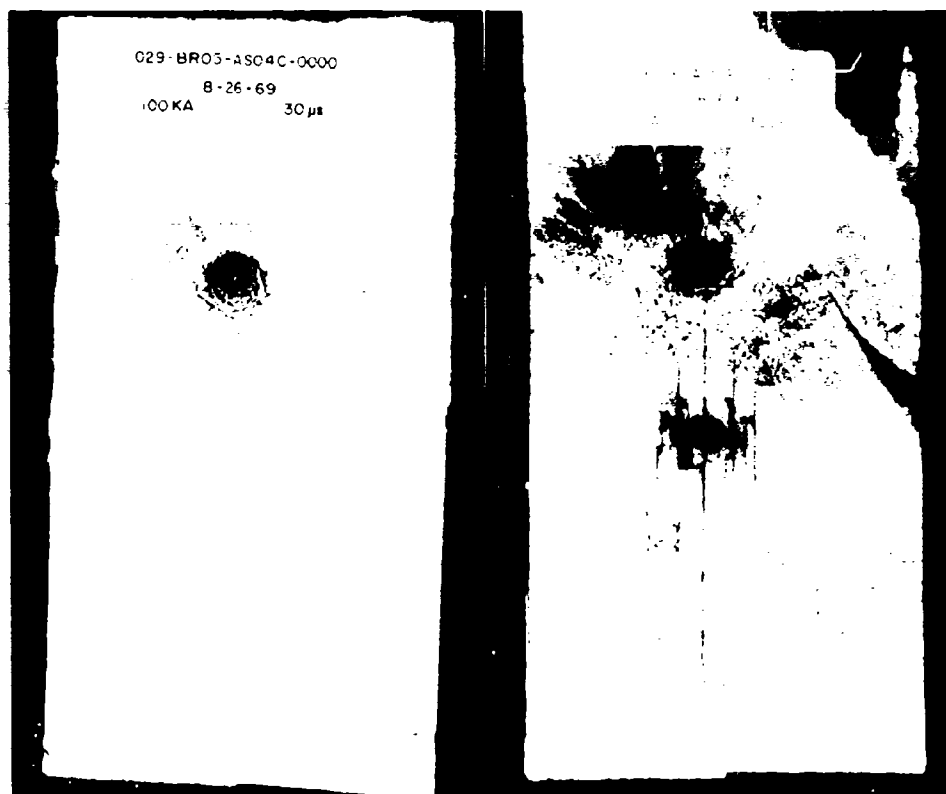
Surface coatings of flame sprayed aluminum were very effective in preventing damage to boron composite panels for 100 KA discharges (Panel 029, Figure 45). The 4 mil coating showed discoloration and some cracking in the immediate vicinity of the probe, but no other damage. A 160 kiloampere oscillatory discharge caused extensive damage to the coated panel (Panel 030, Figure 45).

Figure 45: DAMAGE TO FLAME-SPRAYED ALUMINUM COATED COMPOSITE LAMINATES

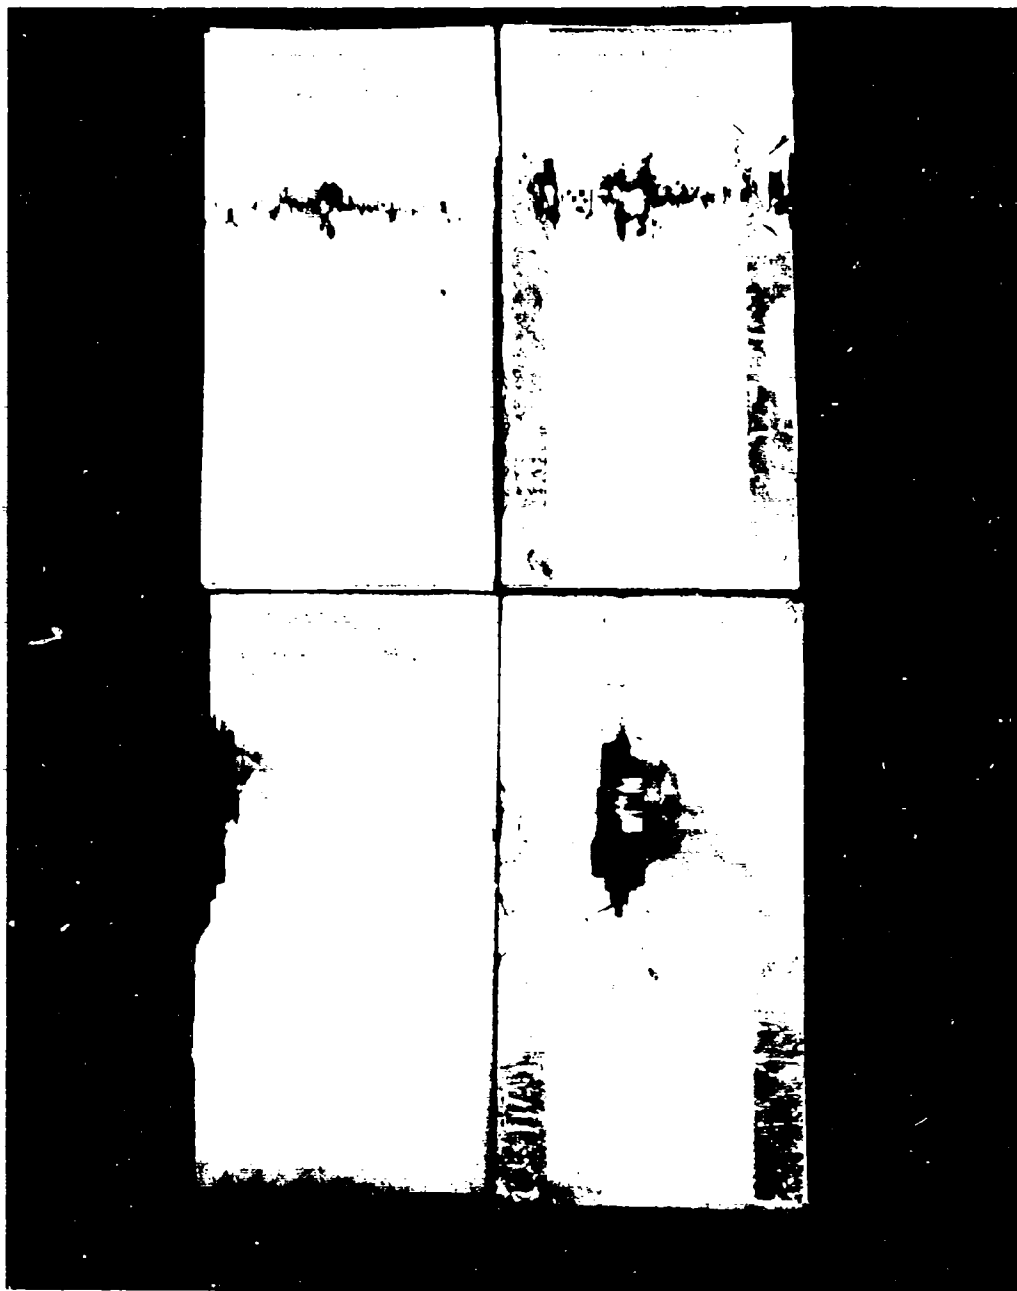
Figure 10. SIMULATED LIGHTNING DISCHARGE DAMAGE TO LAMINATE  
PAINTED WITH INORGANIC PIGMENTED COATINGS

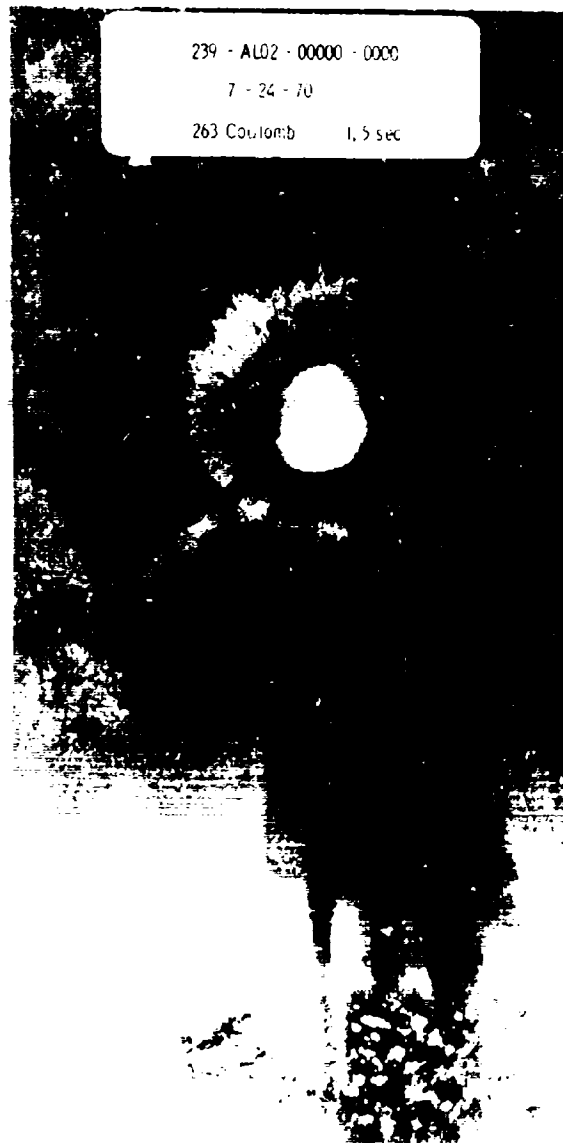
It is apparent from these tests that the coating does not provide complete protection against high coulomb transfer. The coating dissipates some of the charge but significant burn damage to the composites occurs. For comparison purposes, the degree of damage to aluminum sheet is illustrated in Figure 77. This 263-coulomb transfer test burned a 1 inch hole completely through a sheet of 0.040" aluminum. That the arc temperatures can destroy boron or graphite is illustrated in Figure 78. This electron scanning view of the boron at the arc contact shows re-solidified boron, aluminum and tungsten at the high temperature burn

Figure 77. 262 COULOMB TRANSFER DAMAGE TO AN 0.040 SHEET OF ALUMINUM.

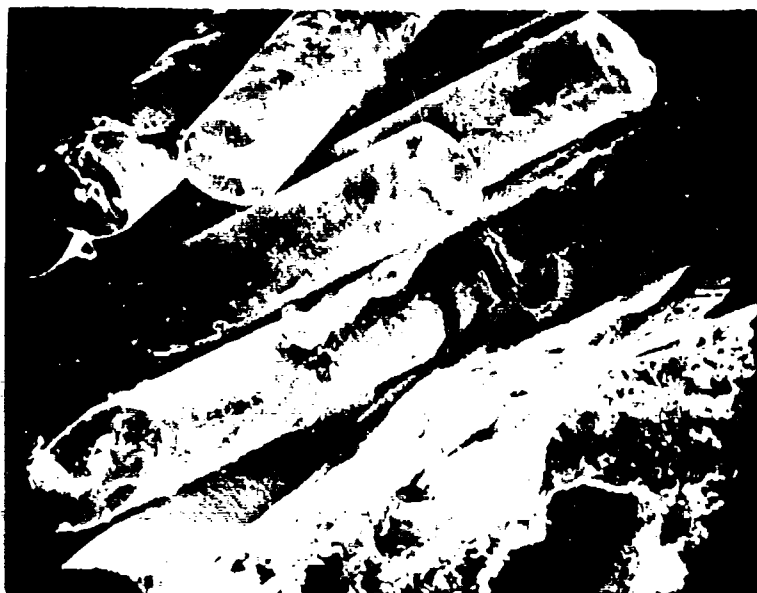
Figure 28 SEM VIEW OF DAMAGED BORON FILAMENTS

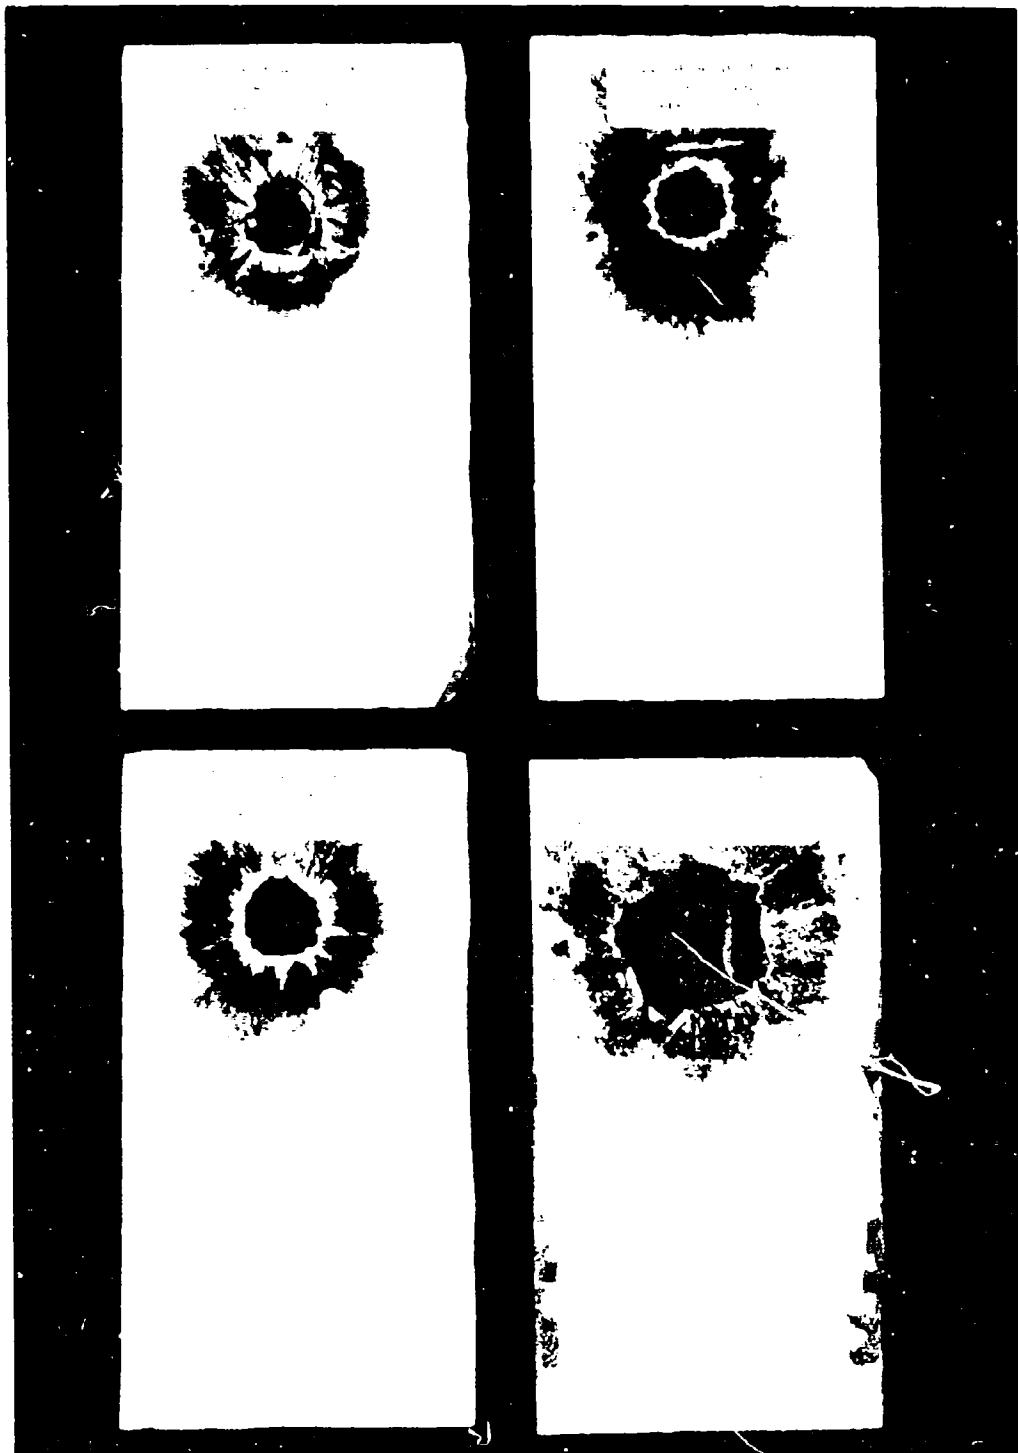
024-GP06-AF01C-KF01

A 3M spray adhesive #77 was used to bond a 3-mil aluminum foil to this graphite panel with an undercoating of a 2-mil Kapton film. A 17 KV discharge was directed to this coated panel; the discharge current had a peak amplitude of 94 KA with a risetime of 16  $\mu$ s and a duration of 30  $\mu$ s.

No visible damage to the substrate was observed.

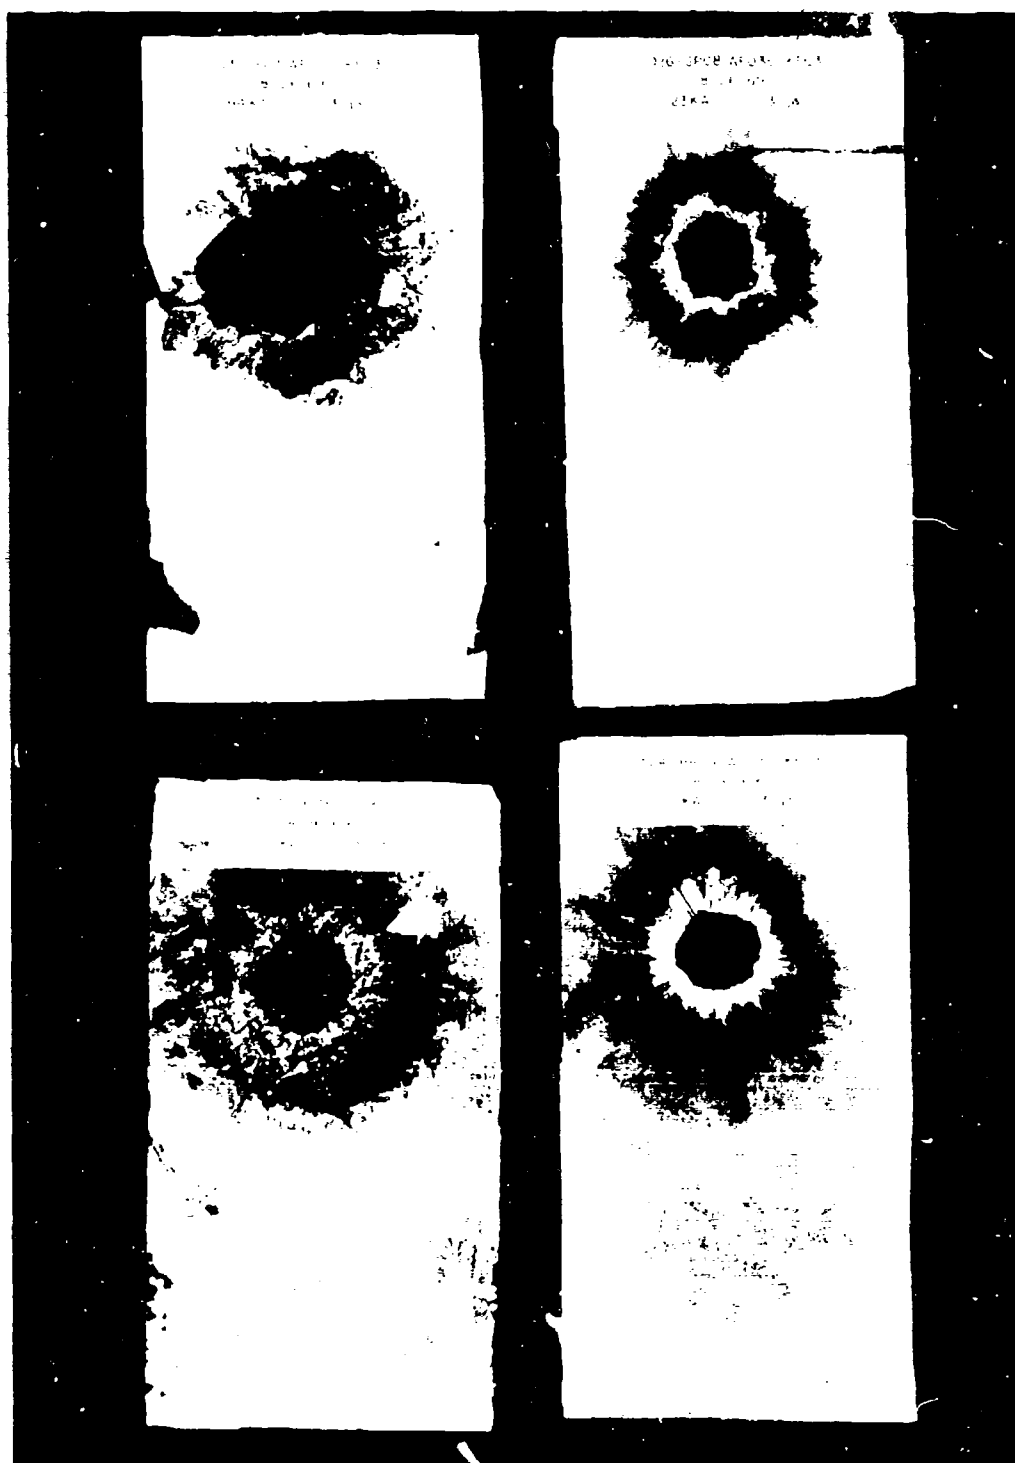
029-BR05-AS04C-0000

A 3M spray adhesive #77 was used to bond a 3-mil aluminum foil to this boron panel with an undercoating of a 3-mil Kapton film. An 18 KV discharge was directed to this coated panel; the discharge current had a peak amplitude of 100 KA with a risetime of 16  $\mu$ s and a duration of 30  $\mu$ s.

No visible damage to the substrate was observed.
