REPORT NATF-EN-1132

BAK-14 RETRACTABLE HOOK-CABLE SUPPORT SYSTEM
COLD-WEATHER TESTS AT GALENA, ALASKA

27 AUGUST 1974

Final Report for Period 15 through 20 January 1974

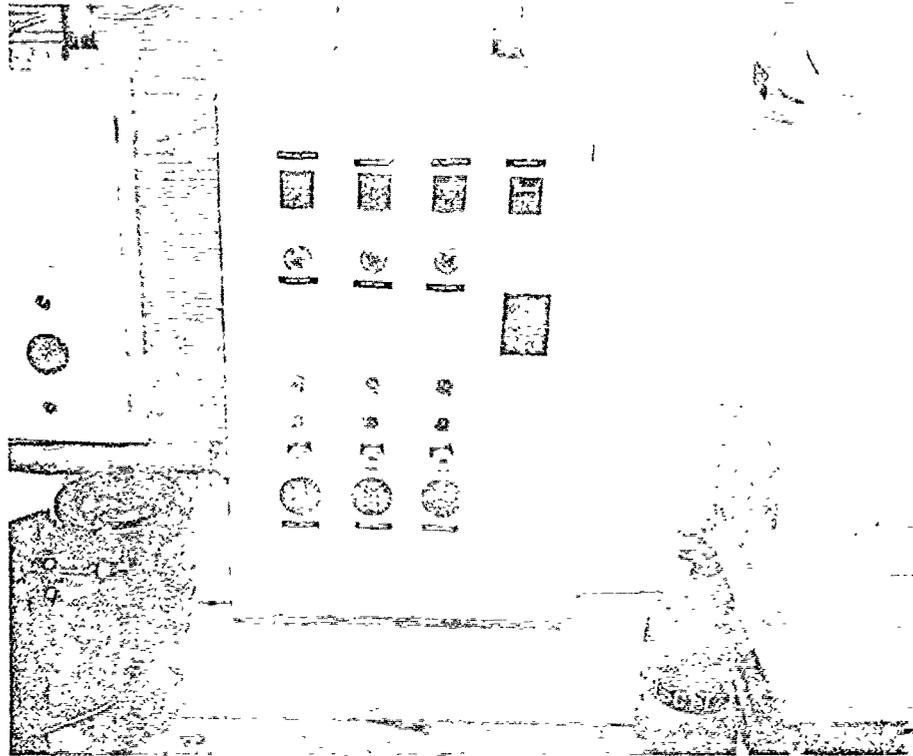
FIGURE 5 - HEATER CONTROL BOX (CENTER) AND THE SUPPORT ARM LIMIT SWITCH CHECK CIRCUIT CONTROL BOX (LEFT)

g. Verification of the electrical continuity of the support-box, trough, and end-trough heaters was attempted by operating the check circuit provided on the heater control panel in the BAK-12 pan. The heater control box is shown in Figure 5 on page 10. The verification was unsatisfactory for the following reasons:

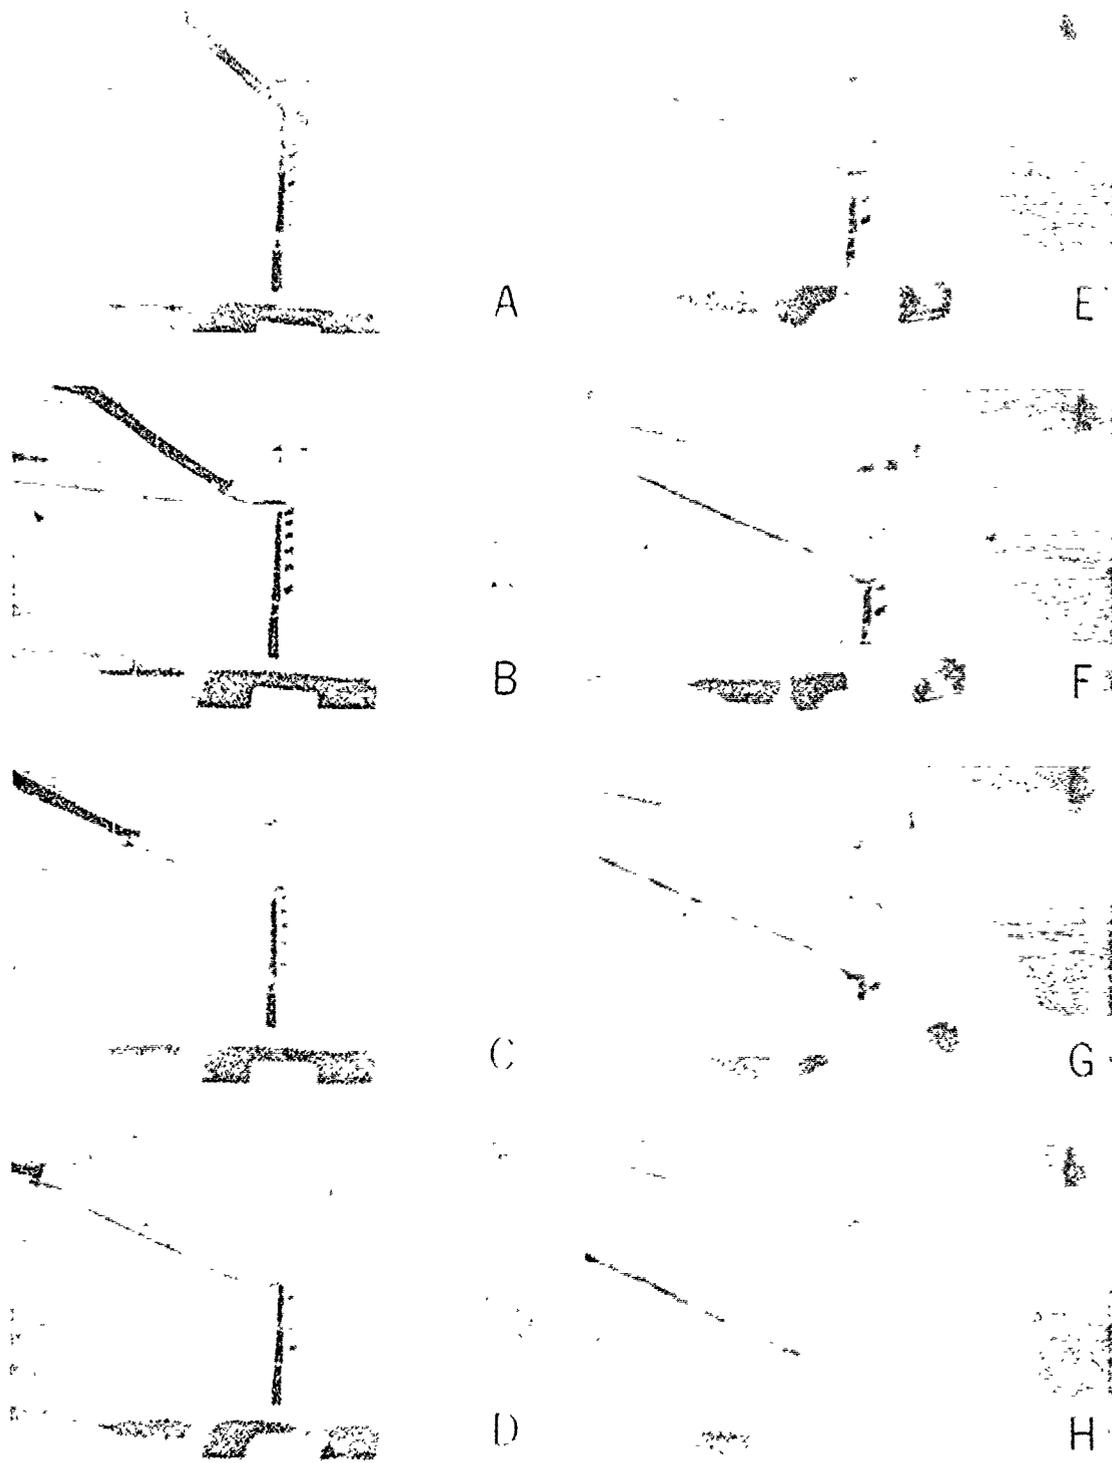
(a) The less serious was the hook-cable entry slot area. Figure 11 shows a damaged support: chunks of rubber were ripped out, enlarging the cable entry slot. Supports 7 and 9 were damaged in this manner during the initial engagement (event 13) at 60 knots indicated airspeed. A high-speed motion-picture film sequence of this event is shown in Figure 12 on the following page.

FIGURE 12 - HIGH-SPEED MOTION-PICTURE FILM SEQUENCE OF EVENT 13: F-4E AIRCRAFT 60-KNOT INDICATED AIRSPEED ENGAGEMENT OF BAK-12 ARRESTING SYSTEM EQUIPPED WITH BAK-14 HOOK-CABLE SUPPORT SYSTEM

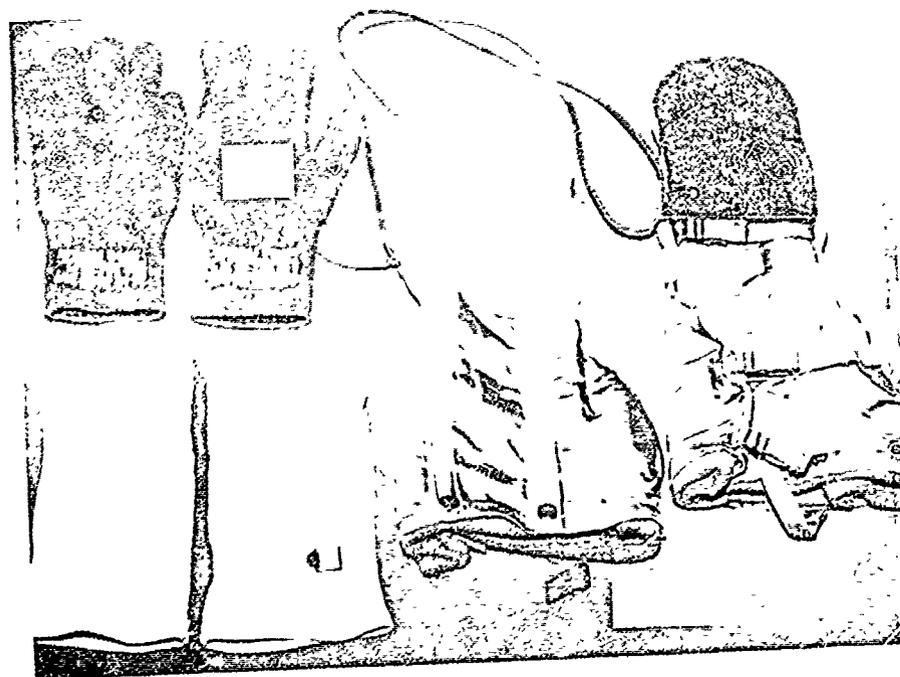
FIGURE 21 - REMOVAL OF SUPPORT-BLOCK EXTENSION SPRINGS WITH BARE HANDS
