SHRIKE AND SPARROW MISSILE BASELINE  
COOKOFF TESTS

Naval Weapons Center

Naval Missile Center

October 1974

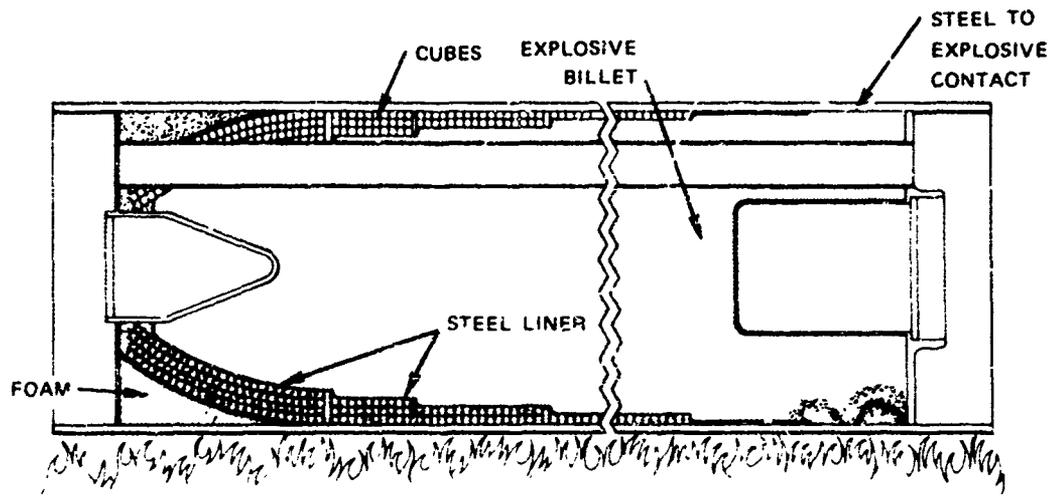
The exothermic heating produced from the potting material and/or cavity paint ignites the explosive sooner than if only heating by conduction from the fire existed without chemical reactions. The explosive is shown burning at the aft end in Figure 4a.

FIGURE 4a. SHRIKE Warhead Explosive Igniting at Lower Aft End.

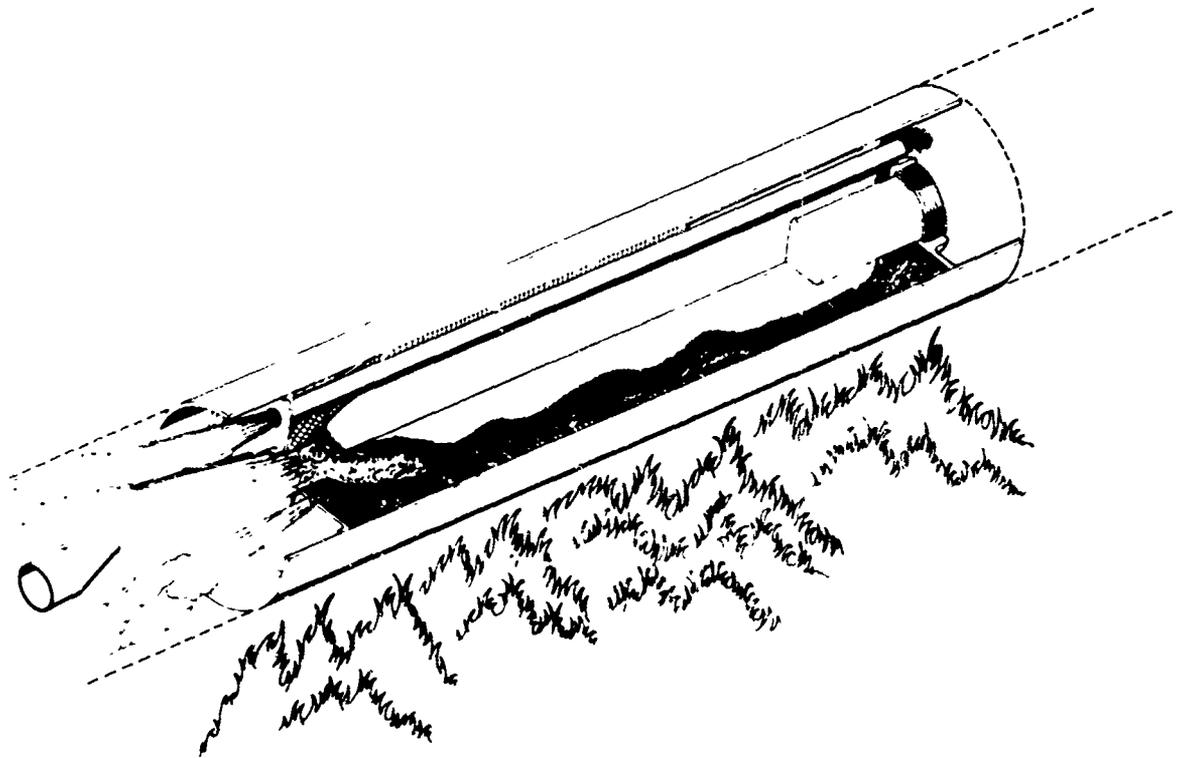
The failure of the SHRIKE warhead is hypothesized to be due to over-pressurization within the steel casing, which causes the crack as shown in Figure 4b. Inadequate venting exists for the SHRIKE warhead, and it explodes before 169 sec, e.g., SH-13A, 128 sec; SH-14A, 109 sec; SH-16A, 169 sec. If the excess explosive-gas can be vented, then there may be deflagrations instead of explosions. Both types of reaction are illustrated in Figures 4c and 4d.

FIGURE 4c. Possible SHRIKE Warhead Venting.

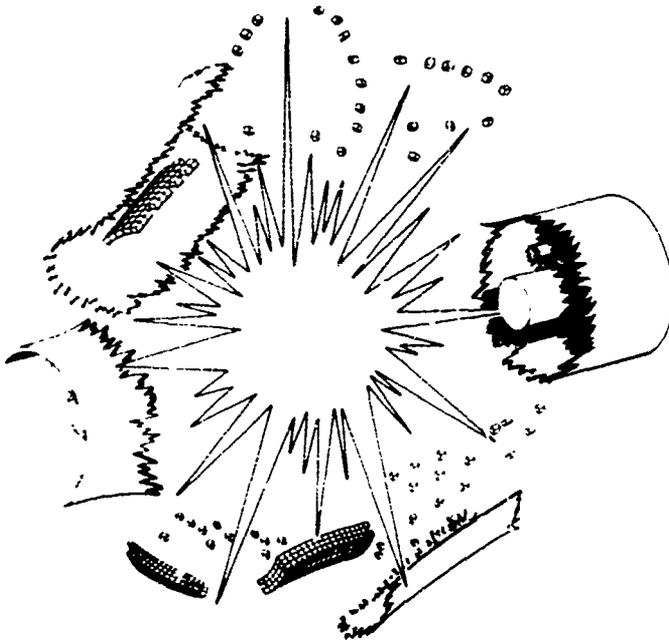
FIGURE 4d. Possible SHRIKE Warhead Explosion Due to Overpressurization.

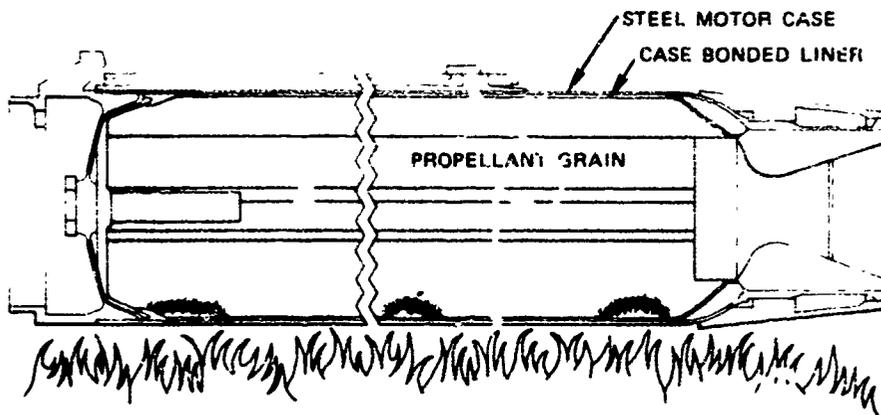
The SHRIKE rocket motors tested were the Mk 53 Mod 1, Mk 78 Mod 0 and the Mk 39 Mod 7. Descriptions of these motors are included in Appendix A. They exhibited internal exothermic reactions in the steel/liner region before 104 sec (e.g., SH-1A, 80 sec; SH-7A, 54 sec; SH-8A, 25 sec; SH-12A, 28 sec; SH-16A, 104 sec). The region where apparent exothermic reactions occur prior to burning of the propellant is between the lower steel case and liner. The exothermic heating produced from the liner and/or other material used to prepare the inside of the steel case for graining ignites the propellant sooner than if only heating by conduction from the fire existed without chemical reactions. The solid propellant is shown burning at the lower surface in Figure 5a.

FIGURE 5a. SHRIKE Motor Propellant Igniting at Lower Surface.

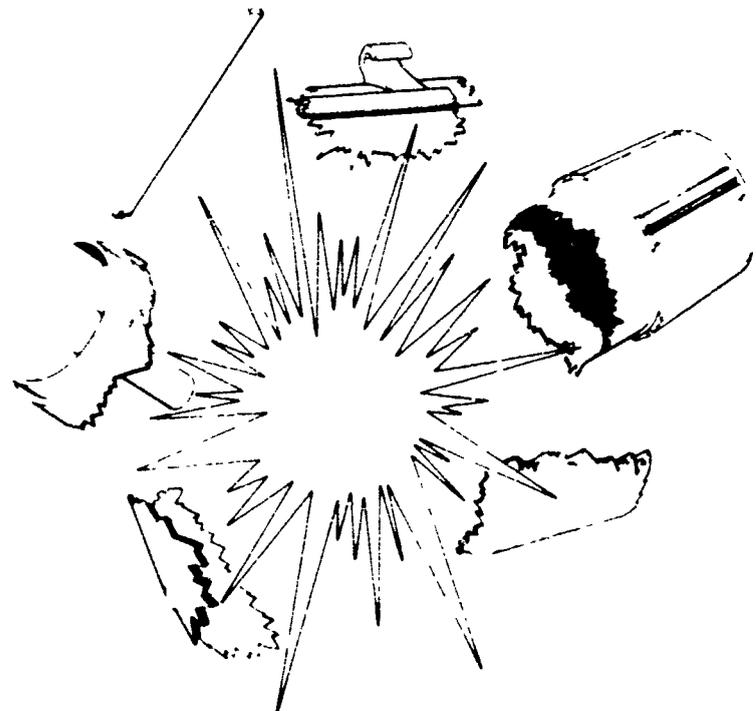
The failure of the SHRIKE rocket motor is hypothesized to be due to over-pressurization within the steel casing, which causes solid propellant cracks (Figure 5b). If the excess propellant gas can be vented (e.g., SH-7A, SH-8A, SH-12A) then the reaction will be one of deflagration; otherwise an explosion may result (e.g., SH-16A). Both types of reactions are illustrated in Figures 5c and 5d.

FIGURE 5d. Possible SHRIKE Motor Propellant Explosion Due to Overpressurization.

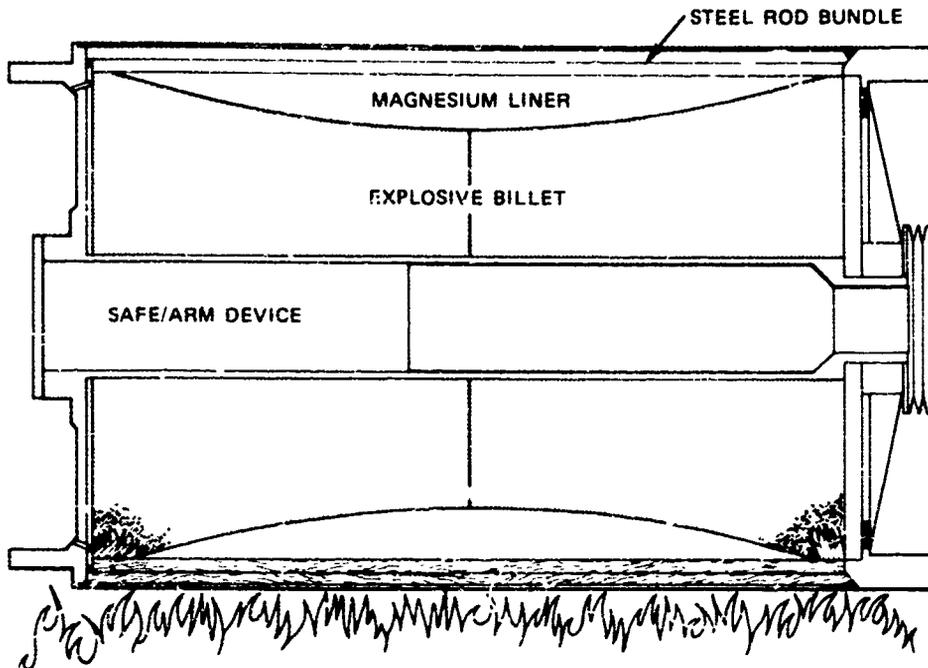
The exothermic heating produced from the potting material and/or cavity paint ignites the explosive sooner than if heating only by conduction from the fire existed without chemical reactions. The explosive is shown burning at its ends in Figure 6a.

FIGURE 6a. SPARROW Warhead Explosive Igniting on Lower Surface.

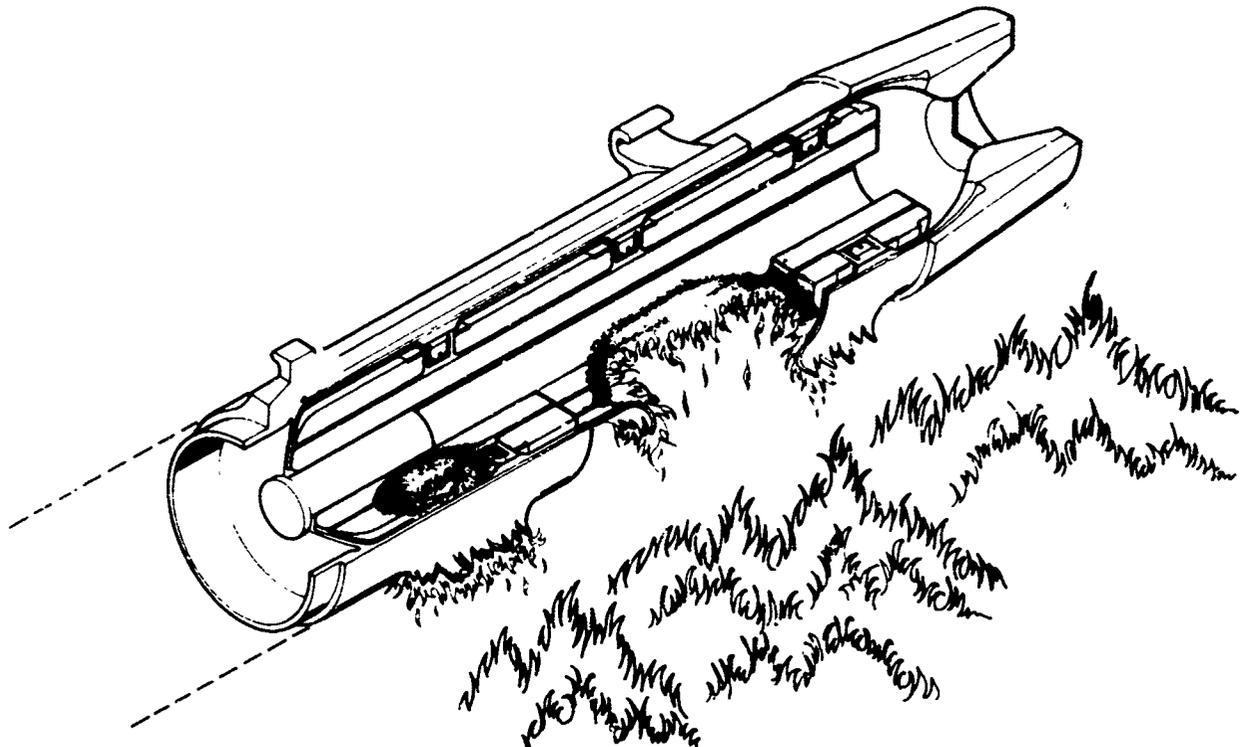
The failure of the Mk 38 Mod 0 SPARROW rocket motor is hypothesized to be due to over-pressurization within the steel casing, which causes the solid propellant to crack, as shown in Figure 7b. If the propellant gas can vent, then the reaction may be one of deflagration, as shown in Figure 7c. Otherwise an explosion may result, as shown in Figure 7d.

FIGURE 7c. Possible SPARROW Motor Venting.

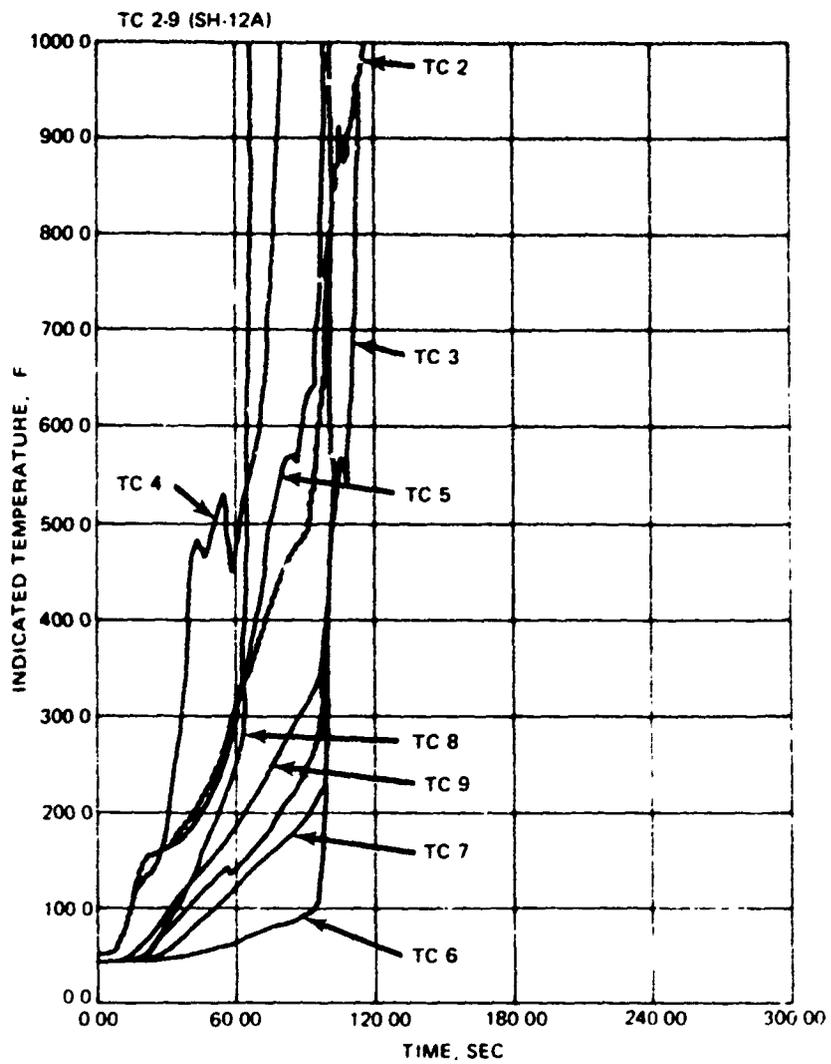
FIGURE C-36. TC 2-9 Response, SH-12A

The responses of the thermocouples in the motor are given in Figures C-36 and C-37. Apparent exothermic reaction is indicated by TC 2 and 4 which were welded to the motor case adjacent to the liner. Failure of TC 2-9 occurred before 104 sec, and was probably due to lead-wire burn-through. TC 8 was the first to fail, and did so at 66 sec.

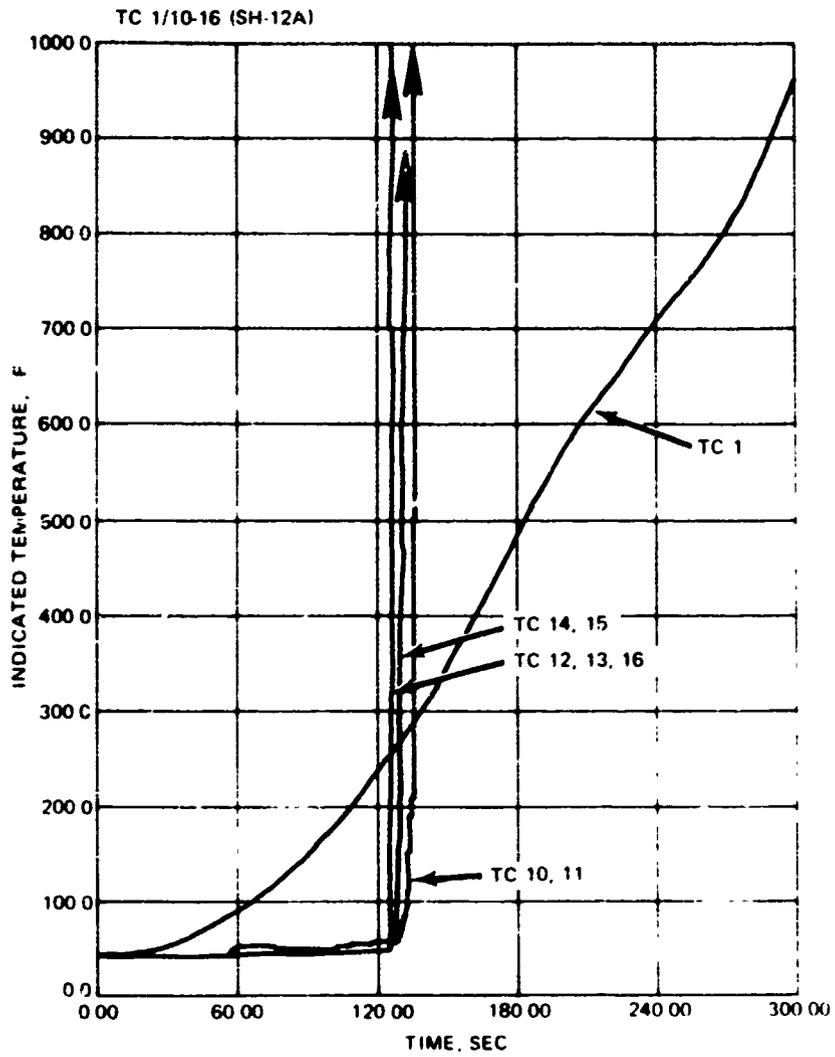
FIGURE C-37 TC 1/10-16 Response, SH-12A

Thermocouples 10-16 (Figure C-37) located in the motor port region showed a small response at 56 sec, but after 128 sec began to fail.

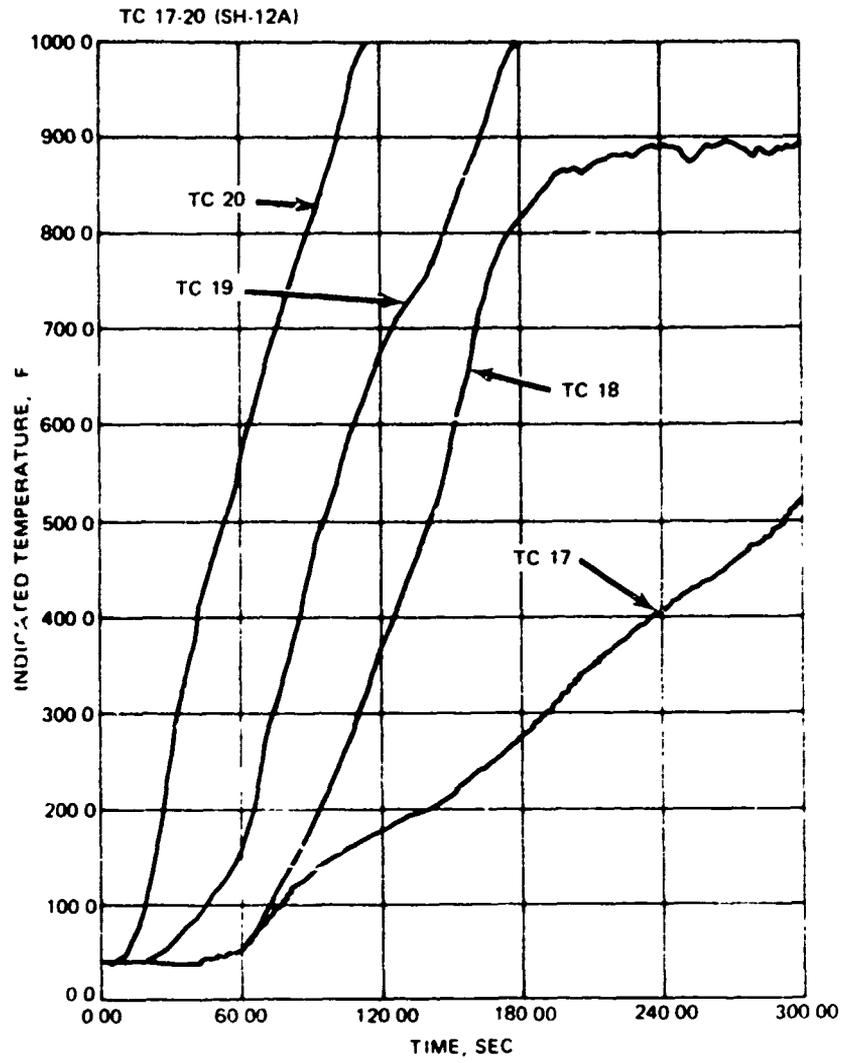
FIGURE C-38 TC 17-20 Response, SH-12A.

Outputs from TC 17-20, located at the forward bulkhead of the warhead, are shown in Figure C-38. The response of TC 18 is unusual, and is not understood, unless the warhead cup had caused a mechanical interference. The responses of TC 21-27 (Figure C-39) are similar to those in Figure C-30 in test SH-8A. Outputs from warheads TC 28-31 are given in Figure C-40.

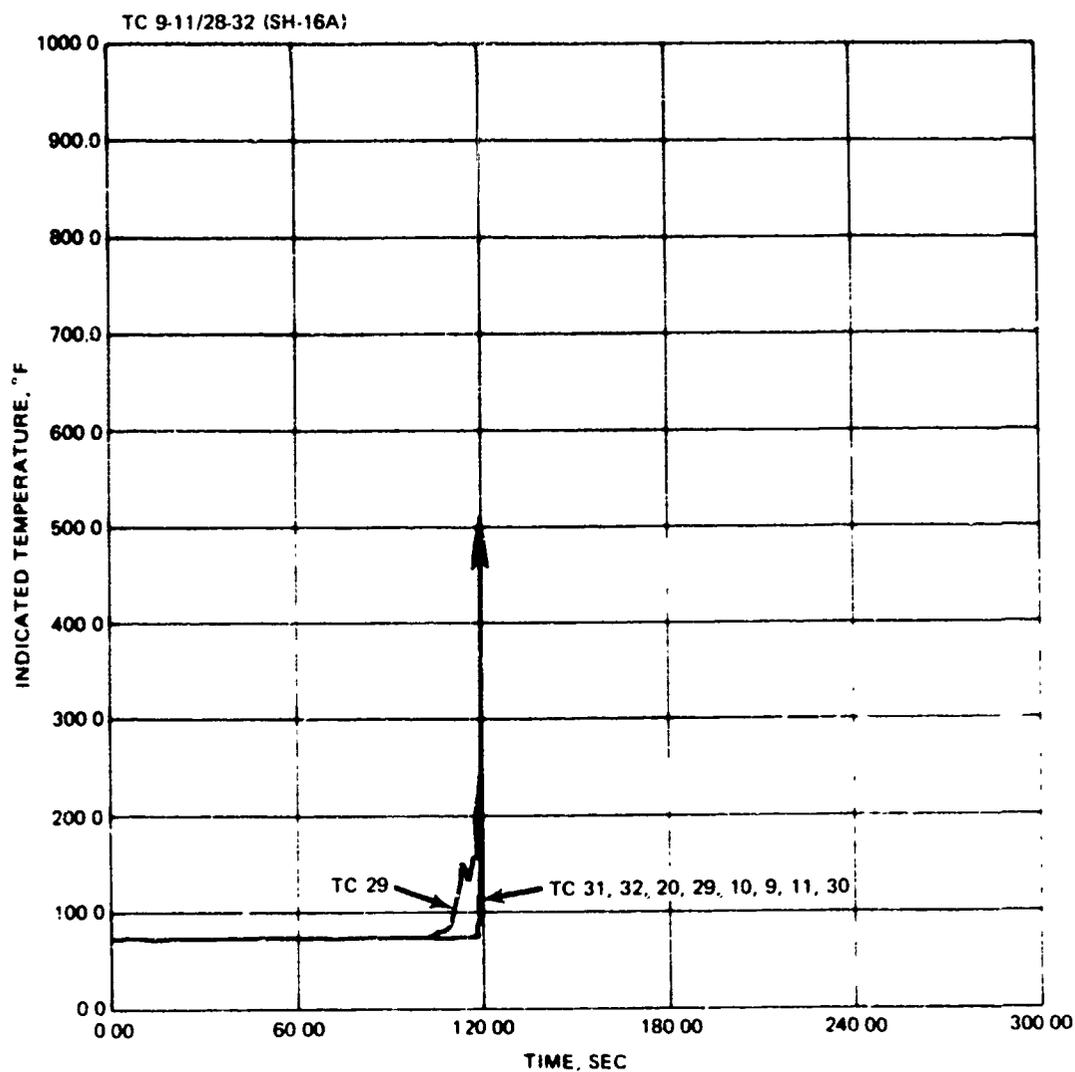
FIGURE C-69. TC 9-11/28-32 Response, SH-16A

The only other thermocouple in the motor to respond prior to thermocouple failure at 122 sec was TC 29 (Figure C-69), showing an apparent exotherm.

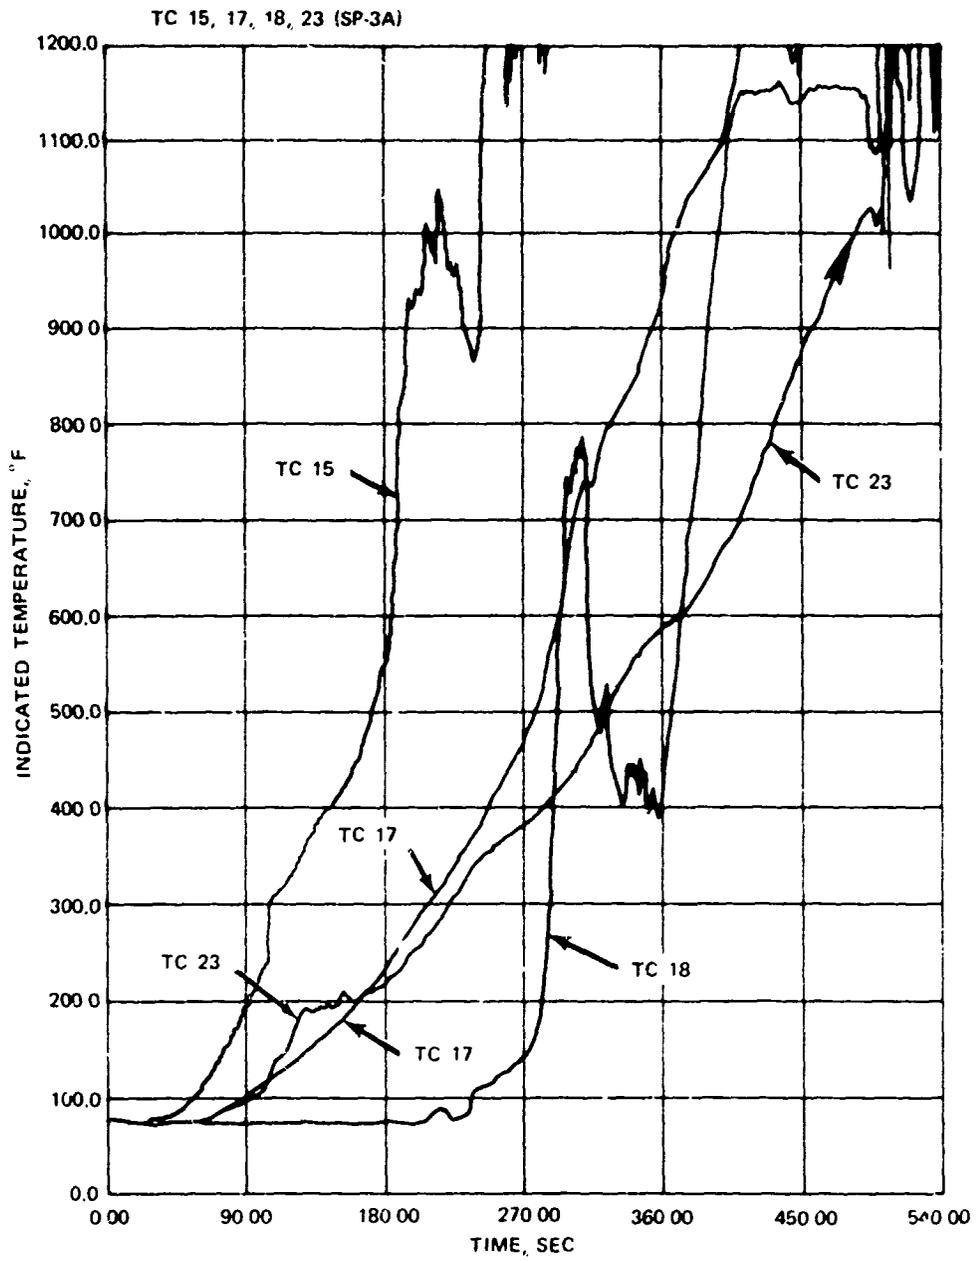
FIGURE D-9. TC 15, 17, 18, 23 Response, SP 3A

Warhead venting can be inferred from the outputs of TC 15, 17, 18, and 23 (Figure D-9). TC 23 suggests that venting out the aft potting material seal occurs by 130 sec, and that the magnesium flames vent by 493 sec. TC 18 suggests that the warhead safe/arm device had ejected before 360 sec. TC 15 and 17 indicate that venting through the forward bulkhead thermocouple holes was well established by 180 sec. It appears likely that the magnesium was burning in the forward portion of the liner by 320 sec, since TC 15 exhibited extraordinarily high temperatures.

It would appear that the warhead vents through the rear seal into the motor safe/arm cavity and out the lower keyhole and/or umbilical hole under the rear launch hangar. If the warhead safe/arm device were expelled then venting would also occur through the warhead cavity into the control section. Another possible vent source was at the point where the thermocouples exit out the front end of the warhead at the weld bead. Finally if the edge welds had failed, then venting would have occurred between the rods and the outer steel-fairing.

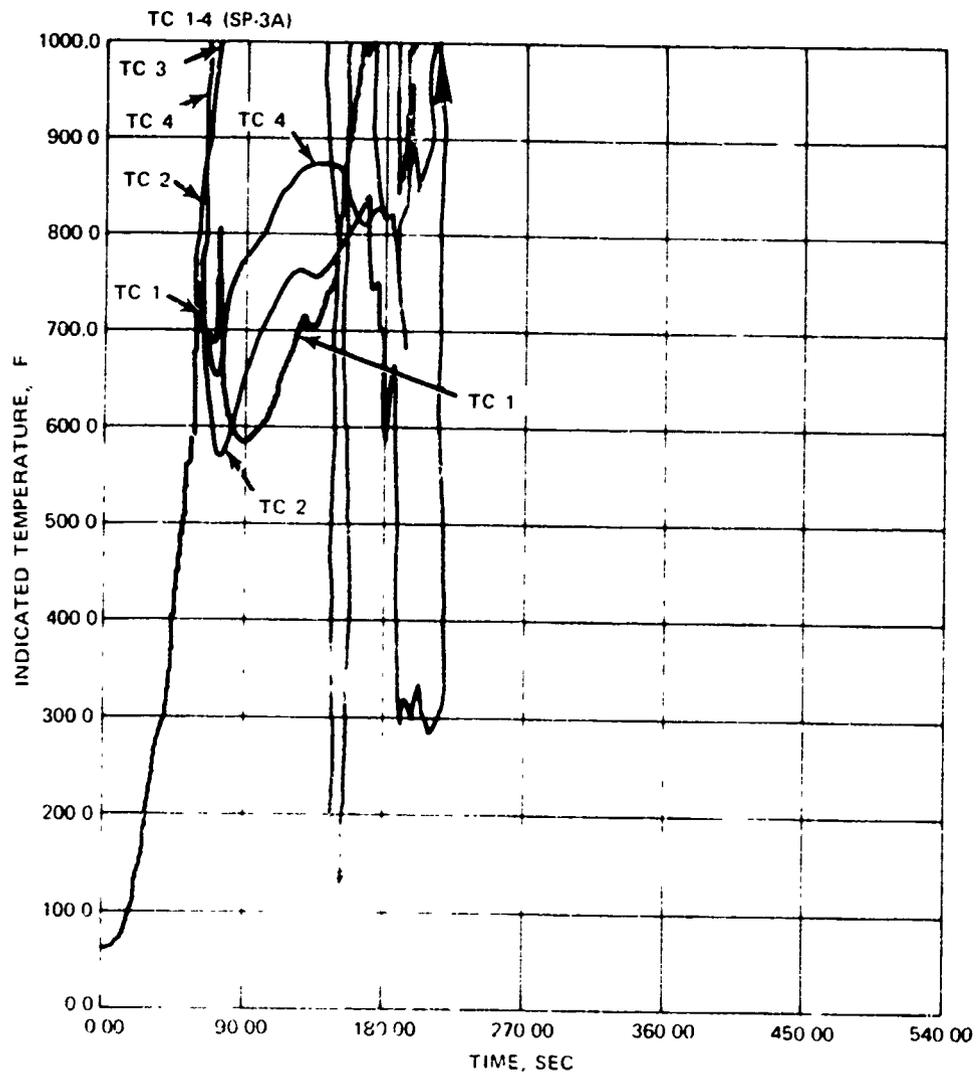
FIGURE D-10 TC 1-4 Response, SP 3A

Rocket motor thermocouples 1-4 were welded to the inner side of the case (Figure D-10) and showed high initial heating rates up to about 70 sec. Then a significant temperature reversal occurred which may be attributed to liner degradation at temperatures above 700°F. This behavior is ascribed to apparent exothermic reaction in the steel-case/liner region. Further evidence of exothermic reaction in this area before 70 sec is indicated by some of the thermocouples placed on the sand side of the liner (Figure D-11). Thermocouples 6-8 responses indicate apparent exothermic behavior at temperatures above 400°F, beginning at about 160 sec. The motor thermocouple data are discontinuous after 216 sec, indicating that the motor dropped into the fire at that time.

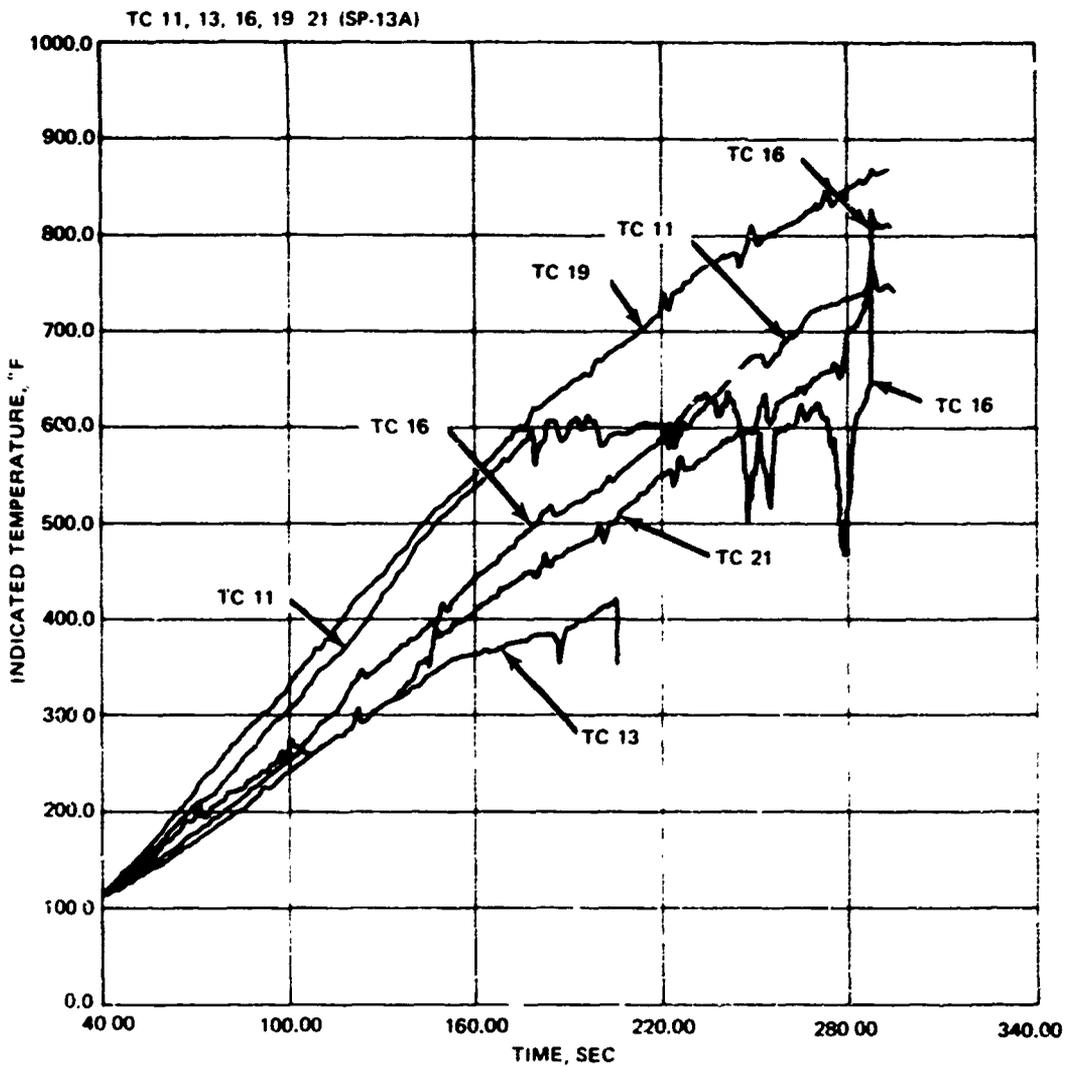
FIGURE D-17. TC 11, 13, 16, 19, 21 Response, SP-13A.

Thermocouples 11, 13, 16, 19 and 21 were located on the warhead rods (Figure D-3). Their responses are shown in Figure D-17. All became inoperative after 295 sec, when the forward section of the test item fell into the pit. Thermocouples 13 and 16 exhibited peculiar behavior from about 190 sec, and failure of these may have occurred prior to the loud report heard at 220 sec. Again, as expected, TC 19 and TC 11 were hotter than TC 13 and TC 21. The loss of all thermocouples at 295 sec precluded further comparison with SP-3A.

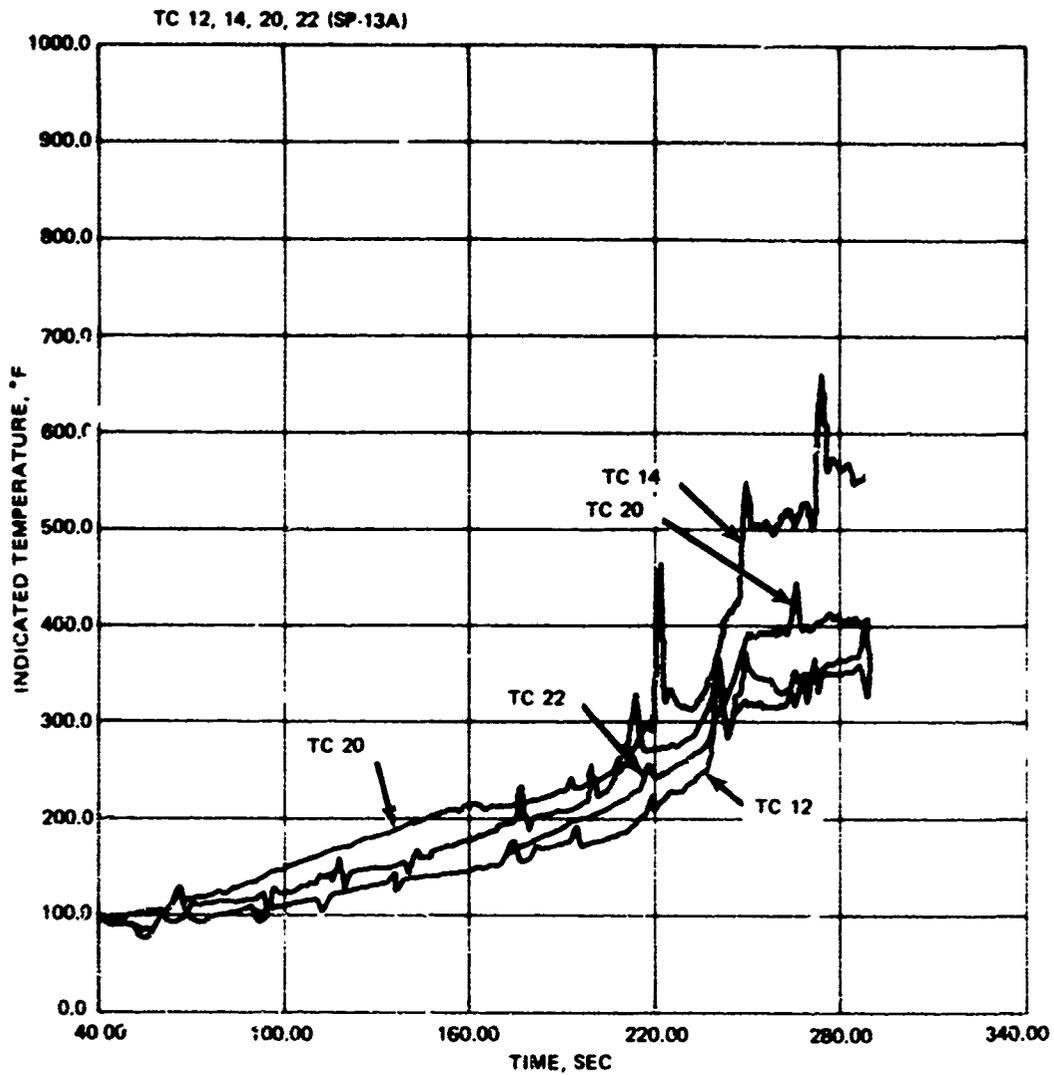
FIGURE D-18. TC 12, 14, 20, 22 Response, SP .3A

Apparent exothermic reaction is given by TC 12, 14, 20 and 22 (Figure D-18). The reactions are not so spectacular as those for SP-3A. This difference may be tentatively attributed to the use of a wood billet in SP-3A as opposed to an explosive in SP-13A. Hence the reverse spikes may be ascribed to exothermic reactions. These thermocouples also were fractured at 295 sec.

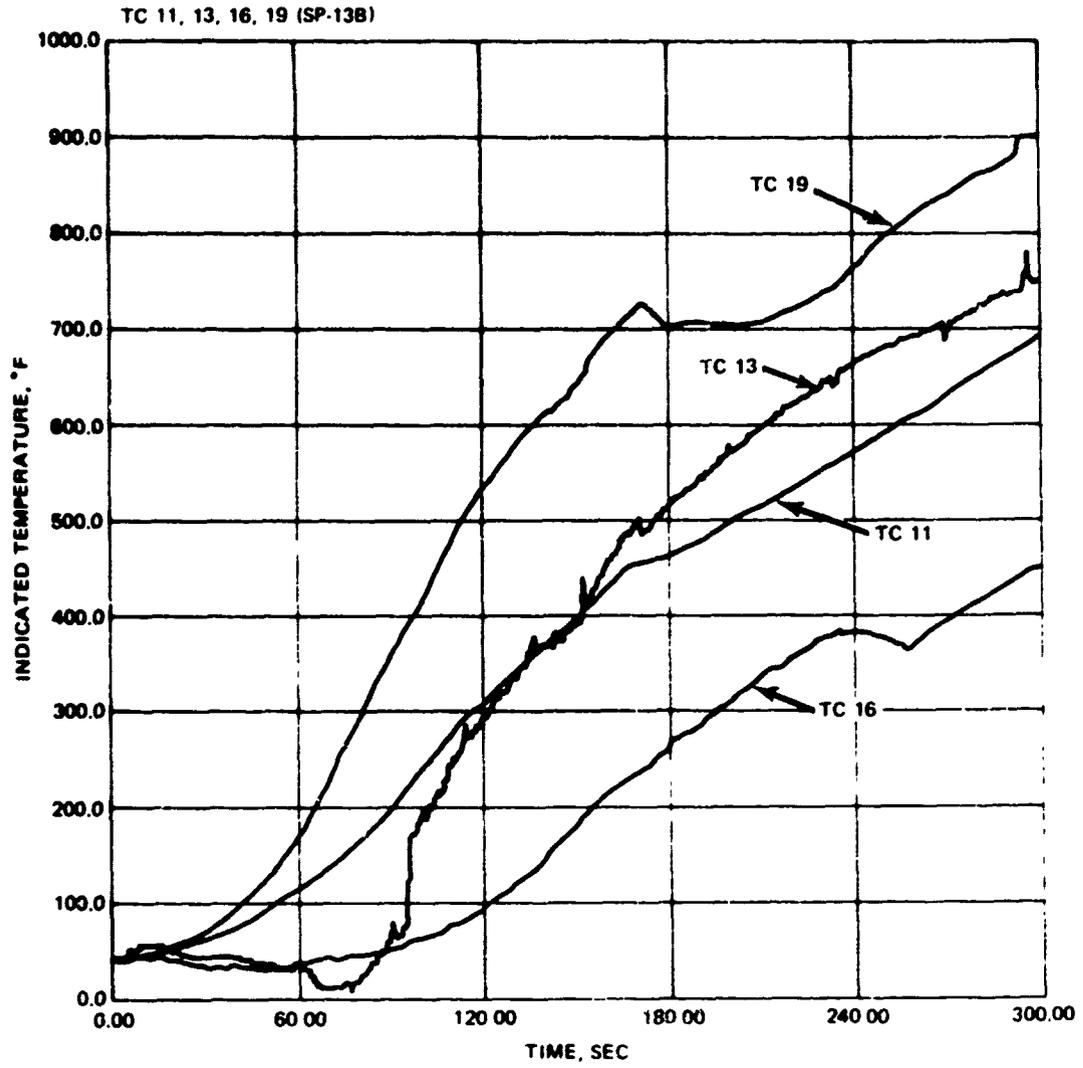
FIGURE D-24. TC 11, 13, 16, 19 Response, SP-13B.

The outputs of the thermocouples attached to the steel rods are given in Figure D-24. There are apparent exotherms for TC 13 at 96 sec, for TC 19 and TC 11 at 152 sec, and TC 16 at 465 sec. TC 19 failed at 535 sec.

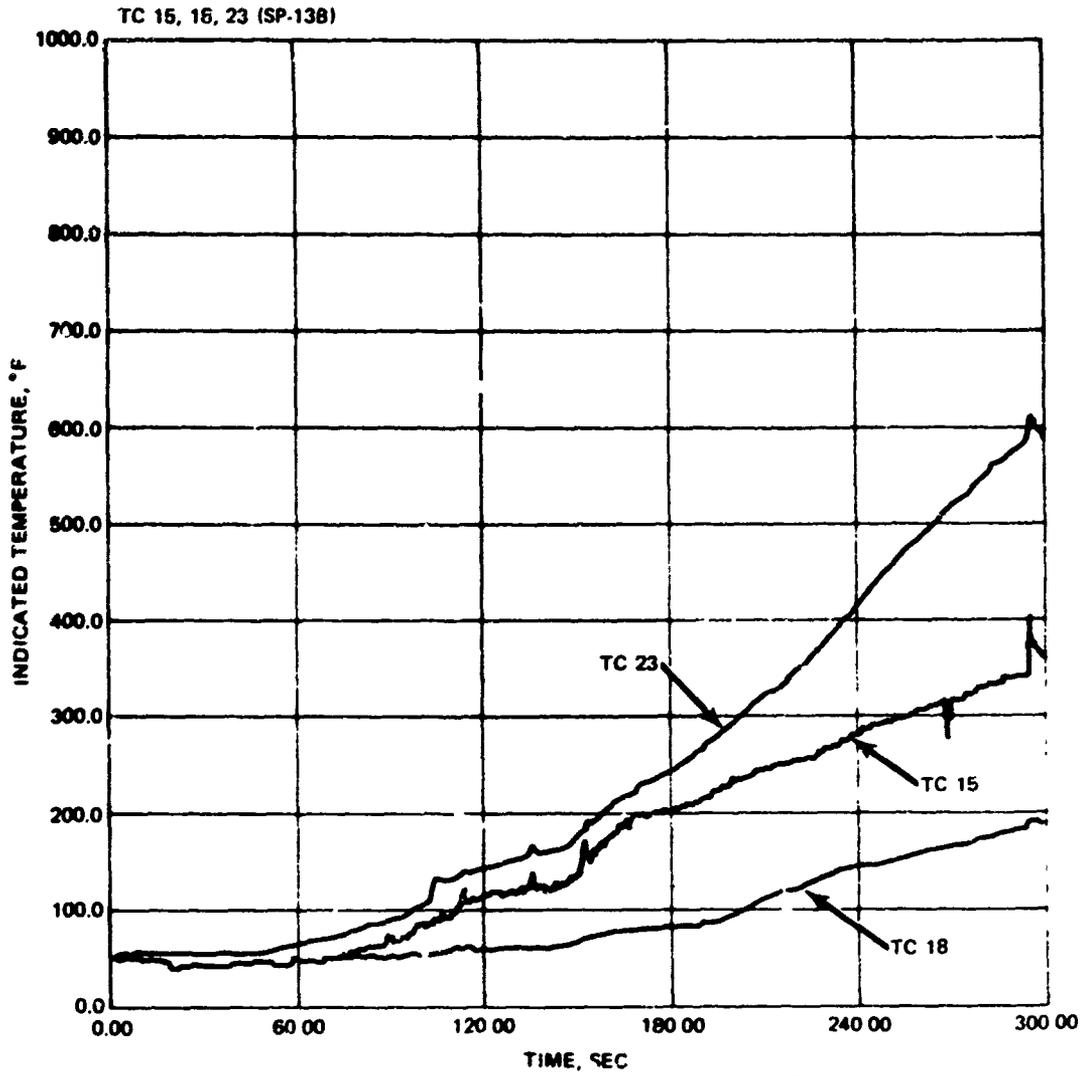
FIGURE D-26. TC 15, 18, 23 Response, SP-13B.

Outputs of TC 15, 18, and 23 are given in Figure D-26. Venting at the aft of the warhead is suggested by the exotherm at 102 sec for TC 23. Venting through the forward thermocouple fillet holes is indicated at 150 sec by TC 15. Venting through the safe/arm cavity is suggested by TC 18 to have occurred by 195 sec, and then again at a higher rate at 490 sec. The magnesium was completely consumed during the test. Further evidence of internal burning with gases exiting through the simulated guidance section and the motor/warhead interface was the deposit of a very fine white ash around the exit regions.

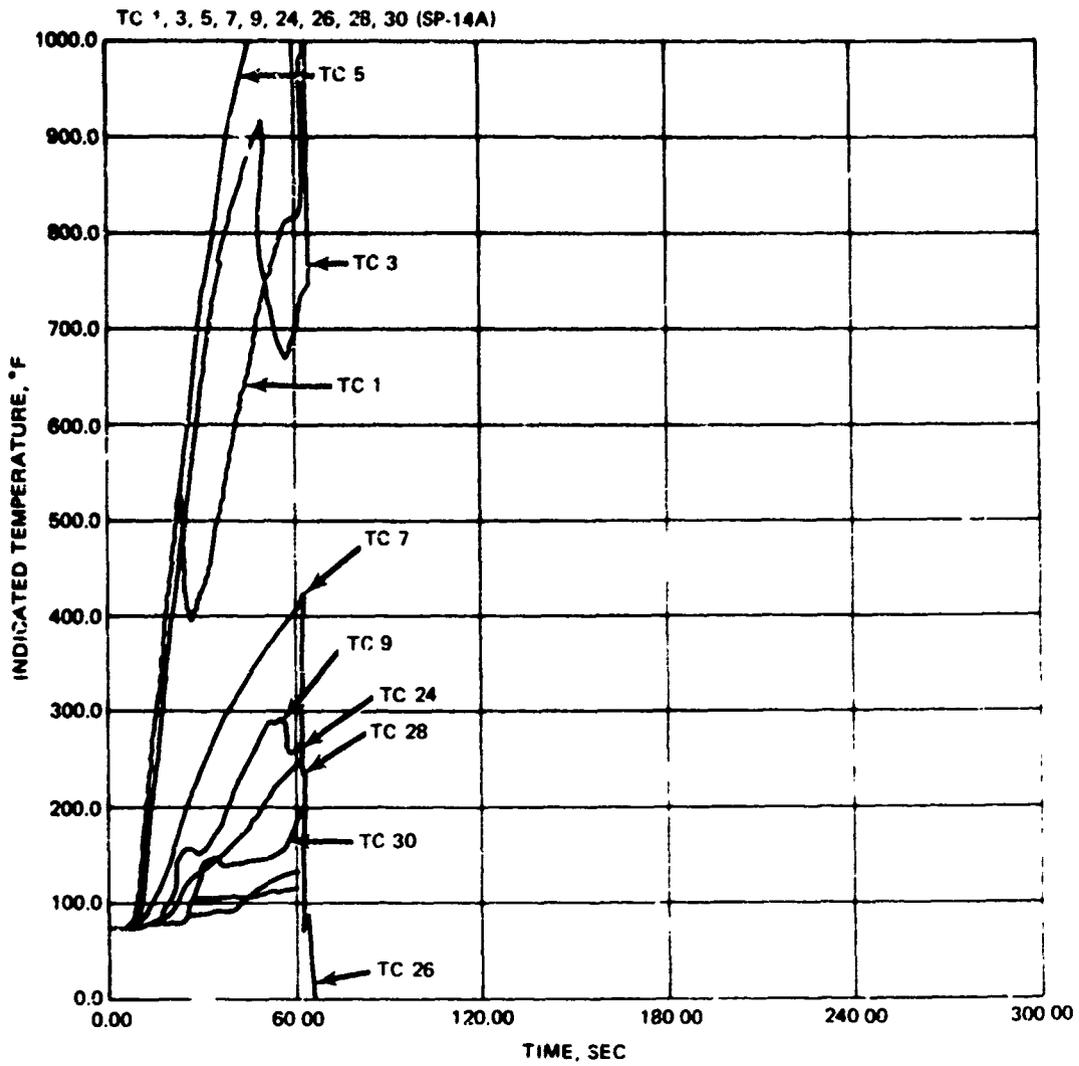
FIGURE D-36. TC 2, 4, 6, 8, 10, 25, 27, 29, 31 Response, SP-14A.

Output from thermocouples 1-10 and 24-36 located in the motor are shown in Figures D-35-D-38. All of these data ended at 62 sec, suggesting that the motor exploded. TC 32-34 (Figure D-38) indicate that the grain bore had not yet ignited at the time the thermocouples were fractured. The same can be said for TC 36 at the igniter (Figure D-37). On the other hand, the airspace behind the nozzle seal began heating at 34 sec. The thermocouple responses from the bottom of the grain are shown in Figure D-35. Thermocouples 1, 7, and 26 are typical of thermocouples in the steel case to glass liner, between the glass liner and air, and between air and propellant respectively. Apparent exothermic behavior of the interface thermocouples 1, 3, 9, 26, 28, and 30 is shown at times between 20 and 60 sec. Thermocouple responses from the side of the grain are shown in Figure D-36. These data are similar to those in Figure D-35, except that apparent exothermic behavior is observed only for the interface thermocouples 10, 12, 27, 29 and 31.
