INVESTIGATION OF HELICOPTER DOOR,  
WINDOW, AND ACCESS PANEL LOSSES

Naval Air Development Center

Naval Air Systems Command

15 January 1975

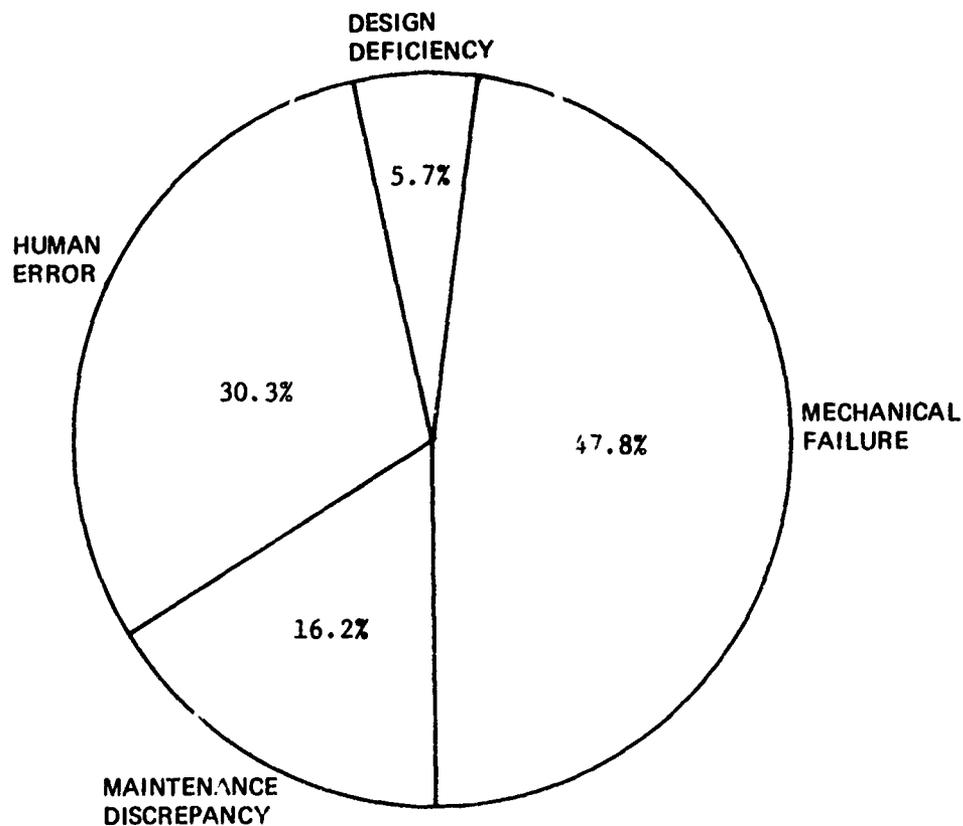
FIGURE 1. GENERAL FINDINGS FROM NAVSAFECEN REPORTS

Figure 1 illustrates the proportional distribution of the results. It is significant to note that the basic causes can almost be equally divided between equipment (1 and 2) and personnel (3 and 4).

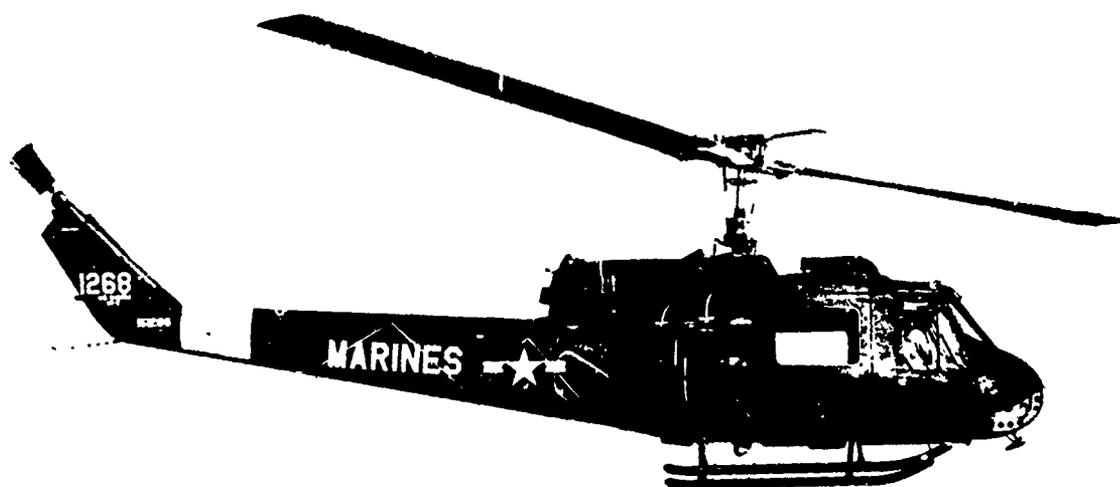
FIGURE B-1. UH-1E HELICOPTER-GENERAL VIEW

Information obtained from the NAVSAFECEN computer compilation demonstrated that the Transmission Cowling Panel is the primary problem area on this aircraft. Specifically, material failure of the latch mechanism was most critical. History indicates the need for a positive retention feature for the Transmission Cowling. In-flight Transmission Cowling problems accounted for 55% of the UH-1E reports. Figure B-1 provides a general view of the UH-1E aircraft, and the panel details are highlighted in Figure B-2. Figure B-3 summarizes the findings of the analysis of the NAVSAFECEN reports on the H-1 helicopters.

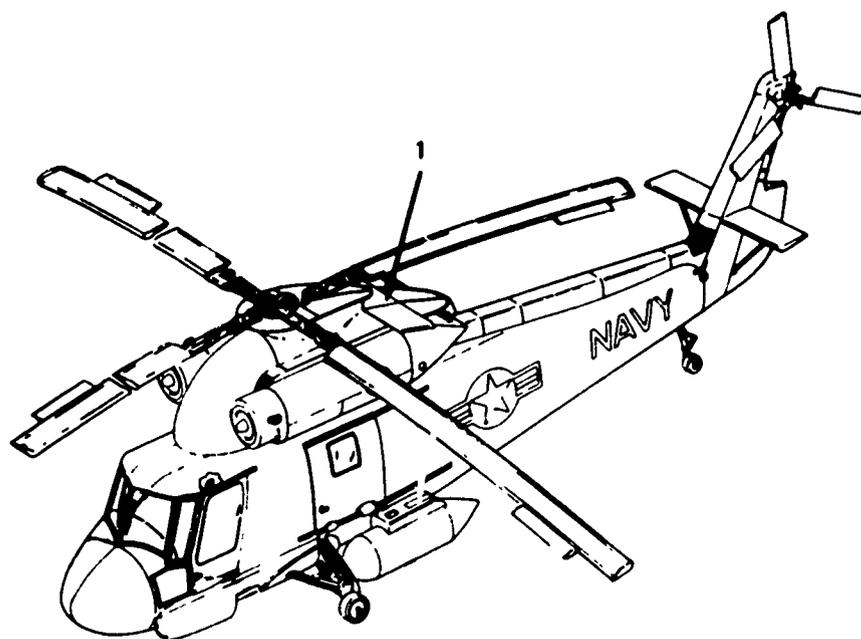
On the H-2C and the H-2D helicopters, the Engine Oil Access Panel has caused the most problems. These rectangular panels open horizontally on each side of the aircraft and are nicknamed "diving boards". The NAVSAFECEN compilation did not indicate a high frequency of in-flight openings of the Engine Oil Access Doors; but in each case reported, the doors became involved in the Rotor System. In two cases the aircraft were lost and the airmen were casualties due to Rotor unbalancing. The panels which are located just aft of the Rotor Blade Hub and just below the blades can be pushed together and closed without being secured. In one of the cases mentioned above, the accident investigation revealed that the panels were not fully locked. During the flight they vibrated open and finally separated from the aircraft on the landing approach. Realizing the critical nature of the panel, some of the active squadrons have made adjustments in their procedures. Some make a last minute, prior to flight, visual, double check to

1 ENGINE OIL ACCESS DOOR  
2 PILOT AND RESCUE DOOR

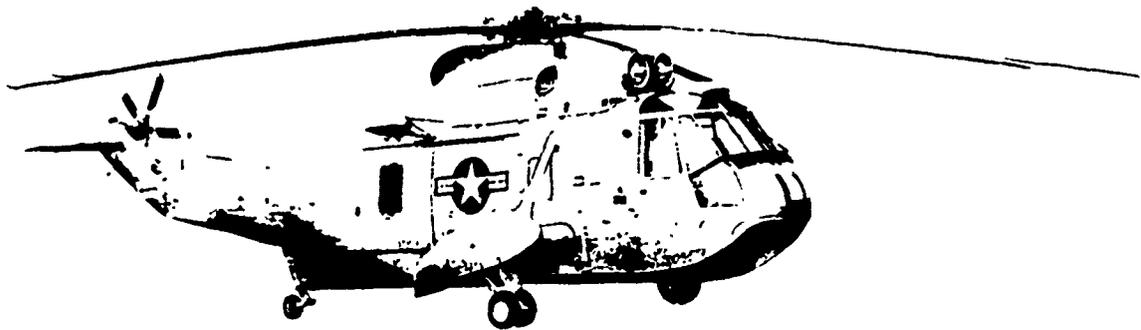
FIGURE D-1. H-3 HELICOPTER

Cockpit Windows encompass a variety of windows such as the Overhead Greenhouse Windows, Windshields, and Pilot's and Copilot's Sliding Windows. These components have been identified in the NAVSAFECEN and 3-M surveys. A number of cases of water leaking into the cockpit have caused electrical problems. The sliding, jettisonable windows on each side of the cockpit were cited for inadvertent release. These windows have popped out with their frame.

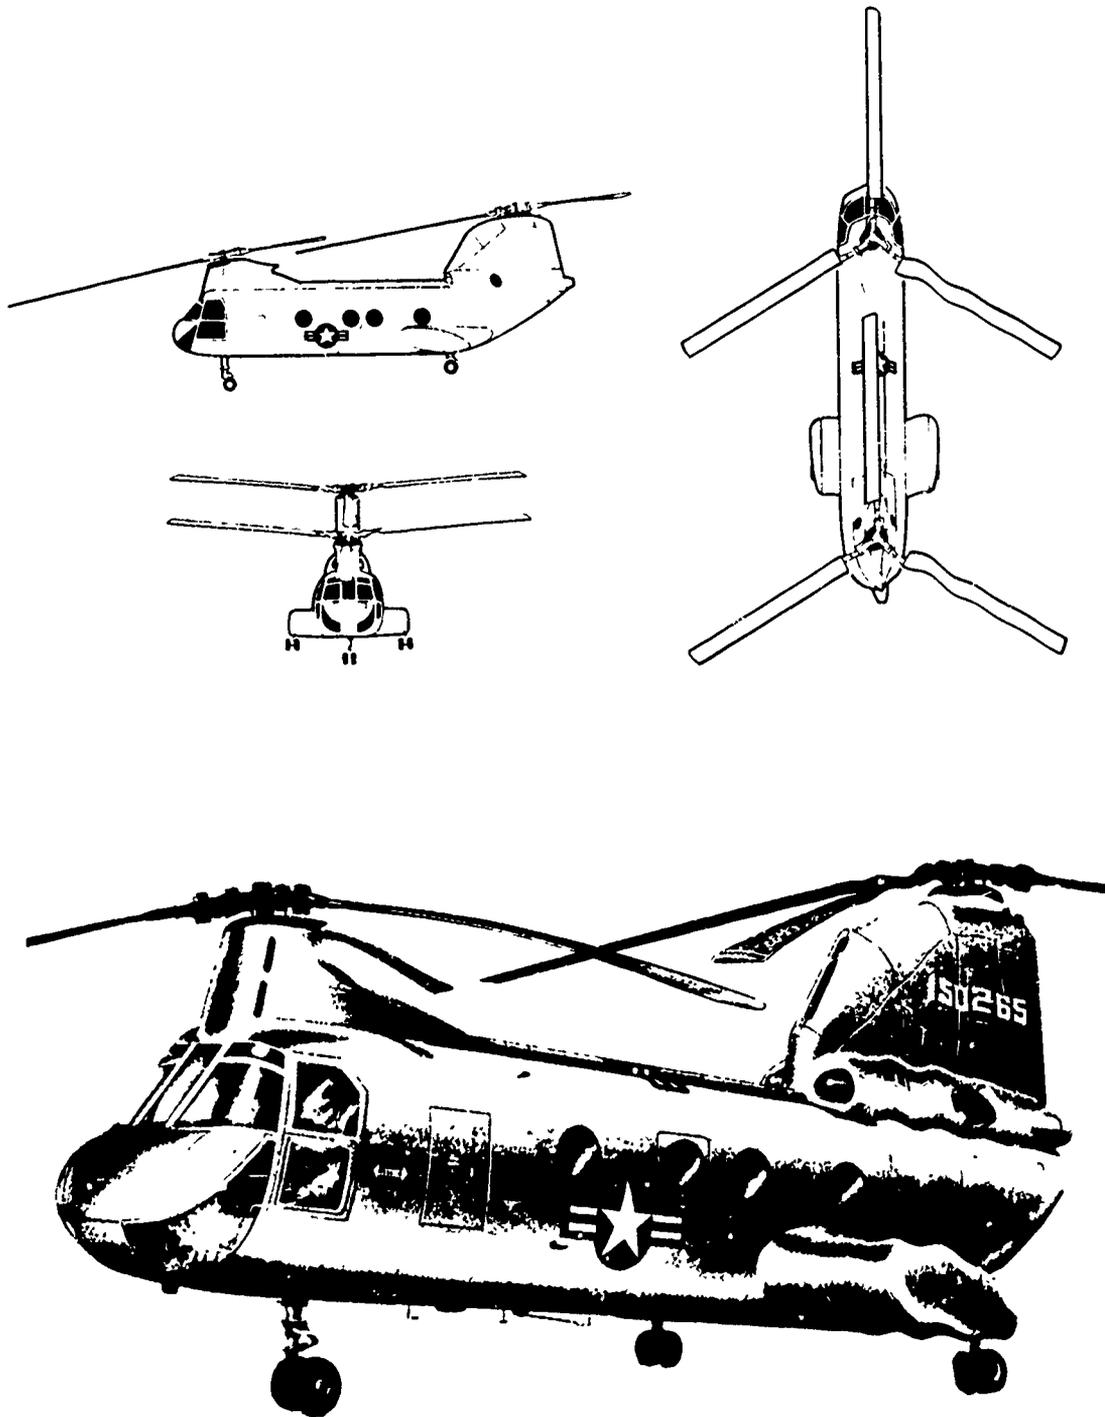
FIGURE E-1. H-46 HELICOPTER - GENERAL VIEW

To clarify the terminology used, it is necessary to distinguish between the two large panels on each side of the forward pylon which are hinged at the bottom. Technically speaking, only the aft panel (Reference: Figure E-2, Annotation 7) is a clamshell and is referred to in the manuals as the Forward Pylon Clamshell. The forward panel (Reference: Figure E-2, Annotation 8) is referred to in the manuals as the Forward Pylon Access Panel. However, in common usage among the squadrons, both panels are referred to as Clamshells. This discrepancy made classifying the NAVSAFECEN reports difficult. However, since the largest percentage of reports which specify a part number refer to the forward panel, it is believed that most of the unspecified

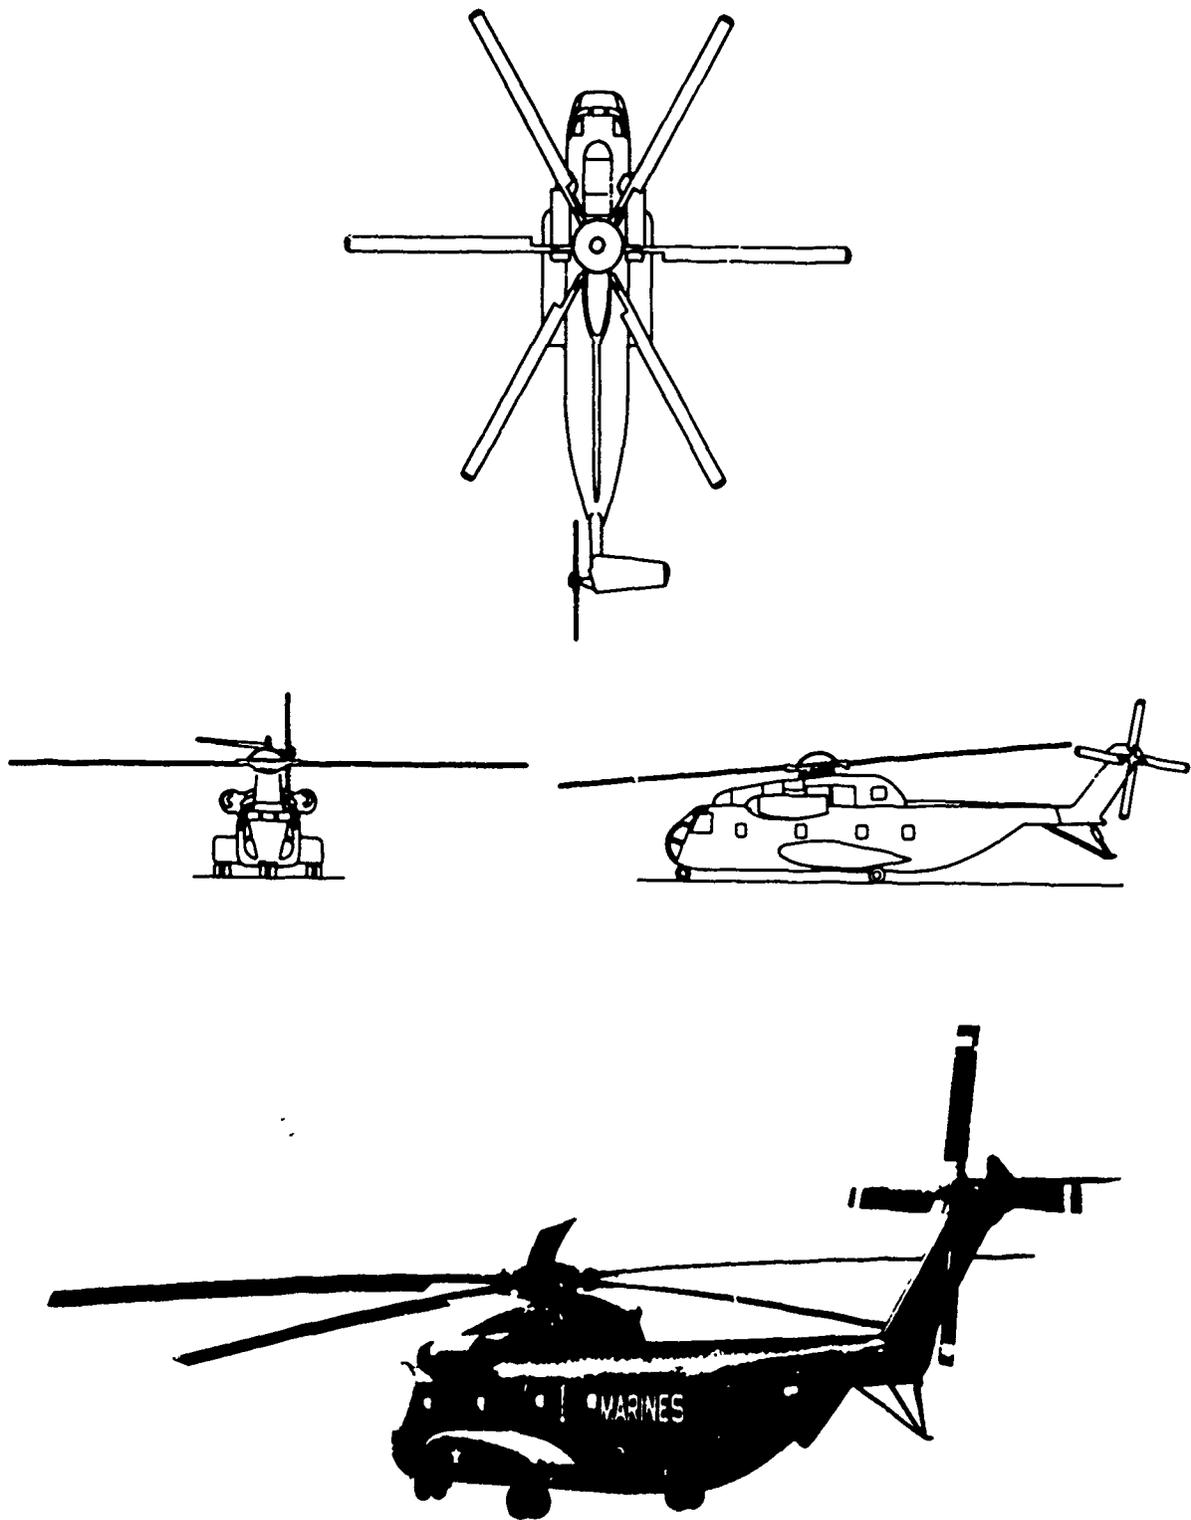
FIGURE F-1. CH-53A HELICOPTER - GENERAL VIEW

The Rotor Brake Access Panel which is just aft of the Work Platform (Reference: Figure F-2, Annotation 2) stands out in all three data sources as being the major problem on the H-53. The NAVSAFECEN data shows the Rotor Brake Access Panel to be the constant contributor to in-flight incident reports (22.4% for all H-53's, 37.2% for H-53D). The 3-M data indicates it is the panel most frequently in need of maintenance action. This panel was also emphasized by squadron
