ANALYSIS OF LIQUID ROCKET TANKAGE

Bell Aerospace Company

Air Force Rocket Propulsion Laboratory

REPORT DOCUMENTATION PAGE		READ INSTRUCTIONS BEFORE COMPLETING FORM
1. REPORT NUMBER AFRPL-TR-74-82	2. GOVT ACCESSION NO.	3. RECIPIENT'S CATALOG NUMBER AD-A008 535

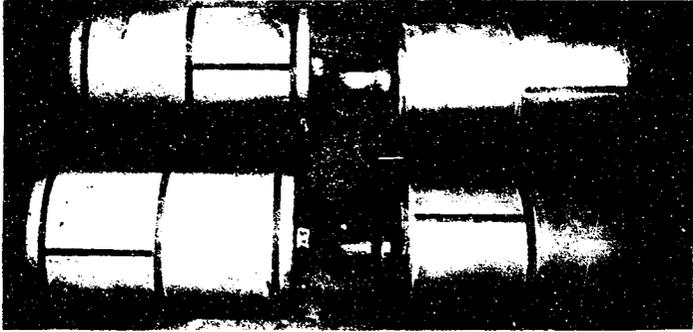
Figure 10. (a)

The unaged cylinders loaded with N_2O_4 are shown in Figure 10. Two of them, S/N's 4 and 7, had a small amount of minor pitting on exterior welds at one end, but this was not considered significant. The other two were completely clean with no corrosion. The interiors of these cylinders were very clean and untarnished with only the faintest indication of a "waterline" to show the level of propellant stored in them.

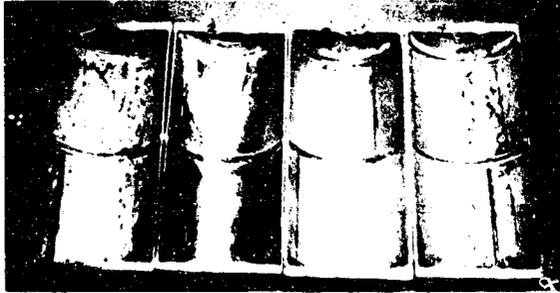
Figure 11. (a) (b) (c) (d)

The aged cylinders loaded with ClF_5 are shown in Figure 11. As with the last group, some very minor pitting was visible on welds and end fittings of S/N's 16 and 17, while the other two were clean and unattacked. The interiors of these aged cylinders were significantly different from the unaged cylinders previously discussed. The surfaces were dulled and uniformly stained to a light medium brown. There was no evidence of any corrosive attack. These cylinders had either been filled completely, or the partial filling with ClF_5 did not cause any change in the internal stain, as it did with the N_2O_4 . This internal dulling and staining was therefore associated with the aging rather than with the propellant exposure.

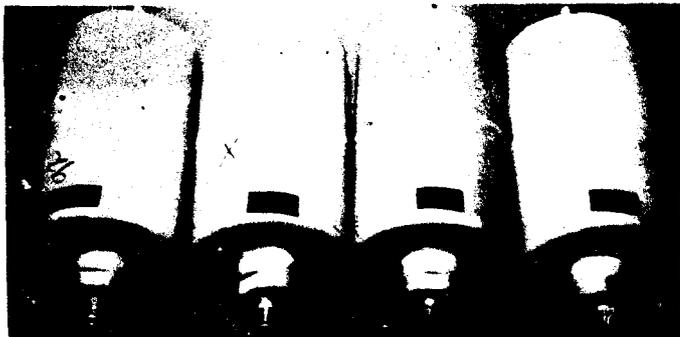
Figure 17

The four 5456 alloy tanks loaded with ClF_5 are shown in Figure 17. The external surfaces were generally clean with only a slight amount of pitting. There was some checking or very shallow cracking associated with the welds on two of the tanks, S/N's 92 and 96, but these were neither caused by nor aggravated by any corrosion and were therefore not considered significant to this program. The internal surfaces were clean and generally bright with no evidence of any corrosion effects, much the same as the 6061 alloy. No further analysis was necessary on this group of tanks.

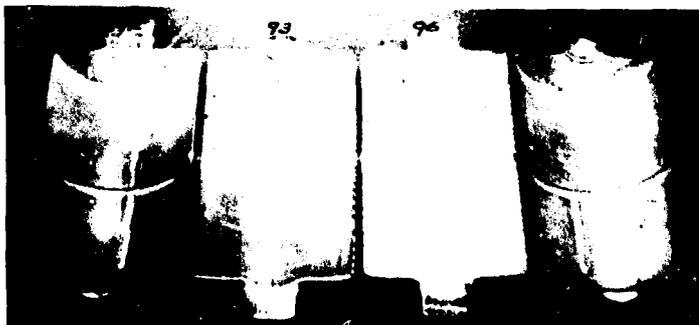
Figure 18

The seven 2014 alloy tanks, loaded with ClF_5 , are shown in Figure 18. The external surfaces of these tanks showed a general etching with pitting of the weld heat affected zones, particularly along the edge of weld lines. This etching and pitting was not deep but does indicate the poorer corrosion resistance of 2014 as compared to 6061, 5456, 7007 and 2219. Tank S/N 81 had a small hole extending inward a short distance at the edge of one weld. This appeared to be a weld induced anomaly, and no local corrosion occurred in or near the hole, so it was not considered further for this program. The internal surfaces of these tanks were dull and discolored, with severe pitting in S/N 19, lesser pitting in S/N 24 and some shallow pits or the start of pits in most

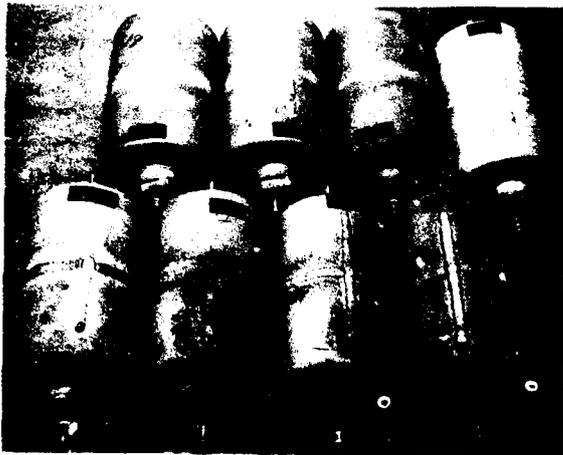
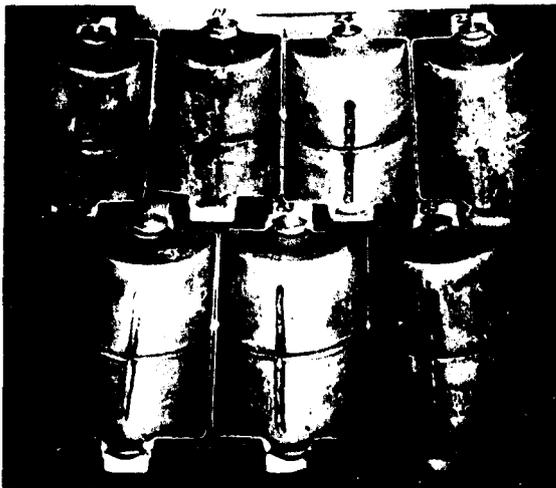
Figure 13. Surface Appearance of aluminum cans which were previously an
loaded with 21K. The cans are in the left hand

Four containers, loaded with N_2O_4 (Specification MIL-P-26539) for over four years, were examined and are tabulated in Table VII. Their exterior and interior surface appearance is shown in Figure 13.

be carried out with care if corrosion is to be prevented. It is therefore believed that the pitting observed is directly attributable to the lack of flushing. The localized appearance of discoloration along a strip which would represent a residual liquid location can be seen in the S/N 4 cylinder in Figure 13 and supports this conclusion.

Pitted
interior of
-1's and to
a lesser
extent -04
were subjected
to detailed
and
confirmatory
analysis

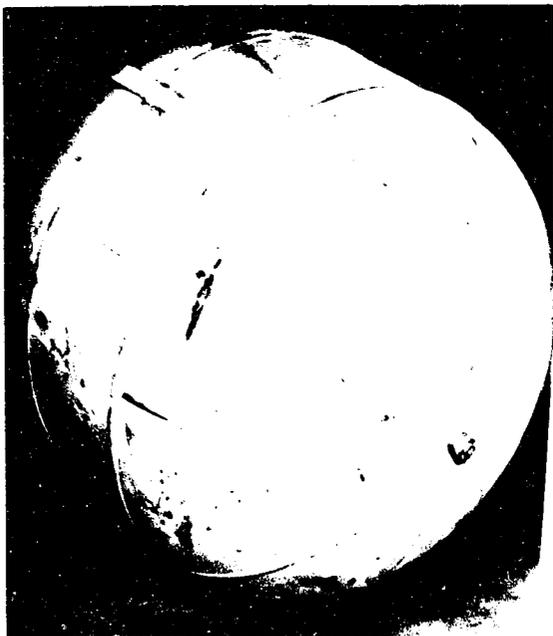
The external surface appearance of the tanks could be divided into two categories. The tanks loaded with N_2O_4 , Systems 7, 9, and 14, shown in Figures 29, 31 and 32, had an etched and lightly frosted external surface. The other tanks, all loaded with MHF-5 were unattacked on their exteriors. This observation correlates well with the observations on individual tanks evaluated in this program, all containing oxidizer, that the oxidizer storage room environment was at times quite corrosive to aluminum components when leaking N_2O_4 or ClF_5 .

External View

Internal view is essentially identical
to S/N N-11 shown in Figure 43

Figure 44. External Appearance of Aluminum 6061-T6
Tank (General Dynamics-Convair)
Loaded with N_2O_4 for Five and One Half
Years

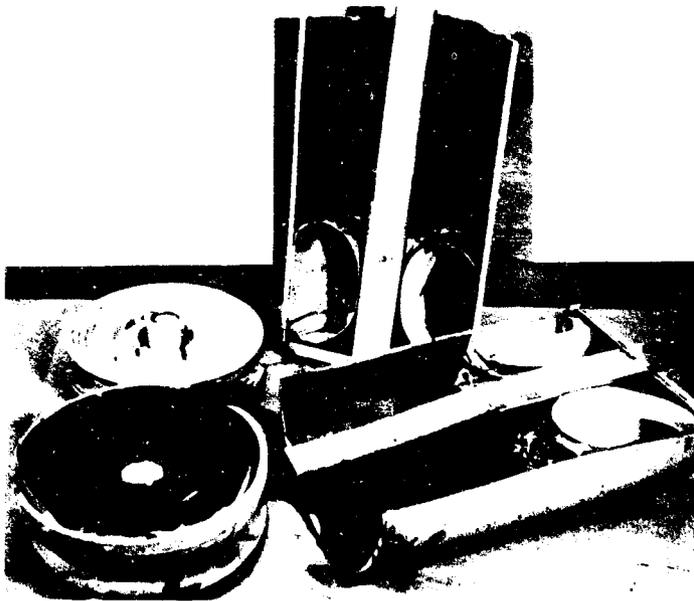
NOTE: This motor was a model sent to manufacturer, General Dynamics, and was fitted with the propellant of AFM-150. The motor was fired for four and one half seconds before explosion. Exterior surface is covered in black soot.

Figure 29. View after Preliminary Test of Prepackaged System S/N 009 Showing Exterior Surface, Internal Surface and Expulser Condition.

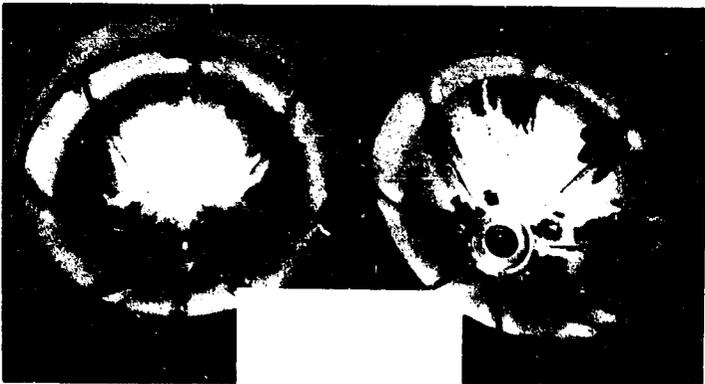
Interior view showing hatch, unattached tooling, exterior of this tank is essential to that of M11 shown in Figure 10.

Figure 11. Captain Joseph G. of Aluminex M11 Tank No. (General Dynamics-Jonvalir, S/N N-11) loaded with Na_2O_2 for Five and Three Quarter Year.

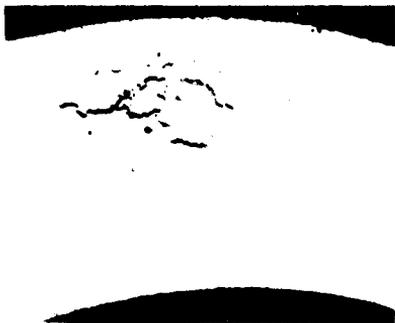
The corrosion leading to perforation of the subject tank shell wall was externally initiated. Location of the corroded and perforated area is shown in Figure 44 of Section VI. Close-up views of the corrosion and perforation are shown in Figure 82. The actual perforations can be seen in Figures 82 and 83. A view of the internal surface, showing severe abrasion of the weld root and the perforations at the edge of the weld, is presented in Figure 83. The natural step formed by the transition from a heavier flange assembly wall thickness, is accentuated by this clean-up, as shown in the Figure 83 cross section. Note the start of a pit on the external surface of the weld bead.

- a. Fractured end of tube showing corrosion product at arrow.
Mechanical fracture caused separation after corrosion.

- b. Fracture in pipe section aligned to the direction of the
fracture in the pipe section.

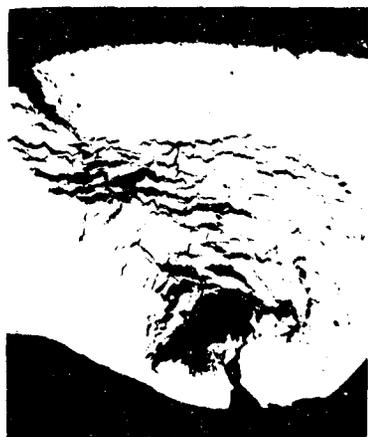
Figure 50. Cross Section of Tube Weld Adjacent to Perforated Area Shown in Figure 49. Probable Initial Vapor Leakage Path is Discernible Between External and Internal Openings

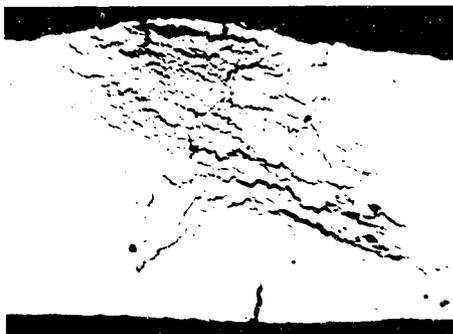
Weld Filler
Alloy:
4043 Al
Tube Alloy:
2024 Al

Figure 51. Tube Weld Leak in Bottom Outlet Tube From Martin 10-gallon Tank No. 4 (S/N 203) used to Store HF₂ Propellant. Note Small Crack on Internal Surface and Similarity to Figure 48 and Figure 50

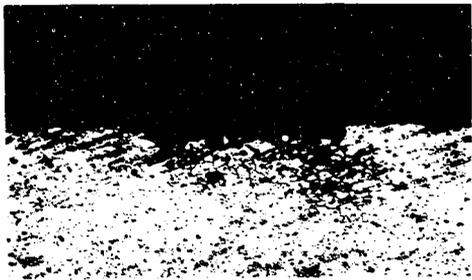
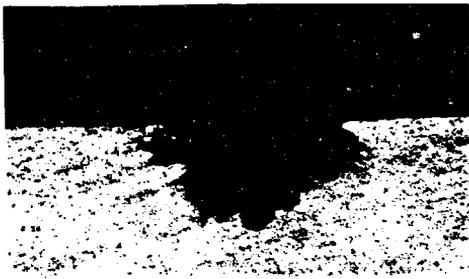
Early stage
of pit
formation
in parent
metal

Well
defined
pit in
parent
metal

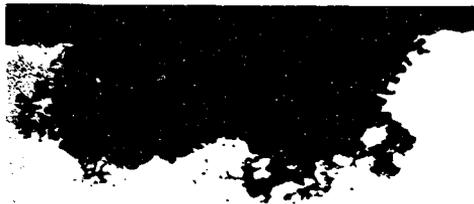
Figure 60. Cross Section of Deepest Pit Observed on Internal Surface of 2014-T6 Aluminum Alloy Container S/N 19, in Contact with ClF_3 Propellant for 42 Months

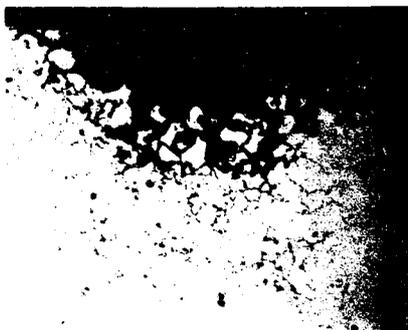
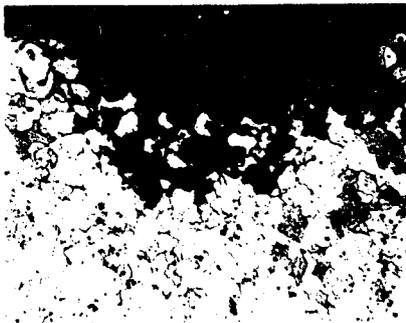
Intergranular
pitting
attack -
Unetched

Same as
above -
Etched
with
Keller's
Reagent

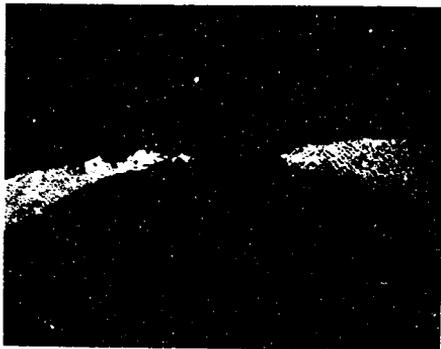
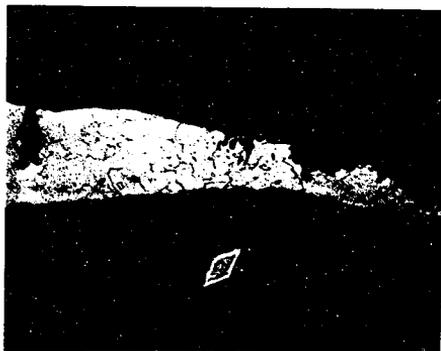
Figure 24. Cross Section of a Perforation Shown in Figure 23. Note Location of Perforation Immediately at Edge of Weld, in HAZ of the A-101 Alloy. HAZ Propagation is Transgranular.

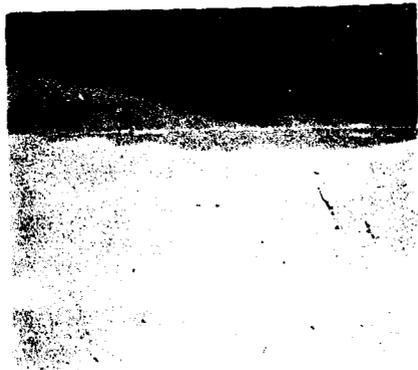
NOTE: Uniform continuous nature of surface, reproducing tank shell surface and showing lathe turning pattern of shell

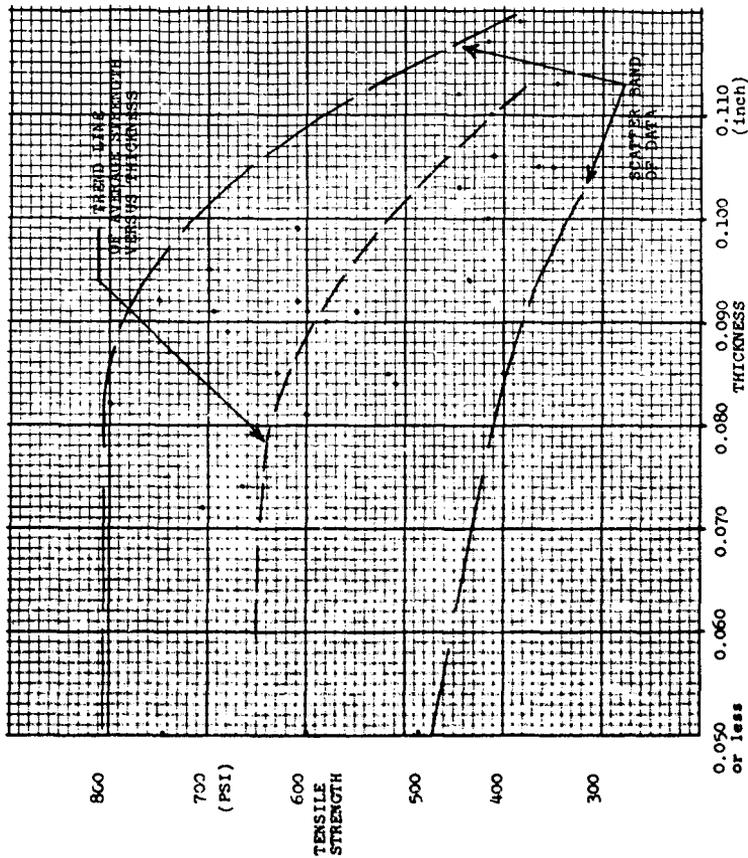
Figure 89.

Strength Versus Thickness Characteristics of Poly 634 Silicone Rubber Liner Material from Prepackaged Feed Systems.

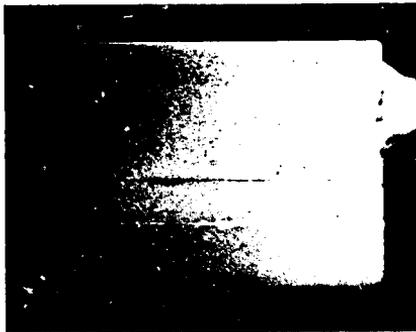
Figure 1. Micrographs showing multiple discontinuities in the metal bodies used in the "C" and "D" systems. The metal bodies were obtained from other sources.

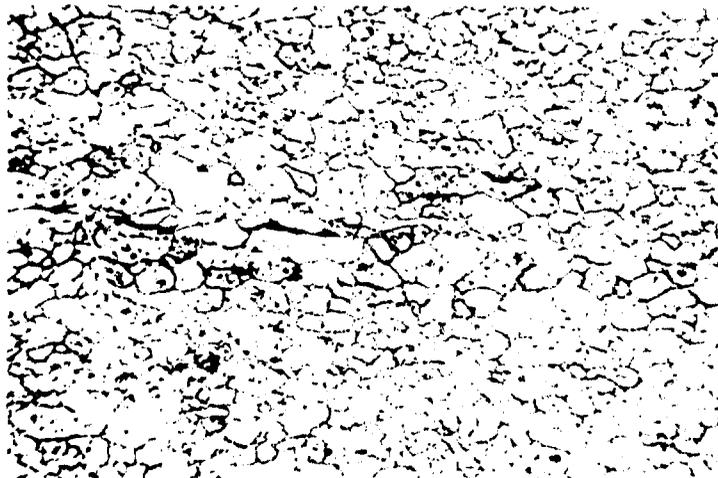
- c. Etched view showing extension grain boundary network of CuAl_2

MATERIAL:
2024 AlAl Alclad

Figure 24. Solid State Bond Joint Shape and Microstructure
