AFRPL-TR-77-25

ANALYSIS OF PROPELLANT STORAGE TANKS AFTER FOUR YEARS
HYDRAZINE STORAGE

FINAL REPORT - MAY 1976 - APRIL 1977

BELL AEROSPACE TEXTRON
DIVISION OF TEXTRON, INC.
P. O. BOX ONE
BUFFALO, NEW YORK 14240

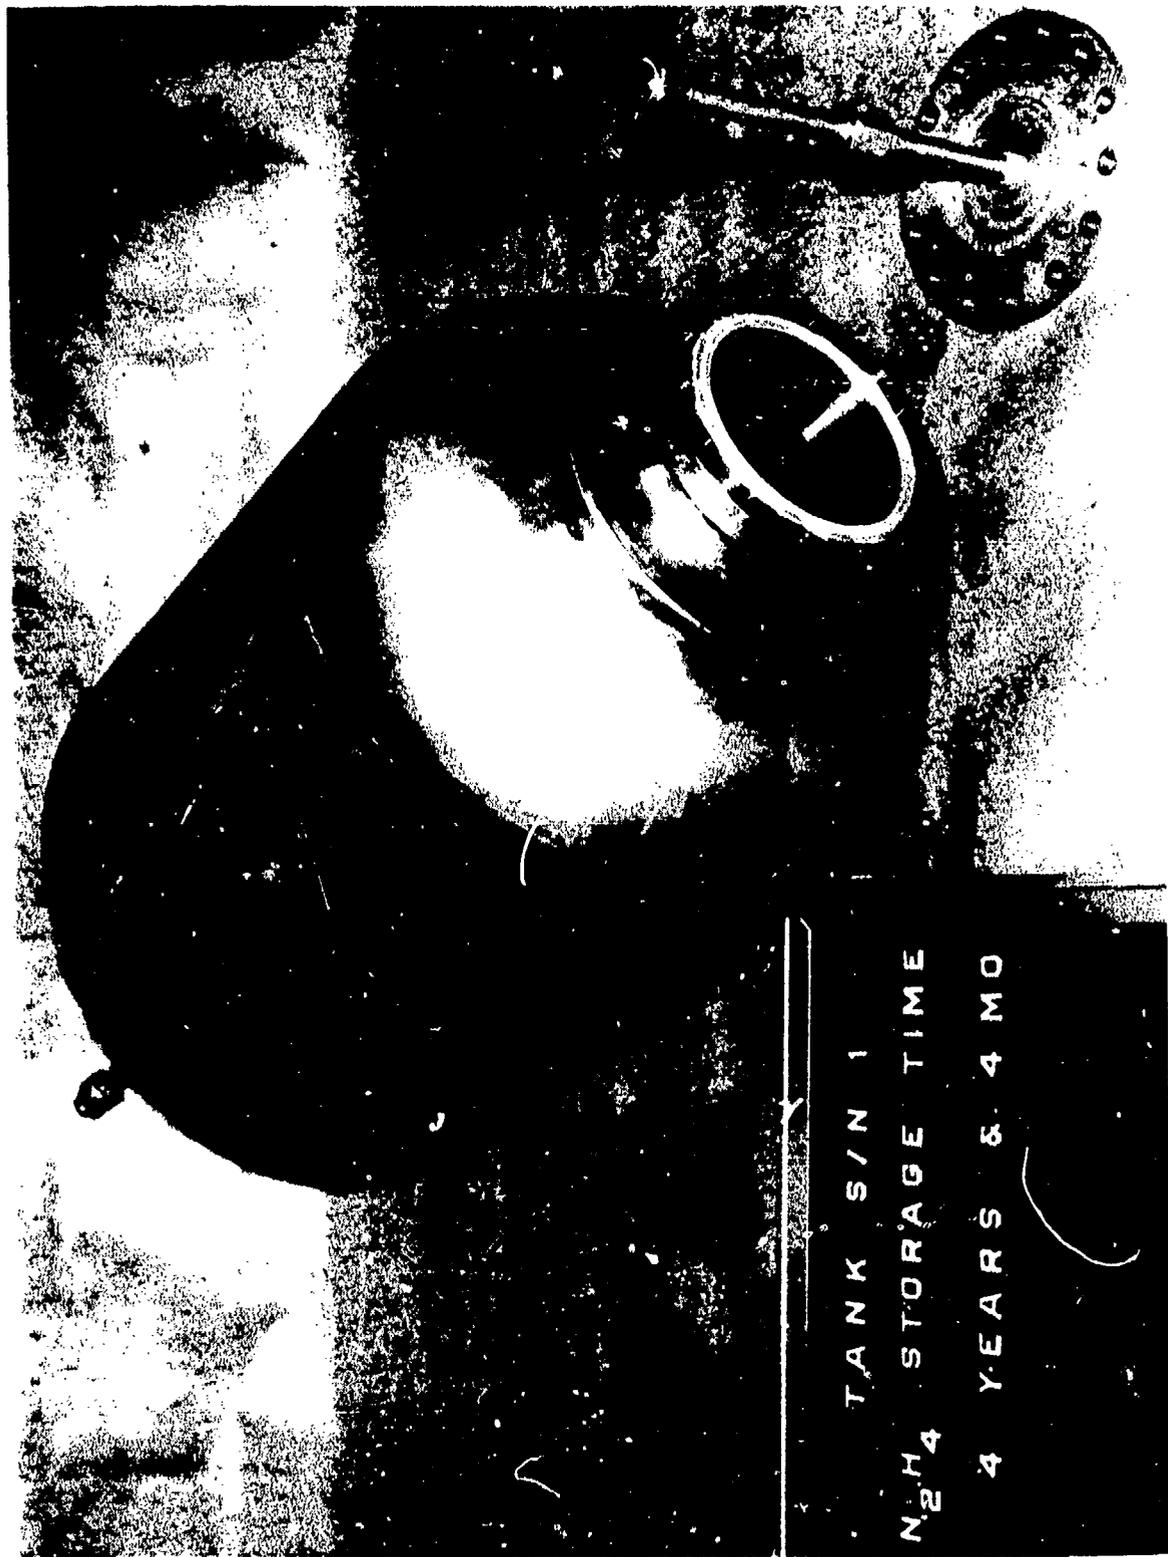
FIGURE 1. TANK SIN 1 IN NIP AS-RECEIVED CONDITION WITH EXP. GURE TESTING

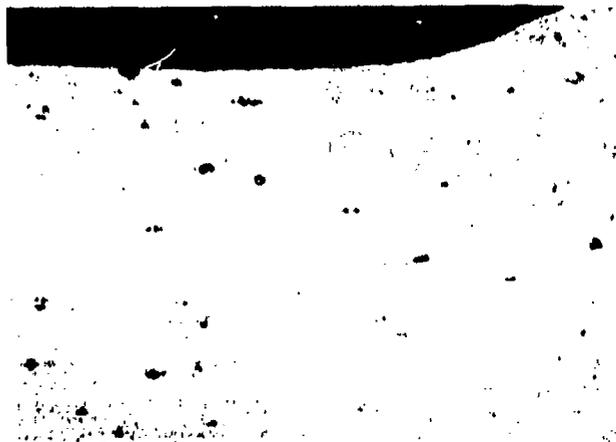
The flange and outlet components in each tank were machined from thick forgings and contained a very coarse structure, indicative of the deformation that such processing conditions achieve. This coarse structure is shown in Figures 27, 29 and 31. Even where the welds met this coarse, nonoptimum structure, no defects or unusual conditions were noted.

All welds were closely examined for evidence of corrosion on either the internal, hydrazine-wetted surface or the external atmosphere exposed surface. No evidence of corrosive attack was found. Views are shown in Figures 25, 27, 29 and 31 from the edge of weld location for welds from each of the four tanks sectioned. This location is considered to be most susceptible to corrosive attack, because of the sharp gradient in structure and thermal exposure in this region. It was evident that there was no unusual attack of any of the tank welds or adjacent heat affected zones in these tanks.

- a) Outlet Fitting to Dome Weld showing coarse structure of Fitting but no corrosion or even alteration of as machined inside surface.

- b) Girth Weld on Cylinder Side

FIGURE 27. HIGH MAGNIFICATION VIEWS OF TWO TANK S/N 3 WELDS SHOWING ABSENCE OF ANY SURFACE ATTACK.

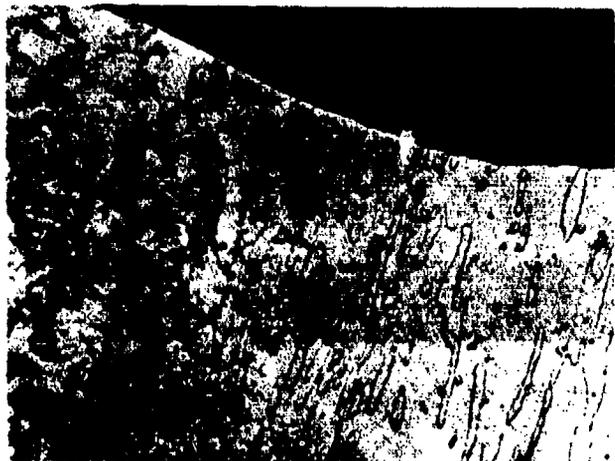
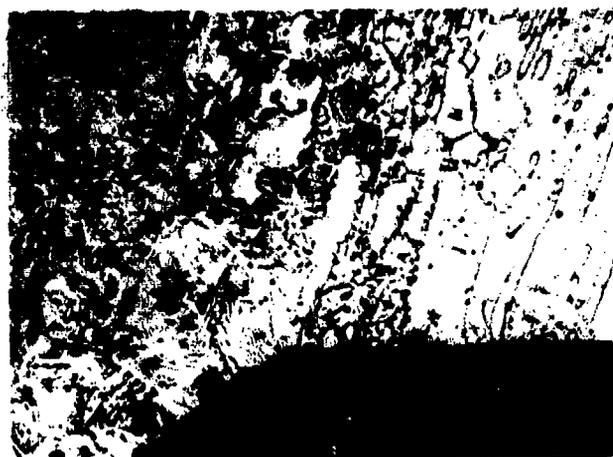
FIGURE 29. HIGH MAGNIFICATION VIEWS OF TWO TANK S/N 4
WELDS SHOWING ABSENCE OF ANY SURFACE ATTACK.

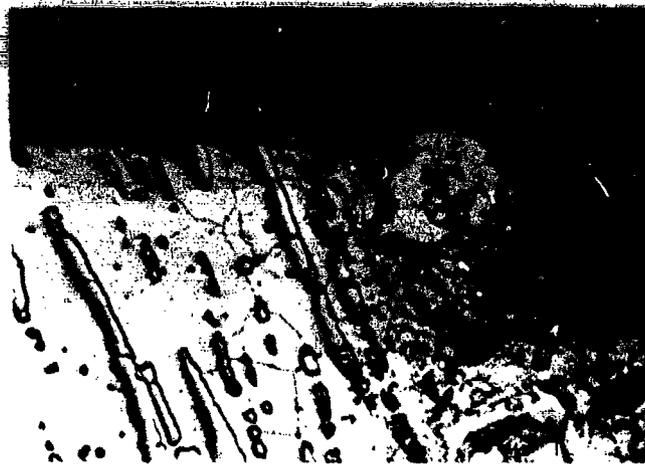
FIGURE 31. HIGH MAGNIFICATION VIEWS OF TWO TANK S/N 5
WELDS SHOWING ABSENCE OF ANY SURFACE ATTACK.

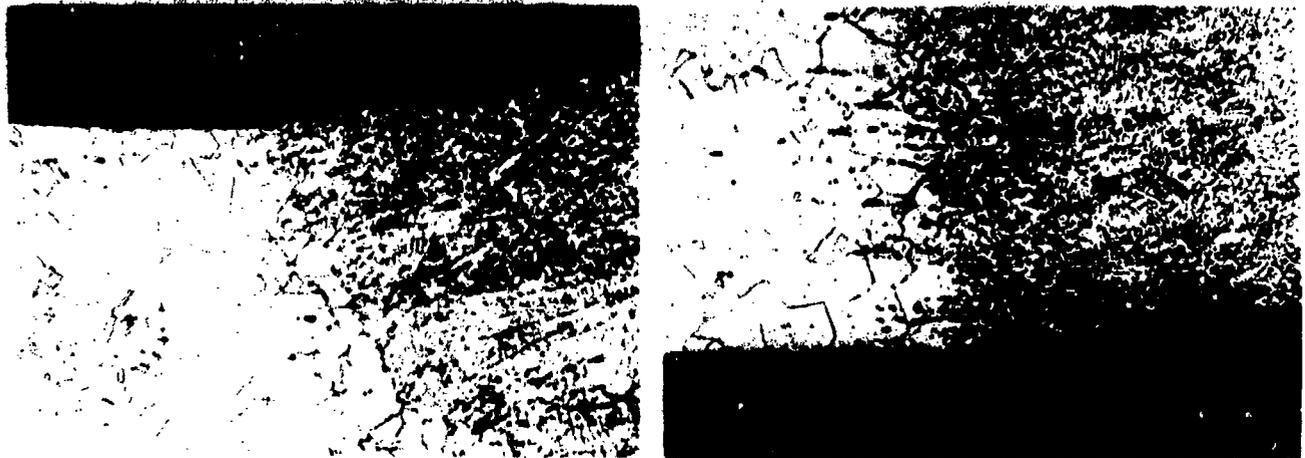
a) Normal and desirable configuration of tube weld produced by Astro-Arc process

b) Higher magnification view of connector to extension tube weld showing lack of corrosion effects

FIGURE 35. CROSS SECTION CONFIGURATION AND MICROSTRUCTURE OF TUBING WELDS AT FLANGE END OF TANK S/N 5.

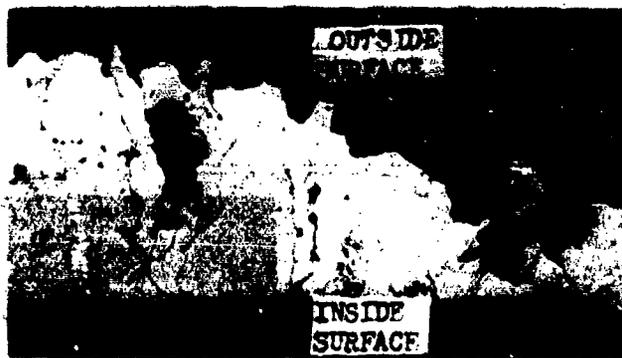
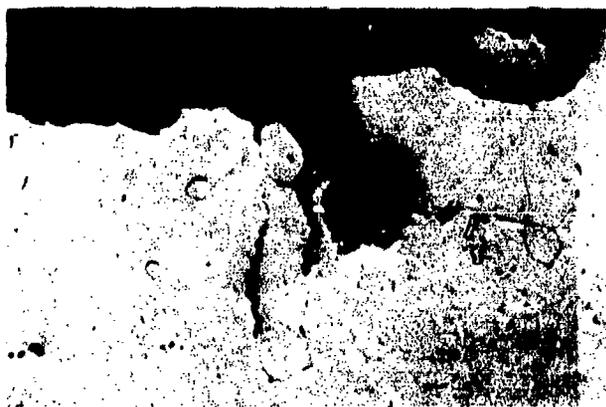
- b) Area where matrix of transformed martensite has been preferentially attacked leaving ferrite stringers unattacked.

- c) Detail view of area where attack is proceeding along ferrite to martensite phase boundary.

FIGURE 37. VIEWS OF LEAK AREA IN OUTLET OF TANK S/N 5 SHOWING RELATION OF ATTACK TO FERRITE AND TRANSFORMED MATRIX COMPONENTS OF MICROSTRUCTURE.

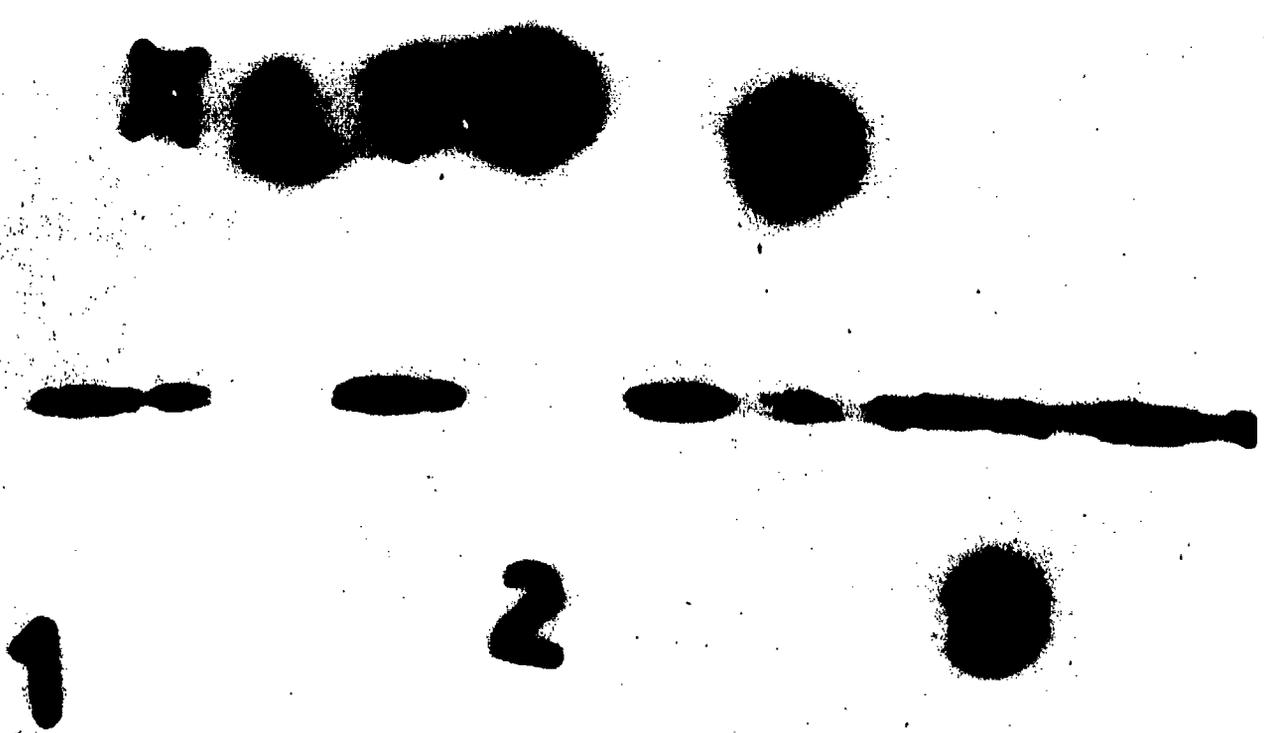
FIGURE 45. REPRODUCTION OF RADIOGRAPH FROM SUSPECT REGION OF GIRTH WELD OF TANK S/N 3.

A positive of a radiograph taken in these areas is shown in Figure 45. Actually this radiograph was made in the early stages of the investigation of this weld. The radiograph only substantiates the irregular geometry of the weld and when first examined gave the impression that drop-through and some weld bead undercutting could have been present. All further studies emphasized an irregular pattern, no undercutting and sound fusion. Microstructurally no area was found which would indicate the presence of a preexistent leak path.

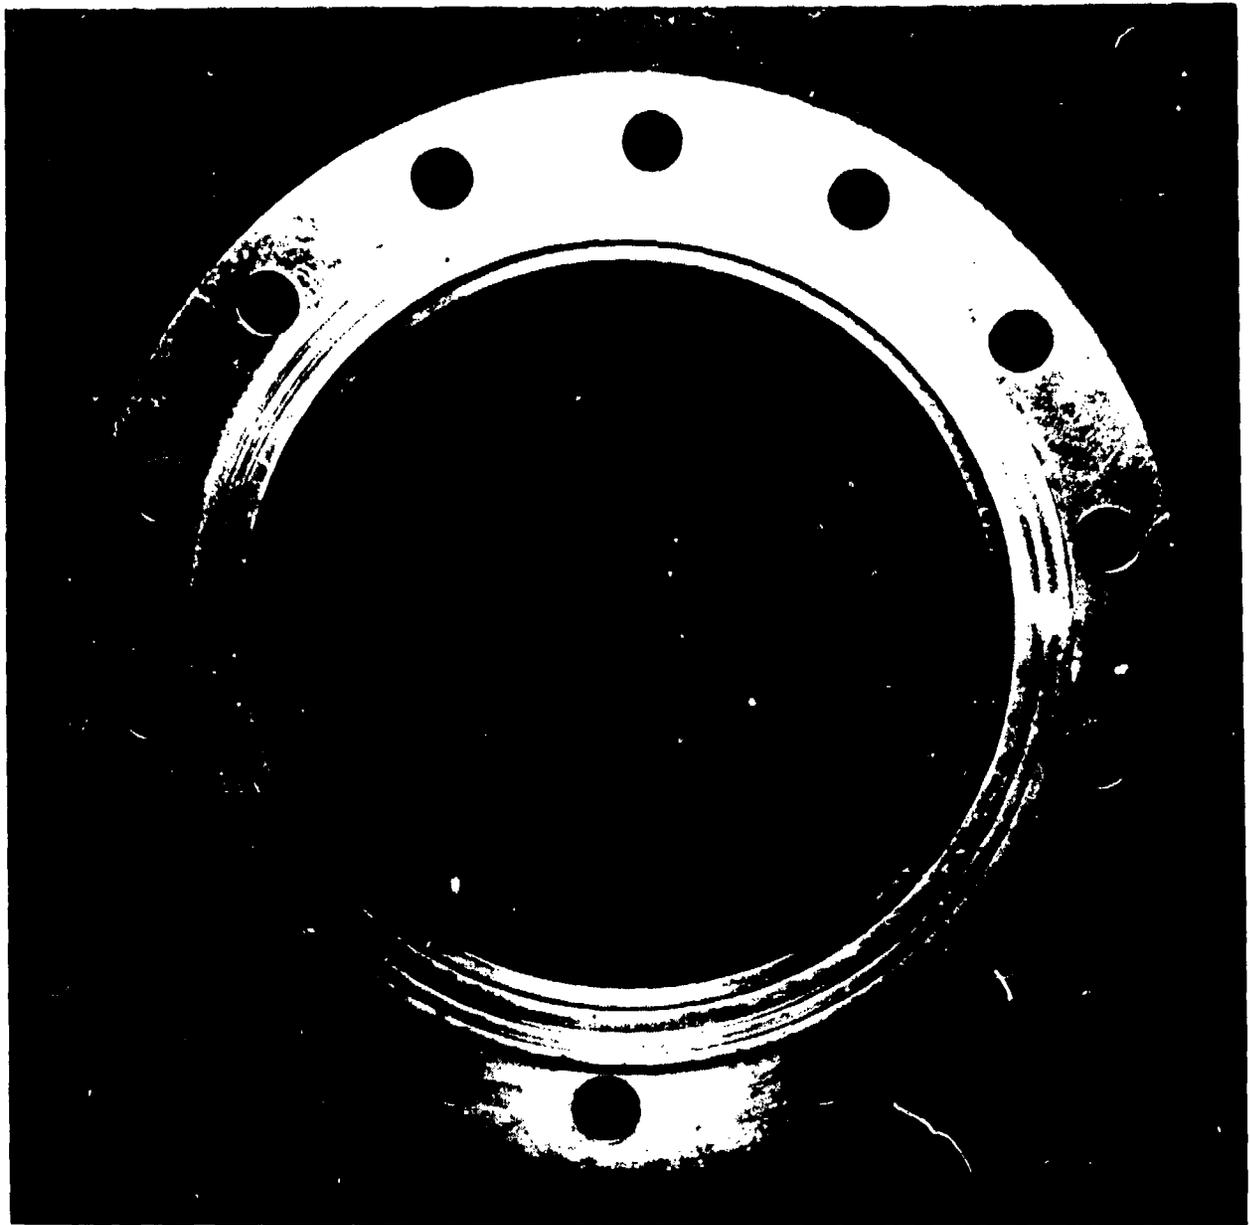
An overall view of the flange of tank S/N 3 with the aluminum sealing ring in place is shown in Figure 46. The corresponding view of the flange cover sealing side is shown in Figure 47. These views were taken after the 30 day water immersed leak test. Slight staining of the stainless steel and of the aluminum surfaces exposed to the water had occurred, but these are not readily apparent. Close inspection of the groove and sealing ridges in the flange cover showed the groove to be reasonably smooth with only a very slight ripple to the surface at some locations. The ridges were quite smooth and appeared to have an excellent machined surface that should have provided very good sealing with the soft aluminum ring, assuming sufficient clamping force was used. This is shown in Figure 48.

TOP VIEW OF FLANGE OF MOTOR
WITH PINS IN PLACE.
