6 CHARACTERIZATION OF ELECTRICALLY ACTIVE DEFECTS IN Si USING CCD IMAGE SENSORS.

Texas Instruments Incorporated

11 Feb 1978

9 Final Technical Report,
30 Jul 1976 - 31 Jan 1978

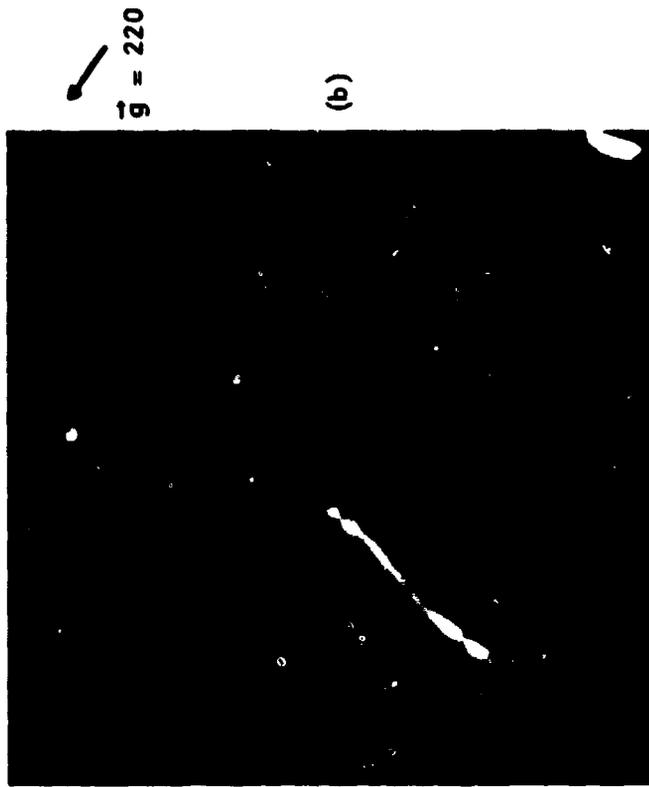
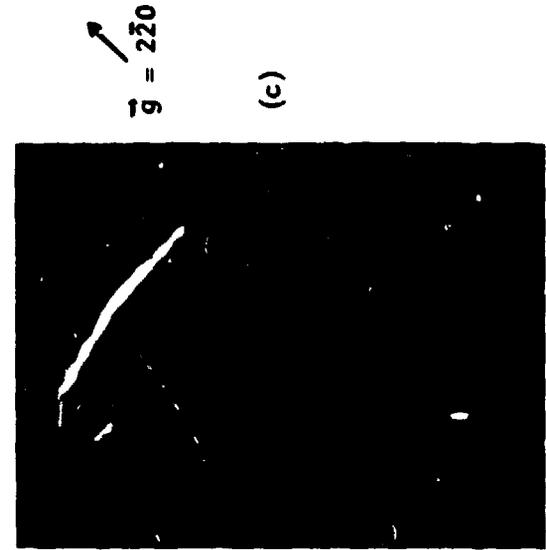
Weak beam experiments were conducted on some of the dislocations in the TEM. Typical results are shown in Figure 11. These defects were found in the channel stops. The ends of the dislocations were frequently found to be dissociated on a (111) plane containing both the Burgers vector and dislocation line. The traces of these planes on the surface of the sample are perpendicular to the projection of the dislocation line.

Figure 11 Dislocations in Channel Stops.
 (a) Bright field, (b) and (c) weak beam. Portions of the long dislocation line are dissociated.

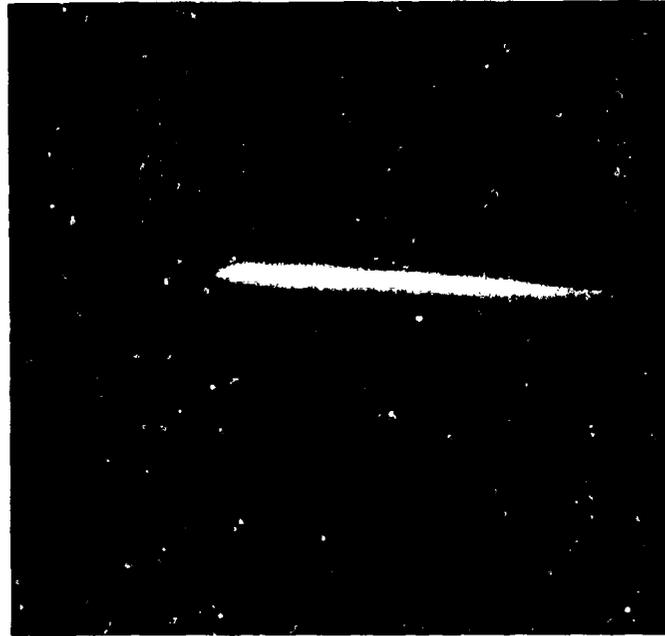
A weak beam micrograph of a typical dislocation in the channel is shown in Figure 12. Only the end of the dislocation was generally found to be dissociated.

Figure 12 Weak Micrograph of Edge Dislocation in Channel. Only the end is dissociated.

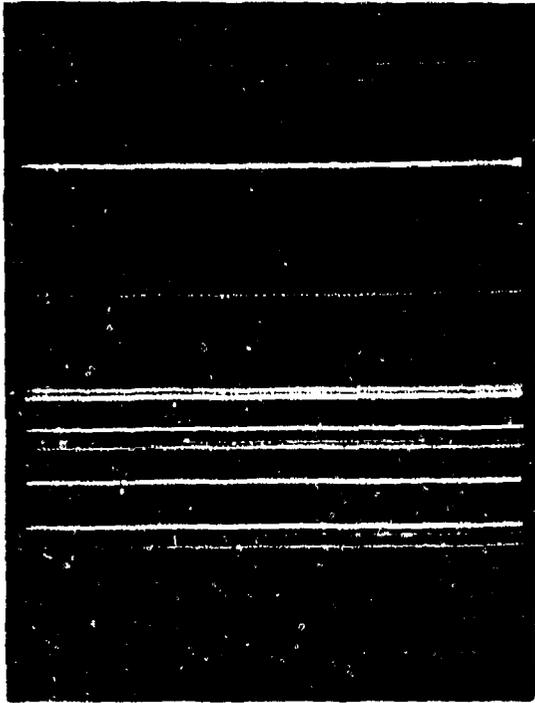
Dark current patterns from imagers on float-zoned material fell into two distinct categories. Devices in the central region of one slice and about the periphery of all slices showed dense patches of dark current lines running in $\langle 110 \rangle$ directions on the slice [Figure 13(a)]. Devices outside of these regions showed a moderately low density of randomly distributed isolated dark current spikes [Figure 13(b)].

Figure 13 Dark Current Patterns - Float-Zoned Group

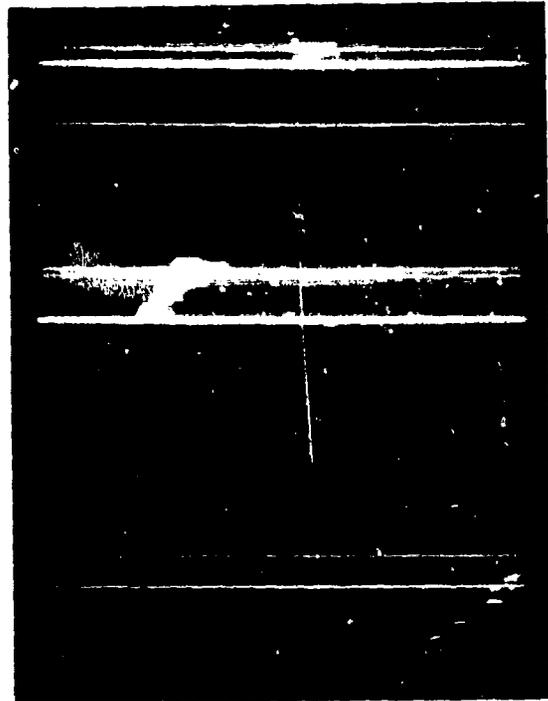
Device 3

Figure 24 Dark Current Patterns of Three Adjacent Devices, Czochralski Group 2. Defect at arrow in device 3 is shown in topograph, Figure 25.

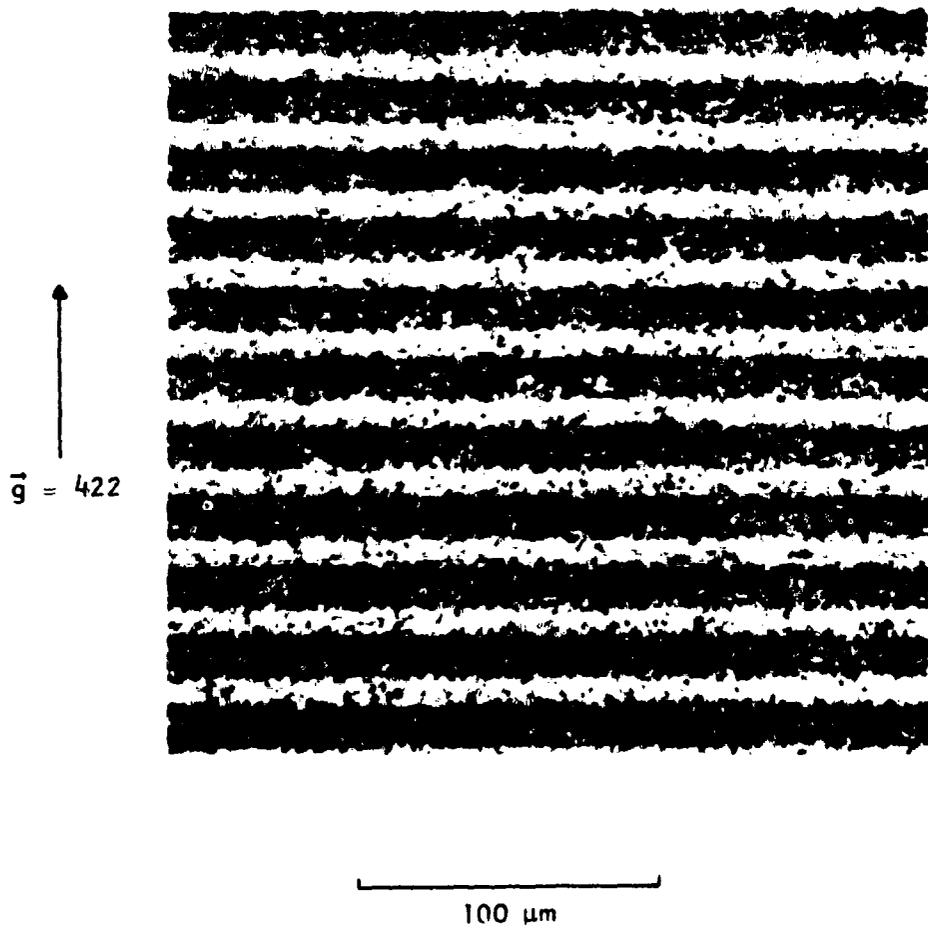
Figure 31 Topograph of Weak Dark Current Source

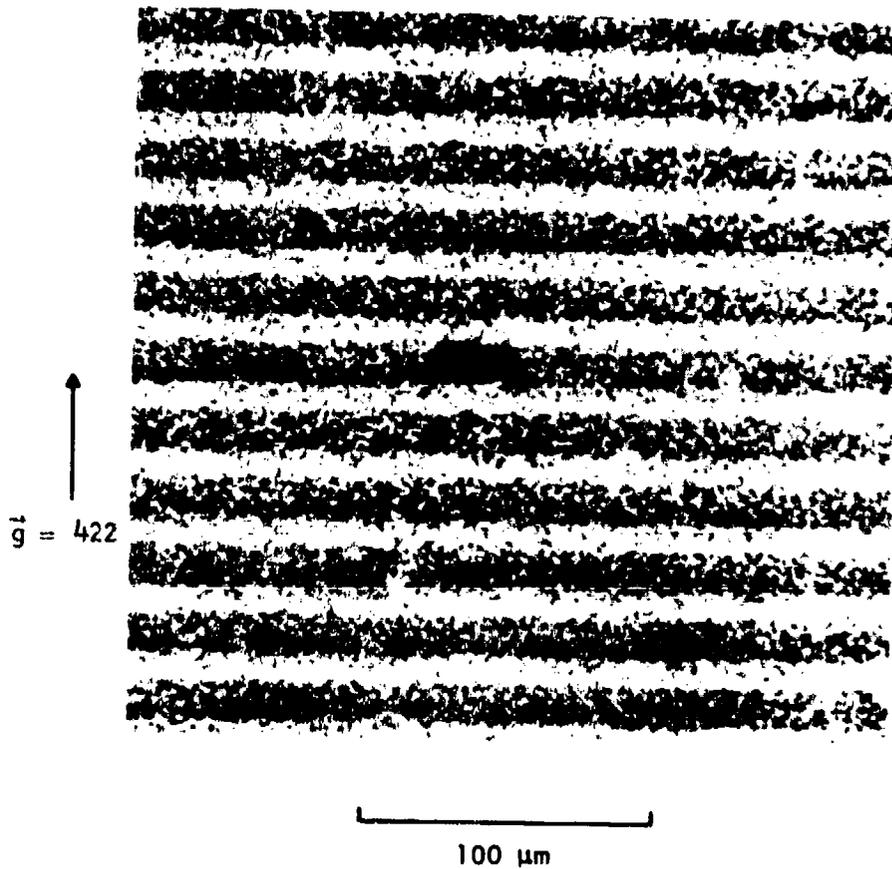
Figure 33 Electrically Inactive Dislocation in CCD Imager

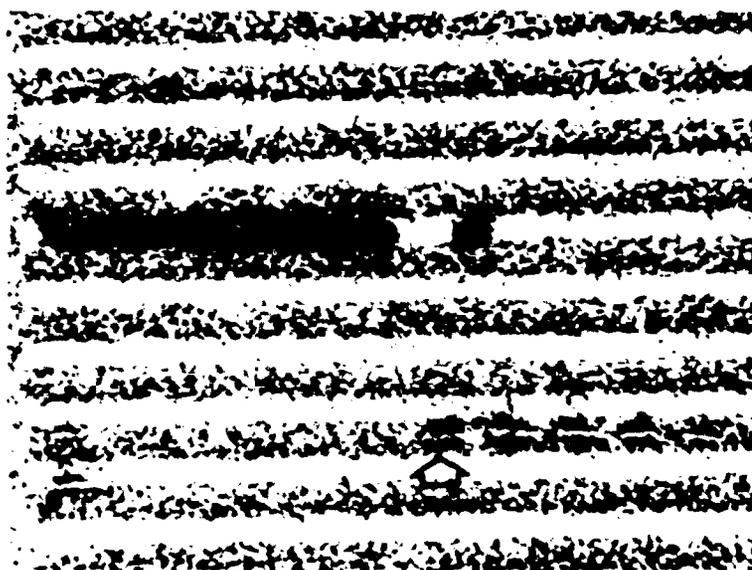
Figure 34 Enlargement of Figure 30(a). Scratch (arrow) is on regions of a channel that were overlaid with polysilicon. Part of the dislocation has been pulled out of the channel stop by the overlying polysilicon.

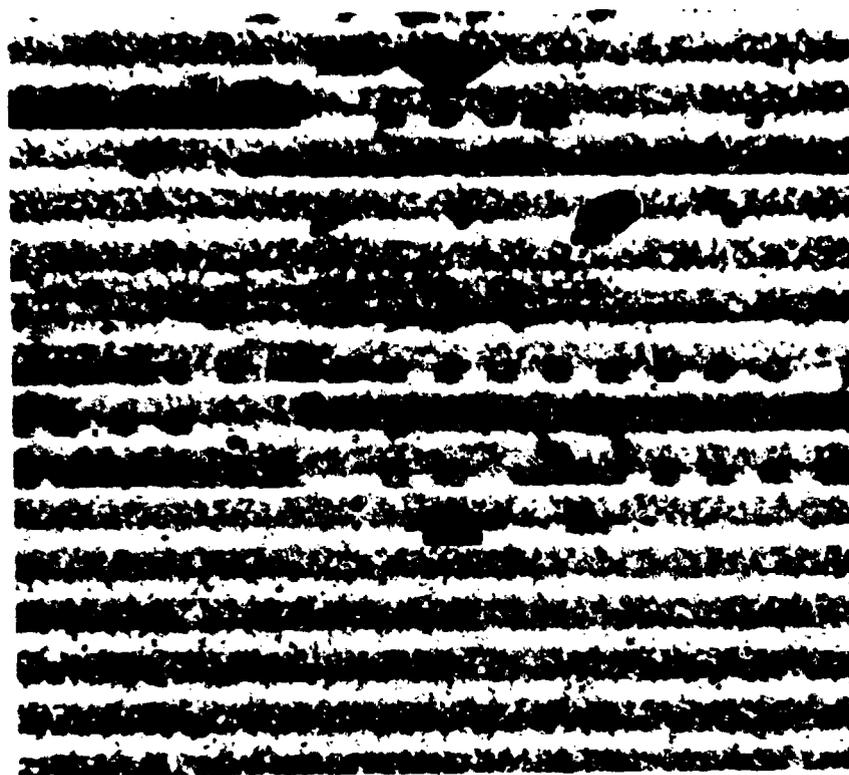
Figure 35 Dislocation Segments in CCD Imager. The segments are approximately $12 \mu\text{m}$ long with a periodicity of $25 \mu\text{m}$. Segments on different channels/channel stops fall on a line perpendicular to the channels/channel stops (arrows). Thus the segments are formed by action of the polysilicon strain field on a continuous dislocation line.

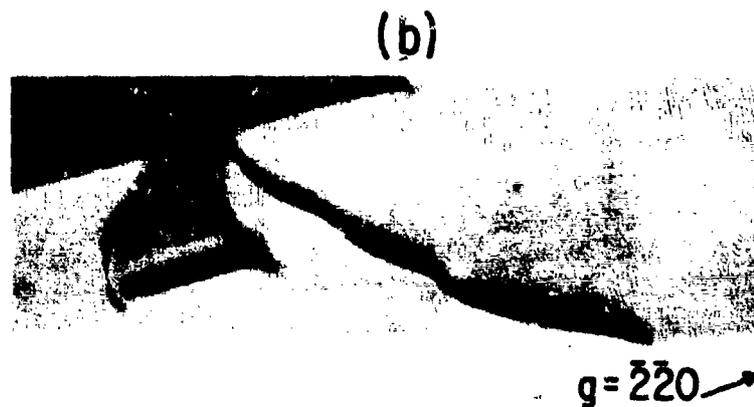
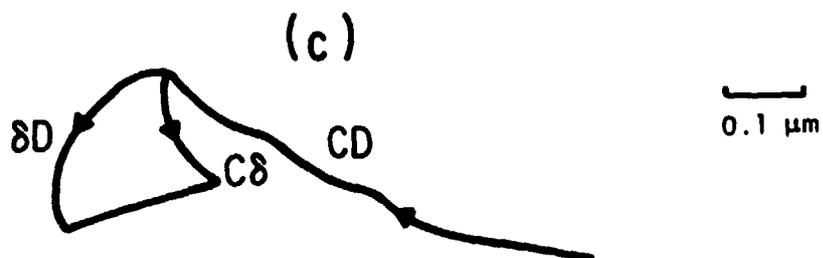
In samples that had been subjected to a rapid pull, a small fraction ($\leq 1\%$) of the stacking faults were found to be in the process of unfauling. An example of a nearly completely annihilated stacking fault is shown in Figure 56. The assignment in Figure 56(c) is made on the following basis: There are three possible reactions by which a perfect dislocation will produce two partial dislocations separated by a stacking fault:

Imaged in the TEM under two-beam conditions with $\vec{g} = 220$, the partial dislocations in reaction (1) would be visible along with the stacking fault; for reactions (2) and (3), the partial dislocations would be visible, but the stacking fault would be out of contrast. When $\vec{g} = 2\bar{2}0$, the Shockley partial and stacking fault of reaction (1) would be invisible, while the Frank partial would show weak contrast where it did not lie in a $\langle 1\bar{1}0 \rangle$ direction. The partial dislocations of reactions (2) and (3) would be out of contrast for this reflection, but the stacking fault would be in contrast. Clearly, reaction (1) is the only case consistent with Figures 56(a) and 56(b).

Examination of Figure 56 shows that the perfect dislocation created by the unfauling reaction has moved off the (111) plane on which it was created (we shall show below that the stacking fault is, in fact, being annihilated rather than created), illustrating that some time has elapsed since the unfauling has occurred. Note also that the Shockley partial is curved into the stacking fault.

Figure 56 Partially Annihilated Stacking Fault. (a) Out of contrast. (b) In contrast. (c) Dislocation assignments according to Thompson notation.

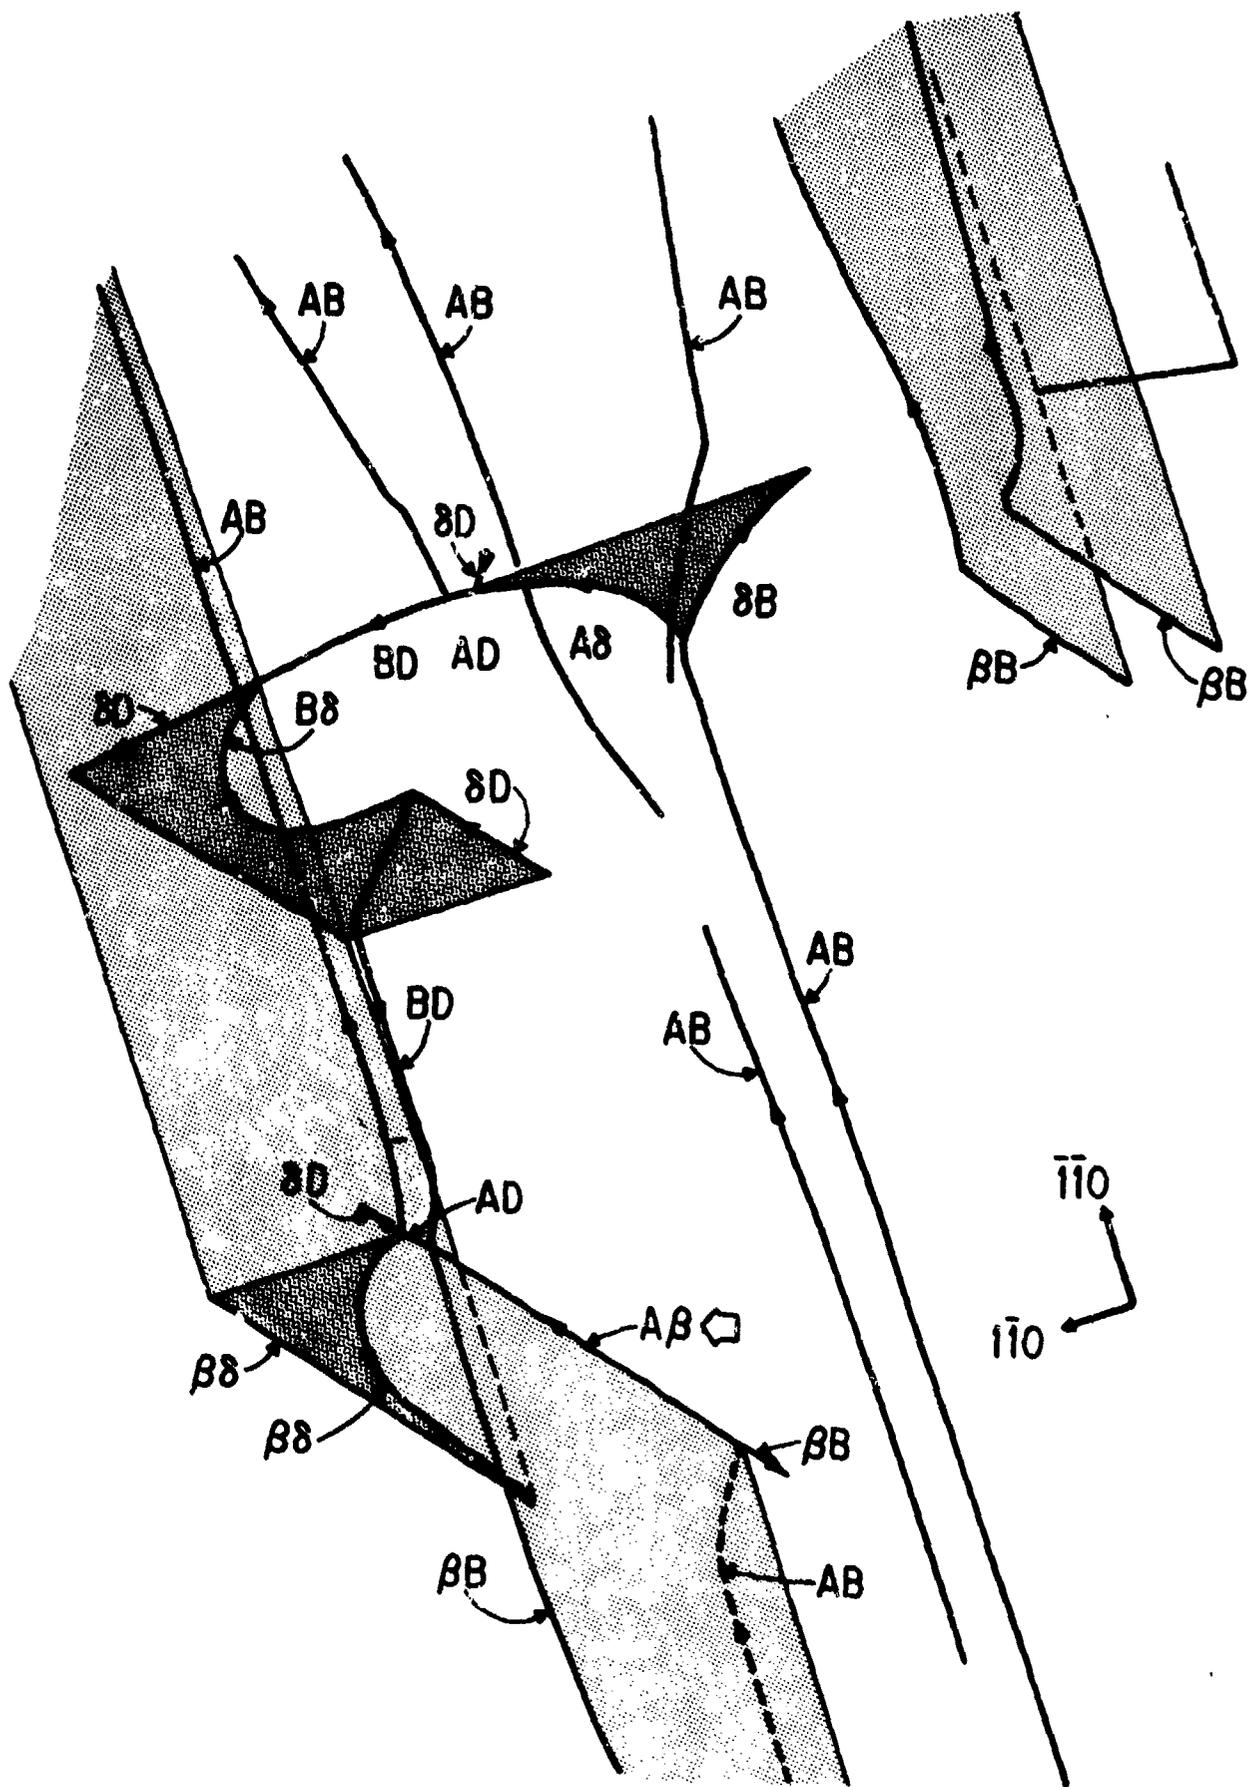
In some cases we have found entire arrays of stacking faults in the process of unfauling. An example of this is shown in Figure 61. From the four micrographs in this figure, the dislocation assignments of Figure 62 may be made. An interesting feature of these figures is a Shockley partial, indicated by the arrow in Figure 62, which is not curved into the stacking fault. This is the only case we have observed where the Shockley partial was not so curved.

Figure 62 Dislocation Assignment of Figure 61 According to Thompson Notation

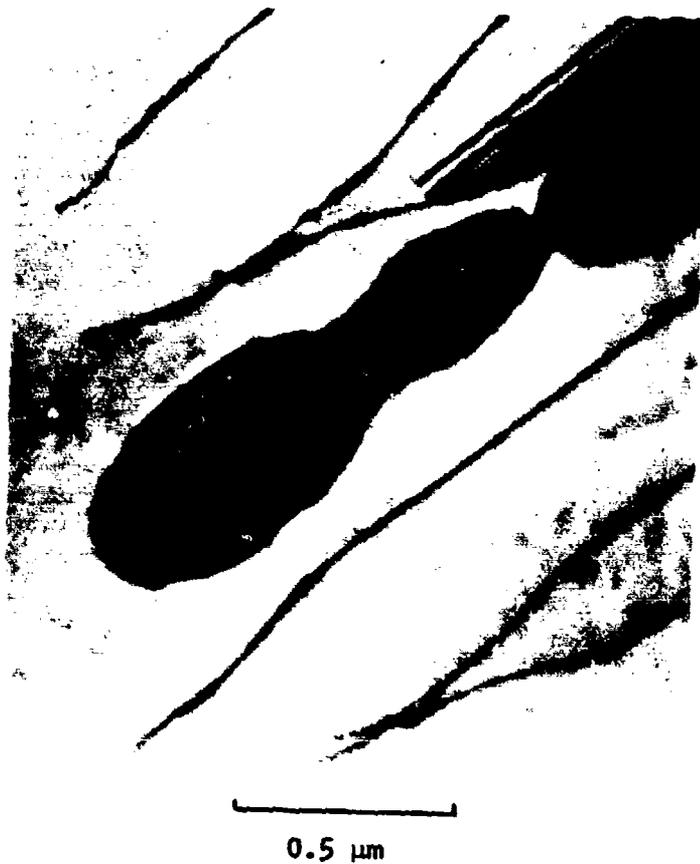
In some regions of the samples, we find areas in which recent bulk nucleation of stacking faults has occurred (Figure 69). Occasionally, we also see peanut-shaped stacking faults such as in Figure 70. These stacking faults must be formed by the nearly simultaneous nucleation of two stacking faults on the same plane and grow together to form the observed shape. The simplest mechanism by which this simultaneous nucleation can occur is that the unfauling of a previous-generation stacking fault leaves behind nuclei on which next-generation stacking faults can occur.

Figure 70 Peanut-Shaped Stacking Fault
