1. REPORT NUMBER		2. GOVT ACCESSION NO. 10	3. RECIPIENT'S CATALOG NUMBER
4. TITLE (and Subtitle) Phase I Inspection Report Owasco Lake Outlet Dam Oswego River Basin, Cayuga County, New York Inventory No. NY 776		5. TYPE OF REPORT & PERIOD COVERED Phase I Inspection Report National Dam Safety Program

OSWEGO RIVER BASIN

OWASCO LAKE OUTLET DAM

INVENTORY No. NY 776

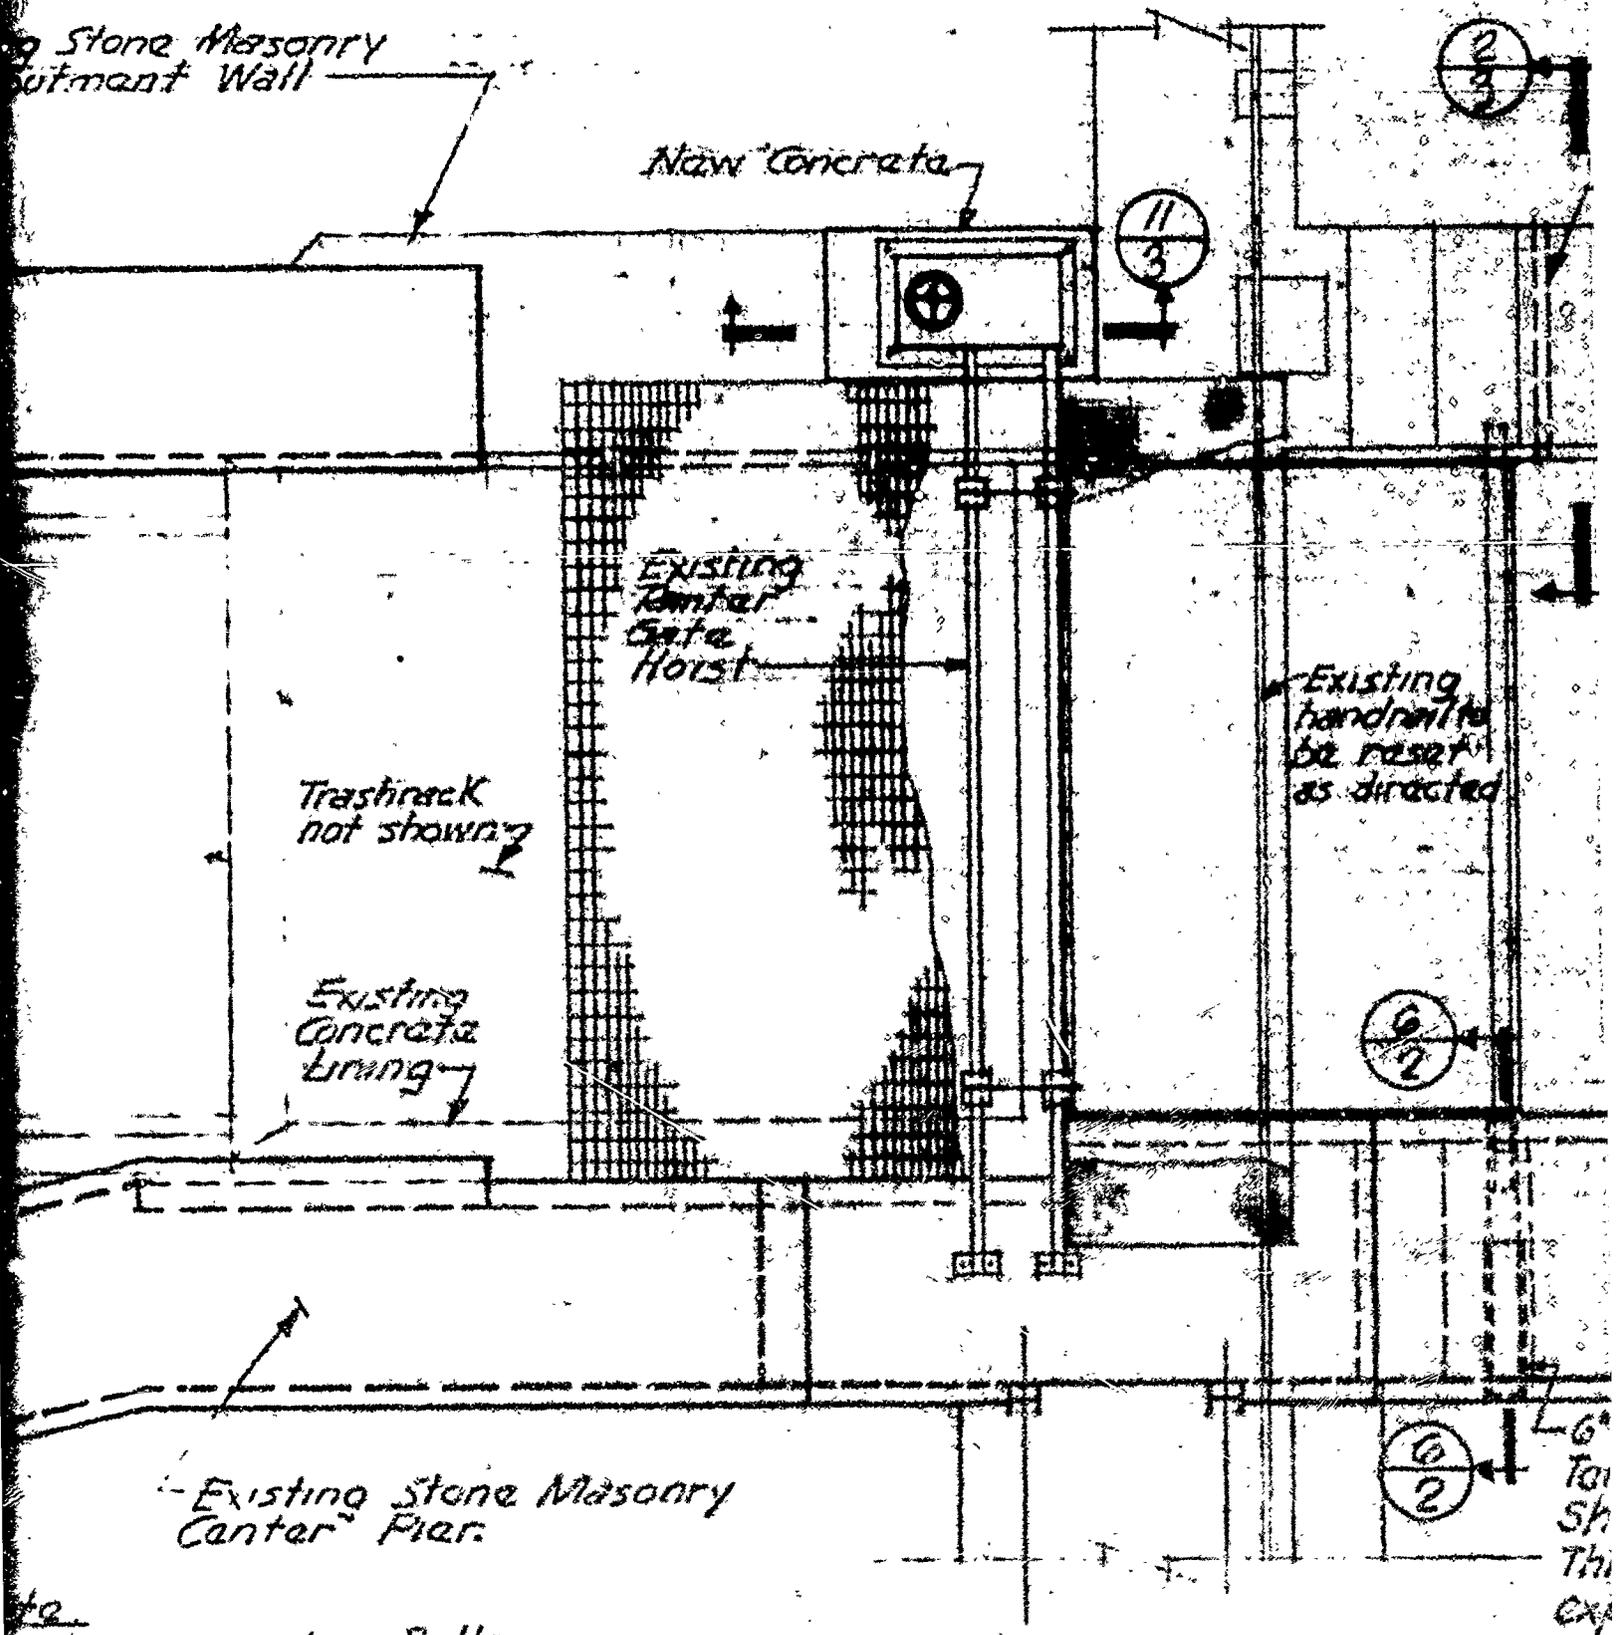
LEFT ABUTMENT AND CENTER PIER

Deteriorated Concrete Lining to be repaired - Similar to opposite wall. See Sec. 2 this sheet and Section 2, Sheet 3.

Provide new anchor Bolts
with nuts + bearing. See
Detail #3 for Typical

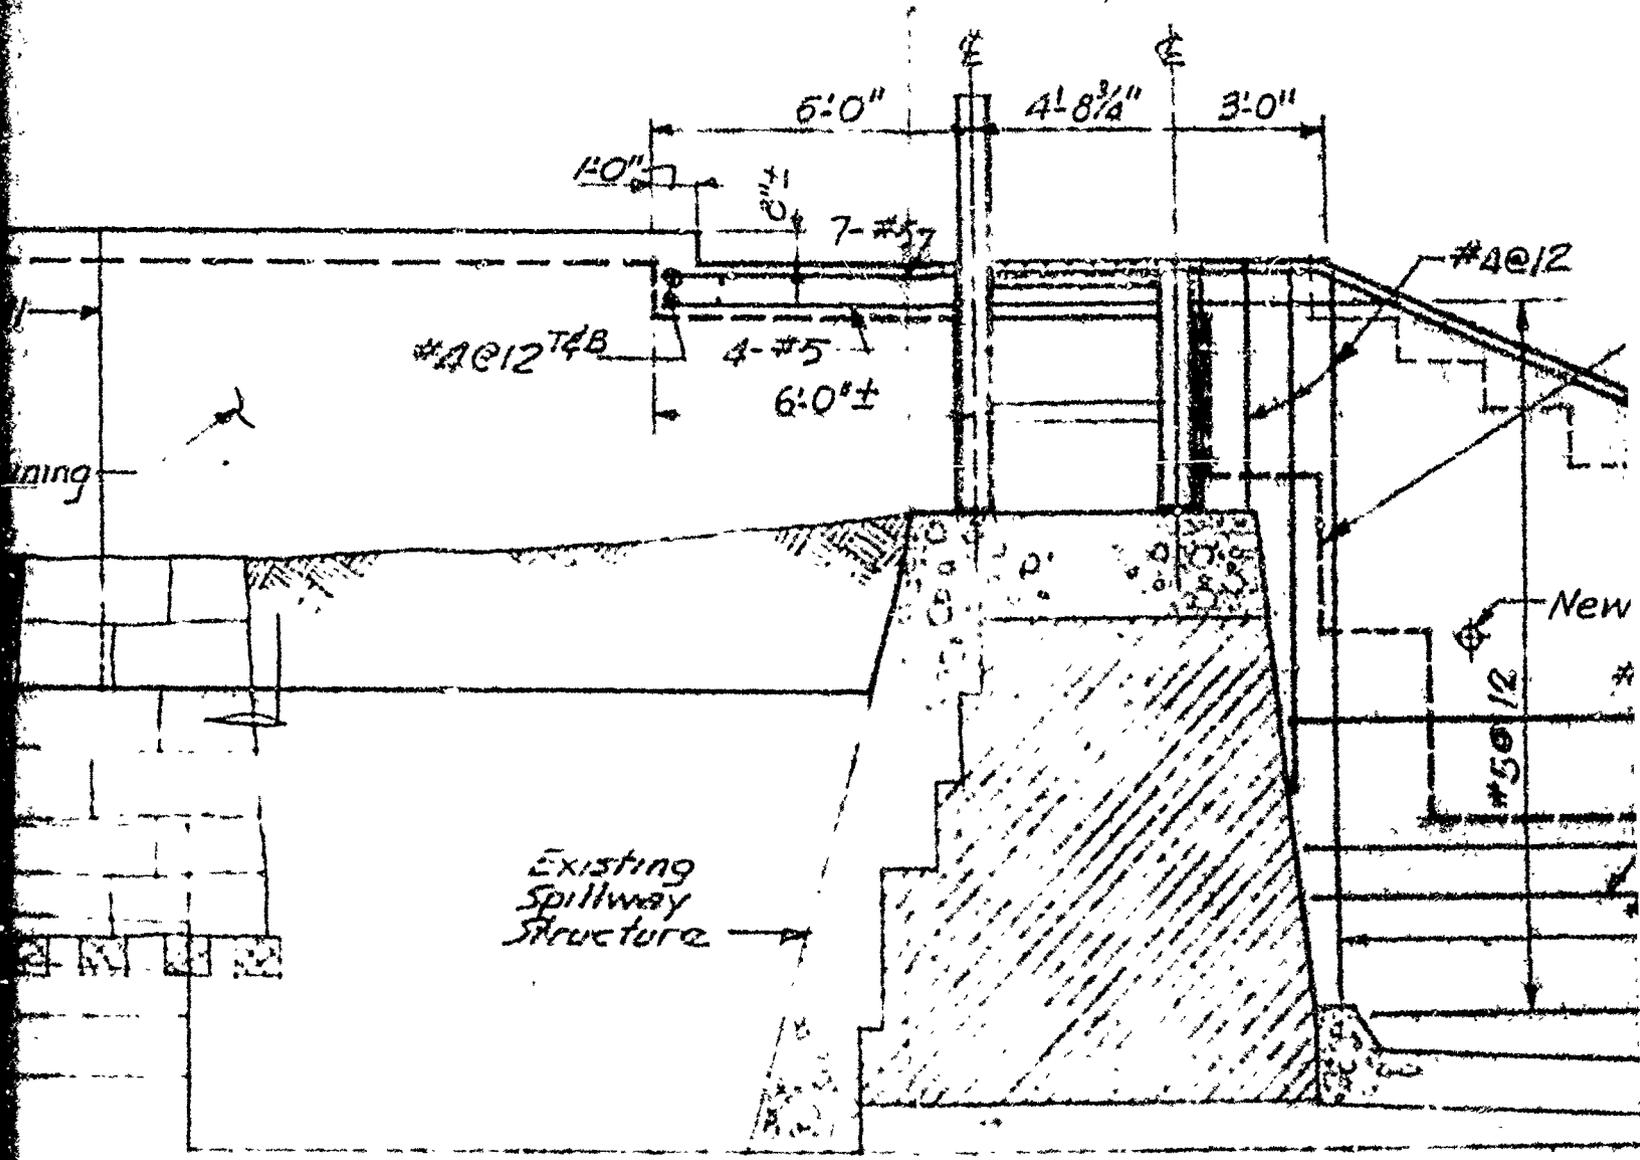
SECTION 5 (5/1) (5/2)
 Scale: 1/4" = 1'-0"

Remove all loose and Deteriorated stone Masonry to the approximate limits shown
