RAILROAD CREEK DAM
~~BUCKS COUNTY, PENNSYLVANIA~~

(NDS I D NO. PA 01062,
DER I D NO. 9-175,
SCS NO. PA 615)

PHASE I INSPECTION REPORT
NATIONAL DAM INSPECTION PROGRAM

JANUARY 1980

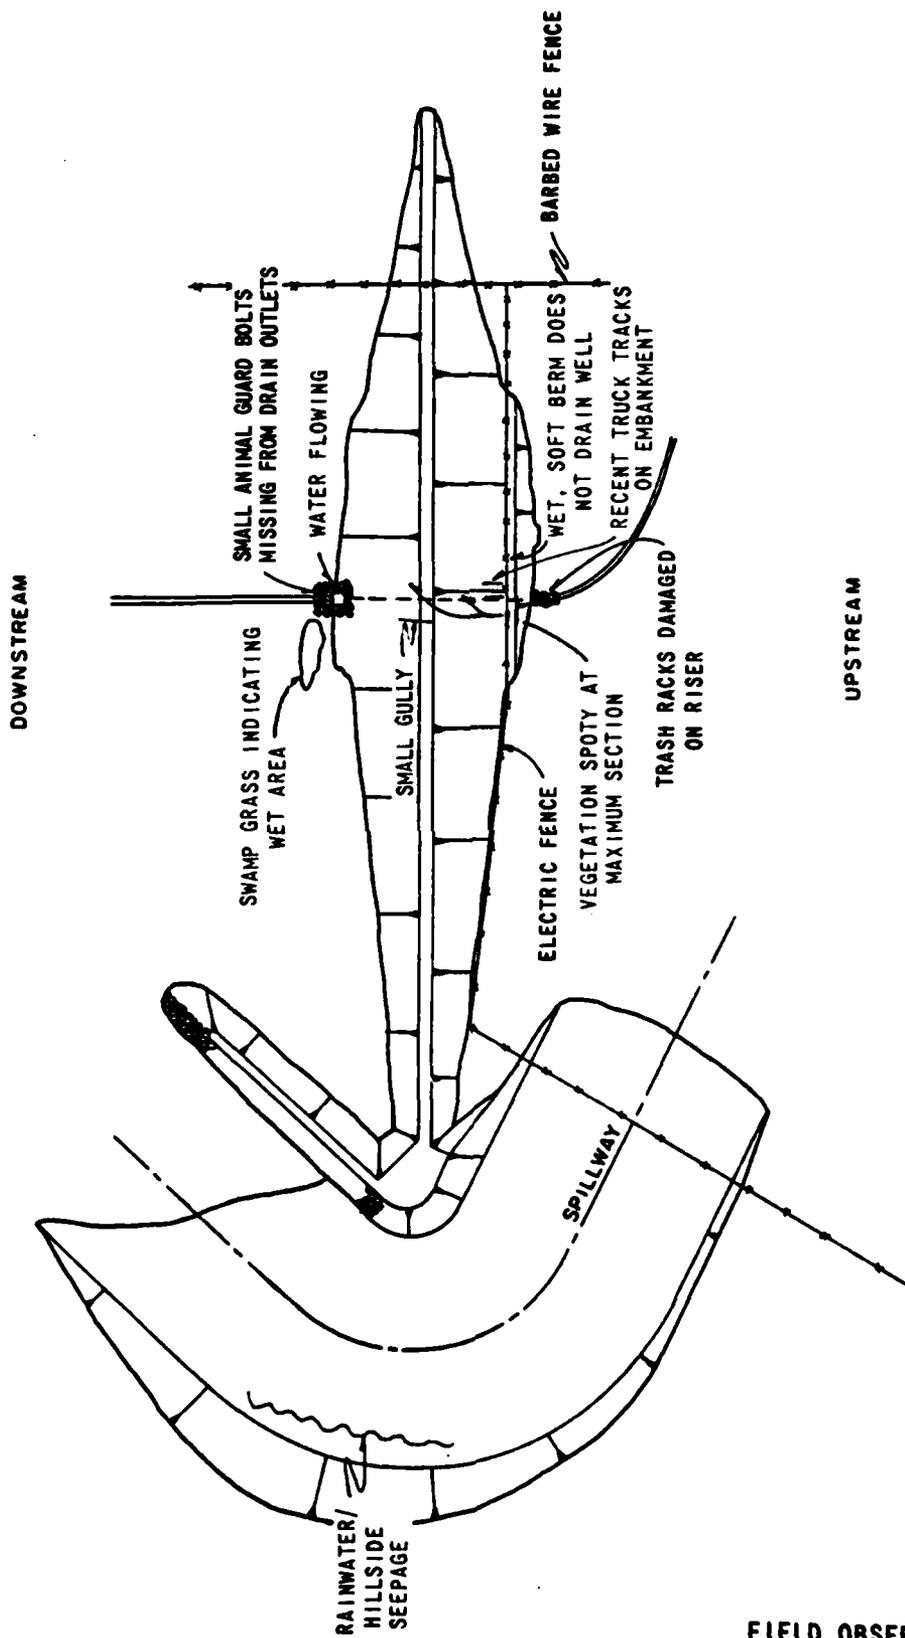
FIELD OBSERVATION PLAN
RAILROAD CREEK DAM

VISUAL EXAMINATION OF	OBSERVATIONS	REMARKS OR RECOMMENDATIONS
MISCELLANEOUS	<p>An electric fence at the upstream toe and berm of the embankment allows cattle to graze in the reservoir and part of the emergency spillway. Currently, little or no damage has resulted from cattle traffic but damage is possible, particularly during a dry summer. It is recommended that the fence be moved away from the embankment toe.</p>	
JUNCTION OF EMBANKMENT AND ABUTMENT, SPILLWAY AND DAM	<p>All junctions of embankment and abutments in good condition.</p>	
ANY NOTICEABLE SEEPAGE	<p>None, dry reservoir, see Sheet 5A.</p>	
STAFF GAGE AND RECORDER	<p>None</p>	
DRAINS	<p>Dry, bolts (small animal guards) missing, should be replaced.</p>
