Special Report 80-13

EXTENDING THE USEFUL LIFE OF DYE-2 TO 1986

PART II: 1979 FINDINGS AND FINAL RECOMMENDATIONS

Wayne Tobiasson and Philip Tilton

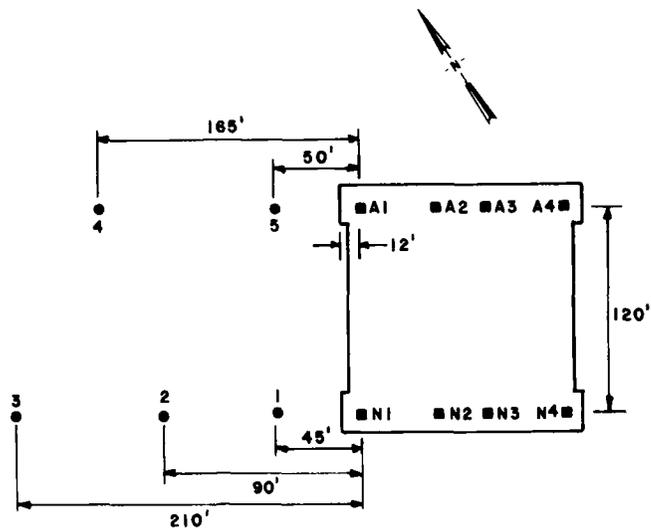
Figure 5. Location of five 1979 boreholes.

Snow studies conducted at DYE-3 prior to the sideways move are summarized by Tobiasson (1979). In 1979 a CRREL coring auger (Ueda et al. 1975) was used to obtain 3-in.-diameter cores of the snow to a depth of 50 ft at five positions along the track of a potential sideways move at DYE-2. Figure 5 indicates the locations of the five boreholes. Samples were stored at 15°F in the truss enclosure, then sized and tested at 20°F in unconfined compression at a cross-head speed of about 2 in./min. Visually, most of the samples resembled ice more than snow. A few relatively thin, weak granular layers were detected but most of the samples were very strong. Overall the snow that would support DYE-2 during a sideways move was significantly stronger than the snow that supported DYE-3 structure during the sideways move. Based on this information it is considered safe to support the DYE-2 structure on this snow during a sideways move.

Concern for inadvertent warming of the supporting snow during a sideways move was expressed in Part I of this report. It is considered important to create retaining walls and a white fabric cover over the new foundation as shown in Figure 4 of Part I.

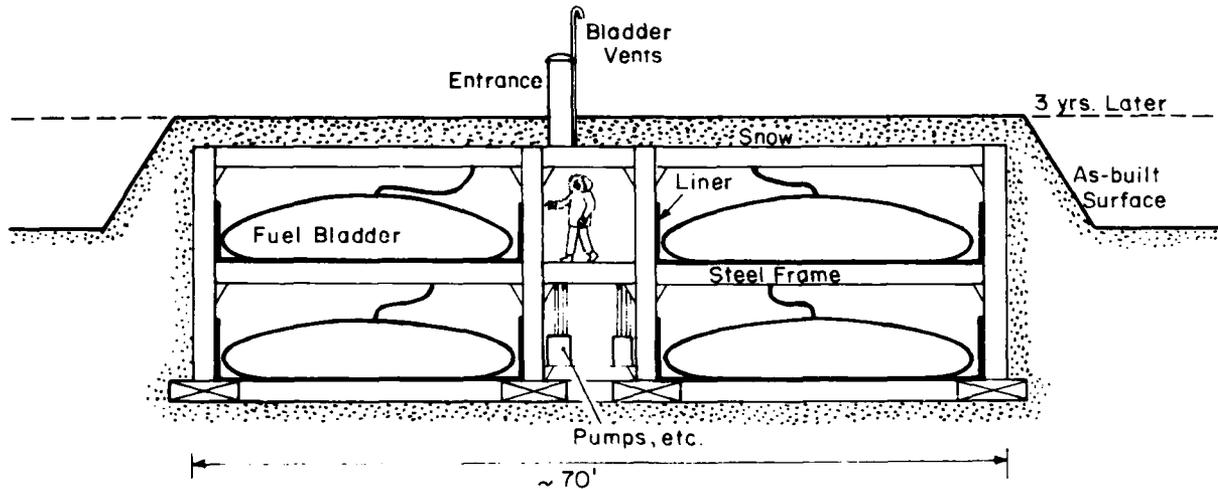
Figure 13. Concept for a rectangular bladder storage system.

Assembling the metal-arch vaults at DYE-3 was difficult and time-consuming. Although it would probably require more steel, a rectangular

bladder storage facility similar to that shown in Figure 13 may be more economical since it would be far simpler to build.
