Name Of Dam: LEE HALL RESERVOIR  
Location: CITY OF NEWPORT NEWS  
Inventory Number: VA. 70001

PHASE I INSPECTION REPORT  
NATIONAL DAM SAFTY PROGRAM

Name of Dam: Lee Hall Reservoir  
State: Virginia  
Location: City of Newport News  
USGS Quad Sheet: Yorktown  
Stream: Headwaters of Warwick River  
Date of Inspection: 28 November 1979

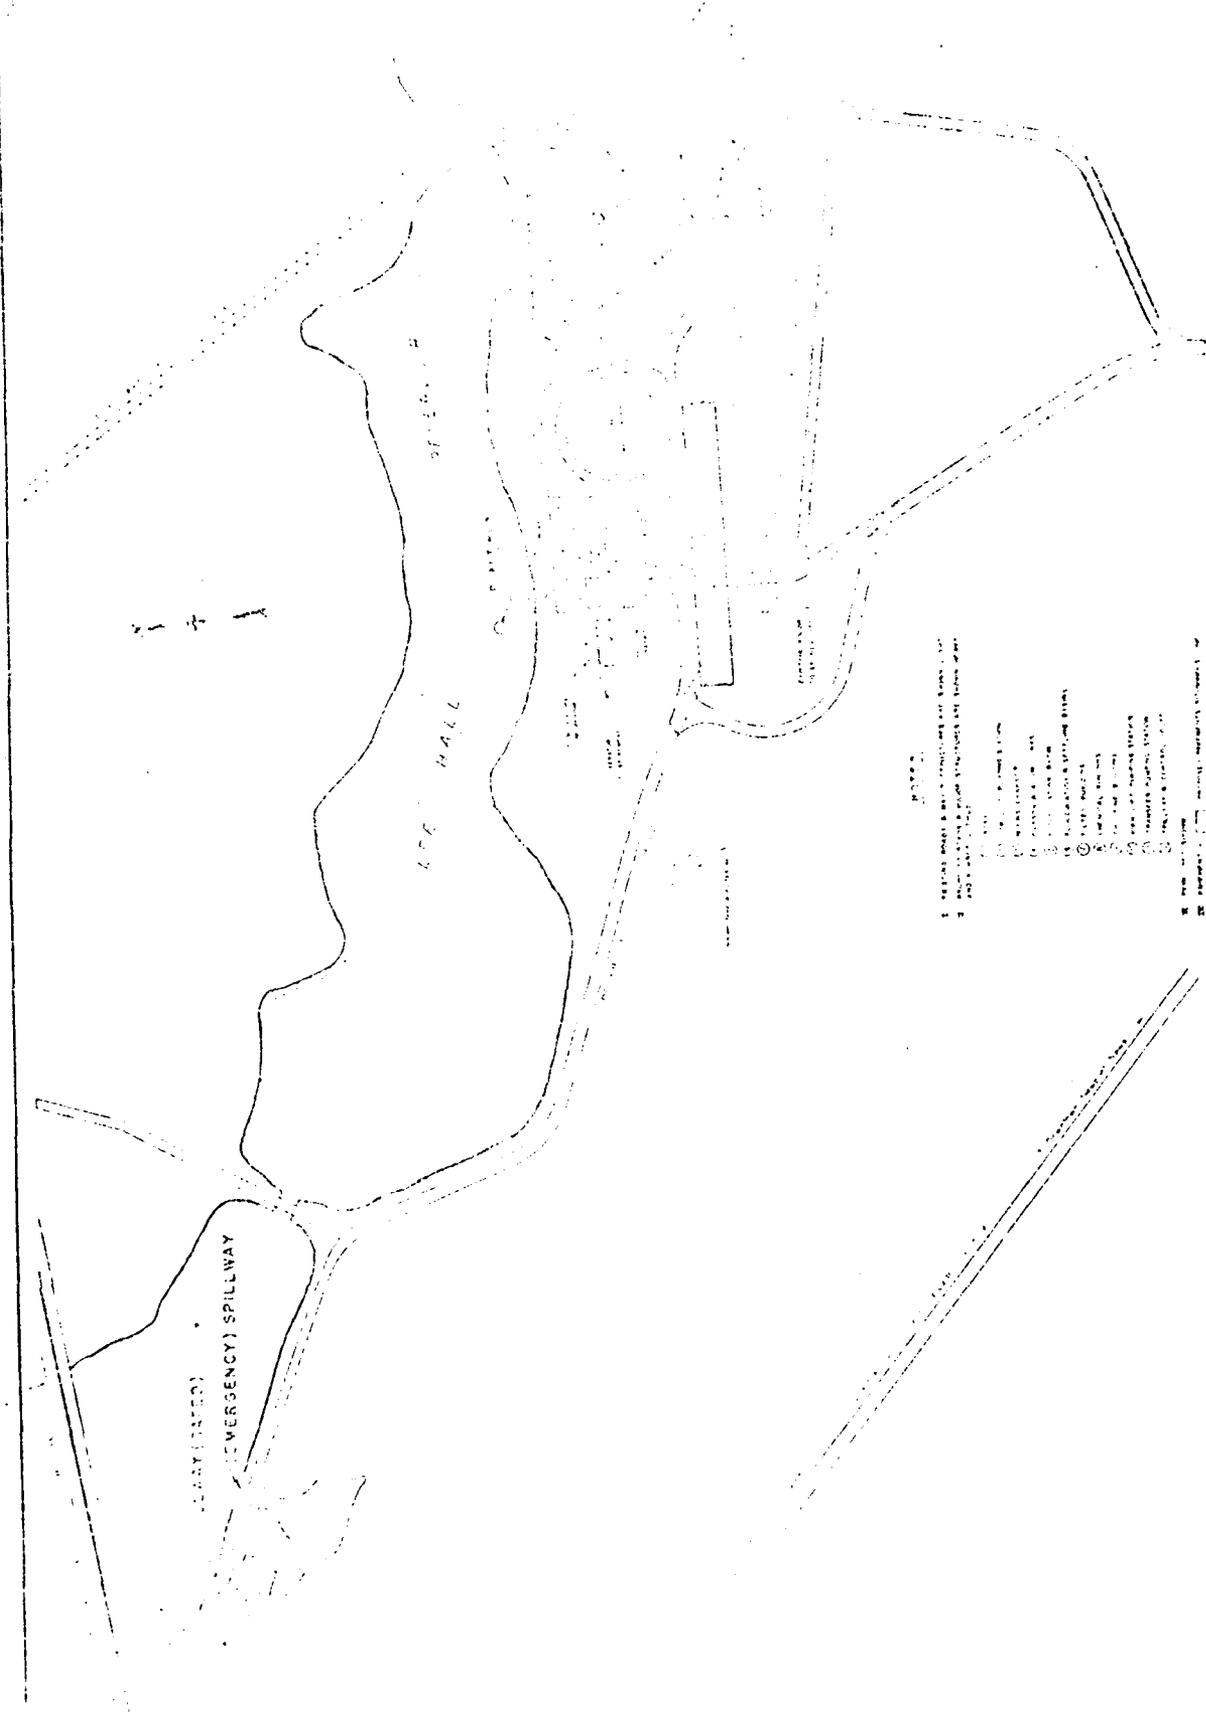
NOTE: DRAWINGS DO NOT REFLECT ACTUAL FIELD CONDITIONS NOTED DURING  
 WPIS FIELD VISIT ON ON 10/23/1973. CONCRETE BEHOLD IS NOT  
 IN PLACE AND 48-INCH ABOVE GROUND WATER LINE SPILLING INTO  
 AND EMERGENCY FILLWAYS IS NOT SHOWN ON THIS PLAN.
