4. TITLE (and Subtitle) Phase I Inspection Report National Dam Safety Program BEAR CREEK RESERVOIR DAM WISE COUNTY, VA		5. TYPE OF REPORT & PERIOD COVERED 9 Final Repts /

7. AUTHOR 10 Ray E. Martin Schnabel Engineering Associates 1 Cary Street Richmond VA 23220		6. PERFORMING ORG. REPORT NUMBER
9. PERFORMING ORGANIZATION NAME AND ADDRESS 12. 642		8. CONTRACT OR GRANT NUMBER(s) 15 DACW65-79-D-0004

PHASE I INSPECTION REPORT
NATIONAL DAM SAFETY PROGRAM
BEAR CREEK RESERVOIR DAM
VA. NO. 19511

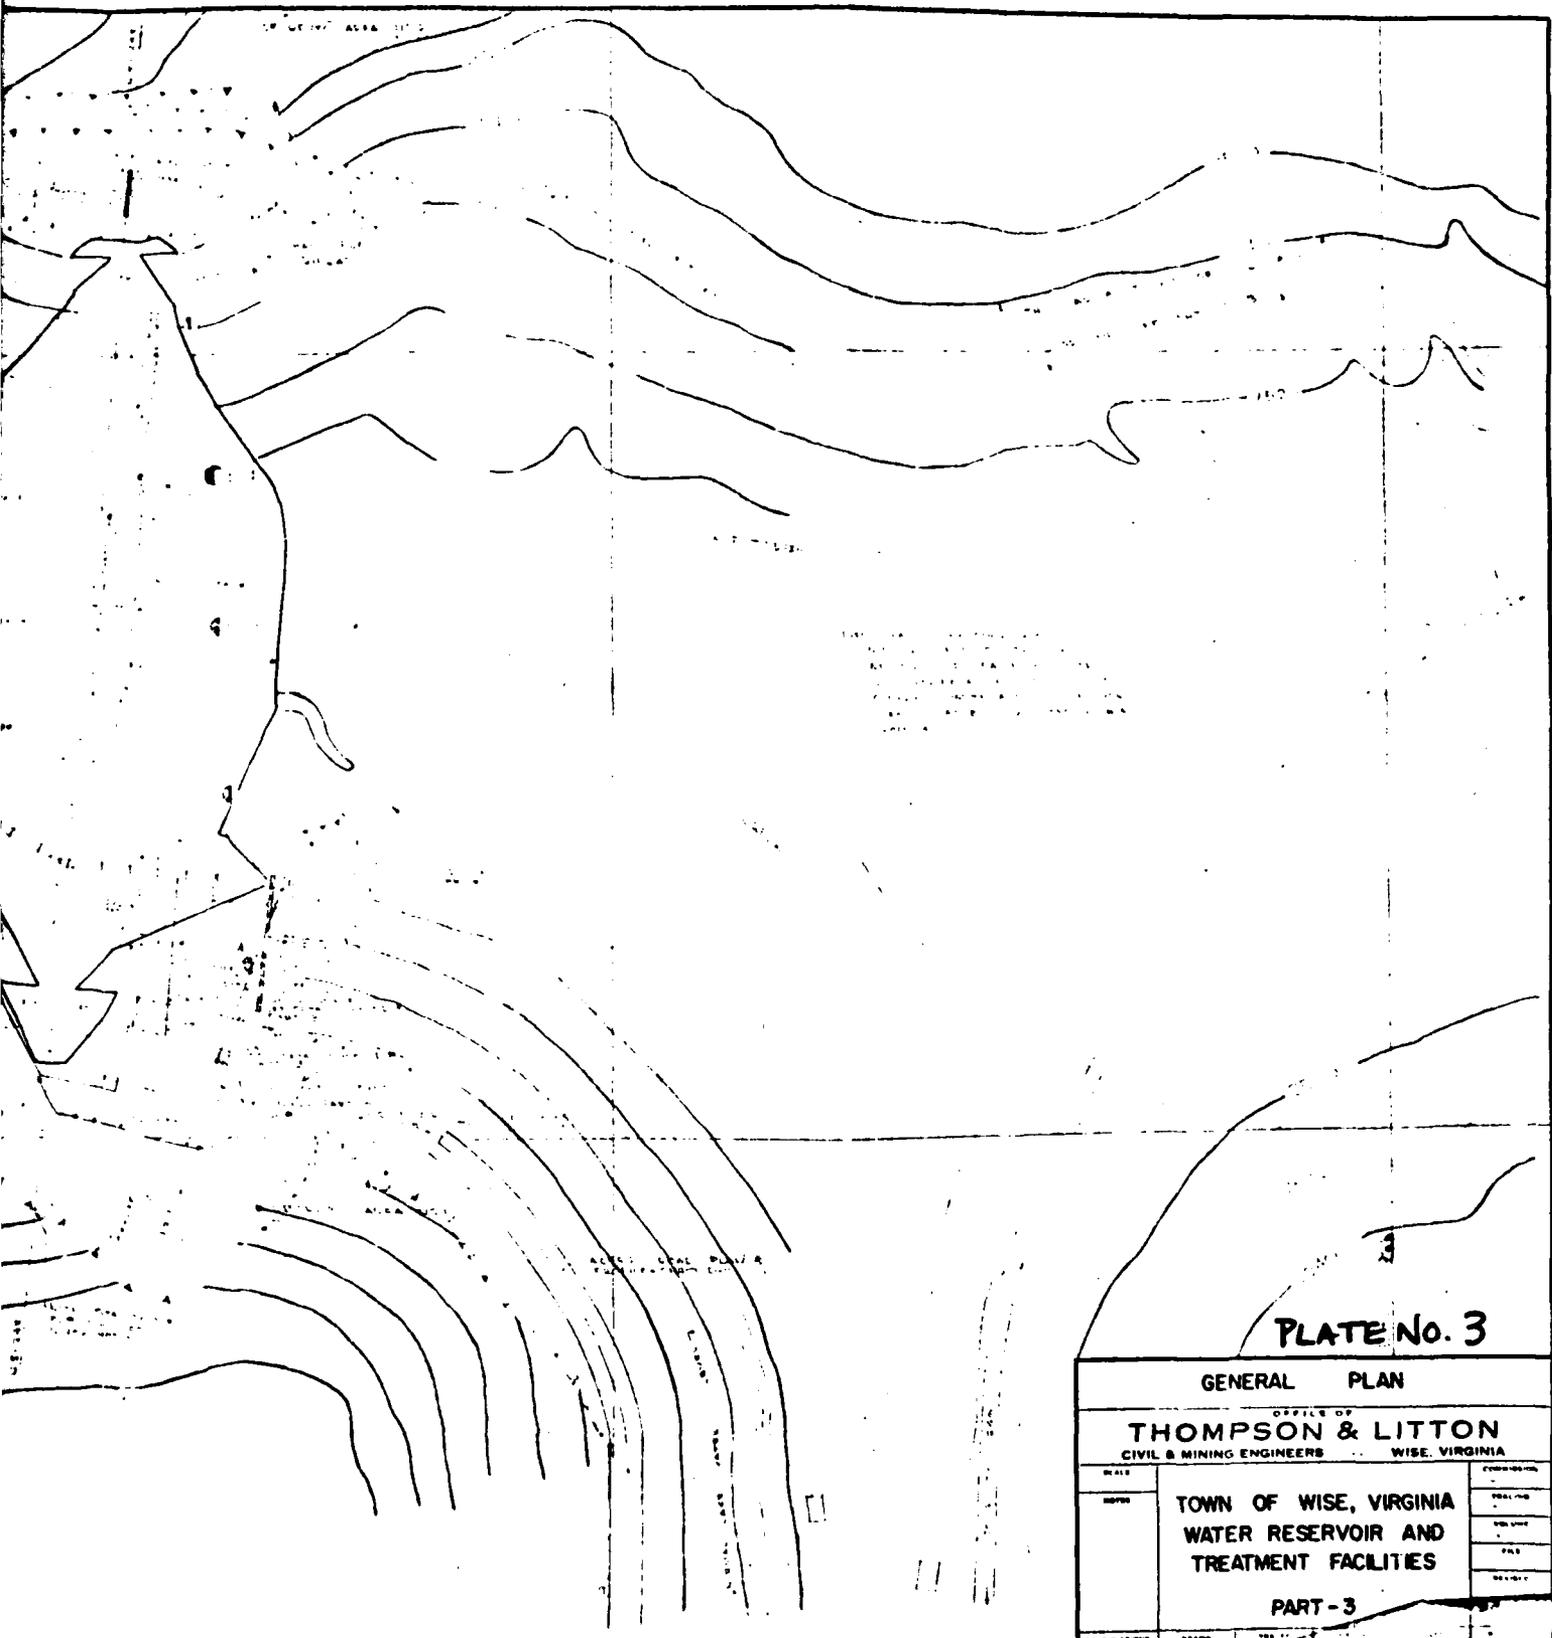
PLATE No. 3

There is an emergency spillway at the right abutment which is a vegetated earth channel with a bottom width of 30 ft and 1.5:1 side slopes. The crest elevation is 2533 msl. The bottom and right side of the emergency spillway is in cut and the left side is in fill. The spillway has a loose section of riprap across the bottom, centered on the control section. (See Plate No. 3, Appendix I)

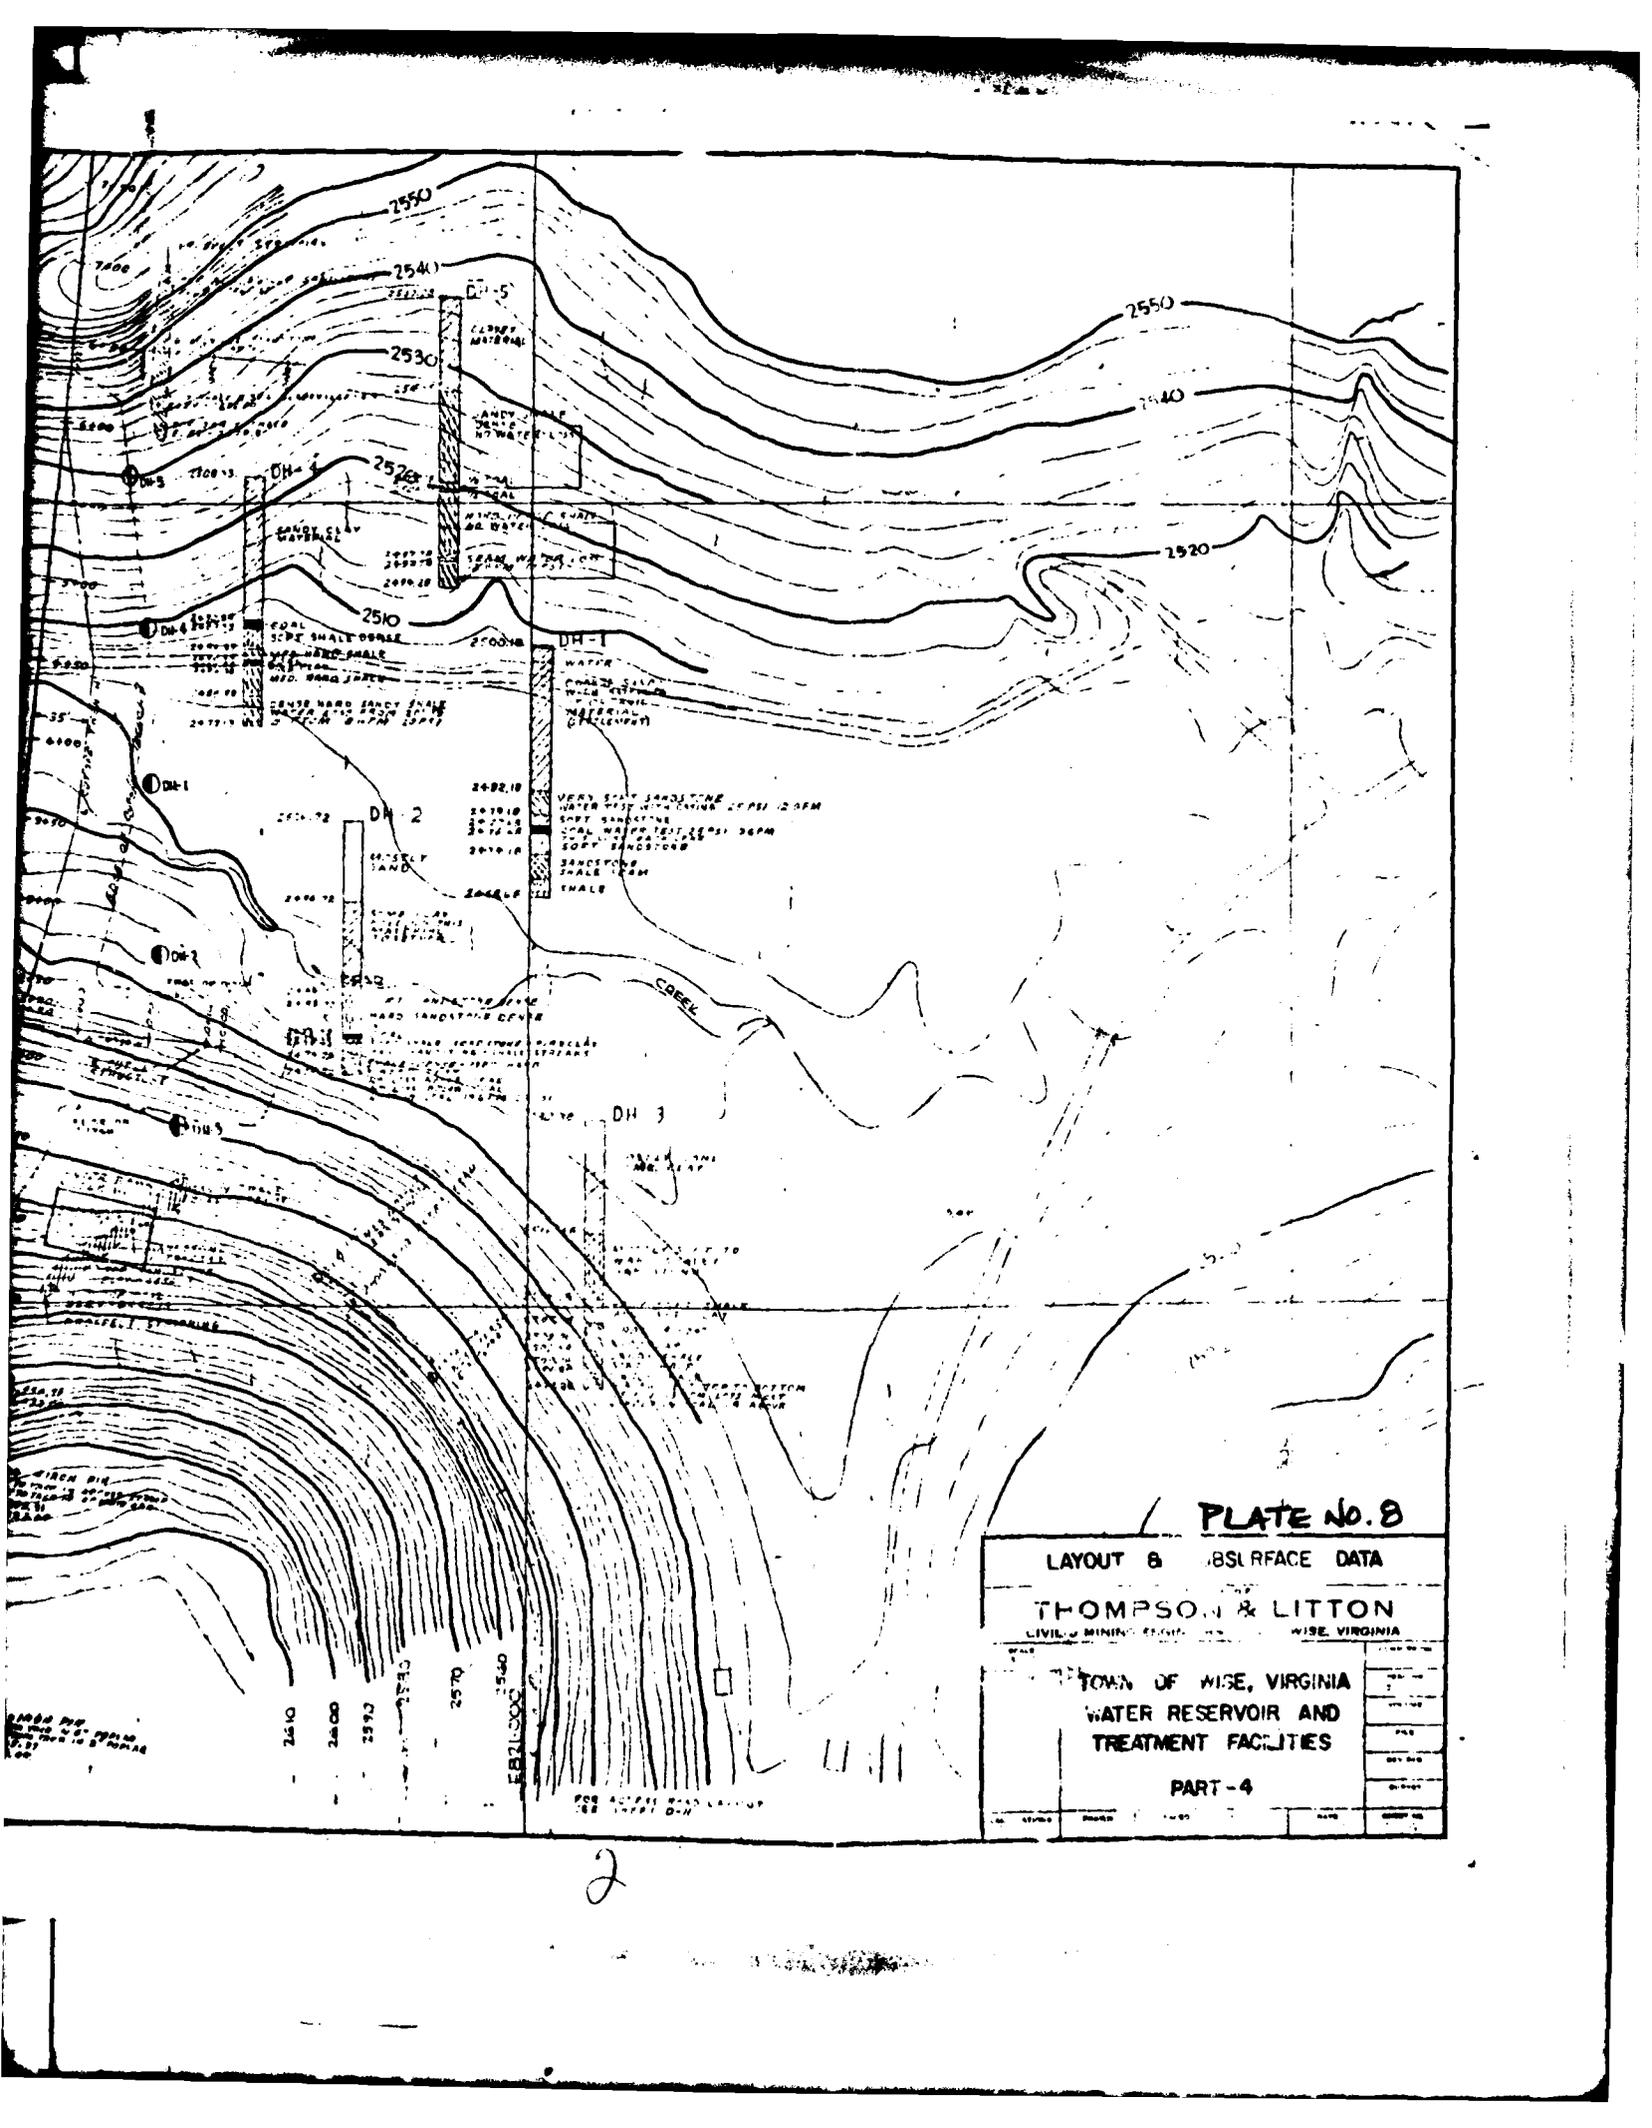
PLATE No. 8

The dam site is located within the southeast portion of the Appalachian Plateau (locally Cumberland Plateau) Physiographic Province of Virginia. The Cumberland Plateau is a stream dissected plateau which is underlain by sedimentary rocks up to upper Pennsylvanian in age (see Reference 3, Appendix IV). The structure is underlain by rocks of the Norton Formation, which consist of alternate beds of sandstone and shale, interbedded with coal. The sandstones are commonly soft and micaceous while the shales are largely clayey. The Norton Formation is overlain by the Gladeville Sandstone, which is exposed in the spillway and abutment areas. The formation is basically a hard quartzose sandstone. Bedrock exposed at the site is essentially flat lying and no faults have been mapped in the immediate area. Five test borings were drilled at the site and this data is presented on Plate 8, Appendix I.

6.1 Foundation and Abutments: Bear Creek Dam appears to be founded on alluvial and/or residual soils, all of which are underlain by the Norton Formation. Design drawings show the cutoff trench extending into bedrock or residual soils. Five test borings drilled at the site (Plate 8, Appendix I) penetrated 12 to 22 ft[±] of overburden before encountering bedrock. From 10 to 24 ft[±] of bedrock was drilled in each of the borings. The greatest overburden thicknesses occurred adjacent to the existing stream channel. The sampled overburden soils ranged from sandy to clayey materials and the underlying bedrock consisted of interbedded sandstones and shales with several thin seams of coal (from 0.2 to 2 ft thick). Water pressure test data presented on the boring logs suggests that at least the upper portion of the bedrock is somewhat weathered and/or fractured, thus allowing water loss during the testing. Local pressure grouting was performed in select areas during construction in order to minimize seepage potential. Slightly to highly weathered sandstones (Gladeville Sandstone) are exposed in the emergency spillway and right abutment. These sandstones are often iron-stained and include rectangular joint sets.
