**INTERIM REPORT OF FIELD TEST
OF EXPEDIENT PAVEMENT REPAIRS
(TEST ITEMS 1-15).**

**RAYMOND S. ROLLINGS
ENGINEERING RESEARCH DIVISION**

MARCH 1980

INTERIM REPORT
JULY 1977 - JULY 1978

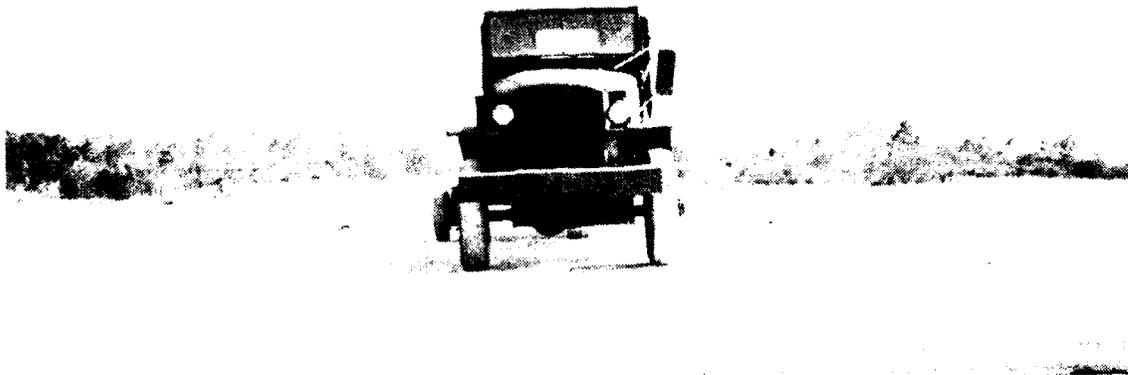
Figure 21. Surface Item 4, 40 Coverages

The surface rutted under initial traffic until, at the end of 10 coverages, ruts (measured from top of upheaved material to bottom of the rut) reached a maximum of 2.5 inches (Figure 20). Further traffic began densifying the material (Figure 21) until it became a very smooth hard surface (Figure 22). The increase in maximum permanent deformation (difference between original untrafficked elevation and elevation after traffic at a point) with increasing coverages is shown in Figure 23, and surface profiles measured along the center line perpendicular to traffic are shown in Figure 24. Traffic was discontinued at 150 coverages, short of the 3-inch failure criterion (Figure 23) for unsurfaced operation. If a 1-inch criterion for paved surfaces had been used, failure would have been at 60 coverages.

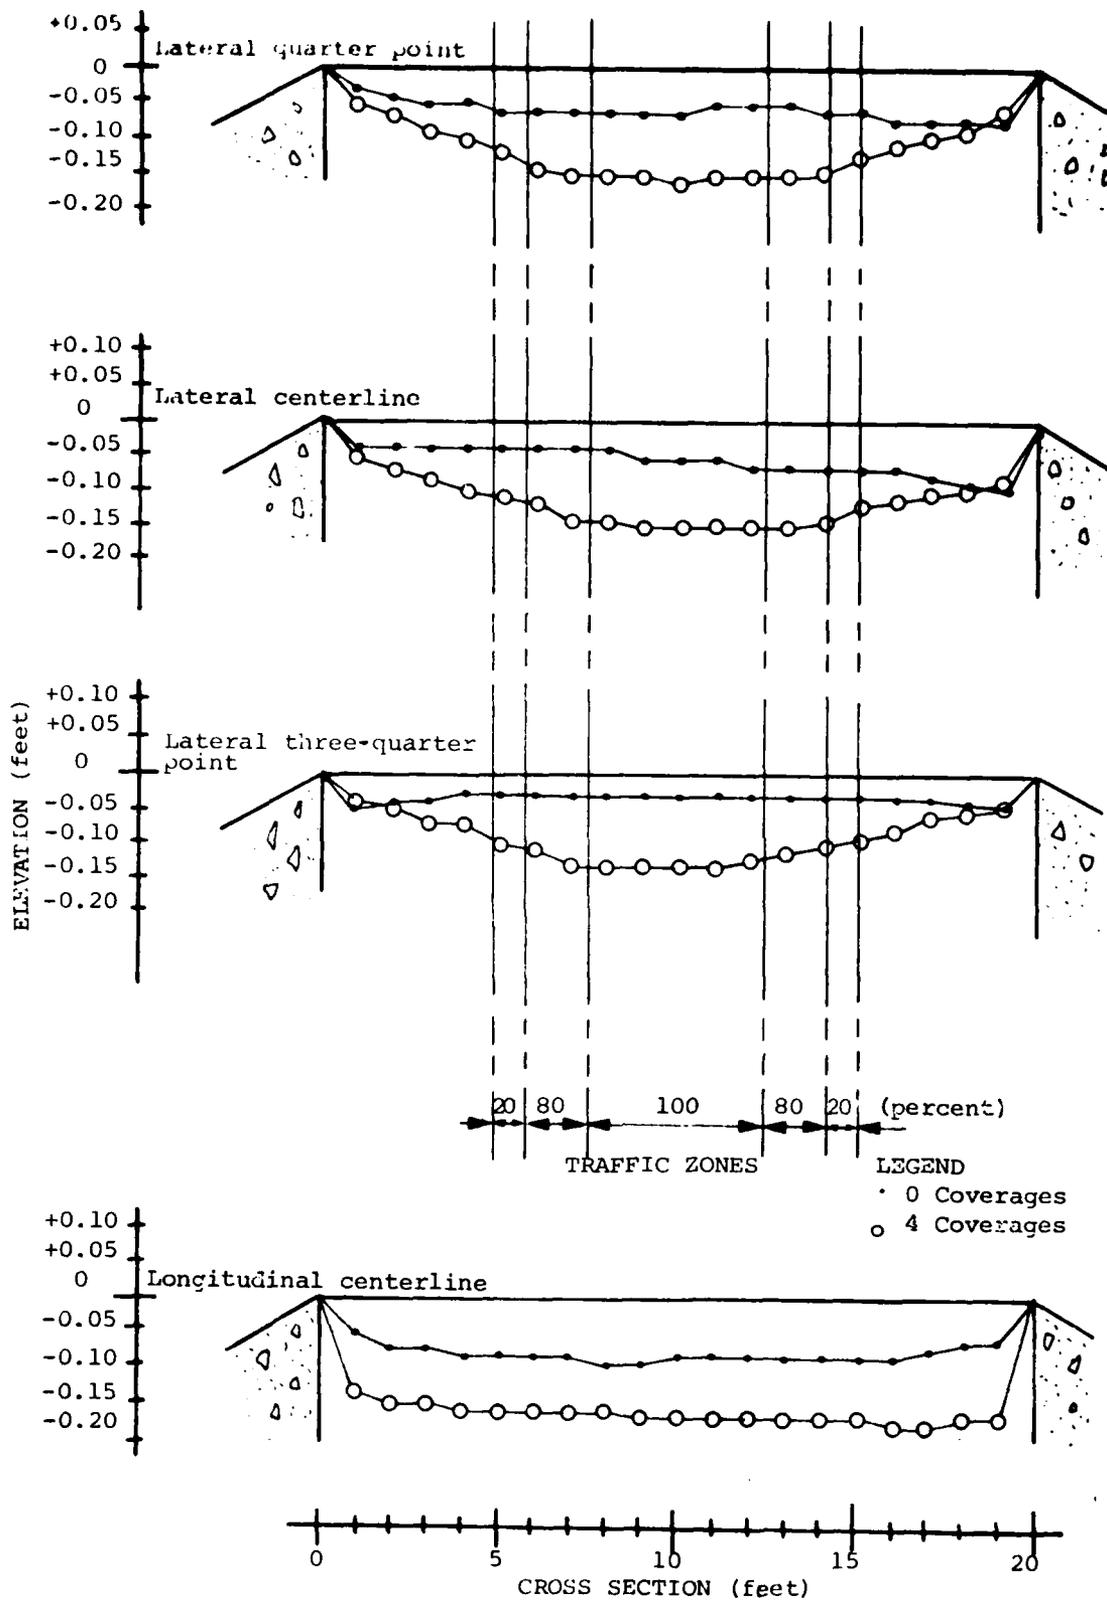
Figure 31. Surface Profiles, Item 7

The mat panels freely rotated about their edge connections so that a bow wave formed ahead of the load cart wheel. An attempt to measure the rise of the mat panels in the bow wave with dial gages failed because of inadequate dial gage capacity. The difference in elevation between leading and trailing edges of one mat panel as the load wheel approached was estimated to be in excess of 0.75 inch. After 4 coverages the item was considered failed because the base course under the mat had rapidly settled and a 1.8-inch lip had formed between the mat and pavement. The mat panels did not conform exactly to the underlying surface and bridged over some depressions. The mat would be depressed under the load tire and then would rebound when the load was removed. The mat surface settled a maximum of 1.32 inches under traffic. Profiles of the mat surface before and after traffic are shown in Figure 31. All profiles are from the unloaded surface.

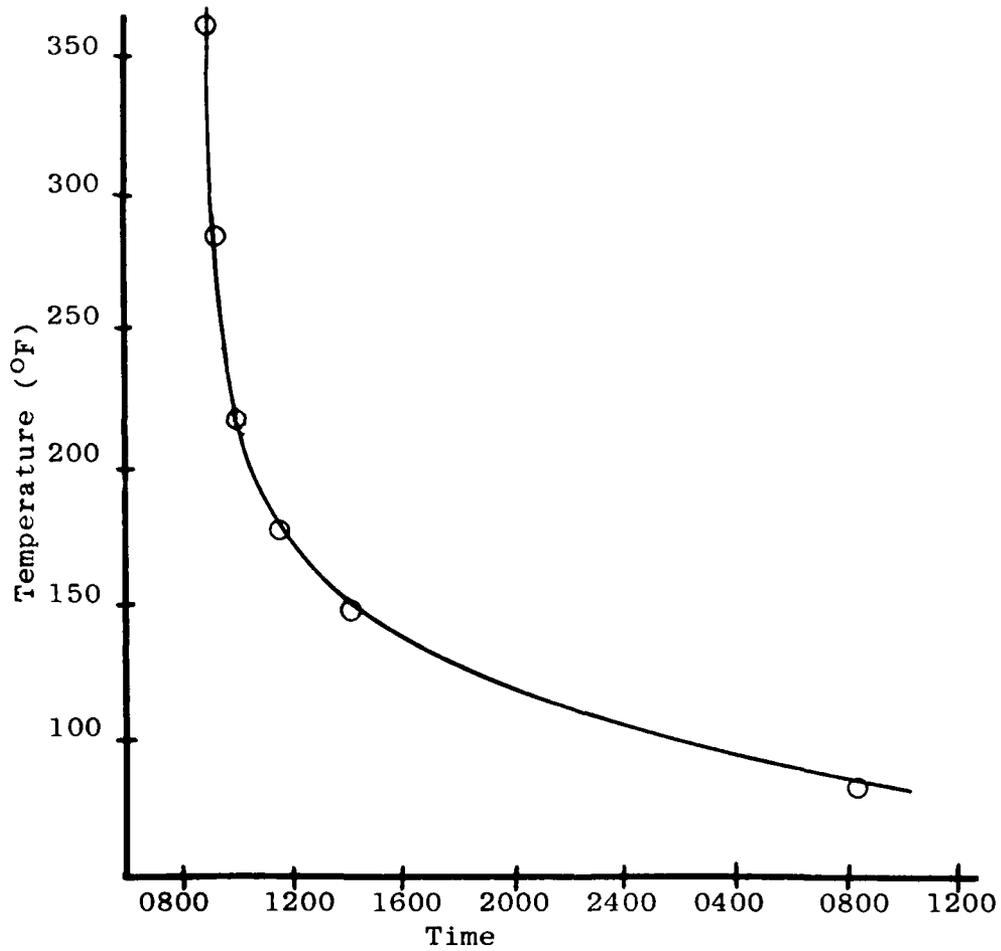
Figure 40. Temperature of Asphaltic Concrete, Item 9

Hot mix asphaltic concrete performed well, but time requirements for heating and cooling the mix are excessive. Figure 40 indicates that 11.5 hours would be required to cool the hot mix in item 9 to 120°F. This test item and results of tests in Reference 25 confirm that, although conventional hot mix asphalt concrete is structurally adequate, considerable cooling times are required before tactical aircraft can operate on the surface. Some shortening of the cooling time may be possible by limiting the initial temperature of the mix, carefully controlling aggregate gradation, and limiting asphalt content; however, the cooling time and hot mix plant requirements remain serious limitations.

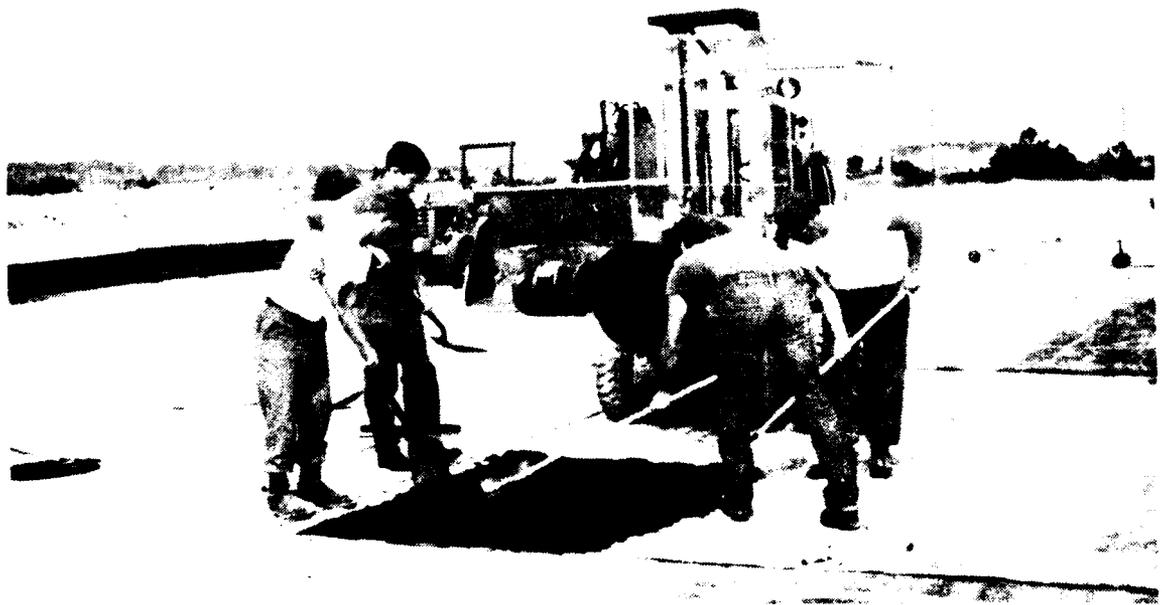
Figure 50. Placement of Zor-x[®], Item 12

Zor-x® is provided in 55 gallon drums. A fork lift was used to handle the drums, and the material was spread and leveled by hand (Figure 50). The Zor-x® surface was rolled with four coverages of the 12-ton steel wheel roller, four coverages with the 13-wheel pneumatic roller, and 2 additional coverages with the 12-ton steel wheel roller.

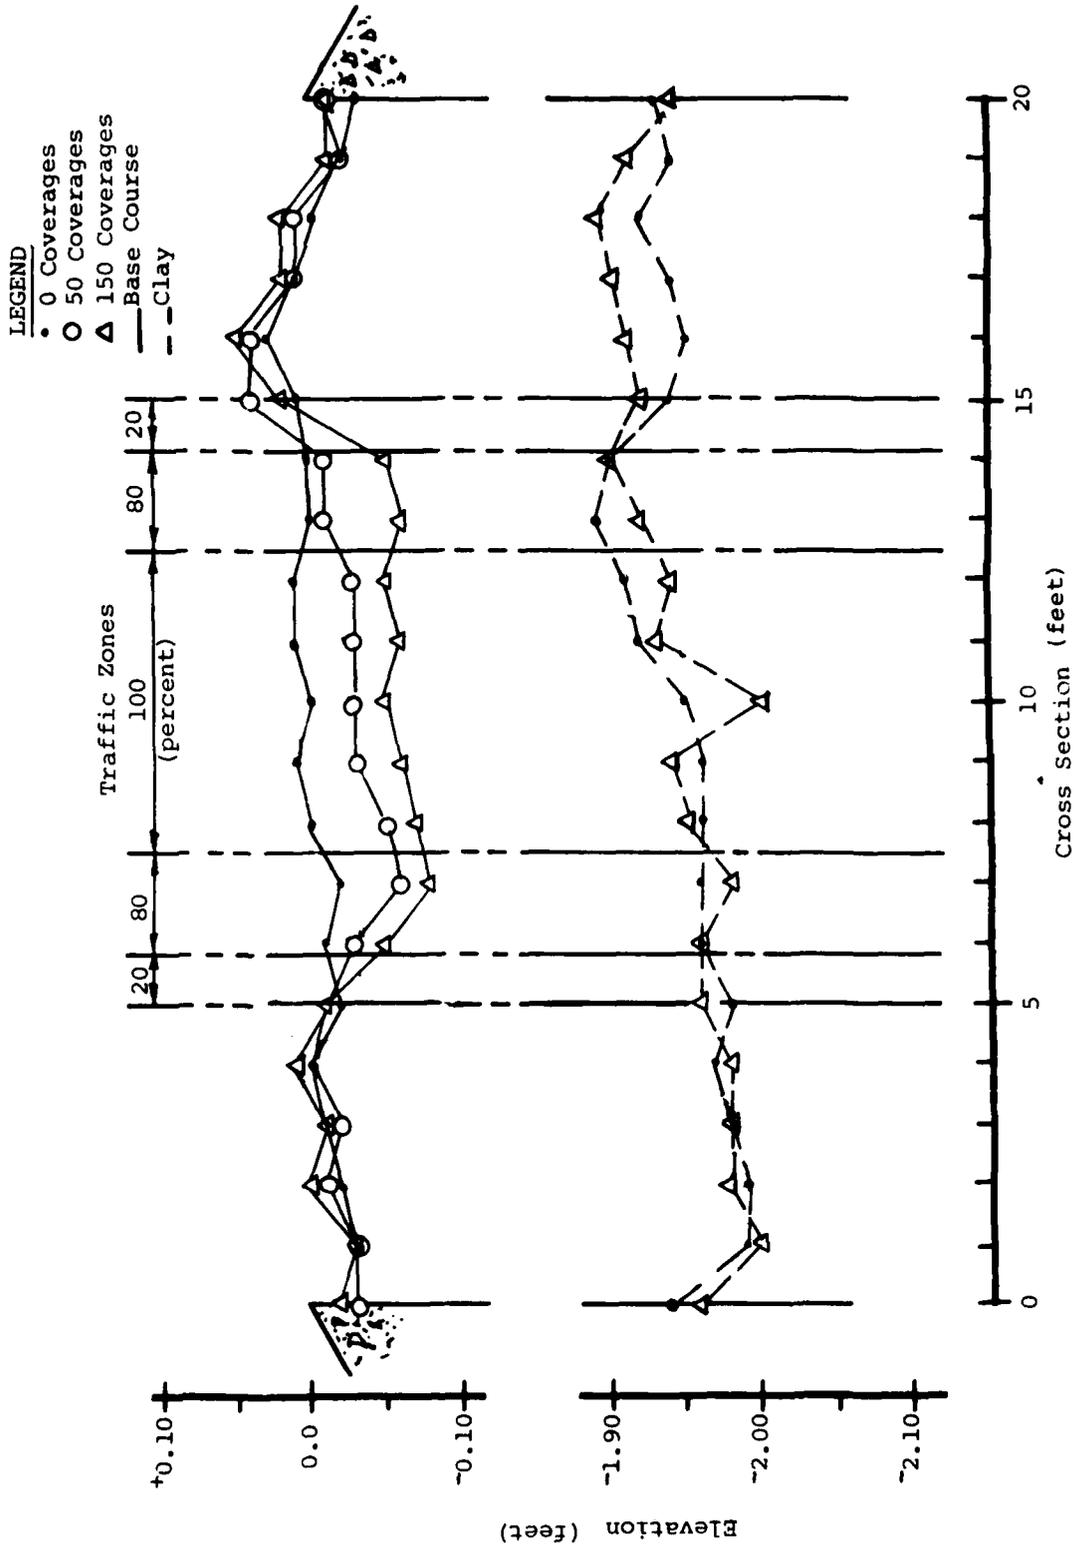
Figure 55. Lateral Quarter Point Profiles, Item 13A

Profiles of the clay subgrade and base course surface at various levels of traffic are shown in Figures 55 through 58. The lack of upheaval at the edge of the traffic lane indicates densification rather than shear deformation was the cause of the surface settlement. Maximum deformation reached 1 inch at 150 coverages. The maximum deformation at various levels of traffic is shown in Figure 59. Results of soil tests are shown in Table 20. Densities were determined from a nuclear gage wet density with the source probe at a depth of 6 inches, and moisture contents were determined from oven dried moisture samples.

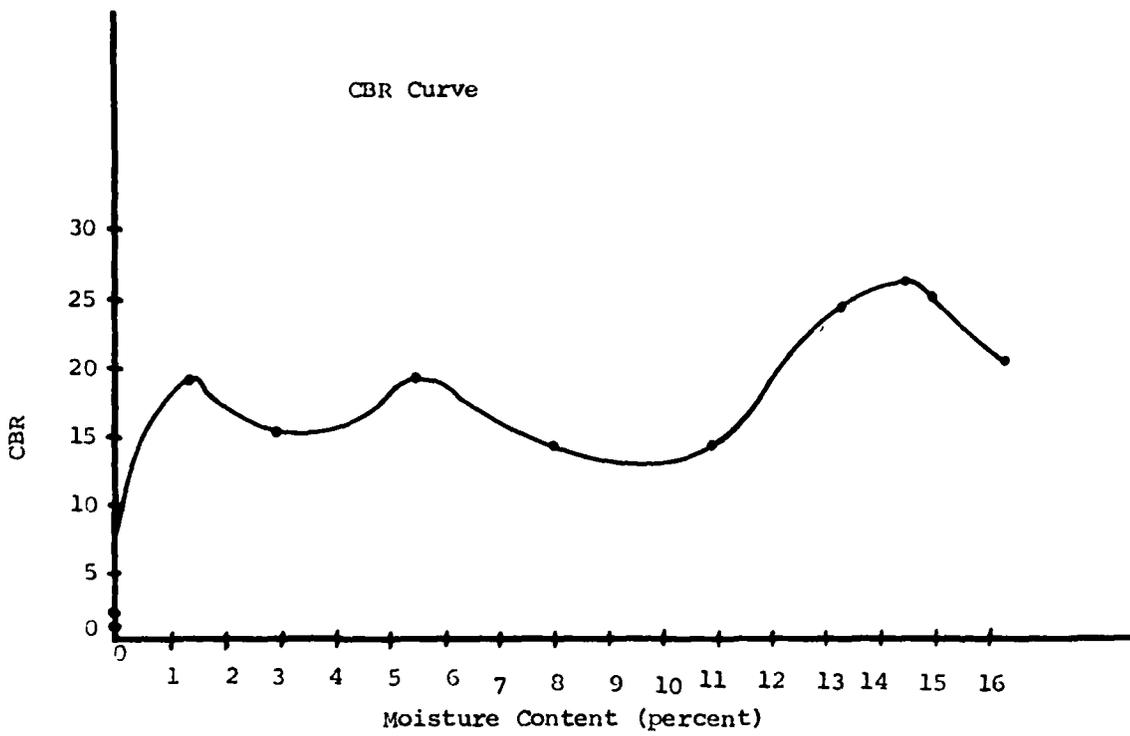
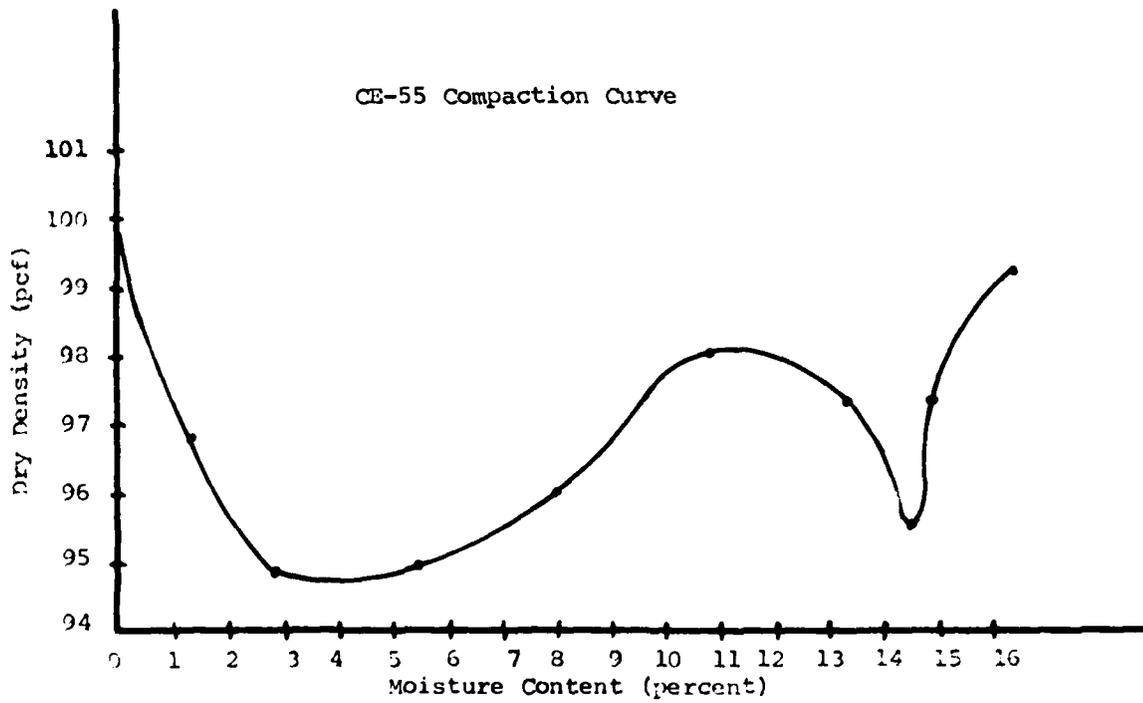
Figure 61. CE-55 Compaction Curve and CBR Curve for Dune Sand, Item 15

Item 15 consisted of a 6-inch base course of well graded, crushed stone and an 18-inch subbase of a local dune sand. The gradation of the sand is shown in Figure 60. A CE-55 compaction curve and a CBR curve are shown in Figure 61.

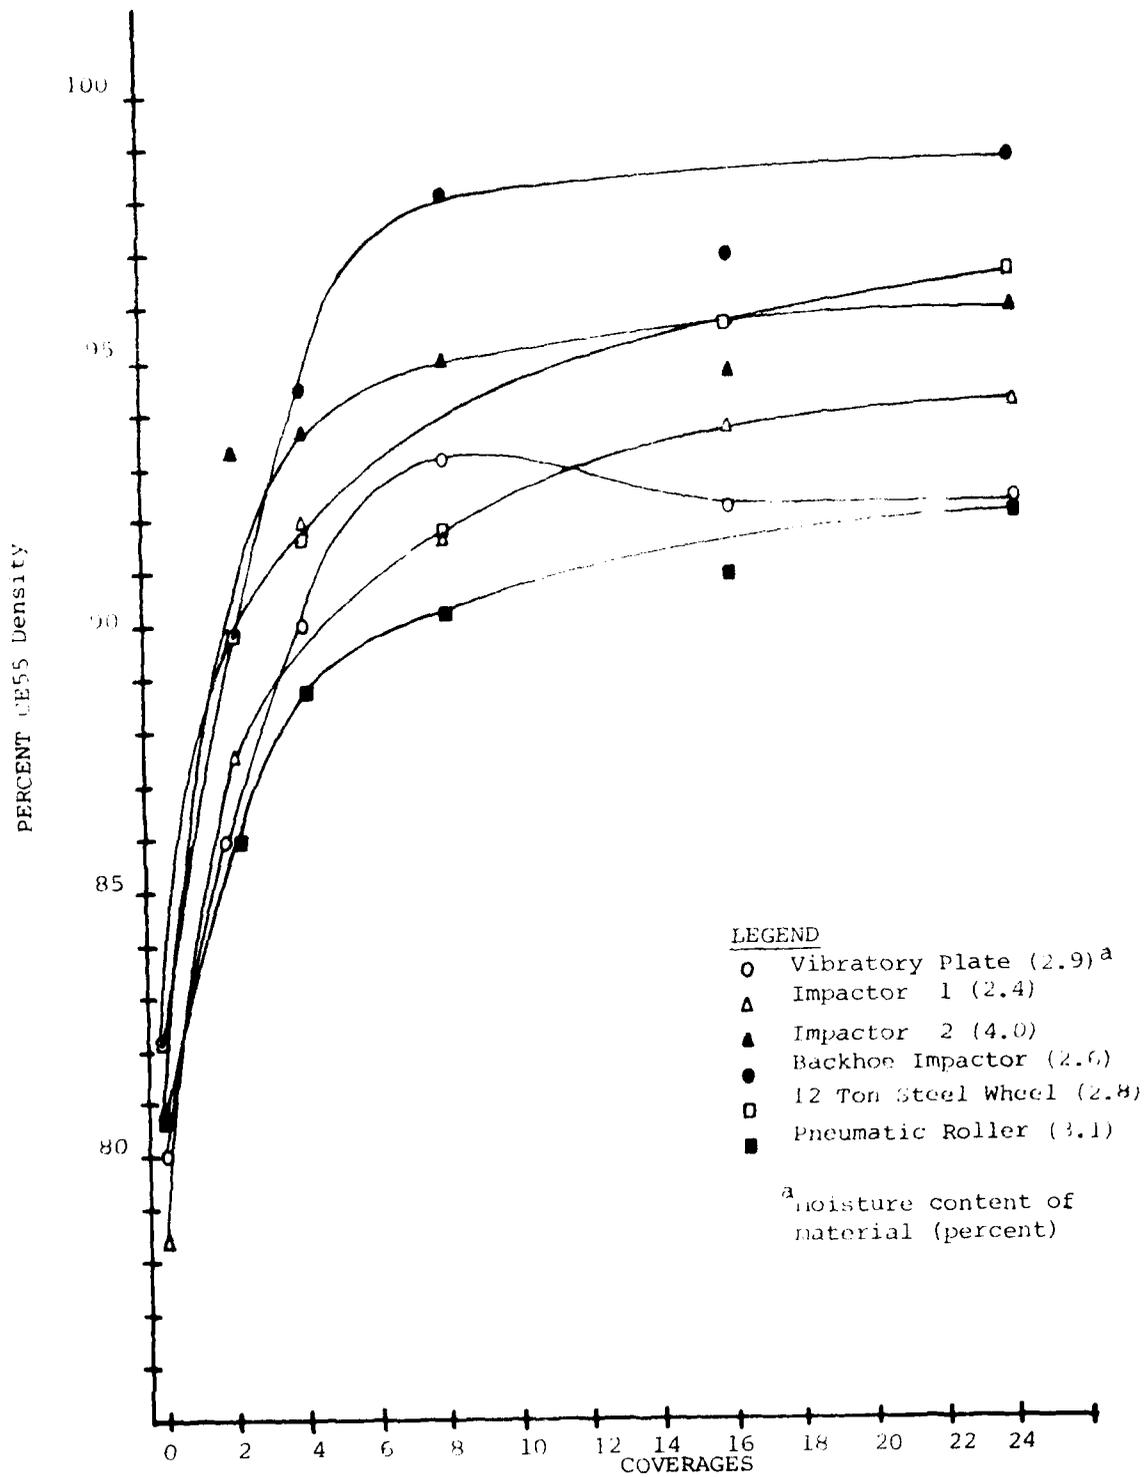
Figure 66. Compaction Results of Various Compactors

Density was recorded with a nuclear gage after 0, 2, 4, 8, 16, and 24 coverages of each piece of compaction equipment. Density and moisture content were recorded with the radioactive source probe at a 6-inch depth. Results are shown in Figure 66.

Of the two hand impact compactors, the smaller compactor (impactor 2 in Figure 66) obtained better results. However, this compactor was also compacting material closer to the optimum moisture content (moisture content shown in parentheses in the legend of Figure 66) which may account for this difference.

the steel wheel roller because it is no longer necessary to get into the hole. All of the equipment listed in Figure 66 required a large number of coverages (and hence large amount of time) to reach the required density.

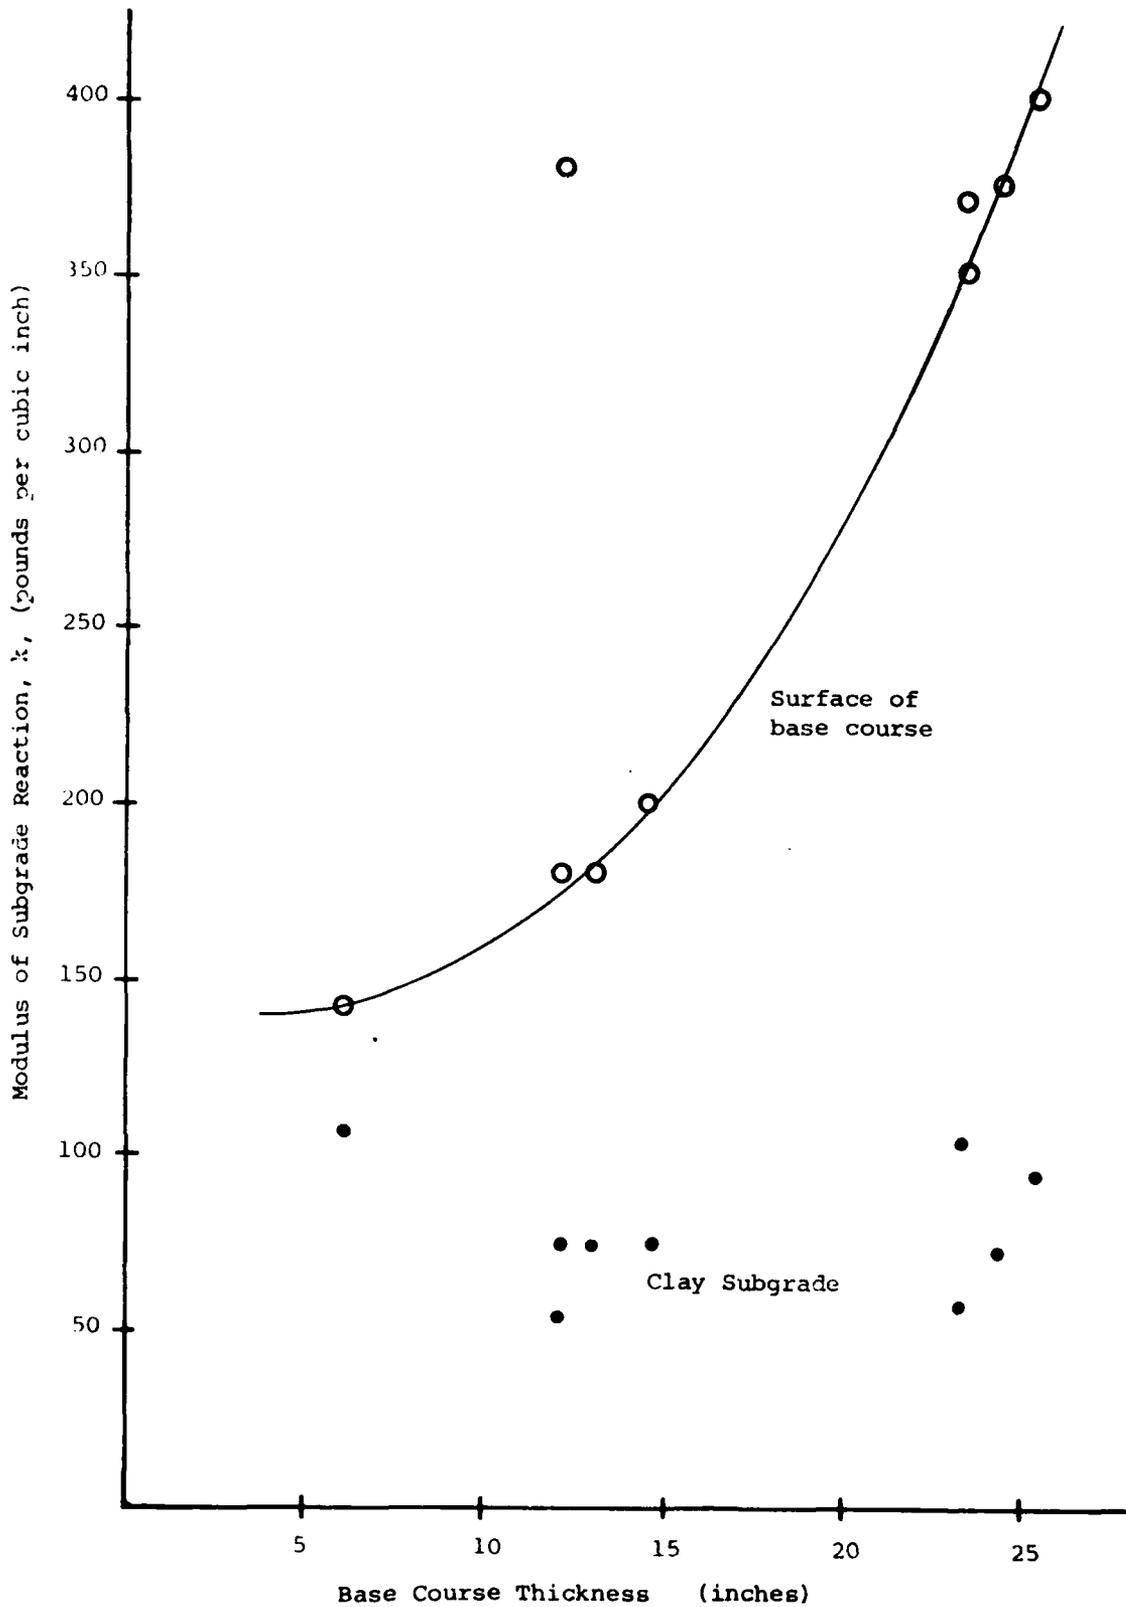
Figure 68. Effect of Base Course Thickness on Modulus of Subgrade Reaction (K)

The current method of debris backfill for craters results in a weak, compressible subgrade. Figure 68 shows the influence of thickness of the base course on the modulus of subgrade reaction. A 6-inch base had little influence, and 20 to 25 inches of base were required to raise the modulus to high levels.
