(6) NATIONAL DAM INSPECTION PROGRAM,  
BEAVER CREEK DAM  
(SCS PA 433).

~~CHESTER COUNTY DAM~~  
(NDS I.D. NUMBER PA 88903,  
DER I.D. NUMBER 15-301)

PHASE I INSPECTION REPORT,  
~~NATIONAL DAM INSPECTION PROGRAM~~

OVERVIEW  
BEAVER CREEK DAM (SCS PA 433), CHESTER COUNTY, PENNSYLVANIA

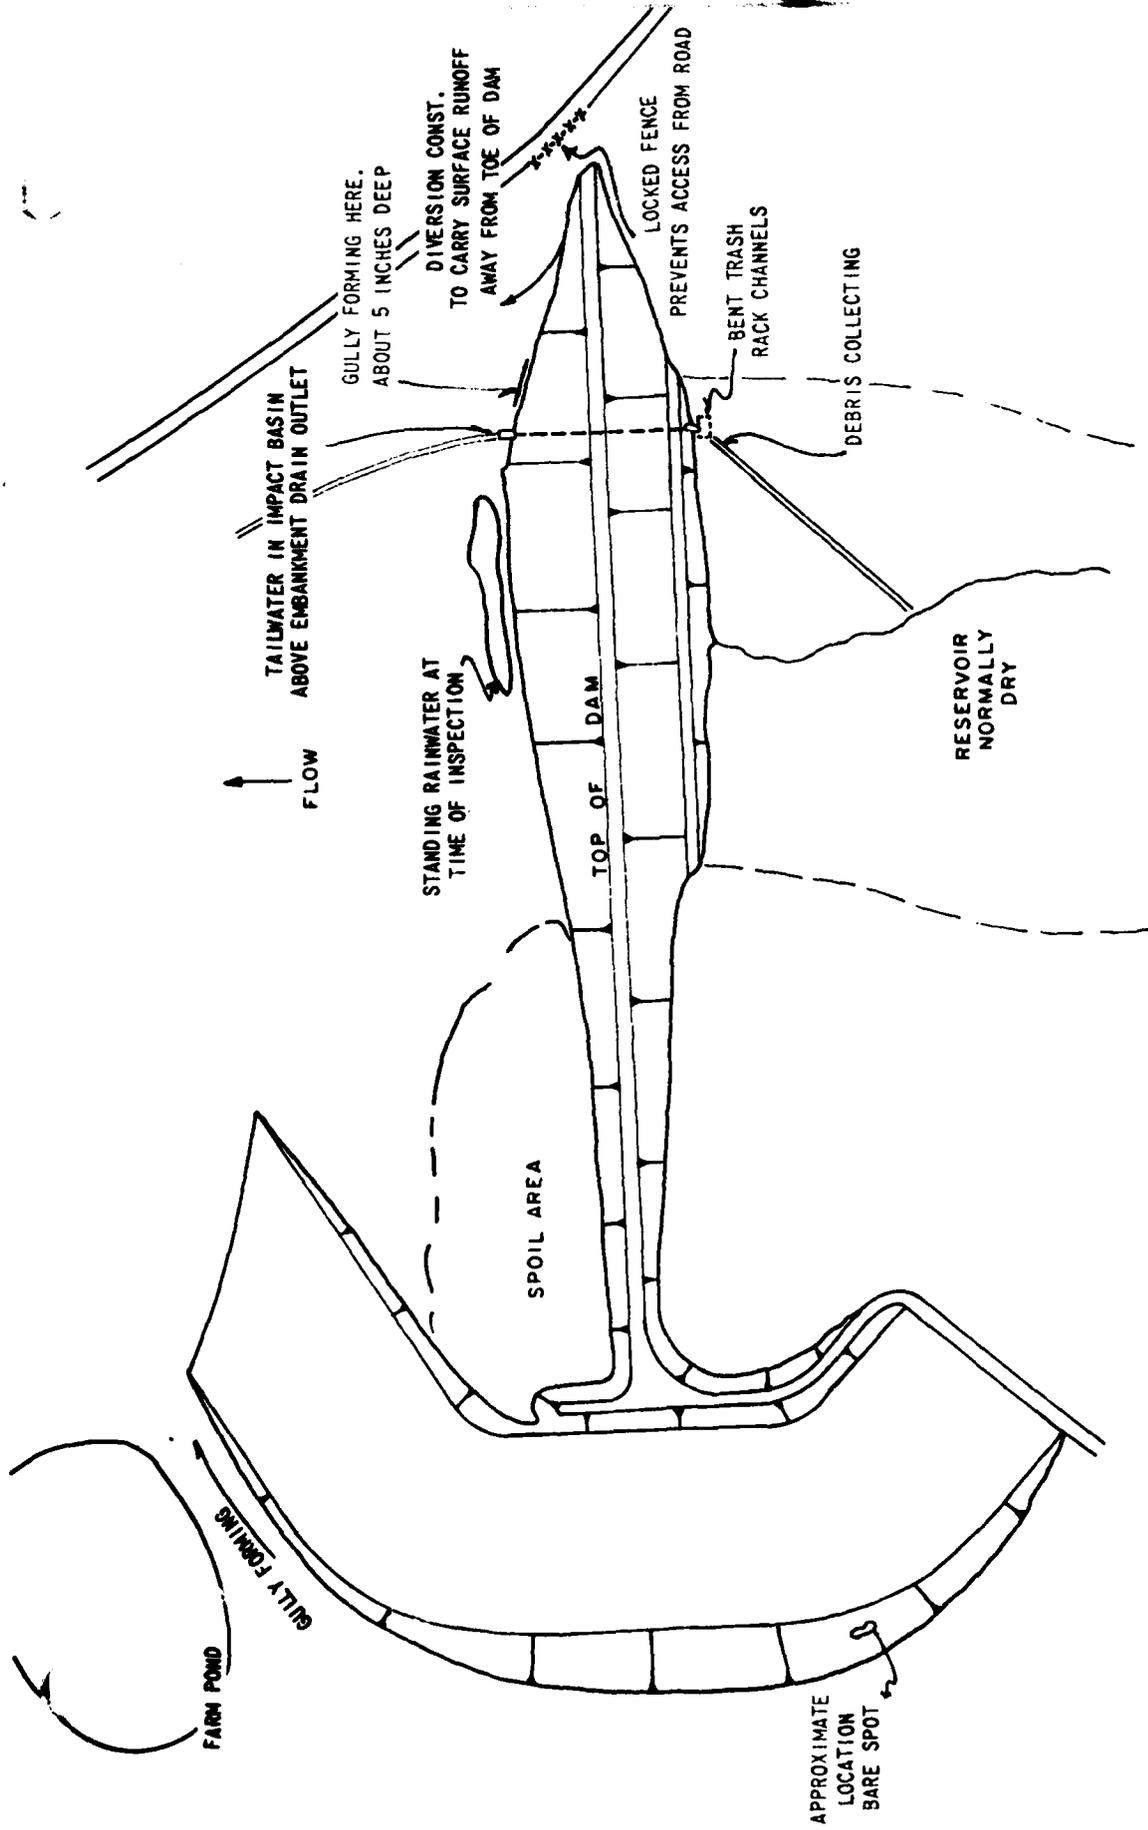
**SHEET 5A OF 11**

Wet areas and standing rainwater were observed on the upstream embankment below the berm and downstream beyond the toe of the dam.

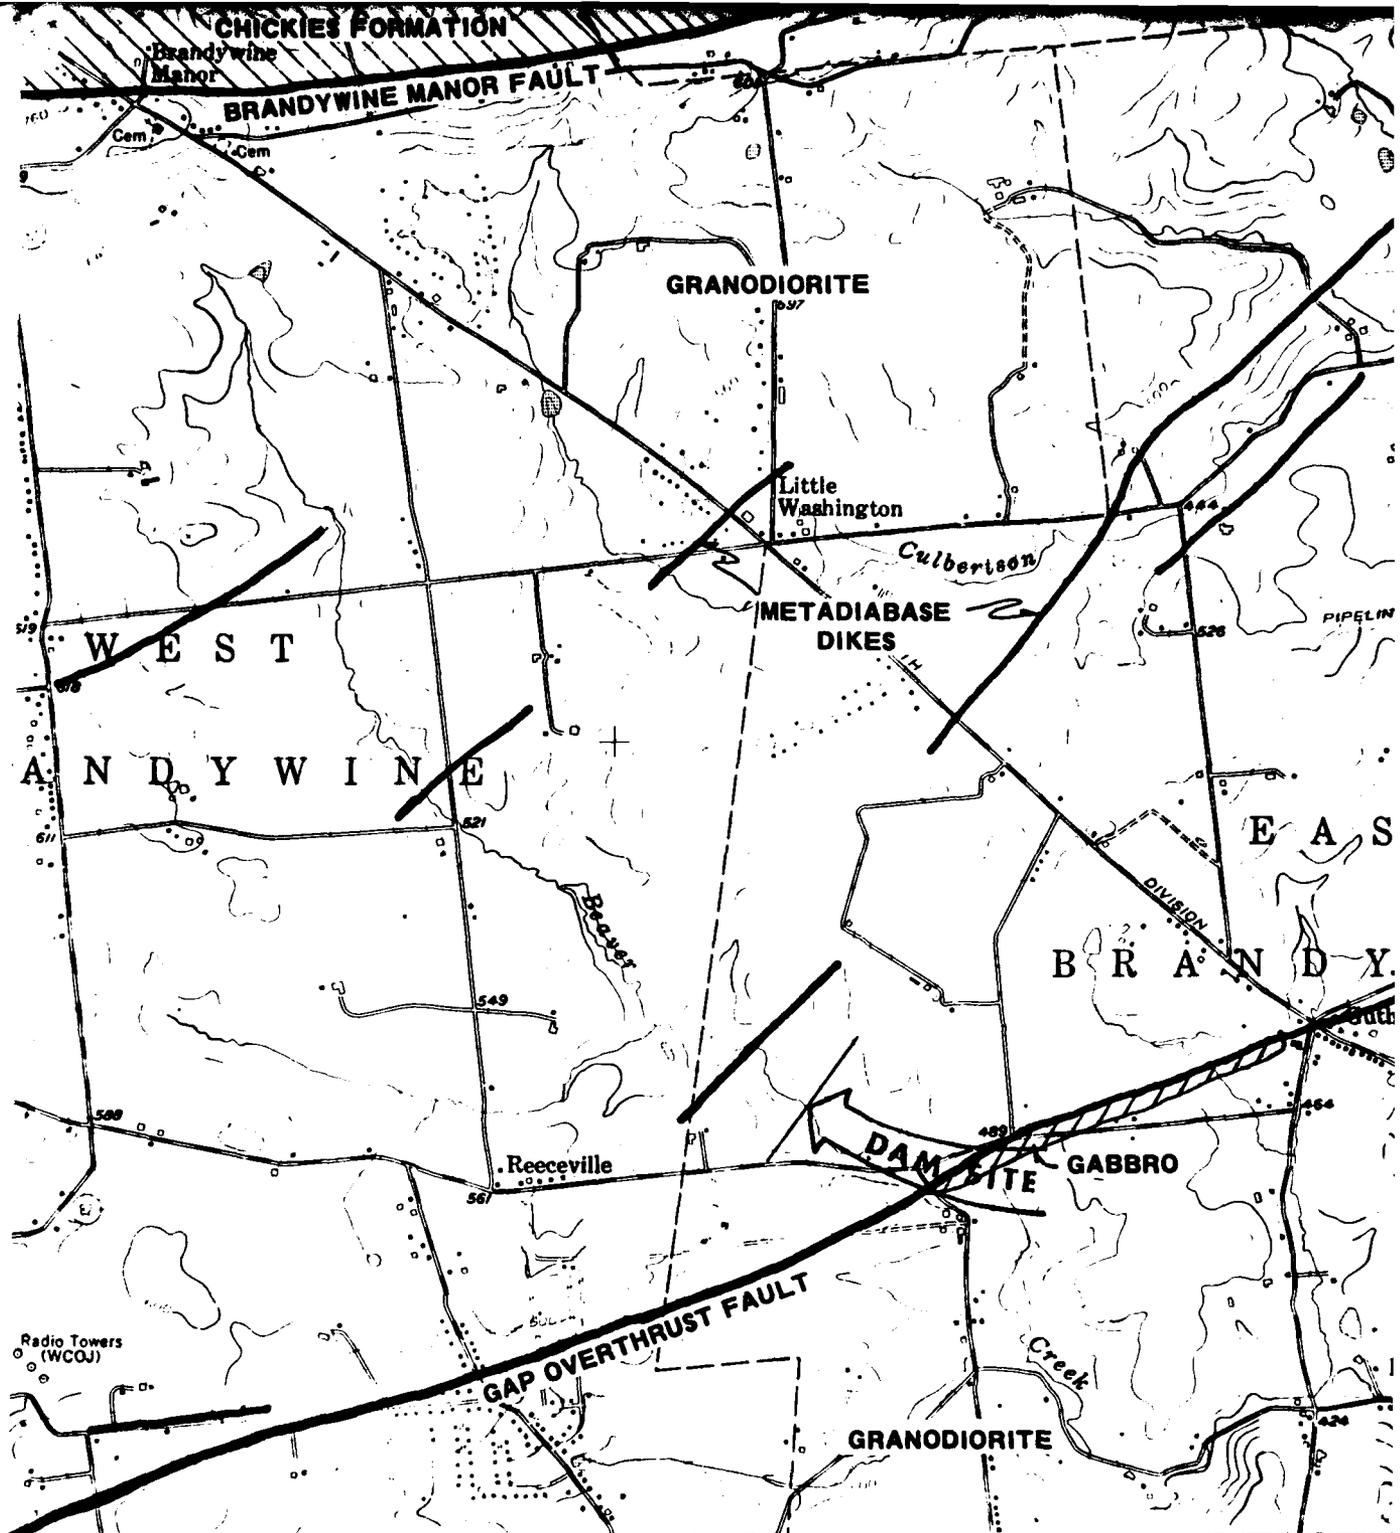
**SITE GEOLOGIC MAP  
BEAVER CREEK DAM  
(SCS DAM 433)**

Beaver Creek Dam is located in the Piedmont Uplands Section of the Piedmont Physiographic Province. As shown on Plate F-1, the area surrounding the dam consists predominantly of a granite like rock called granodiorite (referred to as quartz monzonite in the files of the Department of Environmental Resources in Harrisburg). Throughout the area, minor amounts of pegmatite and metadiabase occur as dikes. No bedrock exposures were observed during the field inspection, but the original geology report describes steeply dipping "flow structures" in the weathered bedrock and saprolite, encountered during the Soil Conservation Service site investigation. Granodiorite is a dense igneous rock usually having variable thickness of weathered or decomposed surficial material above the sound bedrock. Several regional east-northeasterly striking thrust faults occur in the area, one being about 1,200 feet to the north and the other about 1,000 feet to the south of the right abutment.
