LAKE JAMIE DAM

NDI ID NO. PA-00778  
DER ID NO. 45-220

PHASE I INSPECTION REPORT  
NATIONAL DAM INSPECTION PROGRAM

Prepared by  
GANNETT FLEMING CORDDRY AND CARPENTER, INC.  
Consulting Engineers  
Harrisburg, Pennsylvania 17105

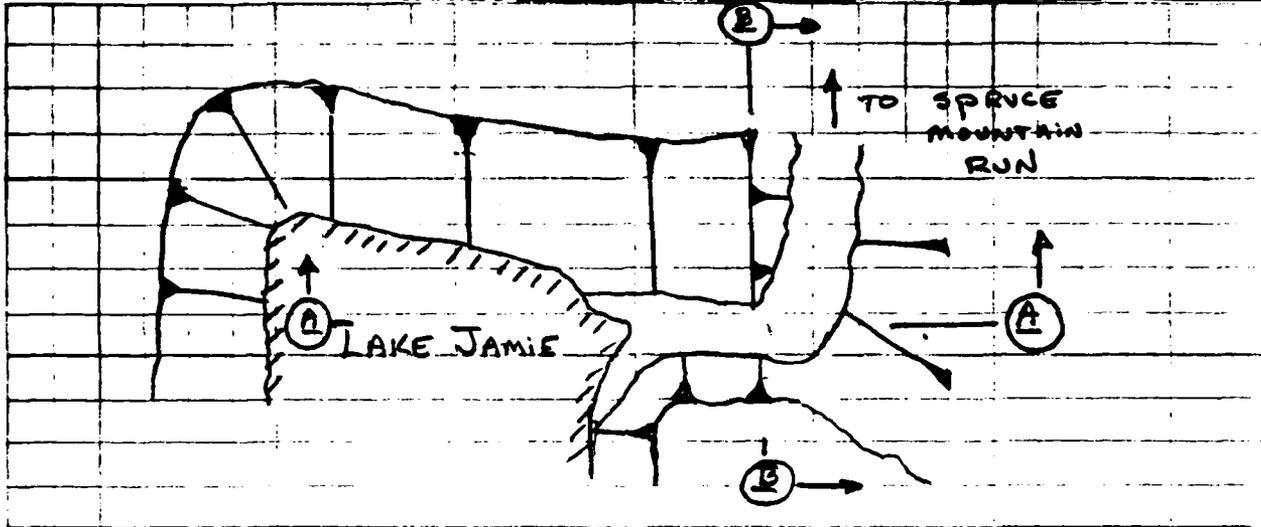
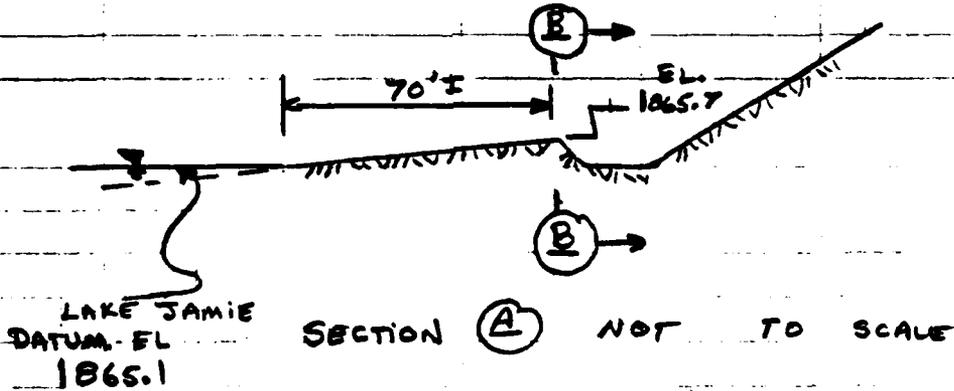
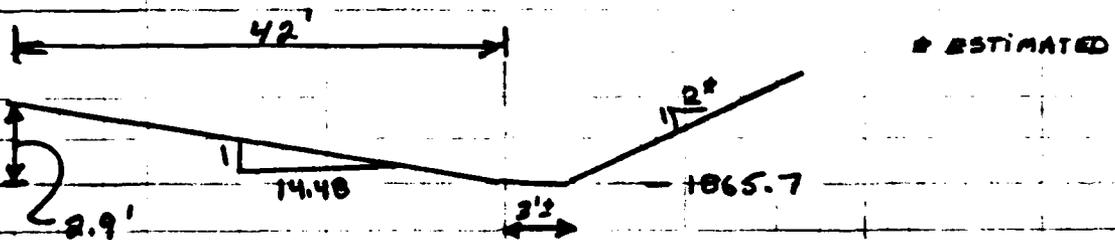
AUXILIARY Spillway

Conditions at the auxiliary spillway are satisfactory at present. Maintaining the area would ensure that its discharge capacity would not decrease.

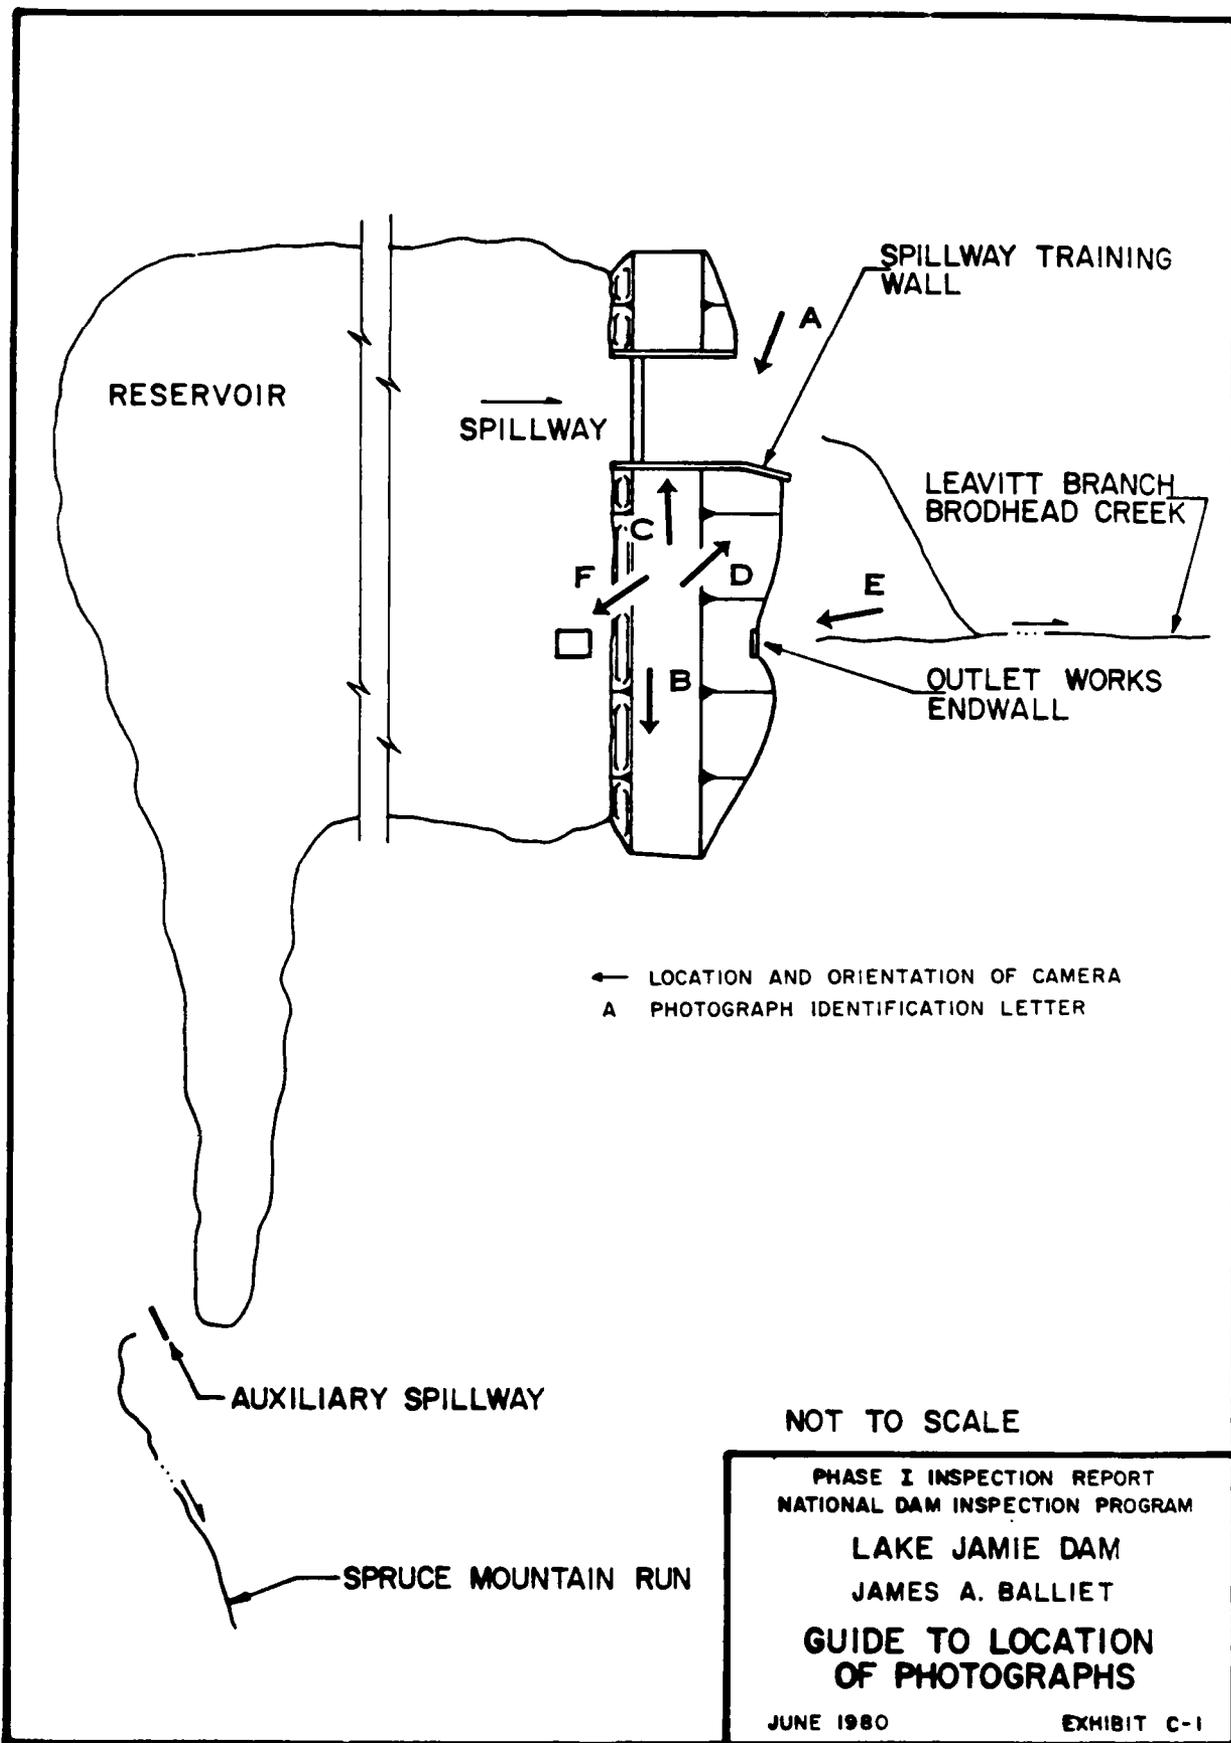
F. Outlet Works Intake Structure

The outlet works is in fair condition. Minor spalling was observed on the endwall and intake structure (Photographs E and F). The intake structure tilts toward the dam (Photograph F). The gate operating mechanism on the intake structure is rusty. The Owner stated that it has not been operated since the dam was constructed; he reported that he had been instructed shortly after the dam was built by a representative of the Commonwealth to never operate the gate. He felt that the intake structure was partially silted, which would hinder the gate operation. Therefore, he declined to attempt to operate it for the inspection team.
