REPORT DOCUMENTATION PAGE		READ INSTRUCTIONS BEFORE COMPLETING FORM
1. REPORT NUMBER	2. GOVT ACCESSION NO.	3. RECIPIENT'S CATALOG NUMBER
4. PHASE (and Subphase) Lake Flower Dam Lake Champlain River Basin, Franklin County, NY Inventory No. 707		5. TYPE OF REPORT & PERIOD COVERED Phase I Inspection Report National Dam Safety Program

7. AUTHOR(s) John B. Stetson		6. PERFORMING ORG. REPORT NUMBER
9. PERFORMING ORGANIZATION NAME AND ADDRESS Stetson-Dale Engineering Company Bankers Trust Building Utica, NY 13501		8. CONTRACT OR GRANT NUMBER(s) DACW-51-79-C-0001

PHASE I INSPECTION REPORT
NATIONAL DAM SAFETY PROGRAM
NAME OF DAM - LAKE FLOWER DAM ID# - NY 707

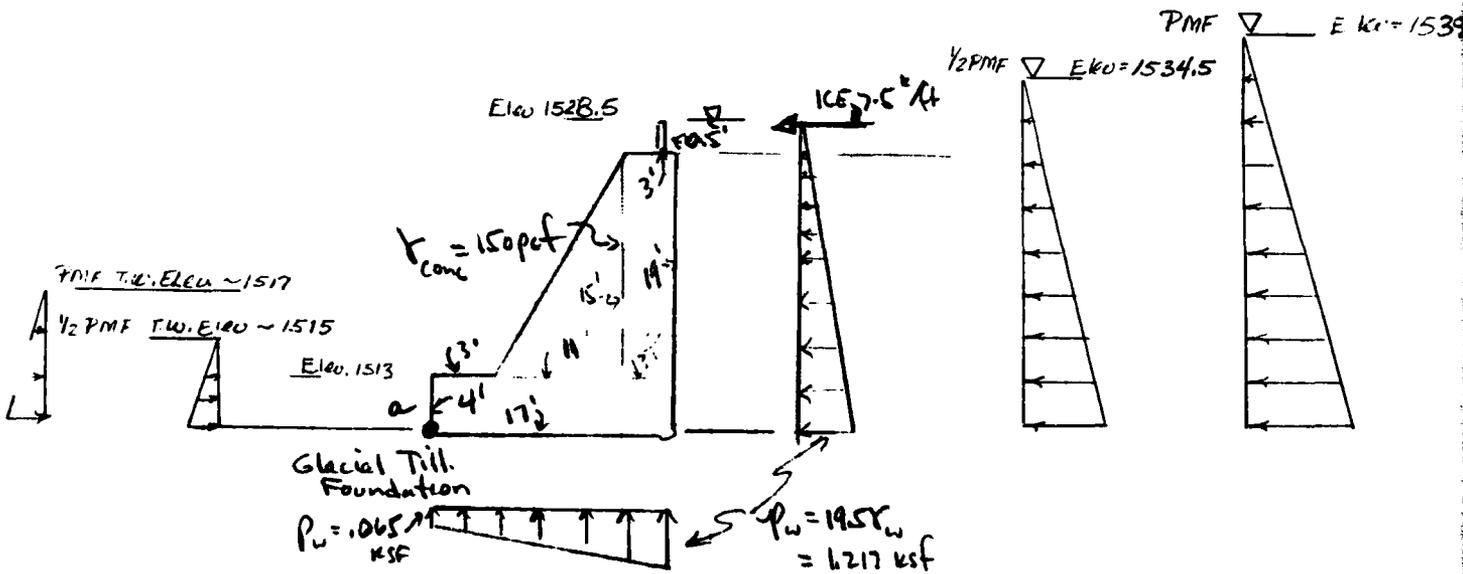
Assumed Cross - Section For Analysis

$$\text{Weight Dam} = (0.150) \left[(17 \times 4) + (15 \times 3) + \left(\frac{1}{2} \times 11 \times 15 \right) \right] = 29.33 \text{ k/ft}$$

$$M_a \text{ due to weight of dam} = (0.15) \left[(17 \times 4 \times \frac{17}{2}) + (15 \times 3) \left(14 + \frac{3}{2} \right) + \left(\frac{1}{2} \times 11 \times 15 \right) \left(3 + \frac{2 \times 11}{3} \right) \right]$$

FS against overturning = $\frac{319.2 \text{ k}}{197.5 \text{ k}} = 1.62$

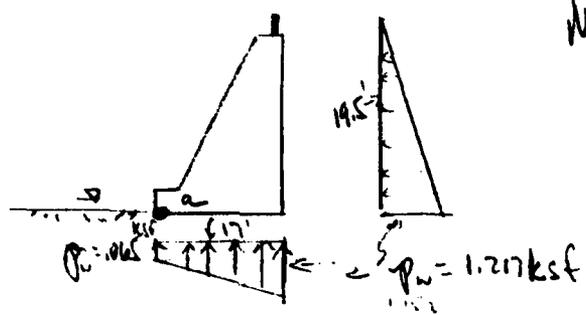
$upl. H_1 U = \left(\frac{0.065 + 1.47}{2} \right) (h)$
 $= 10.9 \text{ k}$

$M_a \text{ causing overturning due to upst. lateral } H_2O, \text{ uplift}$
 $= \left(\frac{1}{2} \times 19.5 \times 1.217 \times \frac{19.5}{3} \right) + \left[0.065 \times 17 \times \frac{17}{2} \right] + \left(\frac{1}{2} \times 17 \times 1.152 \times \frac{2 \times 17}{3} \right)$
 $= 77.13 + 9.39 + 110.98 = 197.5 \text{ k}$

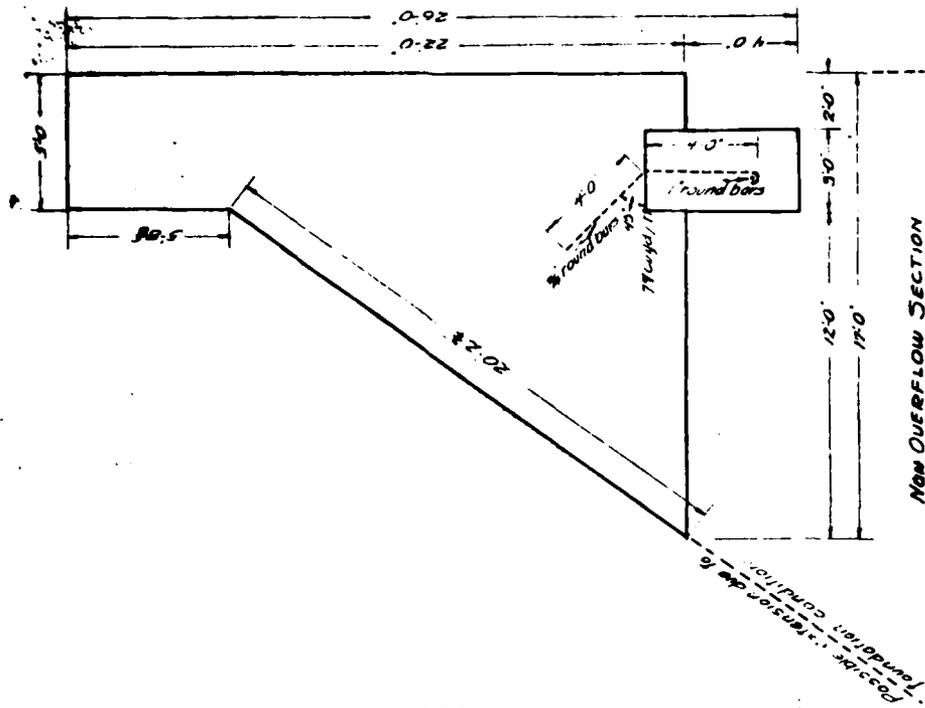
NON OVERFLOW SECTION

$$\text{F.S.} = \frac{20 \text{ k} + 2 \text{ k}}{11.9 \text{ k} + 12.4 \text{ k}} = 0.9 \quad \text{N.G.}$$
