REPORT DOCUMENTATION PAGE		READ INSTRUCTIONS BEFORE COMPLETING FORM
1. REPORT NUMBER	2. GOVT ACCESSION NO. A092219	3. RECIPIENT'S CATALOG NUMBER
4. TITLE (and Subtitle) Phase I Inspection Report Tivoli Lake Dam Hudson River Basin, Rockland County, New York Inventory No. 052		5. TYPE OF REPORT & PERIOD COVERED Phase I Inspection Report National Dam Safety Program

1. OVERVIEW OF DAM

PHASE I INSPECTION REPORT
NATIONAL DAM SAFETY PROGRAM
TIVOLI LAKE DAM
I.D. NO. N.Y. 52
D.E.C. NO. 306
HUDSON RIVER BASIN
ROCKLAND COUNTY, NEW YORK

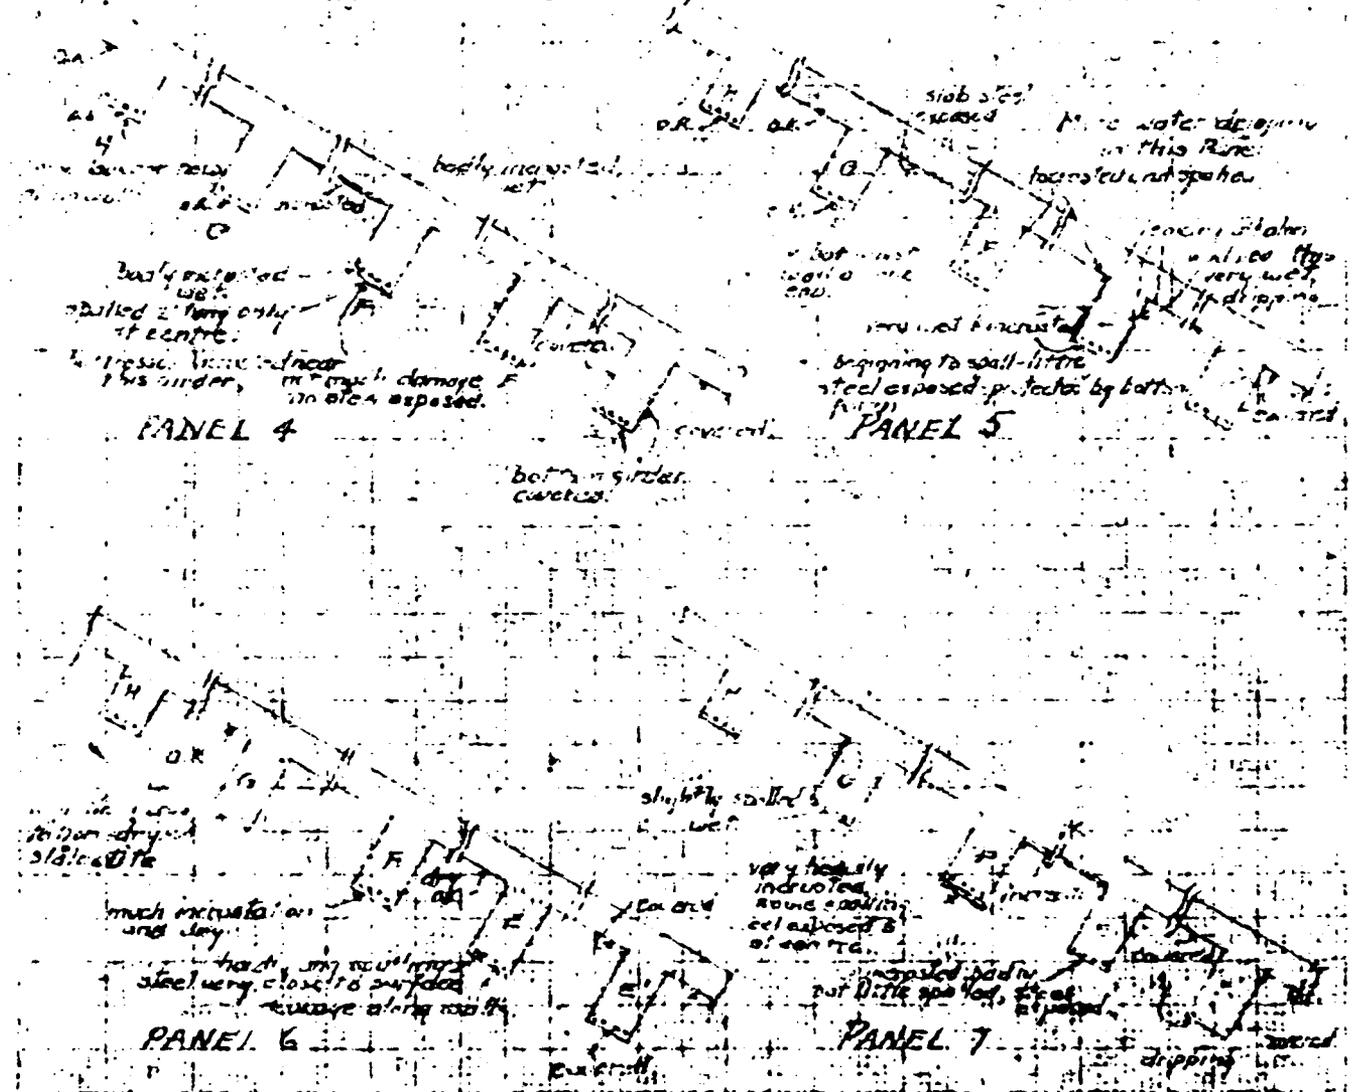
NOTES: DETAIL SECTIONS THROUGH PANELS

1. No concrete floor between buttresses in most panels - ground water saturated with moisture which runs off continuously through slabs. Spacing of some total amount small. Not certain whether or not some water passes at side of buttress whether some water passes under the top of dam.
2. Upper floor of a pair of series of dams especially at left hand end. Water may pass around upper walls or through cracks between wing walls and body of dam. Evidence of seepage does not appear at present to extend or to have done up to wash out parts from the crevices of the dam.
3. This point should be watched in future to be sure that side does not increase to dangerous extent.

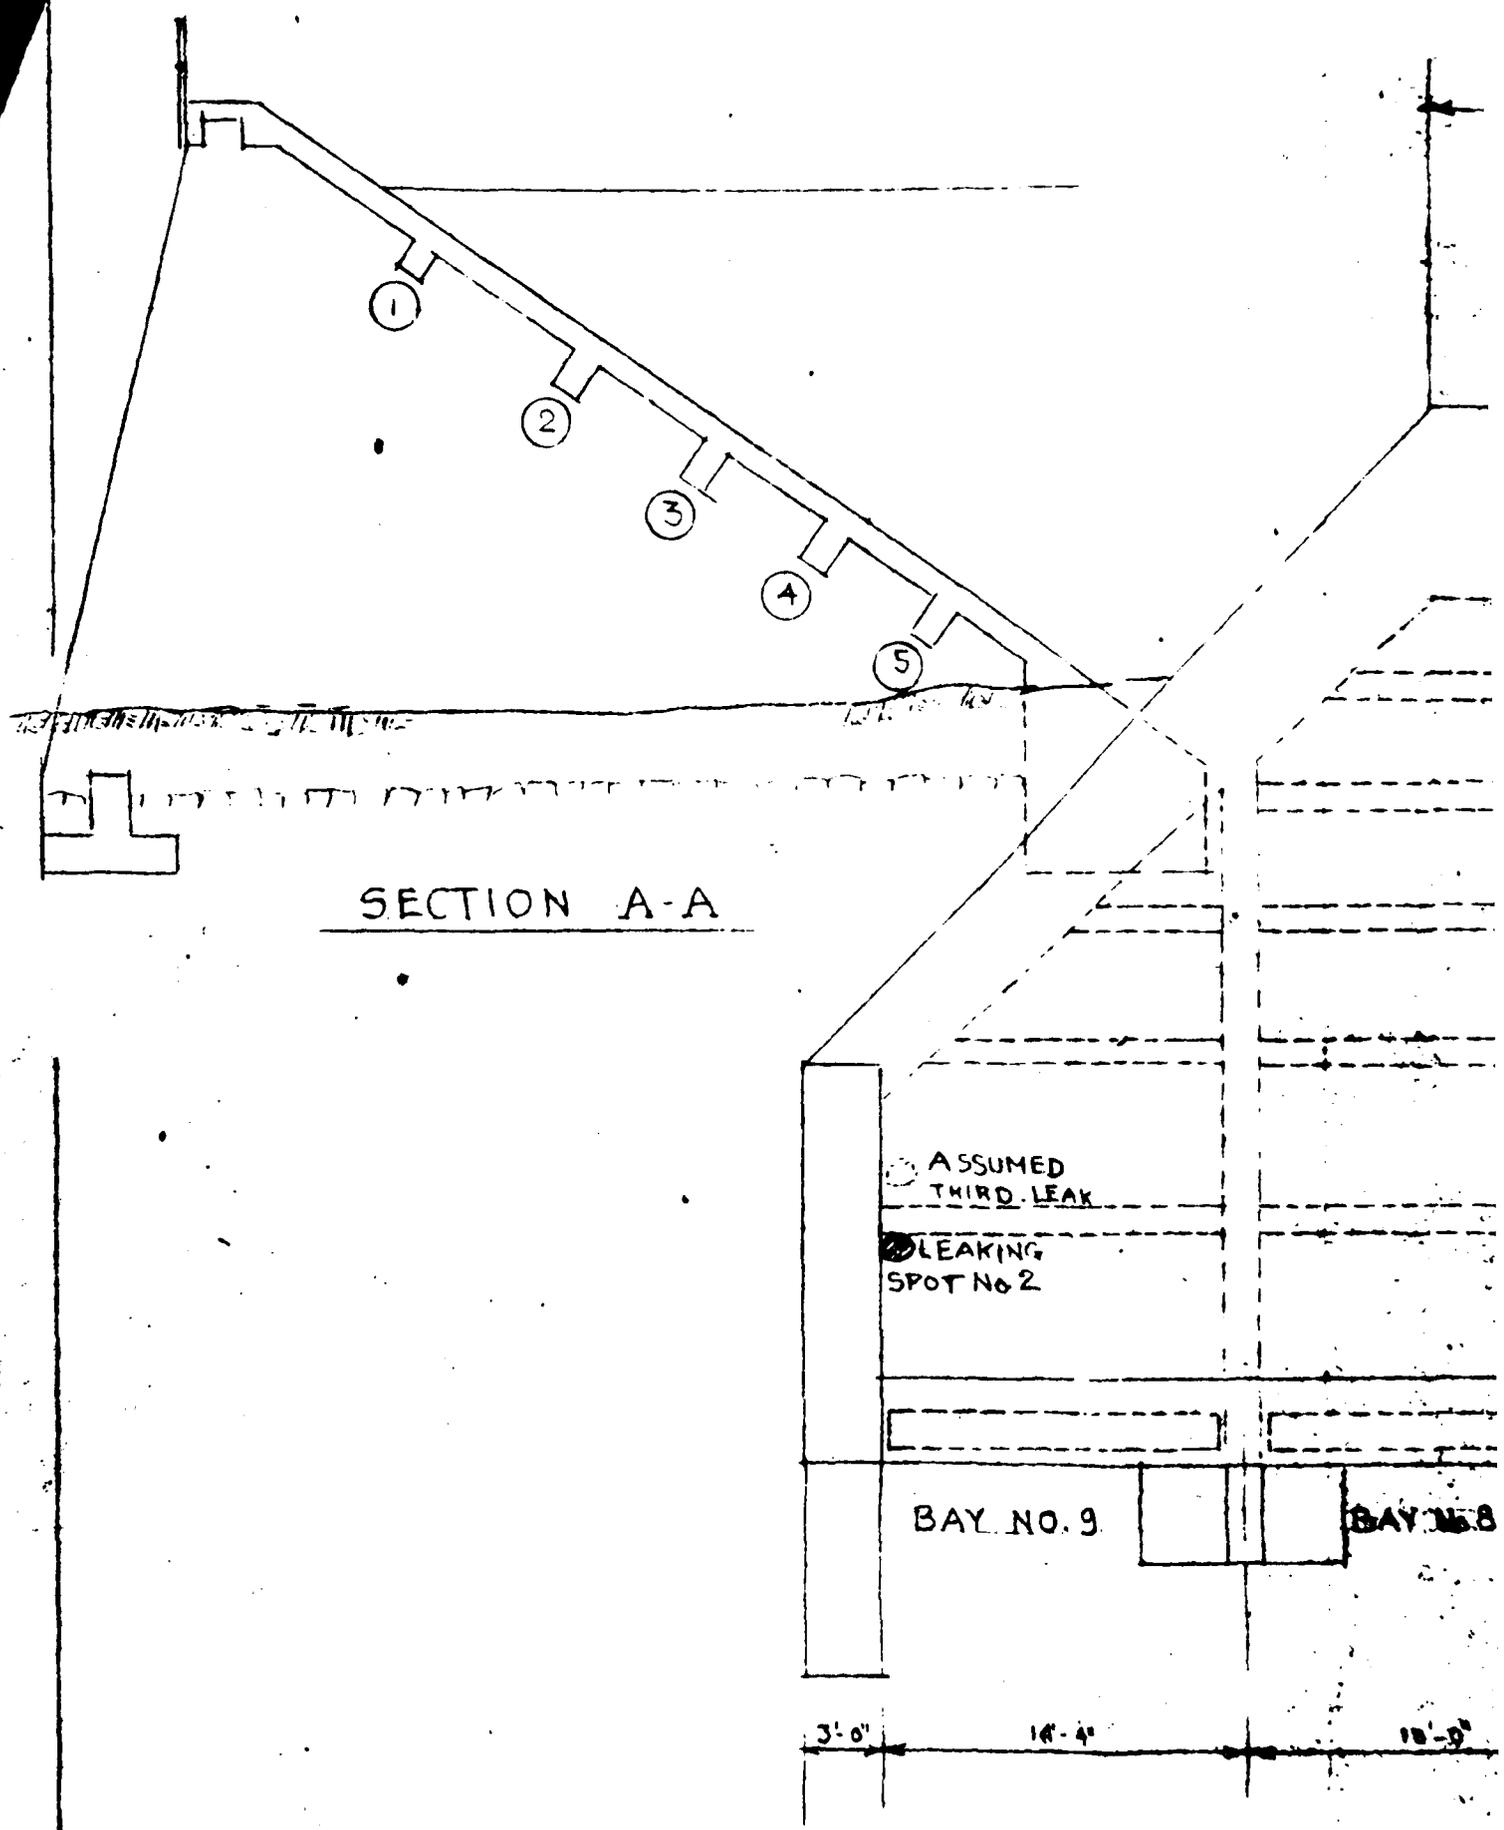
LOCATION OF NECESSARY CONCRETE REPAIRS.

SECTION A-A

○ ASSUMED
THIRD LEAK

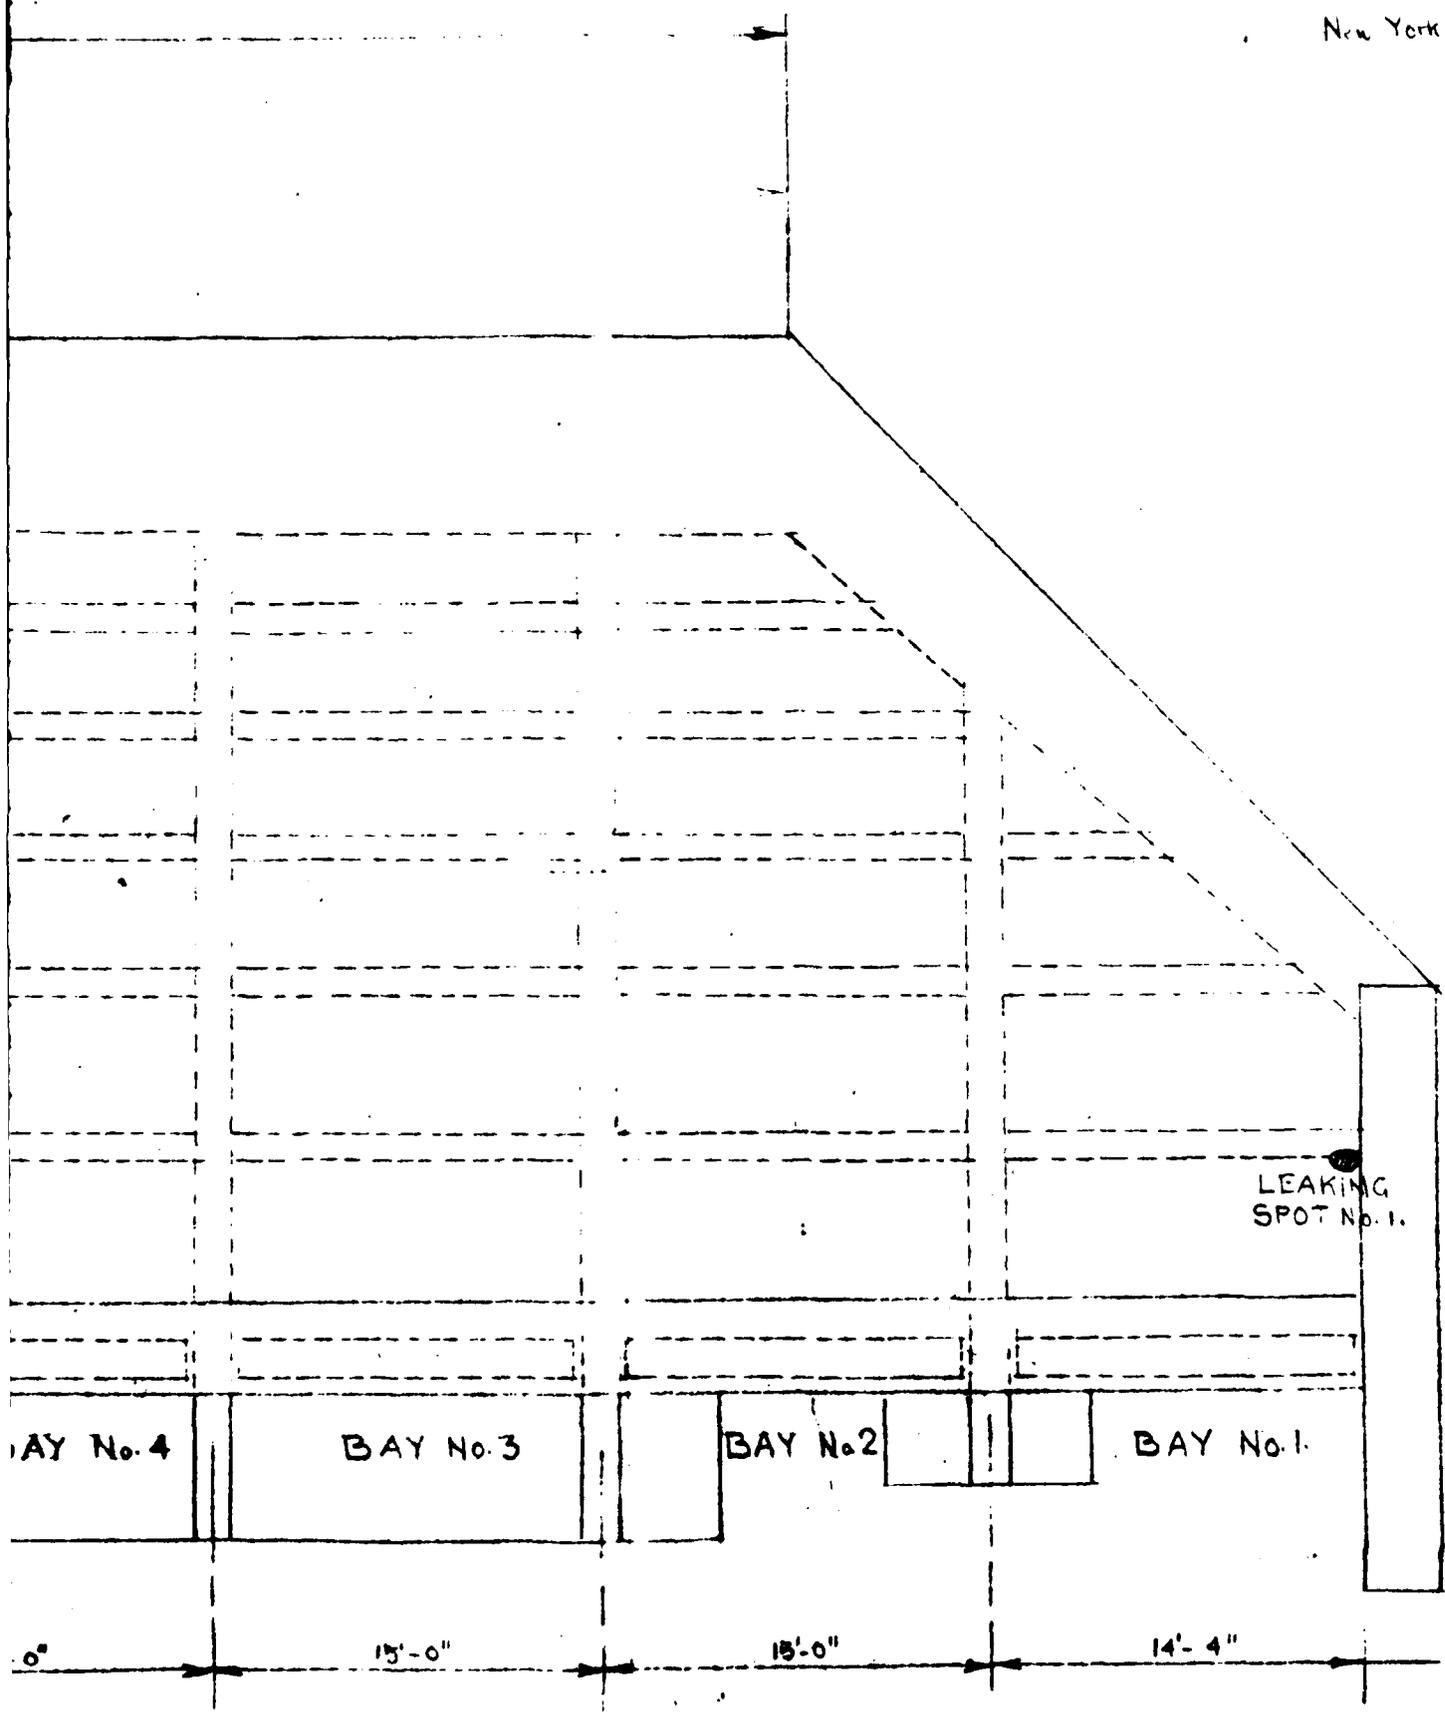
LEAKING
SPOT No. 1.

BAY No. 4

THE INDICATED SPOTS OF NECESSARY REPAIRS DO NOT SHOW ALL THE LOCATIONS WHERE REHABILITATION MUST BE MADE. CONTRACTOR SHALL EXECUTE ALL REPAIRS WITHIN THE QUANTITIES OF THE BID LIST WHICH HE WILL FIND ON THE DAM
