**DSCS II
SATELLITE 9444
TELEMETRY TRANSMITTER ANOMALY REPORT**

AUGUST 1980

**DEPARTMENT OF THE AIR FORCE HEADQUARTERS
SPACE DIVISION (AFSC)**

CDRL Sequence Number 009A2
Contract F04701-80-C-0022
Report No. 36060-AR-022-01

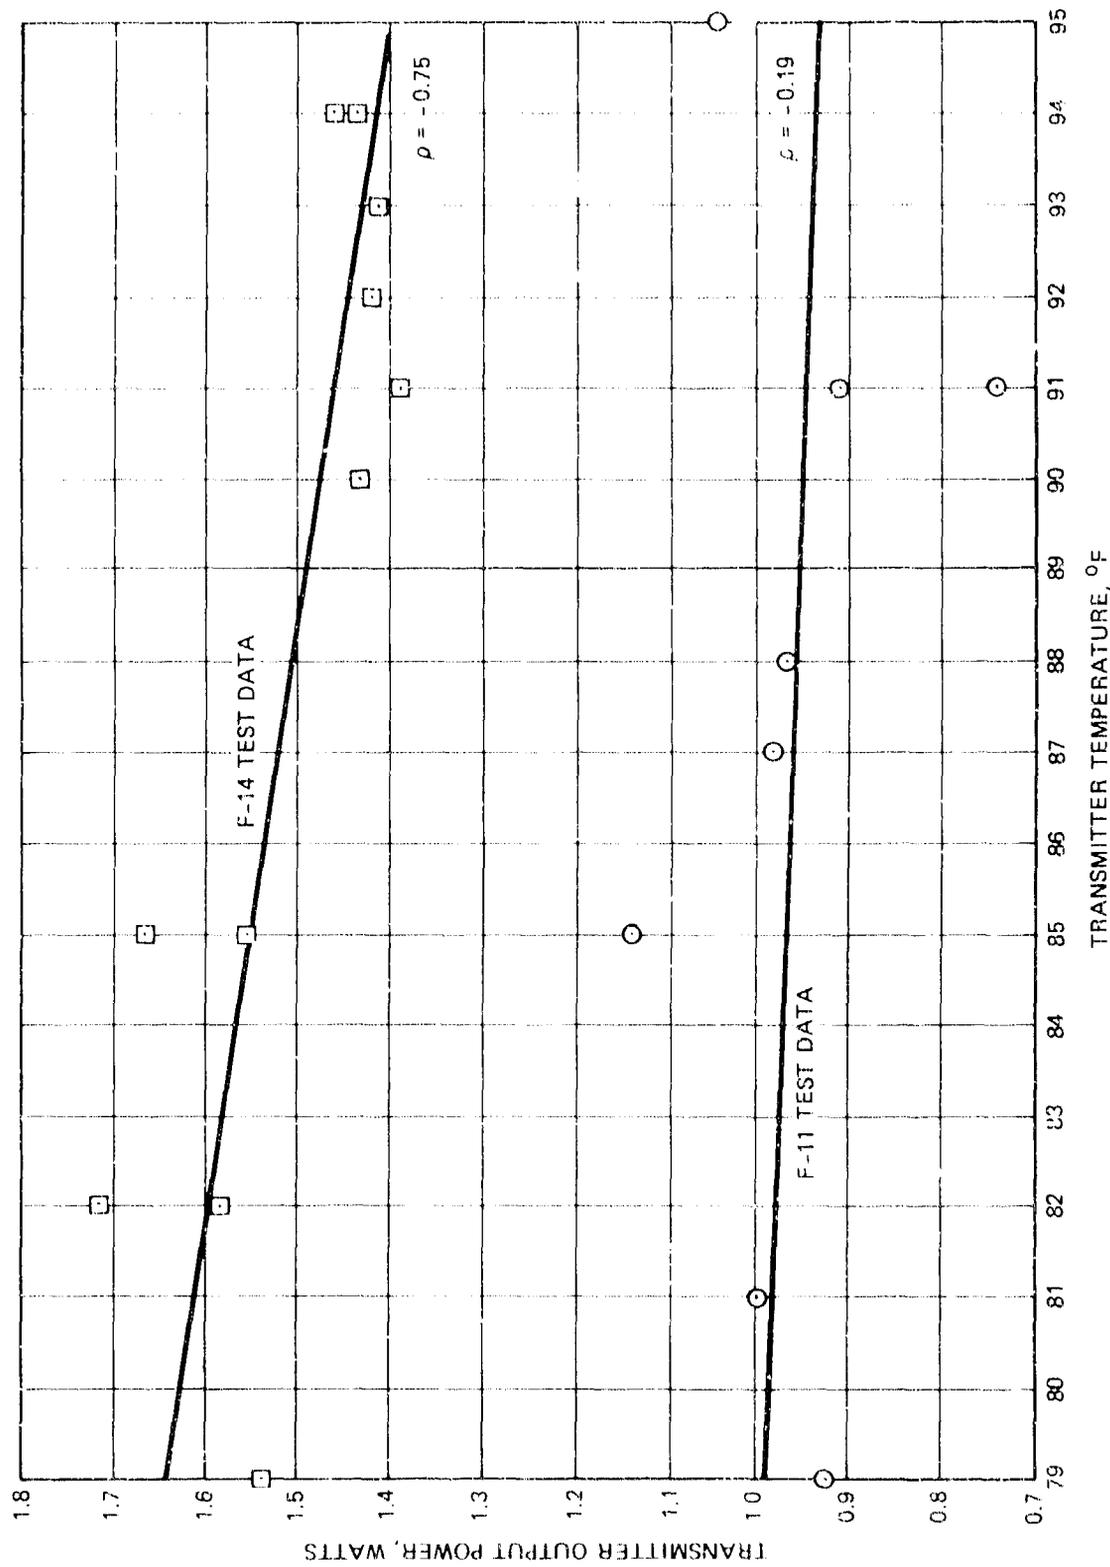
Figure 2-4. Transmitter S/N 3-25 Power vs Temperature

No anomalies were observed during reacceptance testing, subsequent integration testing or prelaunch checkout at Cape Kennedy. The results of integration testing on both F-11 and F-14 are shown in Table 2-1. Transmitter output power versus calendar time are shown plotted in Figure 2-3 together with least squares trend lines. Note the significant improvement in output power after retuning. The effect of temperature on output power is shown in Figure 2-4. There was very little correlation on Flight 11; somewhat more on Flight 14, but not enough to be considered significant.
