**DEPARTMENT OF DEFENCE
DEFENCE SCIENCE AND TECHNOLOGY ORGANISATION
AERONAUTICAL RESEARCH LABORATORIES**

Structures Technical Memorandum 327

A REVIEW OF AUSTRALIAN INVESTIGATIONS ON
AERONAUTICAL FATIGUE DURING THE PERIOD
APRIL 1979 TO MARCH 1981

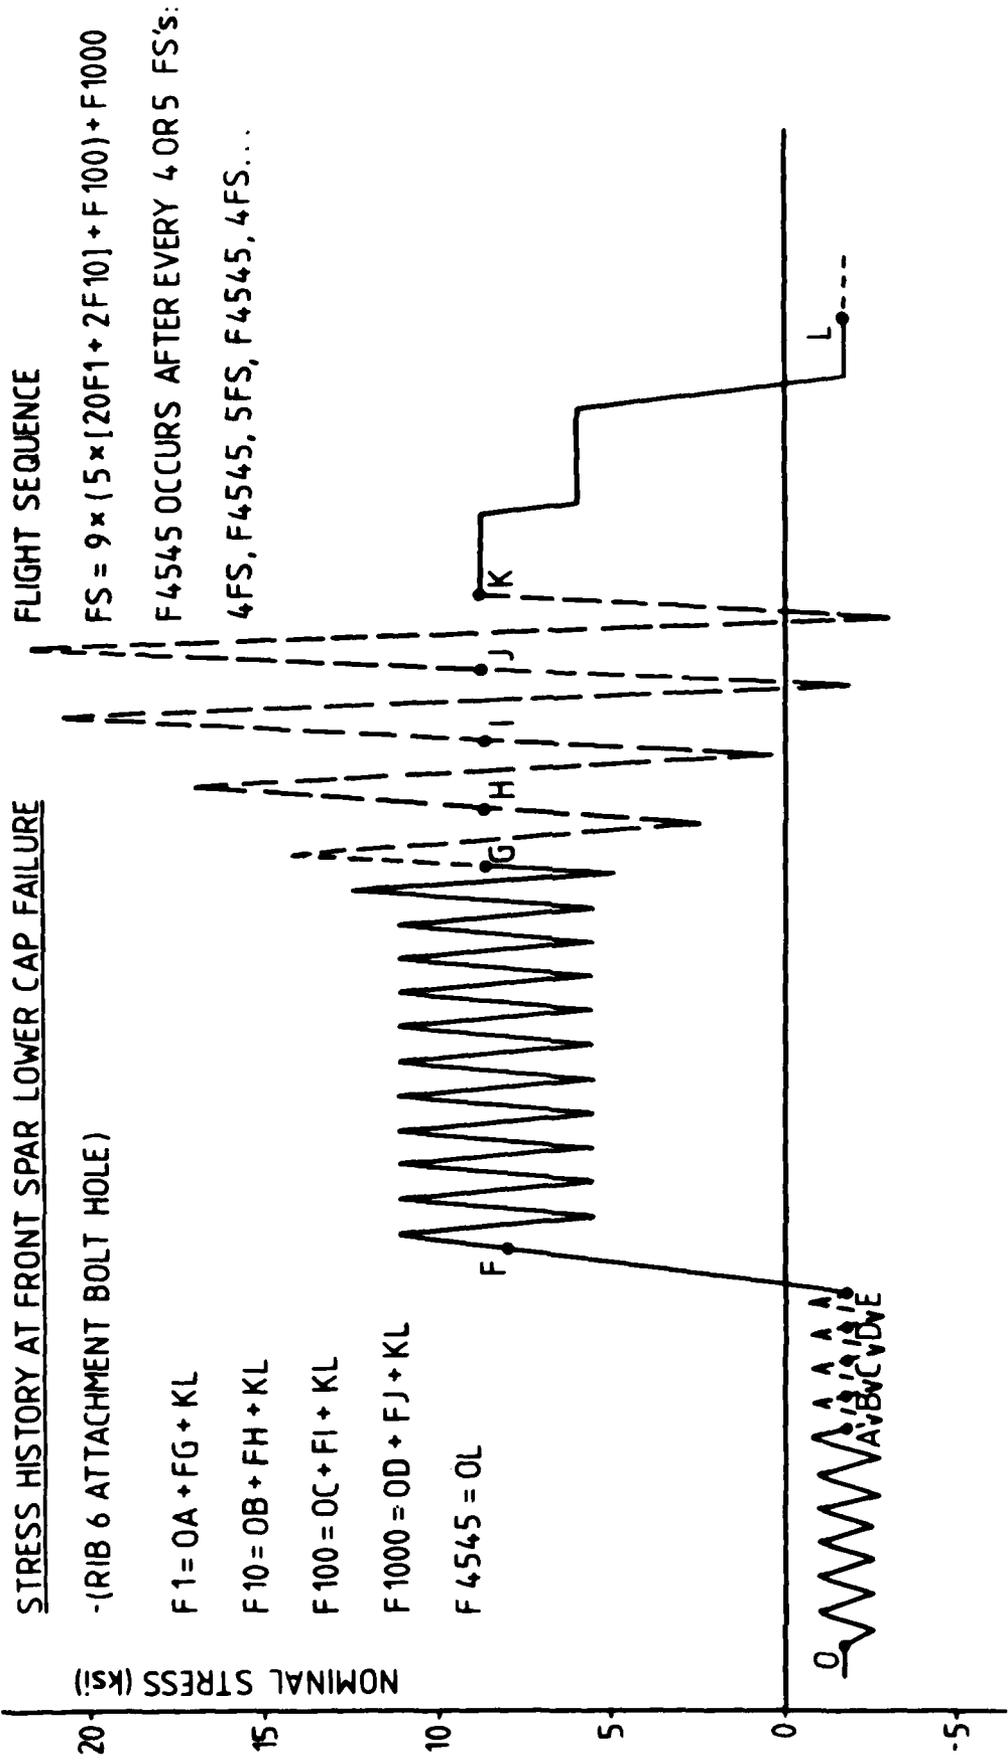
FIG. 9.11 BANDEIRANTE FATIGUE TEST SEQUENCE

THE POSITION OF THE FRONT SPAR LOWER CAP FRACTURES
SITUATED IN THE AIRCRAFT.
