WESTCOLANG LAKE DAM

NDI I.D. NO. PA-00396
PENNDER I.D. NO. 52-4

PHASE I INSPECTION REPORT
NATIONAL DAM INSPECTION PROGRAM.

GAI CONSULTANTS, INC.
570 BEATTY ROAD
MONROEVILLE, PENNSYLVANIA 15146

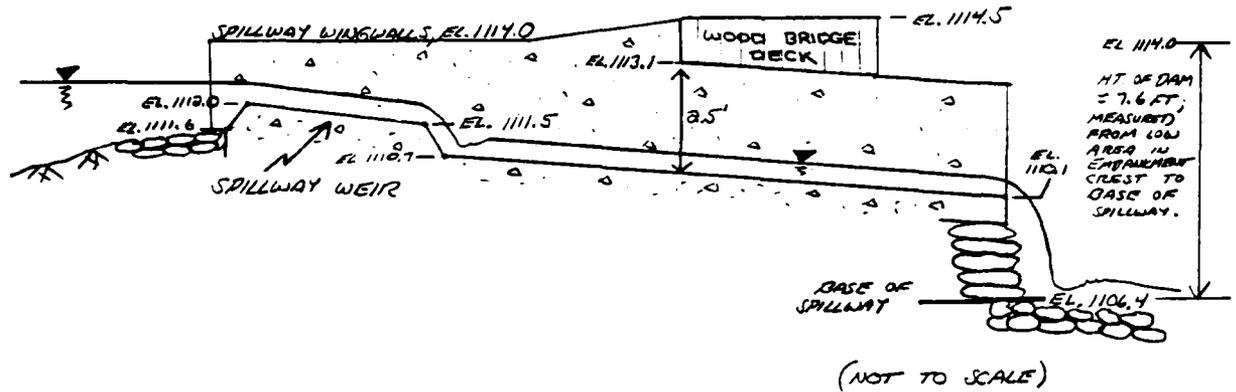
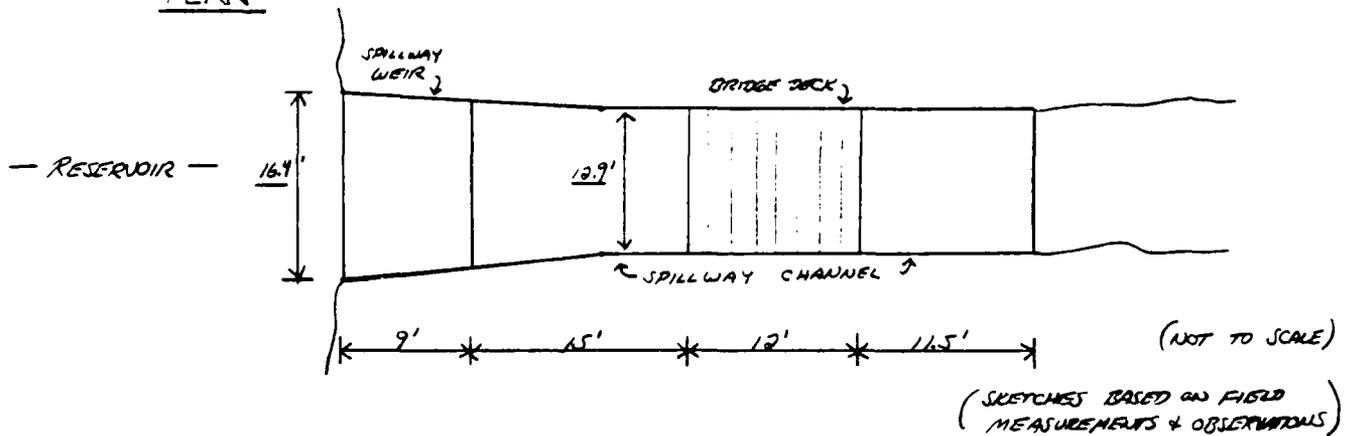
SPILLWAY CAPACITY

THE SPILLWAY CONSISTS OF AN UNCONTROLLED, RECTANGULAR-SHAPED CONCRETE AND MASONRY CHUTE CHANNEL, WITH DISCHARGES REGULATED BY A CONCRETE BROAD-CRESTED WEIR.
