AD-A099 671 NEW JERSEY DEPT OF ENVIRONMENTAL PROTECTION TRENTON F/6 8/8  
NATIONAL DAM SAFETY PROGRAM. SILVER LAKE DAM (NJ00469), WALLKIL--ETC(U)  
MAY 81 R MCDERMOTT, J E GRIBBIN DACW61-79-C-0011

SILVER LAKE DAM (NJ00469)

PHASE I REPORT  
NATIONAL DAM SAFETY PROGRAM

Name of Dam: Silver Lake Dam, I.D. NJ00469  
State Located: New Jersey  
County Located: Sussex  
Drainage Basin: Wallkill River  
Stream: Tributary to Franklin Pond Creek  
Date of Inspection: December 19, 1980

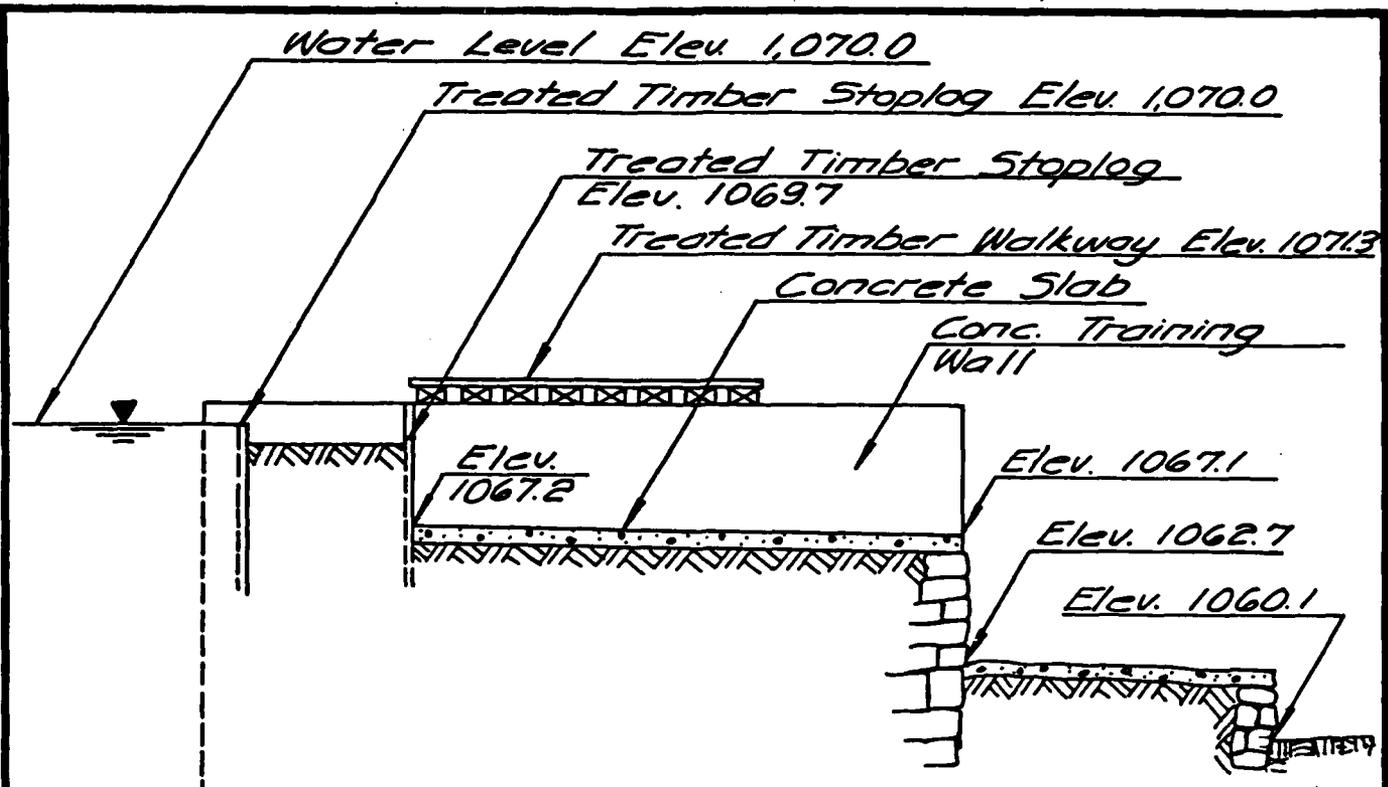
SPILLWAY SECTION

Some of the timber stoplogs were buckled and leaking. The remaining stoplogs appeared to be in satisfactory condition. The timber walkway spanning the discharge channel was in satisfactory condition.

- 1) Deteriorated stoplogs in the spillway should be replaced.
- 2) Deteriorated concrete in the spillway structure should be repaired.
