DEER HEAD LAKE DAM

(NJ 00789)

PHASE I INSPECTION REPORT,  
NATIONAL DAM SAFETY PROGRAM

MAY 1981

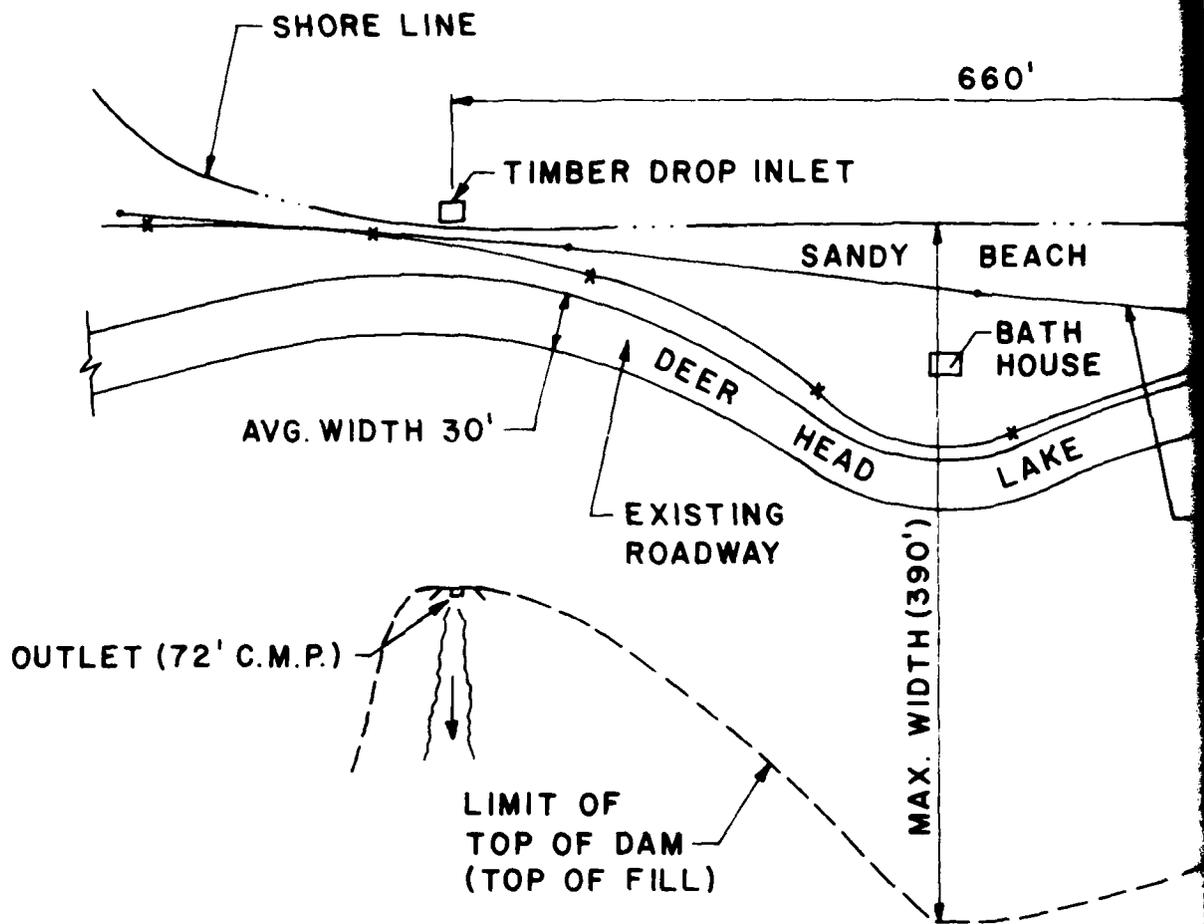
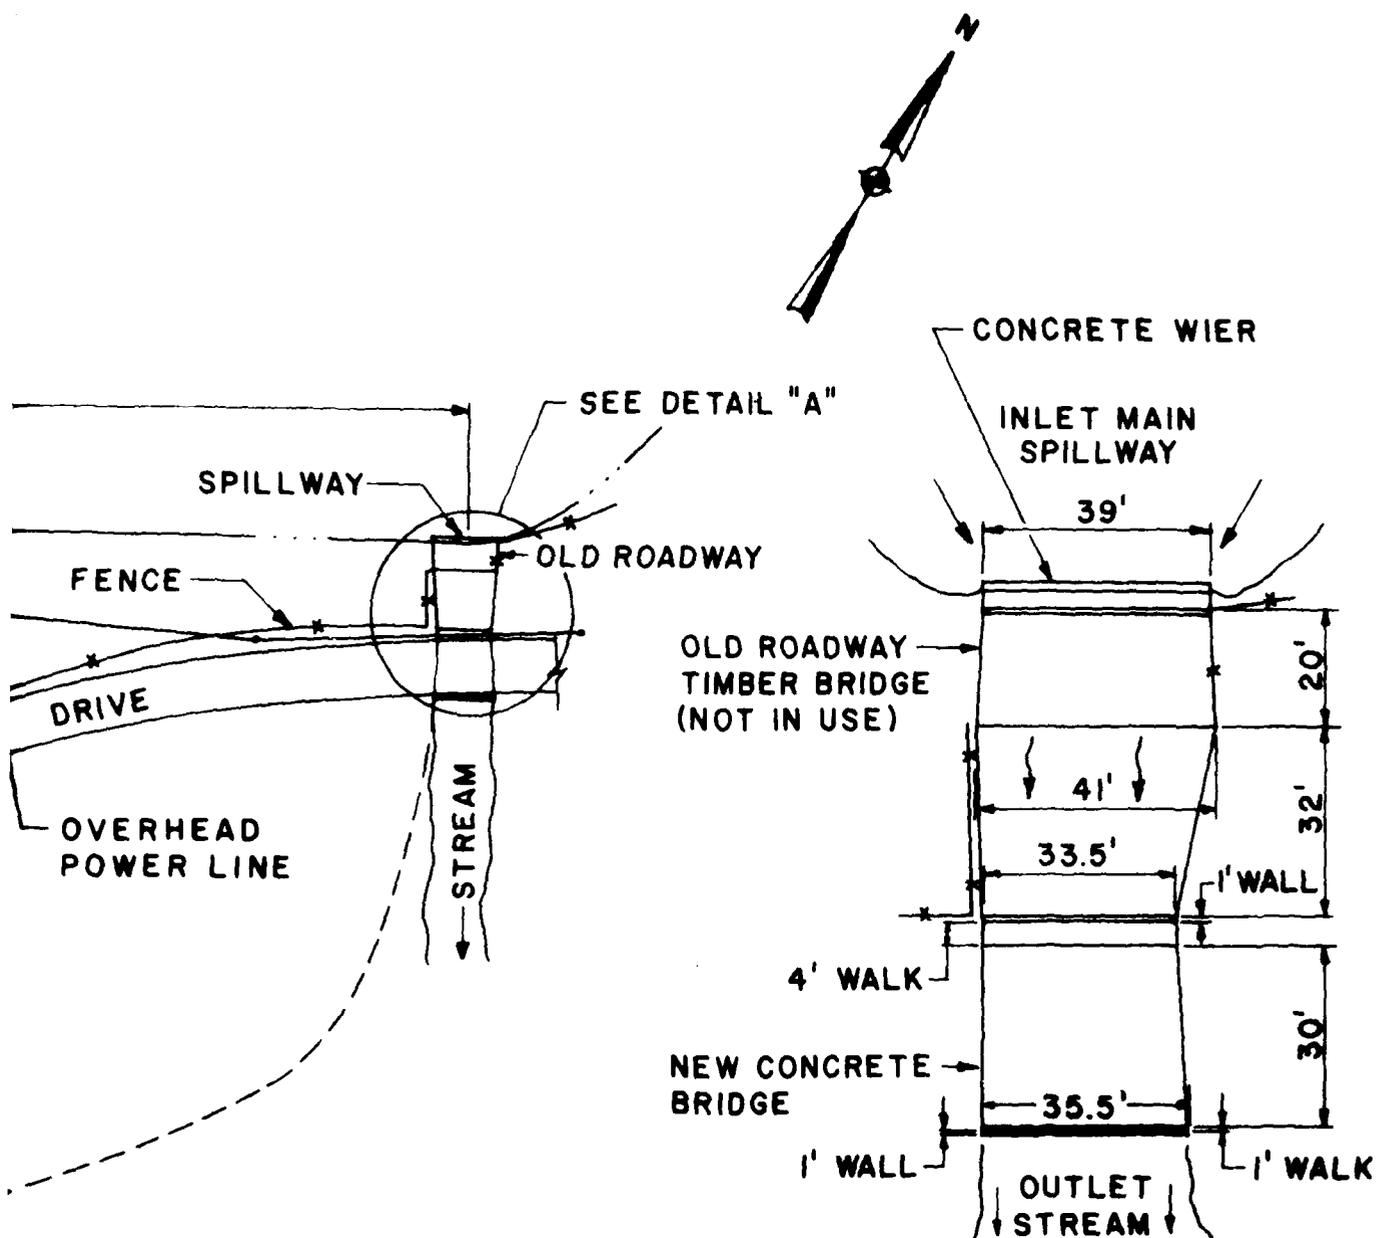
**PLAN**

<b>DEER HEAD LAKE DAM</b> <b>LACEY TOWNSHIP, OCEAN COUNTY, N.J.</b>	
SKETCH OF PLAN PREPARED FROM FIELD NOTES TAKEN DURING INSPECTION ON JAN. 14, 1981.	
BY: HARRIS-ECI ASSOCIATES WOODBRIDGE, N.J.	SCALE: AS SHOWN DATE: FEB. 1981 SHEET: 1 OF 1
