NDI No. PA 01073
PENN DER No. 10-63

LAKE SAXONY DAM

PACW 51-81C-0027
PHASE I INSPECTION REPORT

NATIONAL DAM INSPECTION PROGRAM

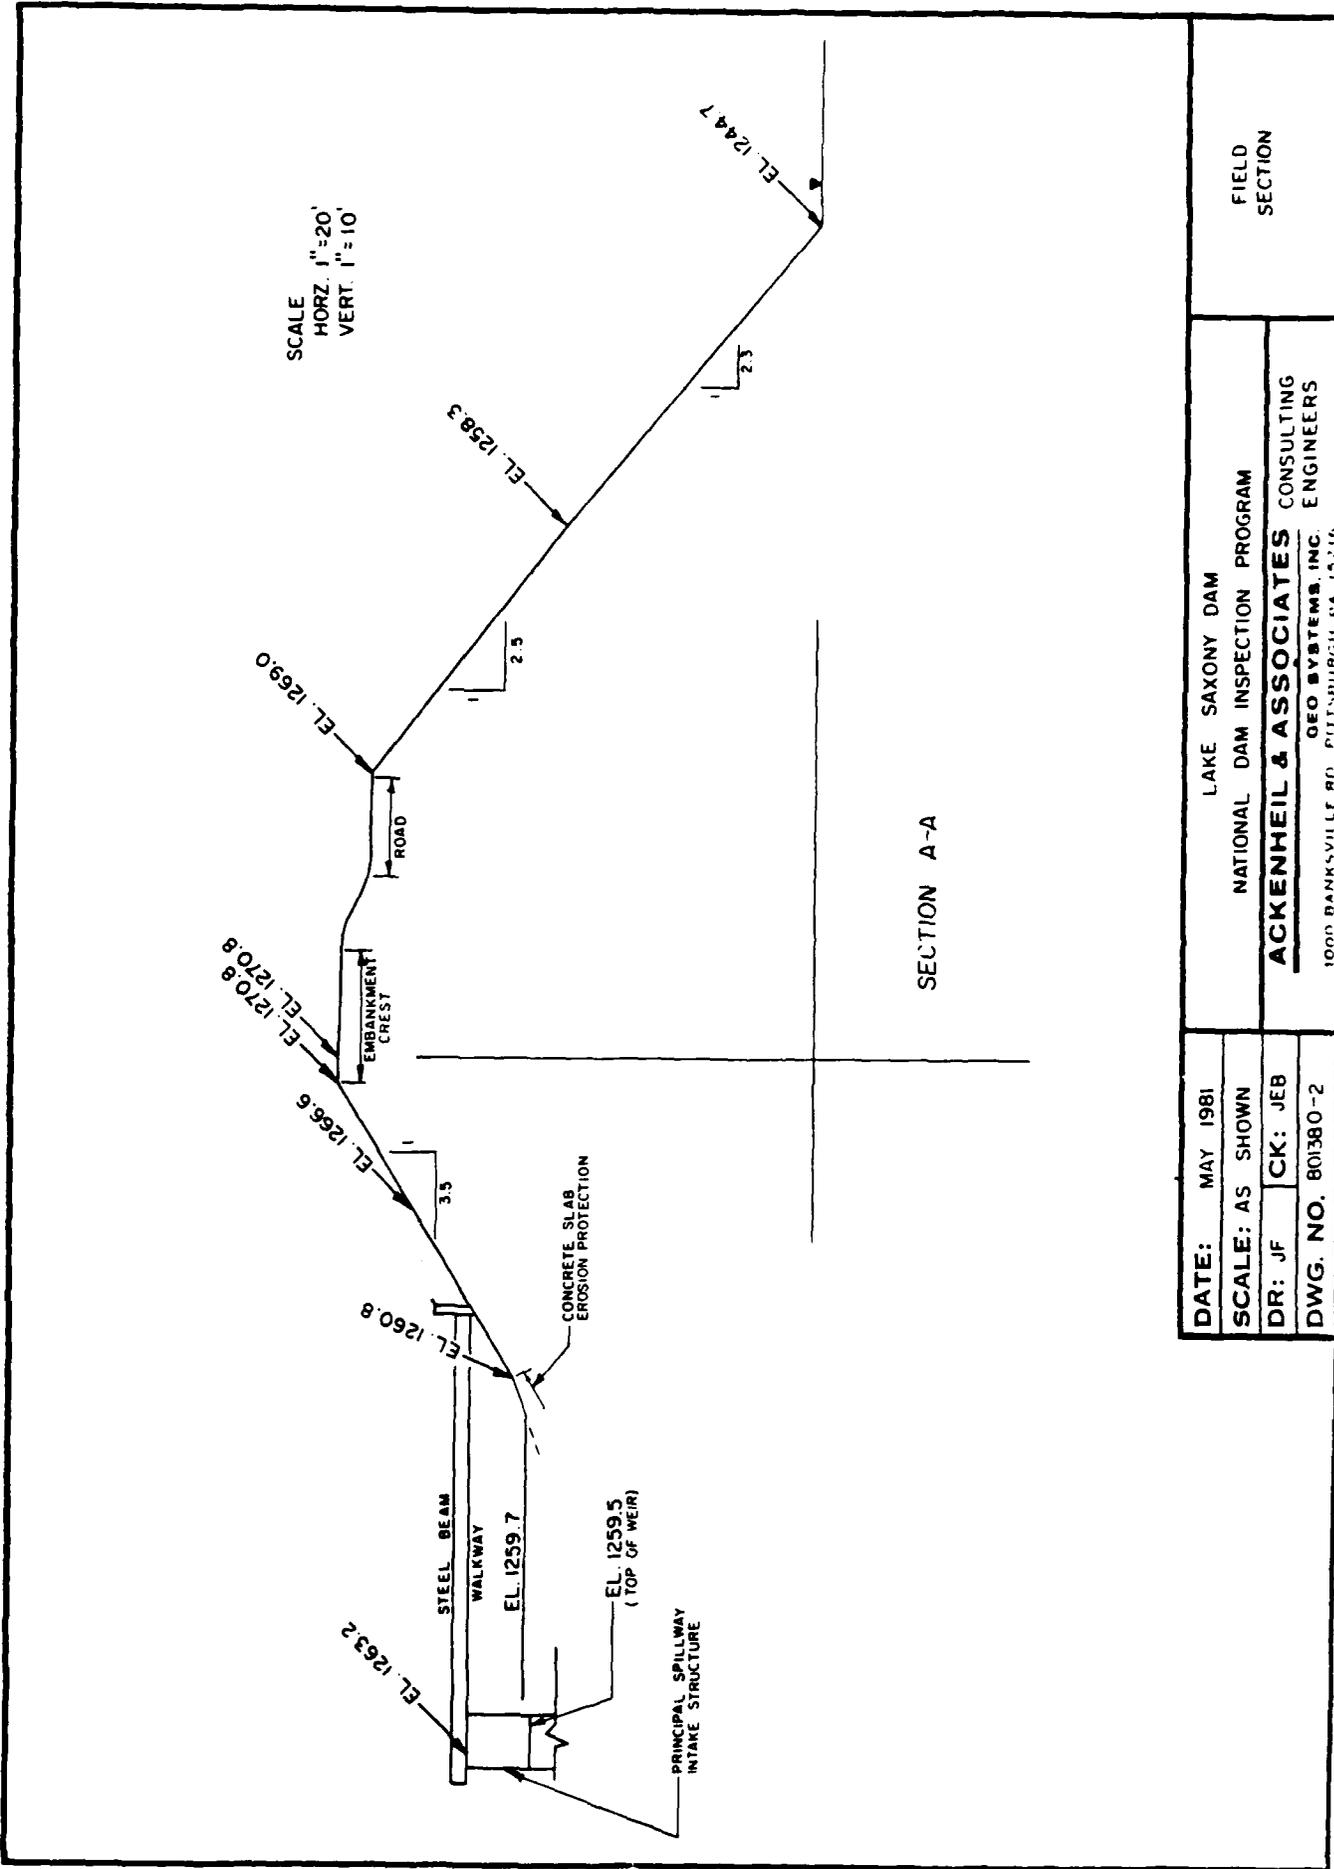
A swampy zone was observed in the junction between the embankment and the right abutment. The swampy zone extended from approximately mid-height of the embankment down to the stilling pool below the principal spillway outlet structure. Two seeps were flowing from the embankment along the wingwalls of the outlet structure. The seep on the right appeared to have a greater discharge than the seep on the left but flow quantities were too small to estimate. Both seeps were located in a region of significant iron staining.

An animal burrow was observed near the junction of the embankment and the abutment on the left side of the dam just below the road.

3. Remedial Work: The Visual Inspection disclosed four minor deficiencies which should be corrected or monitored. These are:
- a. Backfilling the animal burrow on the embankment's downstream slope;

- b. Removal of trees and brush from the embankment's downstream slope;
 - c. Implementation of a regularly scheduled monitoring program to observed seeps and wet zones in the embankment's downstream toe area and the wet zones in the emergency spillway channel;
