**FIELD TEST OF EXPEDIENT  
PAVEMENT REPAIRS  
(TEST ITEMS 16-35)**

**MICHAEL T. McNERNEY  
ENGINEERING RESEARCH DIVISION**

**NOVEMBER 1980**

**ENGINEERING & SERVICES LABORATORY  
AIR FORCE ENGINEERING & SERVICES CENTER  
TYNDALL AIR FORCE BASE, FLORIDA 32403**

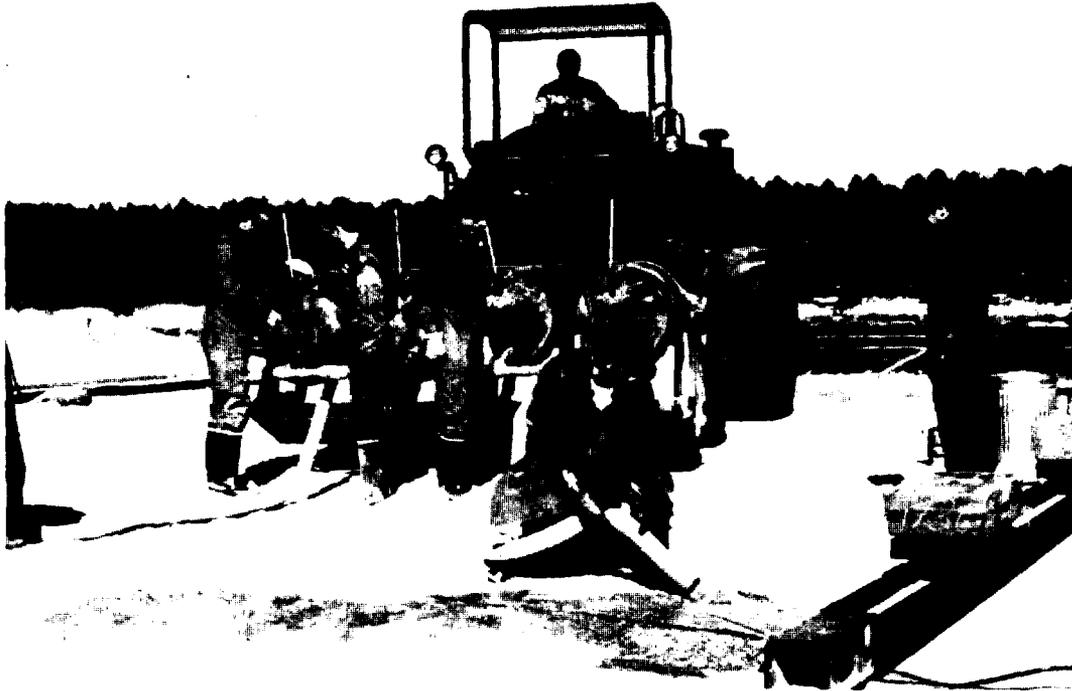
Figure 11. Application of Polymer Liquid, Test Item 16

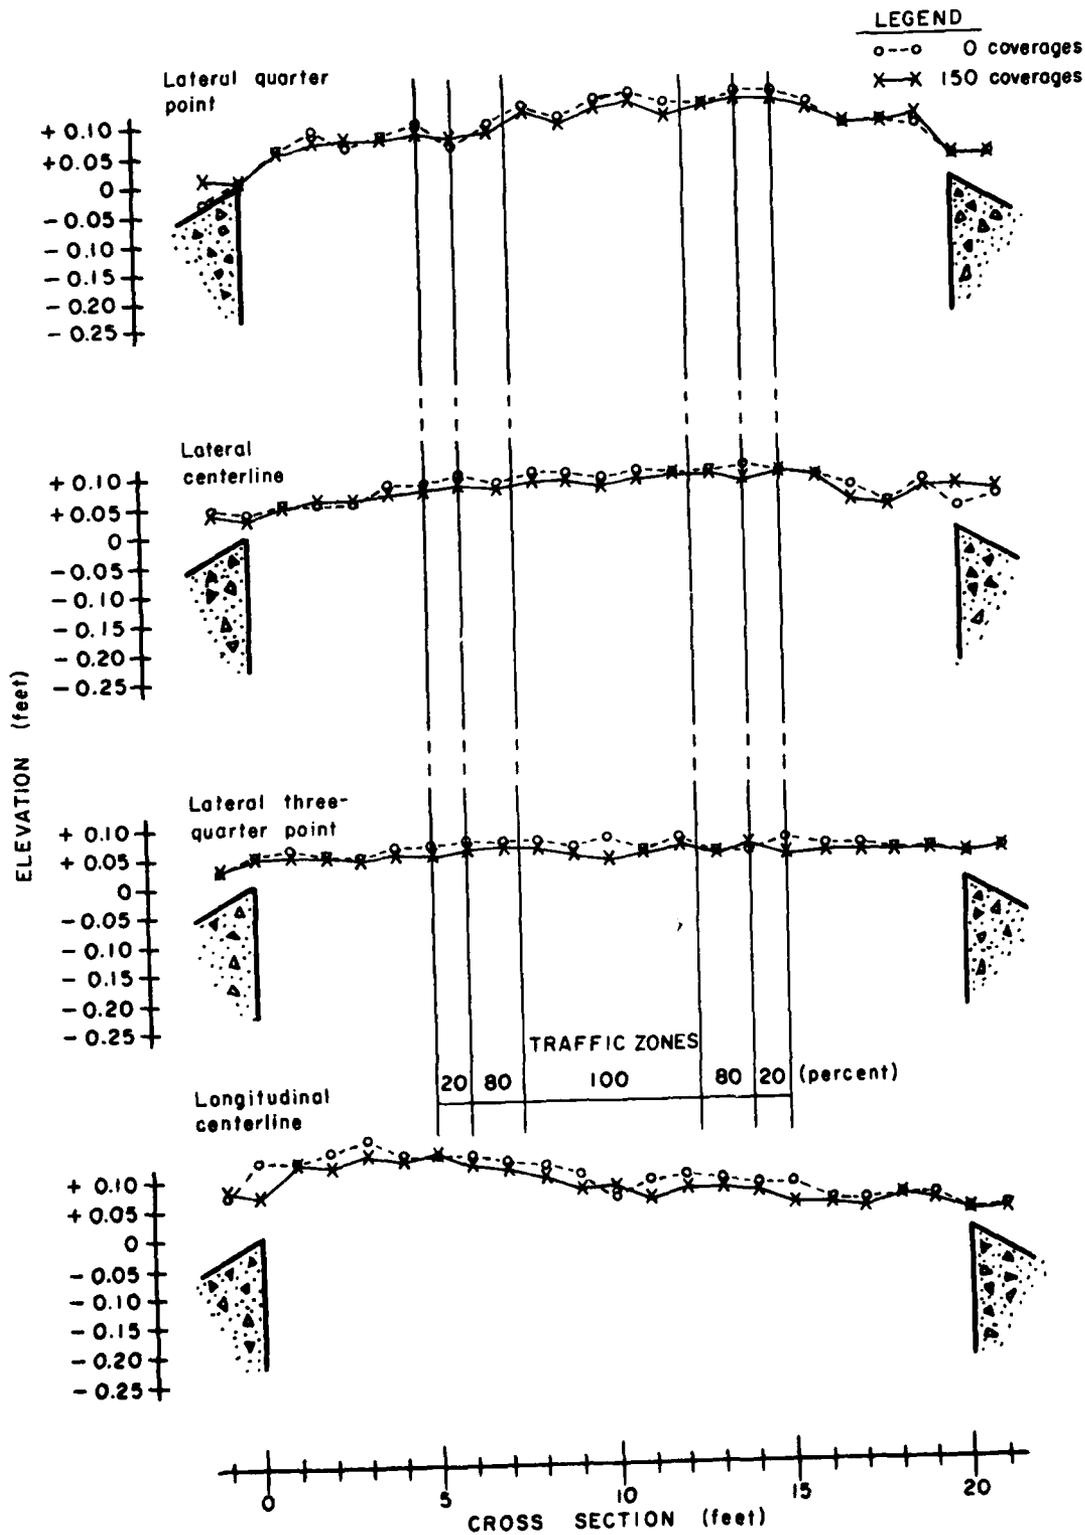
The repair easily withstood 150 coverages of the F-4 load cart. Core samples of the test surface achieved tensile splitting strengths of 297, 492, and 762 psi. Figure 12 shows the results of profiles taken from the surface of the test pit. Deformation of approximately 1 inch indicates the subgrade had consolidated and the bond between the polymer concrete and the existing concrete did not hold. The MMA polymer concrete proved capable of supporting F-4 traffic without excessive repairs. Deformation occurred as a result of the densification of the subgrade and the lack of sufficient bonding between the polymer concrete and the adjacent concrete. The edges of the concrete pit required a clean surface before adequate bonding could occur.

Figure 12. Surface Profiles, Item 16

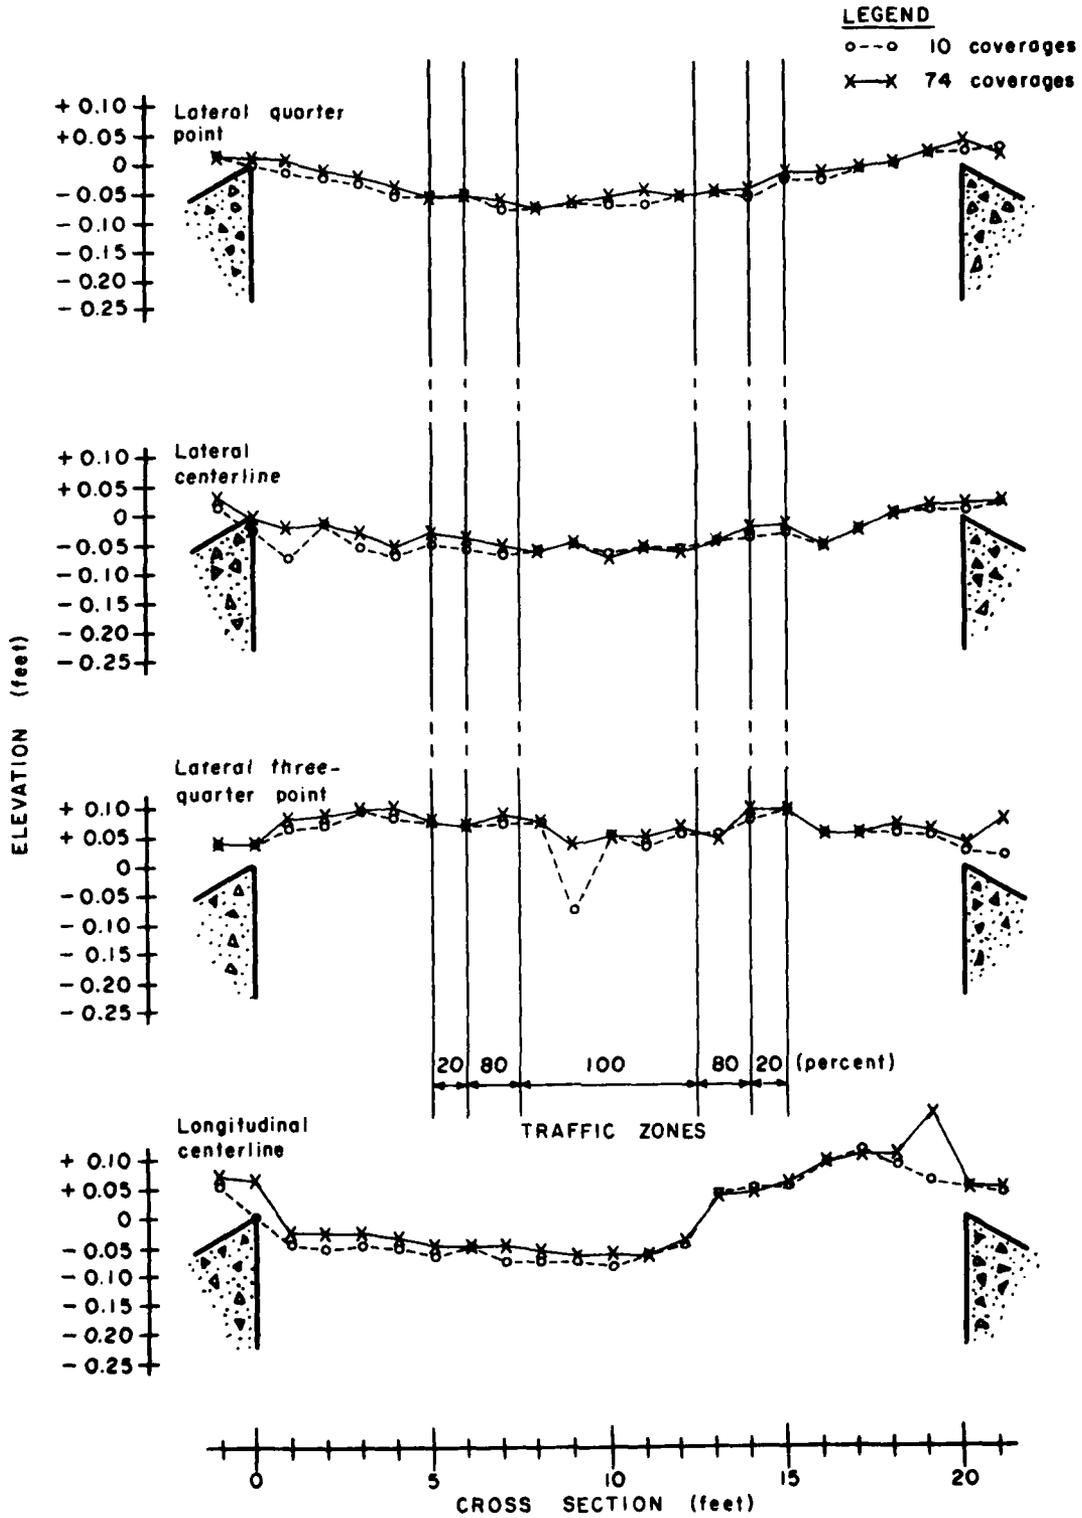
Profiles were taken of the test surface (Figure 18); complete core samples could not be taken in the traffic lane of the first pour due to internal cracks. These cracks caused the flexing that was noted during the coverages.

Figure 18. Surface Profiles, Item 33

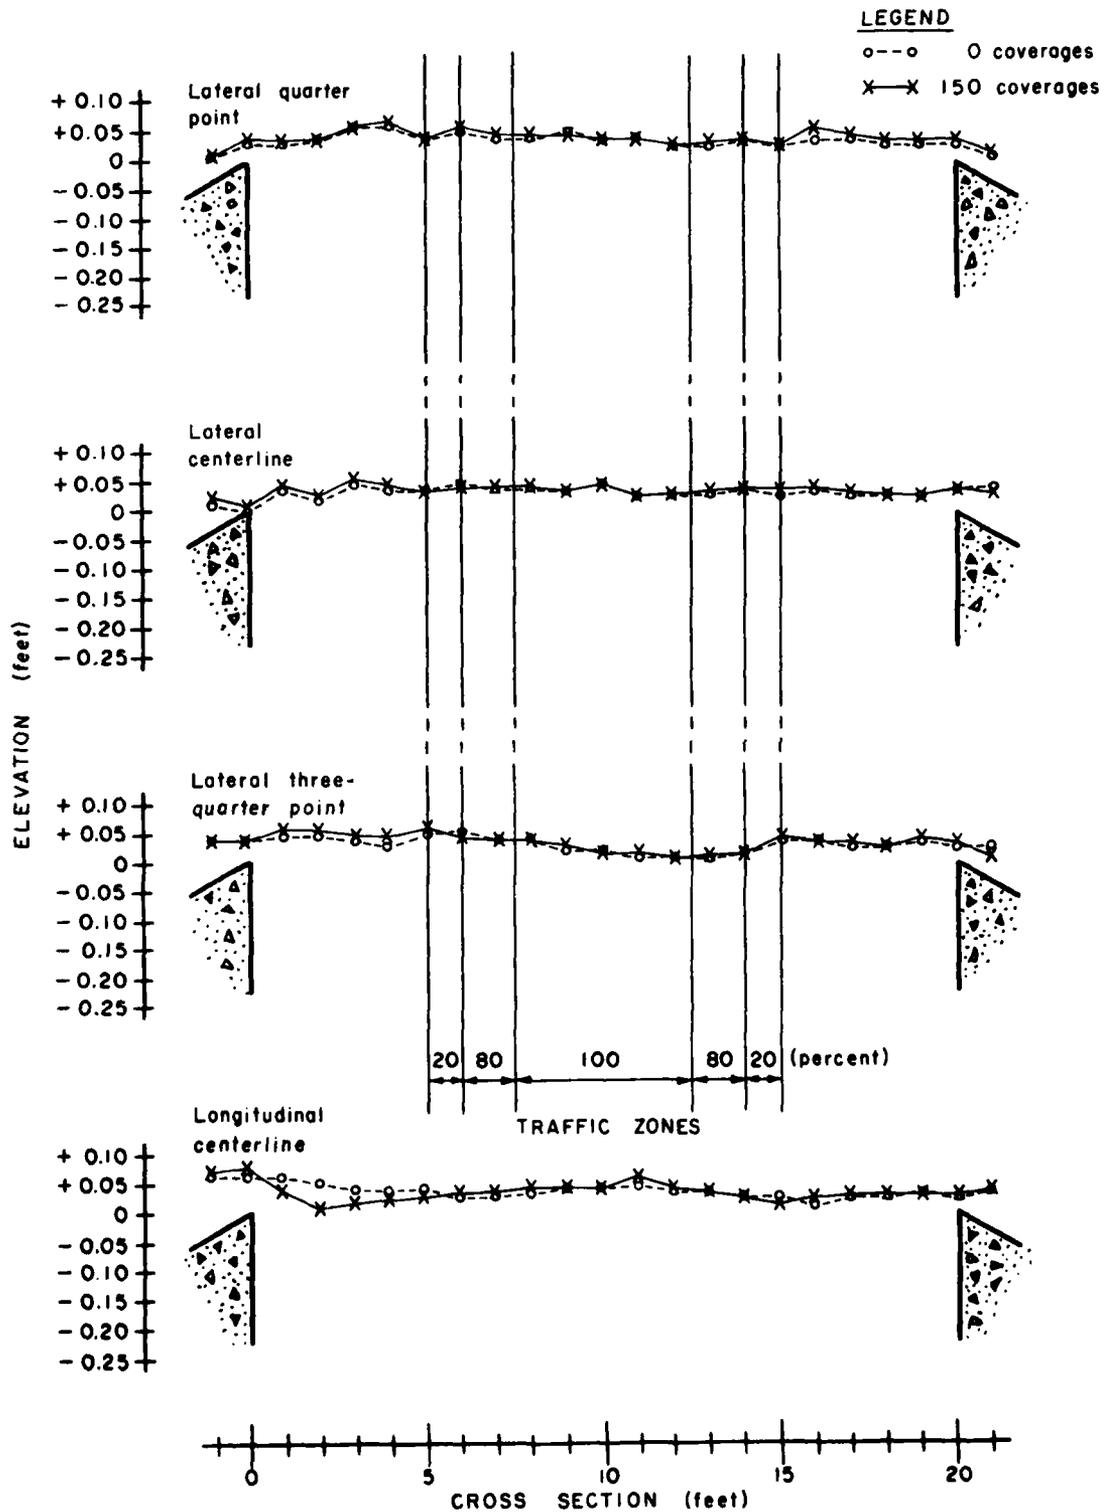
Figure 21. Surface Profiles, Item 35

Flexing was severe enough to rule out C-141 traffic over the test pit. Core samples were taken and found to have monomer at the top and bottom with aggregate in between (Figure 22).

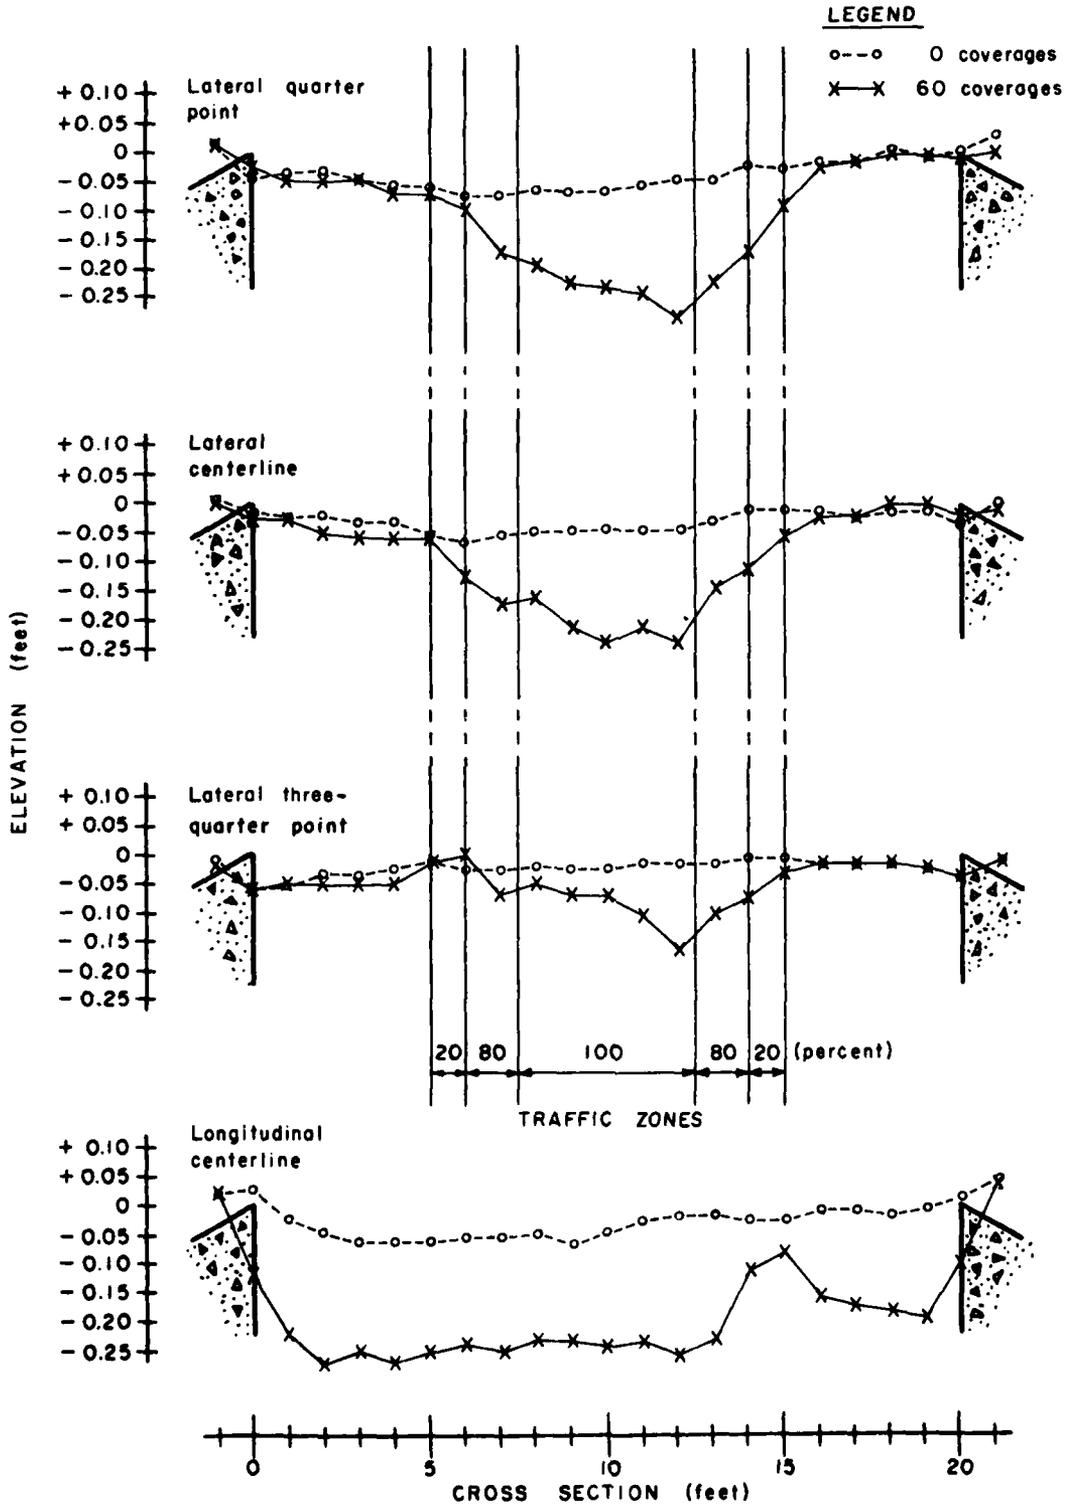
Profiles taken of the surface before repair are shown in Figure 26. Additional limestone was added to the test pit and compacted with two coverages of the RayGo 510A. The base course appeared worn and in need of repair after the completion of the 150 coverages. Profiles of the test surface after 150 coverages are shown in Figure 27. Density measurements obtained during load cart trafficking are recorded in Table 6.

Figure 26. Surface Profiles Before Repair, Item 19

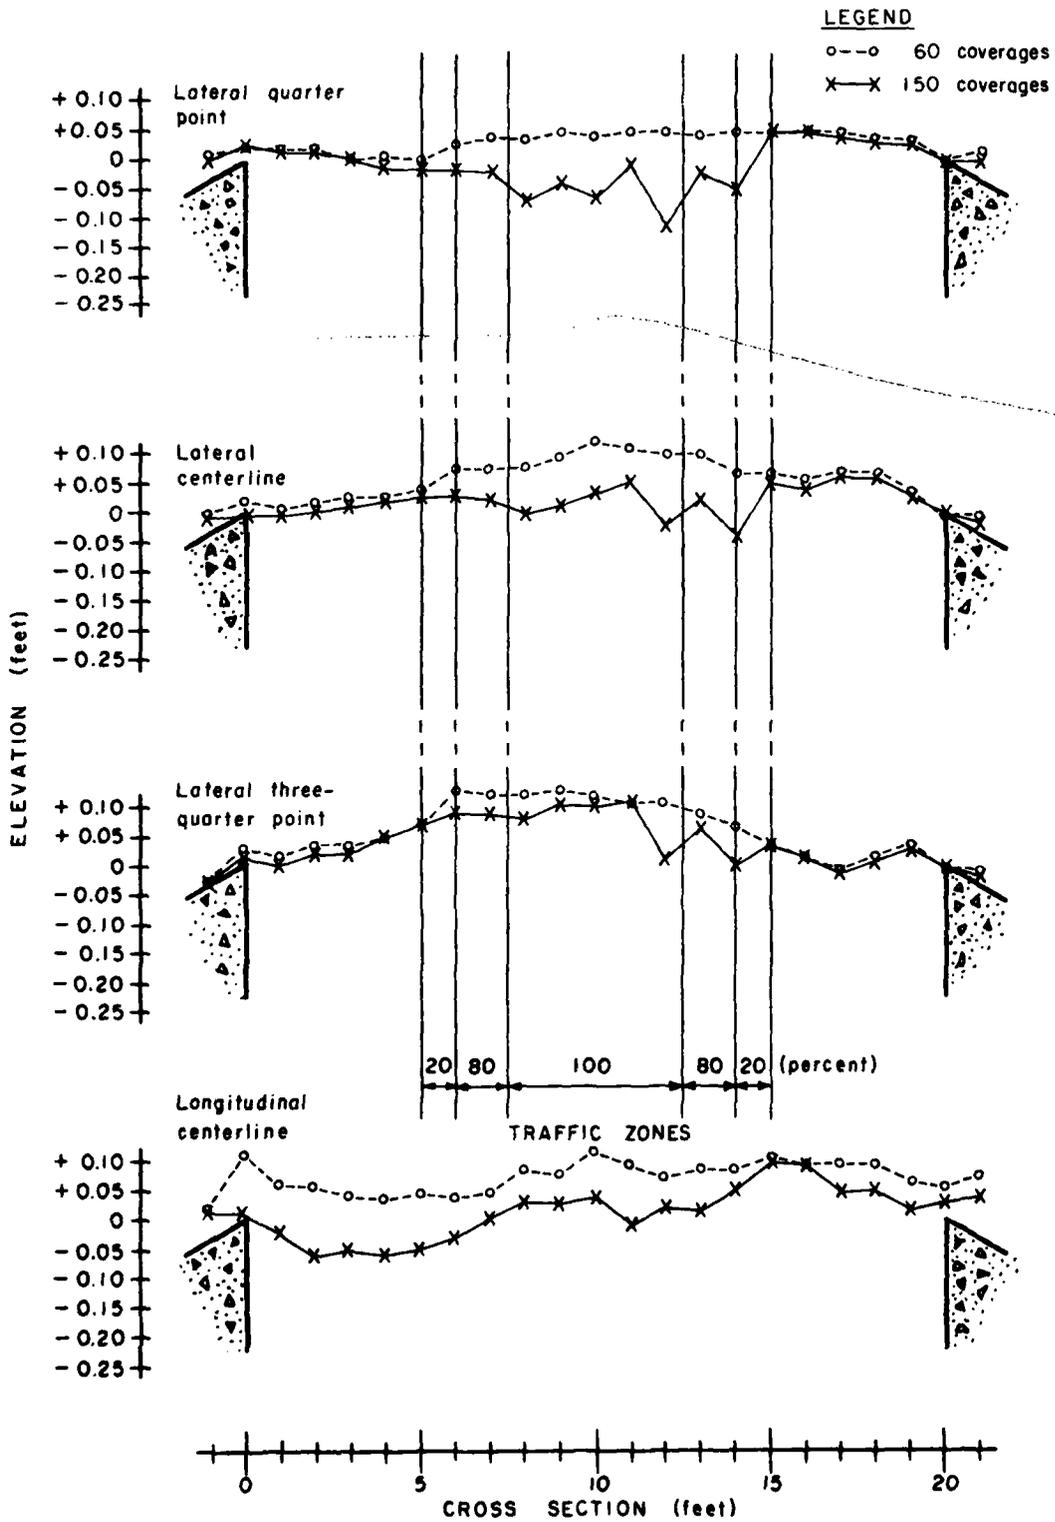
Figure 27. Surface Profiles After Repair, Item 19

CBR measurements of the surface showed a CBR of 56 in the traffic lane, a CBR of 47 out of the traffic lane, and a CBR of 7 on a spongy area in the traffic lane.

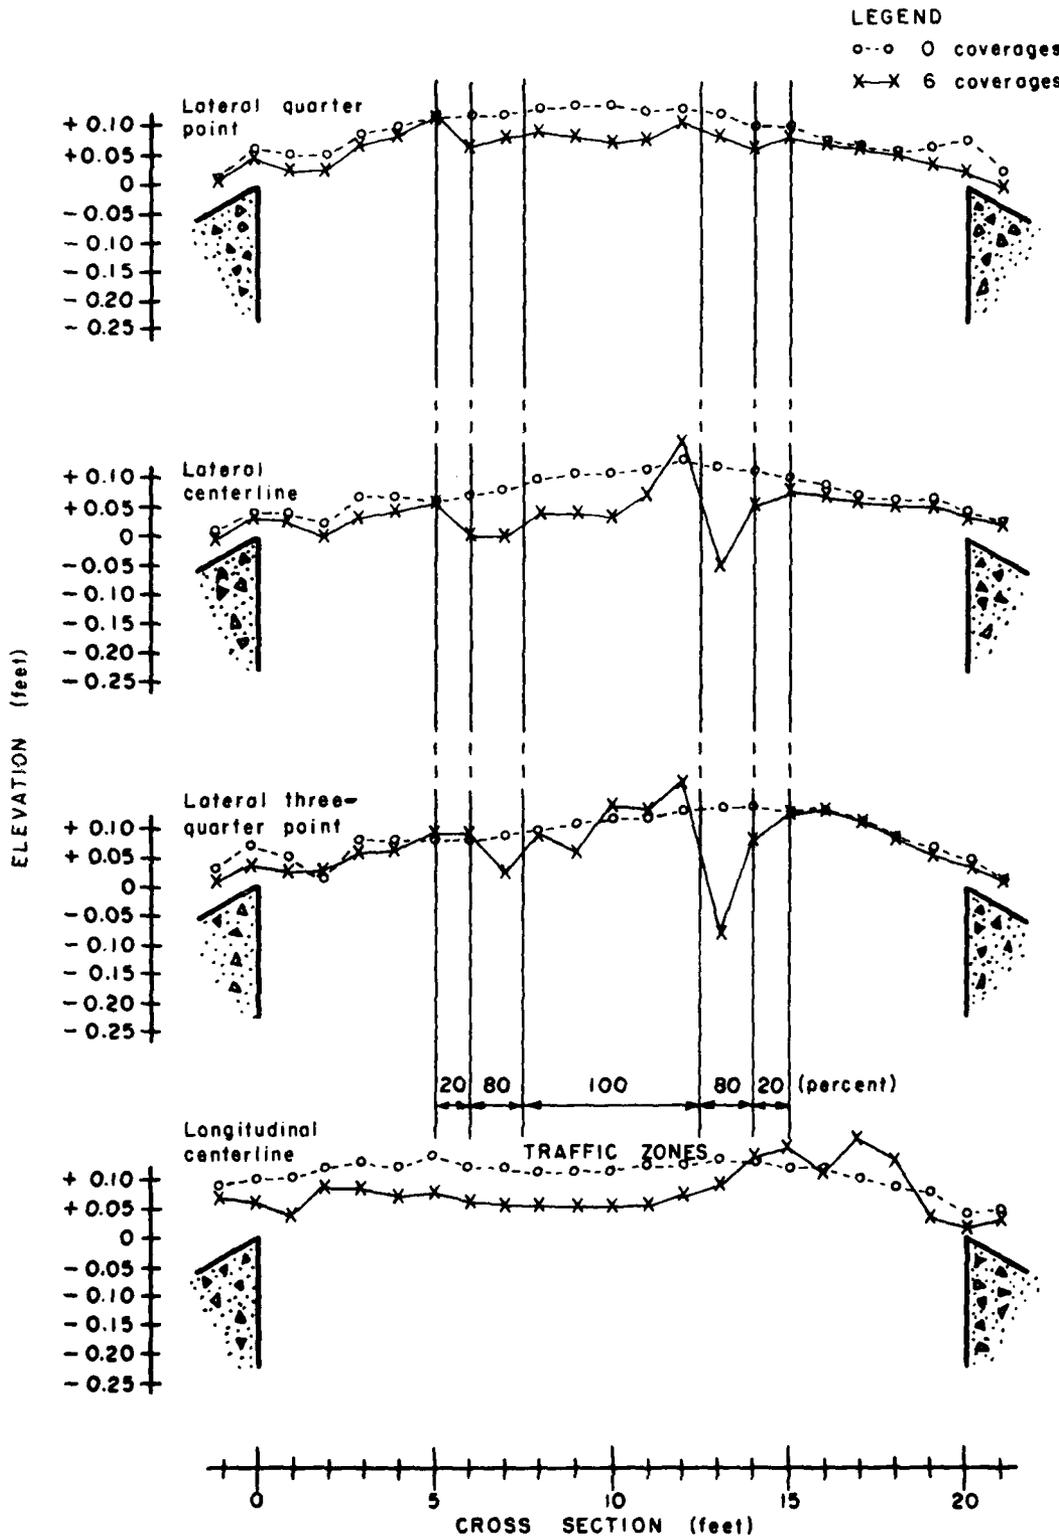
Surface profiles relating to this test are given in Figure 30. Density and moisture content data obtained after the completion of six coverages of the load cart are given in Table 7.

Figure 30. Surface Profiles, Item 21

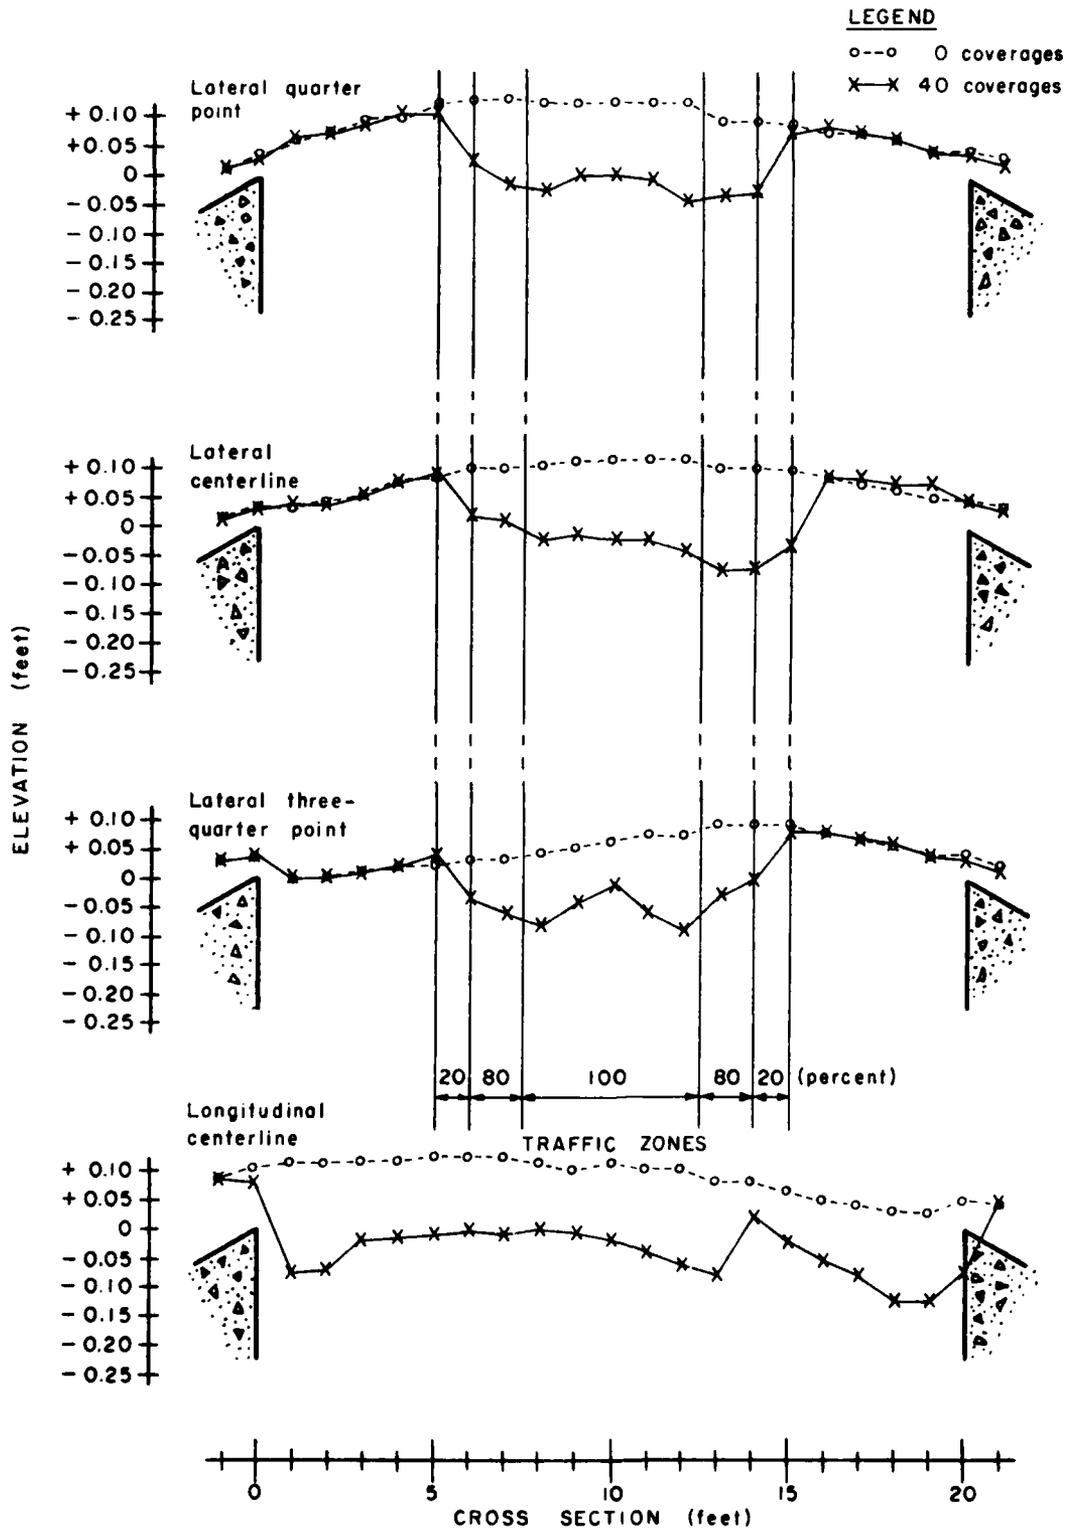
Profiles obtained before repairs were made are shown in Figure 32. Crushed limestone was then added to the test pit and compacted with the RayGo 400A. One hundred fifty coverages were completed without further repair (Figure 33). Profiles taken at this point indicated maximum ruts of 2.25 inches and consolidation of 1 inch (Figure 34). After the initial 40 coverages, the rate of consolidation decreased as coverages increased. Moisture and density readings taken throughout trafficking are given in Table 8.

Figure 32. Surface Profiles Before Repairs, Item 22

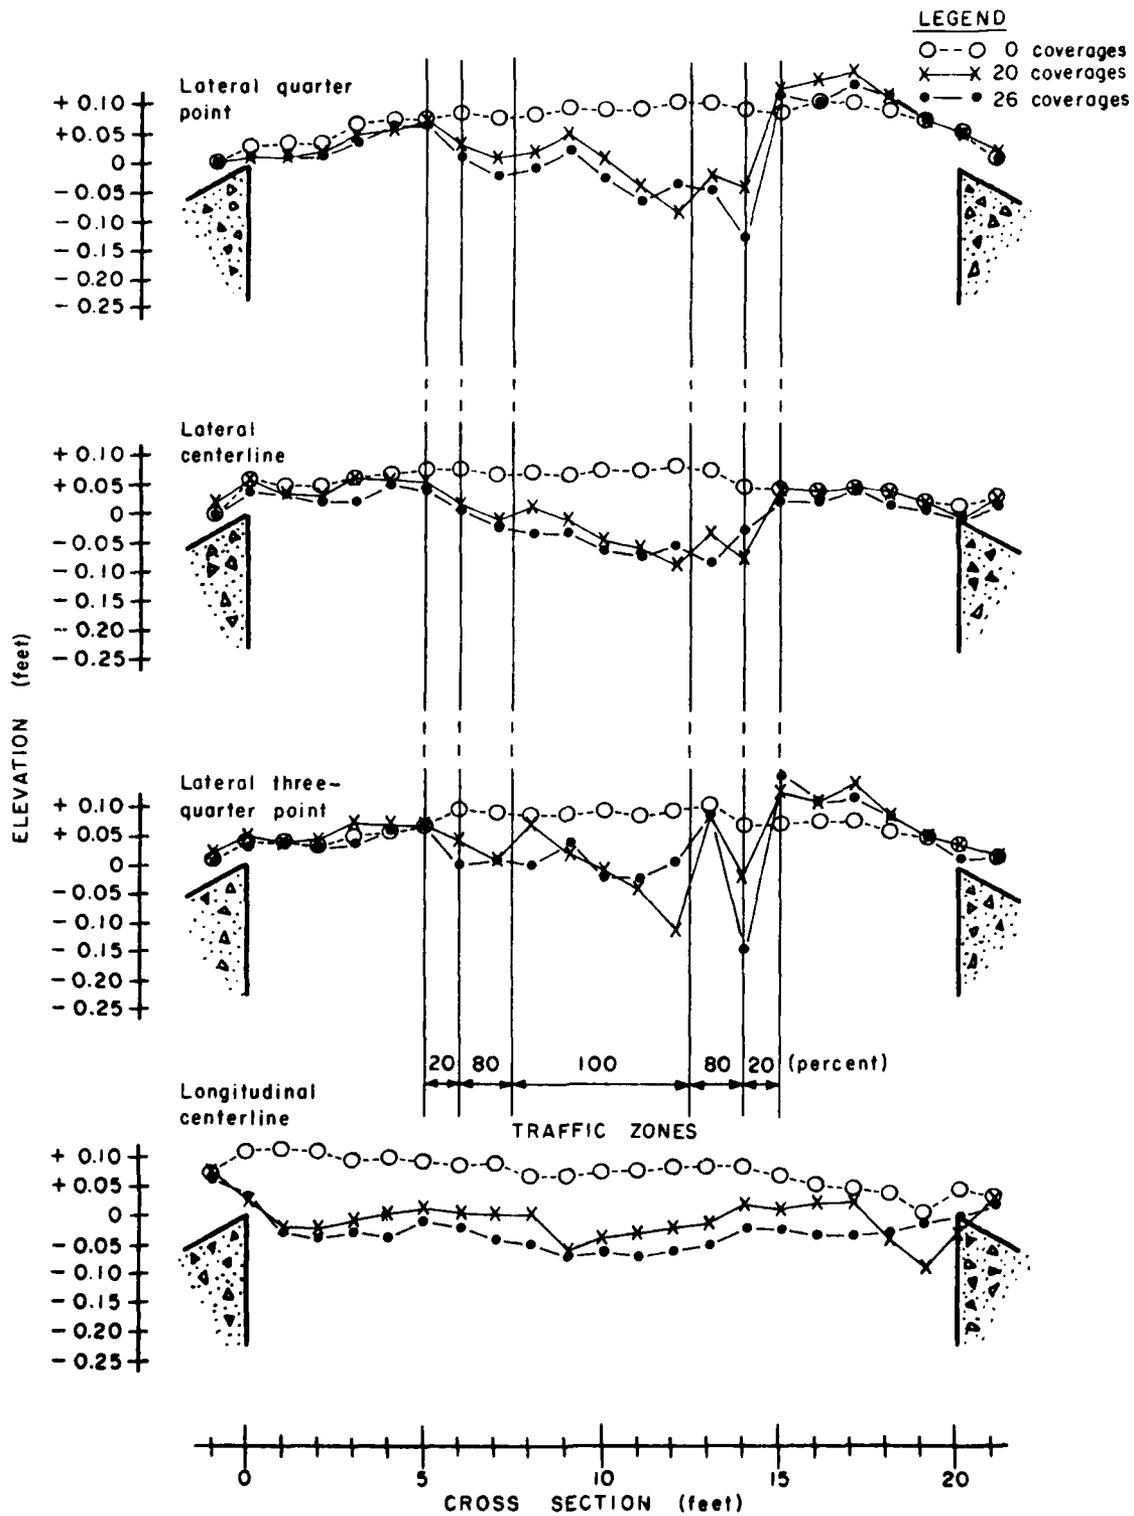
Readings obtained at the point of failure indicated 7.7-percent moisture and a dry density of 145.1 pcf. After repairs were made, four more coverages were achieved before the surface again became unsuitable for further trafficking. Surface profiles taken at the start of trafficking, and after 20 and 26 coverages, are shown in Figure 39. A plate survey of the subgrade indicated a consolidation of 0.02 foot.

Figure 39. Surface Profiles, Item 25

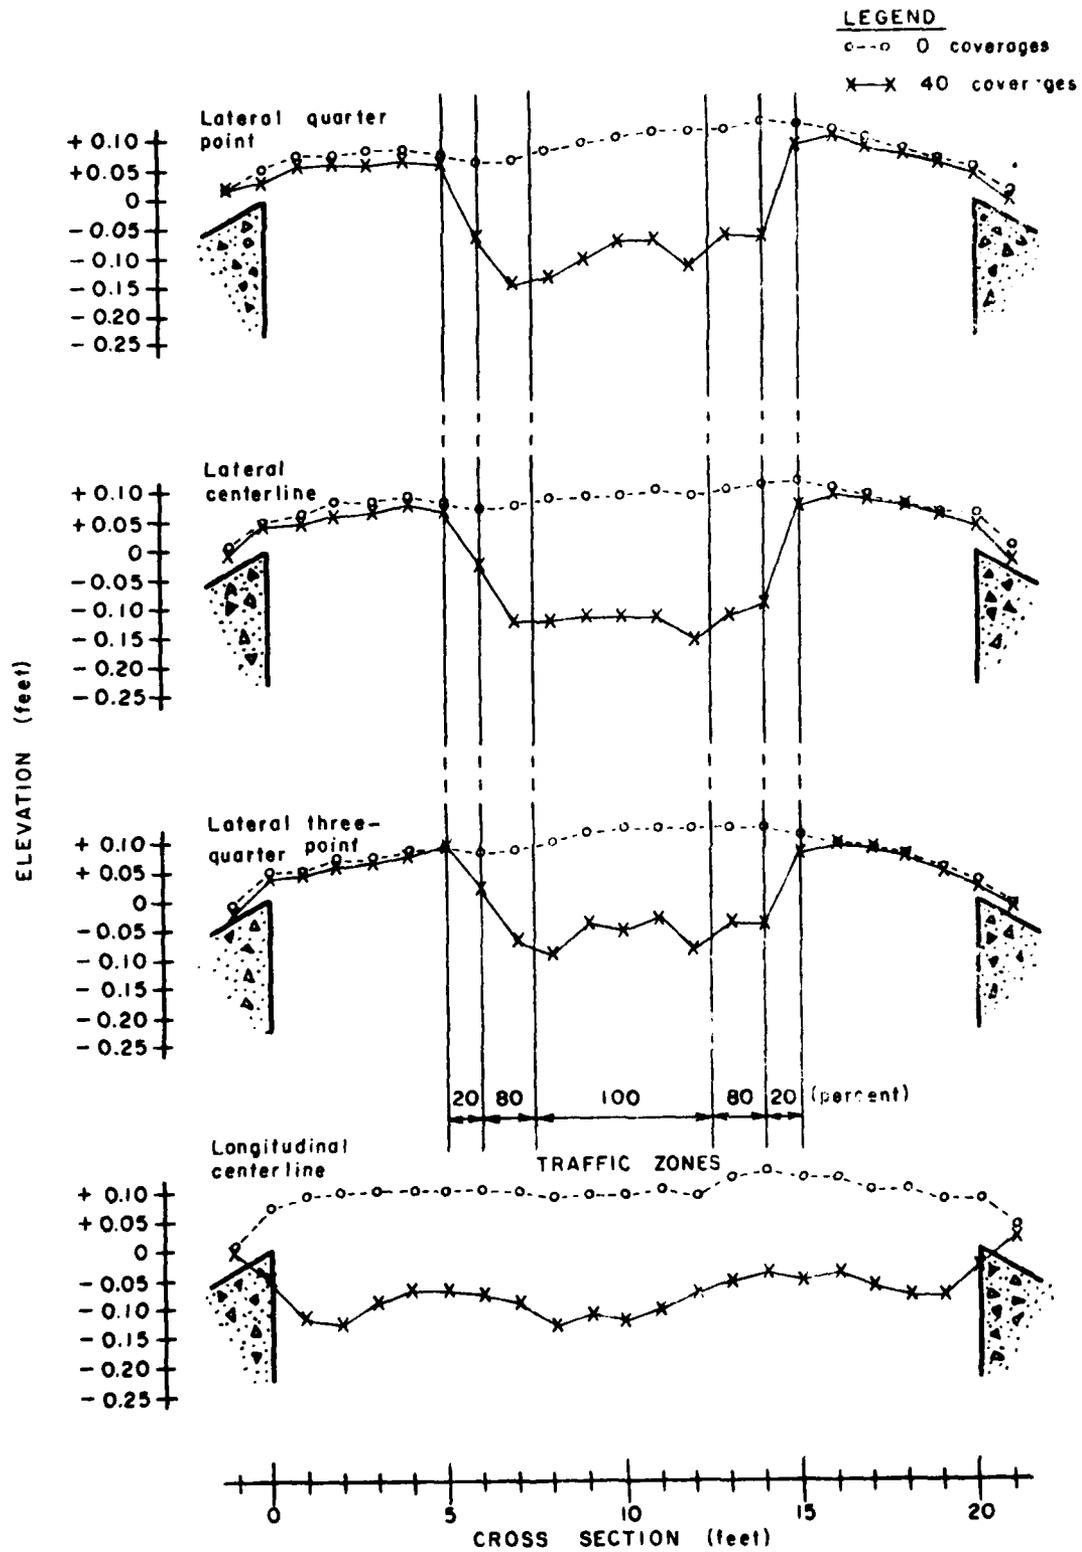
Figure 40. Surface Profiles Before Repairs, Item 26

(2) Results. After compaction, the limestone showed a moisture content of 2.8 percent and a dry density of 141.7 pcf. Twenty coverages of the F-4 load cart produced deformations of approximately 2 inches; deformations had increased to 3 inches after 40 coverages when it became necessary to add limestone and repair the surface. Figure 40 provides profile data prior to repairs. After 60 coverages, the surface deformation was as shown below (Figure 41).

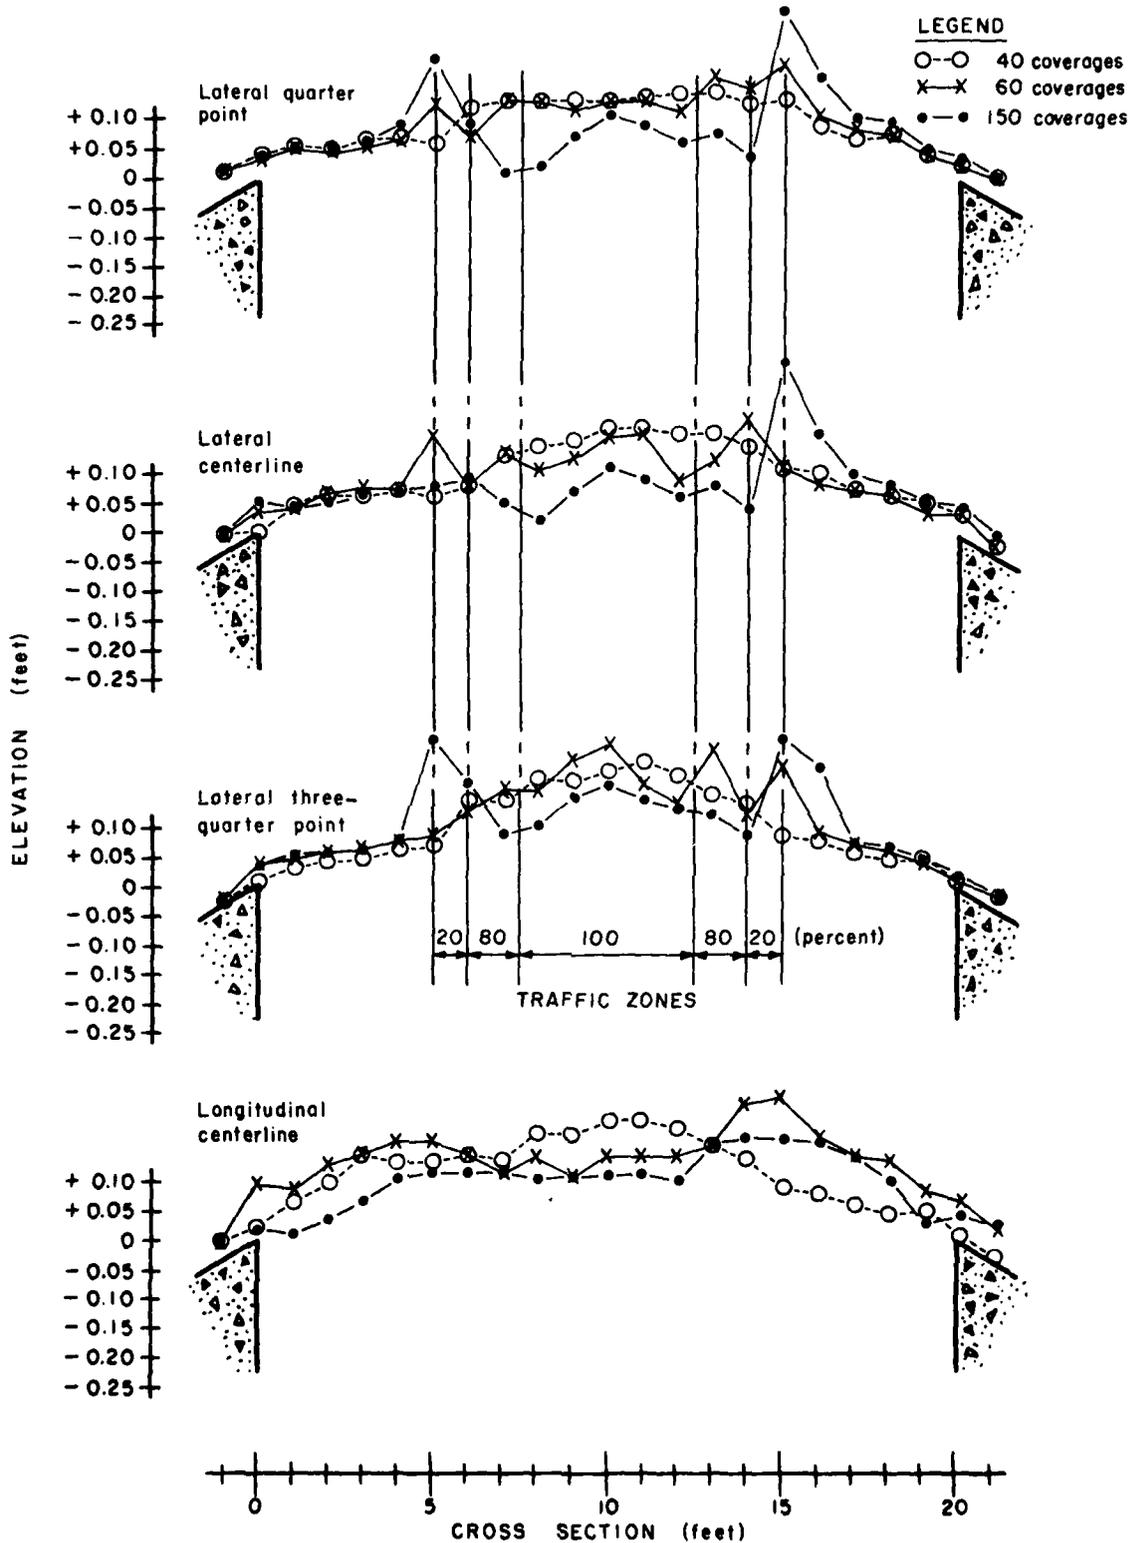
Figure 42 shows profiles at 60 and 150 coverages when trafficking was completed without further repairs. Consolidation in the traffic lane measured 1 inch with 3-inch ridges between ruts. The clay subgrade in the traffic lane had consolidated 0.1 inch. The crushed limestone base course with a moisture content of 2.2 percent after 150 F-4 load cart coverages was termed successful. The lesser moisture content was seen as a positive factor in stabilizing the repair.

Figure 42. Surface Profiles After Repairs, Item 26

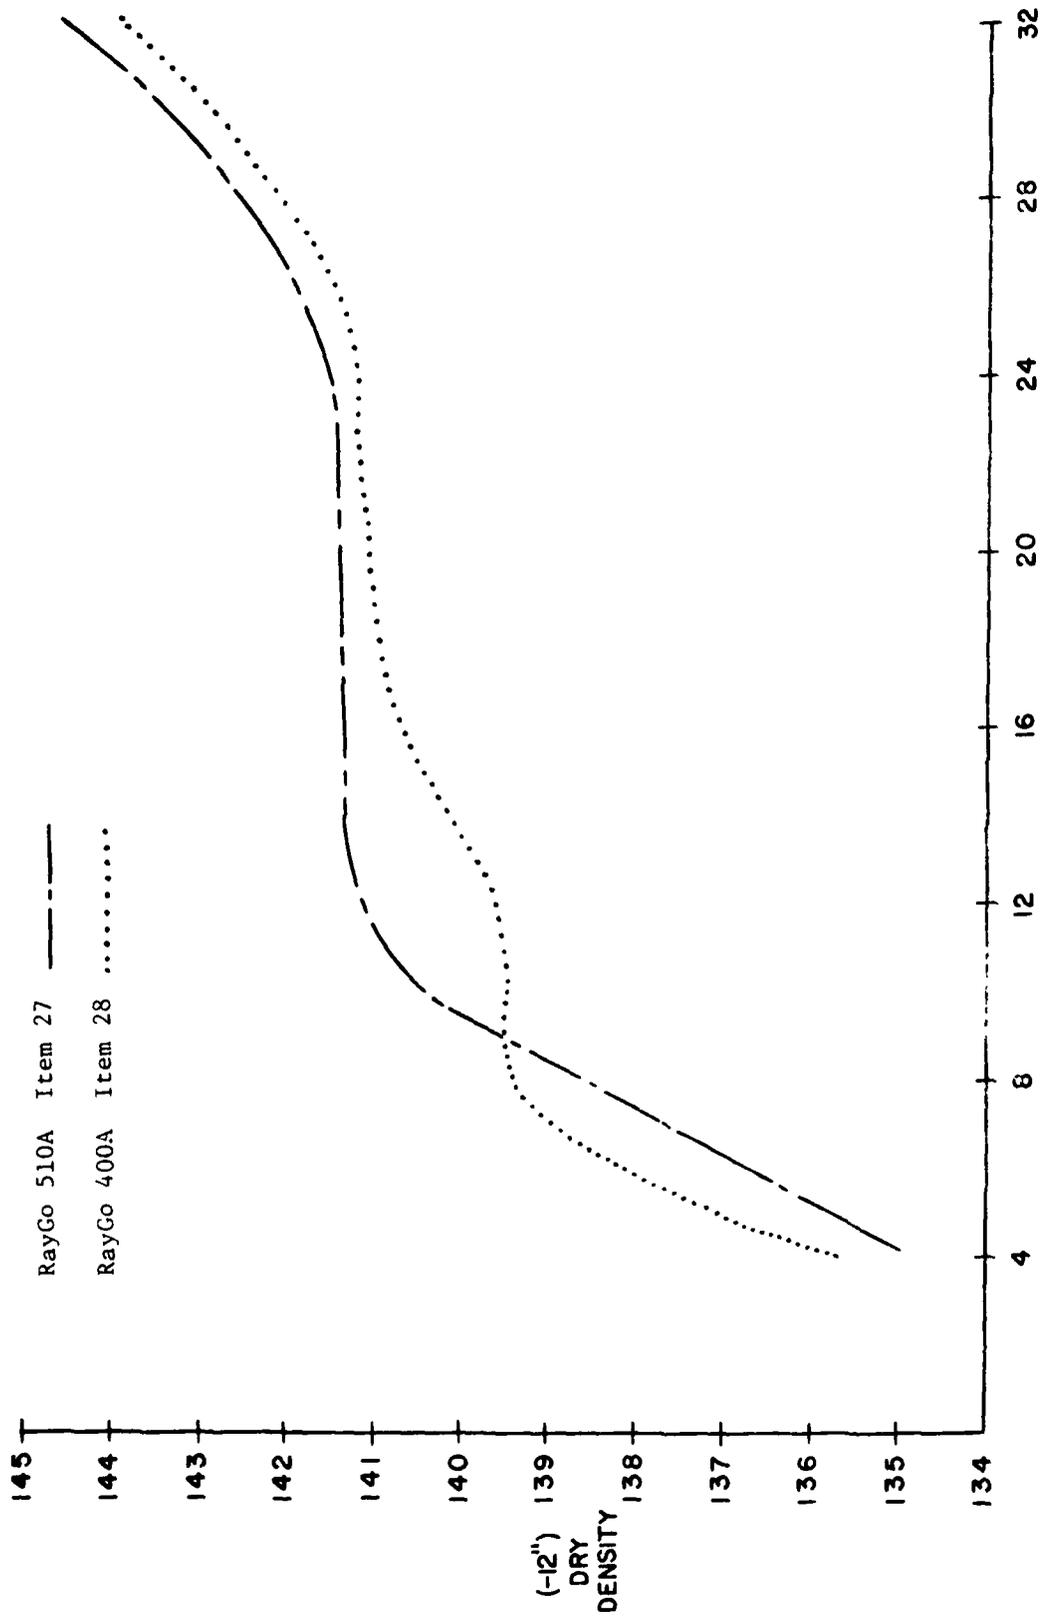
Figure 43. Compaction Results, Items 27 and 28

(3) Compaction. The RayGo 510A compacted test item 27 and the RayGo 400A compacted item 28. After four coverages by the vibratory rollers, the RayGo 510A had compacted the base course to a level 1.0 inch below the surrounding concrete, while the RayGo 400A had compacted test item 28 by 0.5 inch. After limestone had been added to each pit, grading and compacting were continued. After 16 coverages, both test items showed signs of elasticity where water had been drawn to the surfaces. After 32 coverages, water still remained on the surface, with test item 28 (RayGo 400A) showing a larger accumulation. Moisture and density readings taken at successive stages of compaction are shown in Table 11. A graphic comparison of compaction results is portrayed in Figure 43.

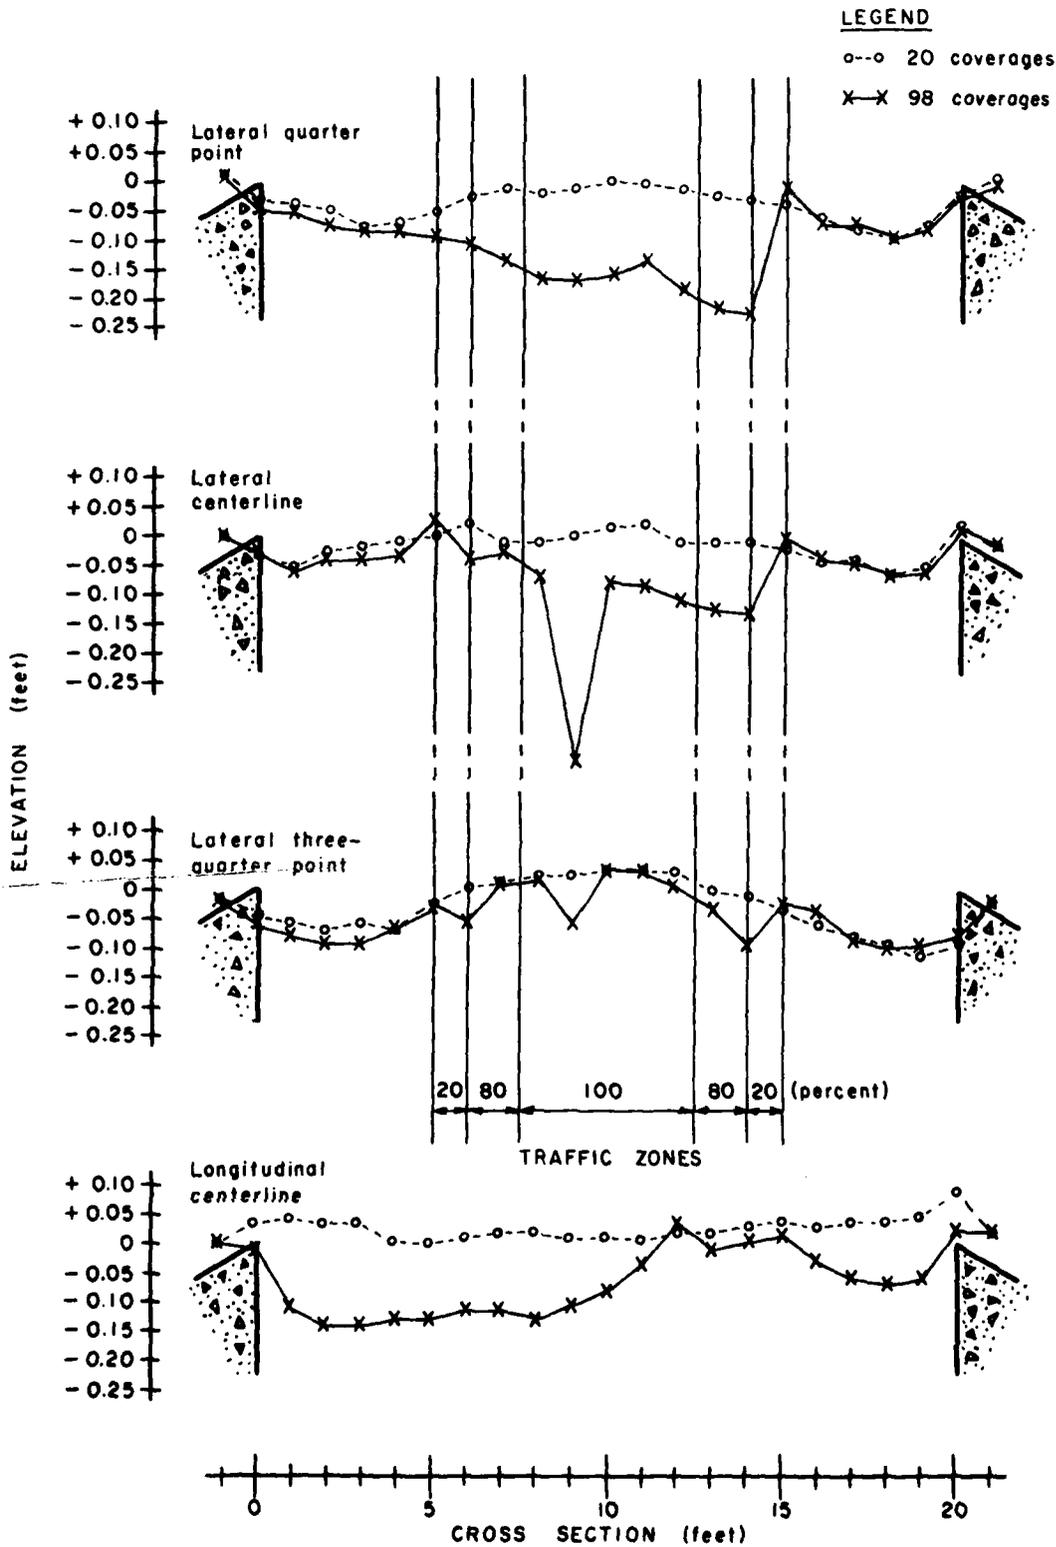
Figure 45. Surface Profiles, Item 27

Surface profiles of item 27 are shown in Figure 45.
