**FIELD TEST OF EXPEDIENT  
PAVEMENT REPAIRS  
(TEST ITEMS 16-35)**

**MICHAEL T. McNERNEY  
ENGINEERING RESEARCH DIVISION**

**NOVEMBER 1980**

**ENGINEERING & SERVICES LABORATORY  
AIR FORCE ENGINEERING & SERVICES CENTER  
TYNDALL AIR FORCE BASE, FLORIDA 32403**

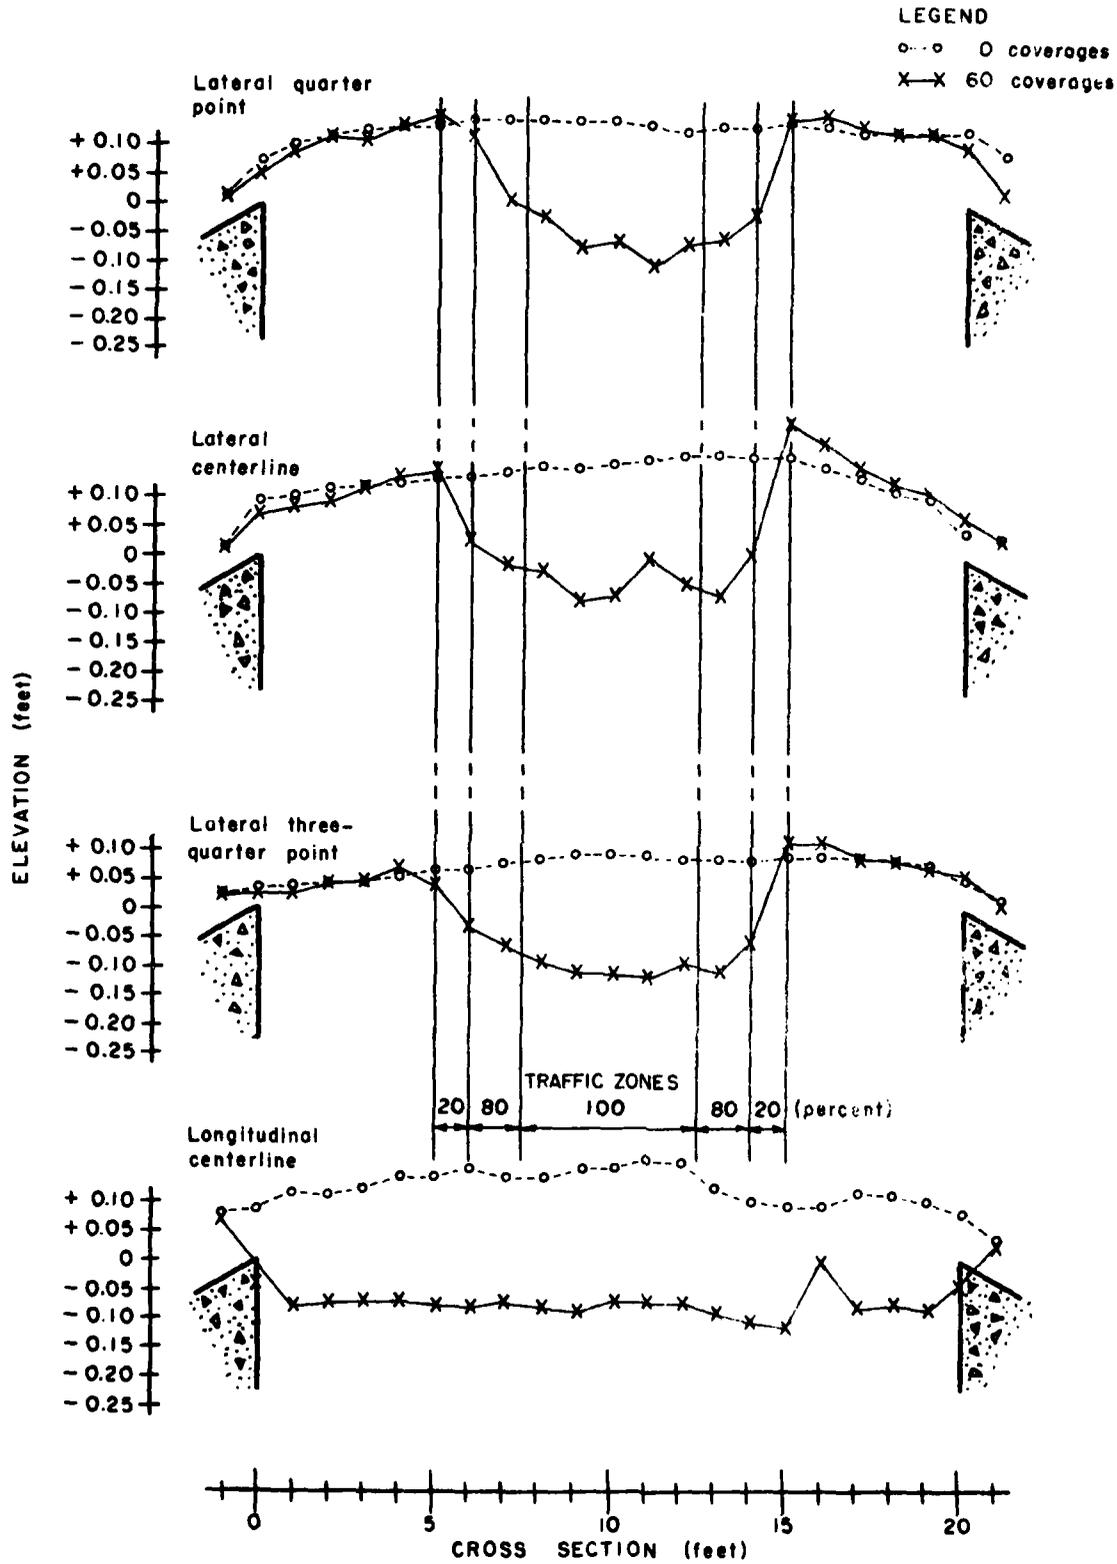
Figure 46. Surface Profiles Before Repairs, Item 32

(3) Results. After 20 coverages of the load cart, a small amount of rutting and pushing of the material at each end of the traffic lane had occurred. Profiles of the test surface indicated consolidation of approximately 2.4 inches. After 40 coverages, the maximum deformation was 2.8 inches, indicating that the rate of deformation was decreasing. The drop from the concrete pad to the base course after 60 coverages made it difficult for the load cart to enter and exit the test pit, necessitating repair of the test pit. Profiles were taken of the test surface prior to repair and are shown in Figure 46. Additional limestone was placed on the traffic lane and compacted within 12 coverages of the RayGo 400A. After 70 coverages of the load cart, the added base course had become fluffy and appeared to have lost its compaction. It was shoving badly under the wheel of the load cart, and the difference between the bottom of the ruts and the top of the ridges measured approximately 3.5 to 4.5 inches. The limestone was overlapping each end of the pit about 8 inches and created a FOD problem.

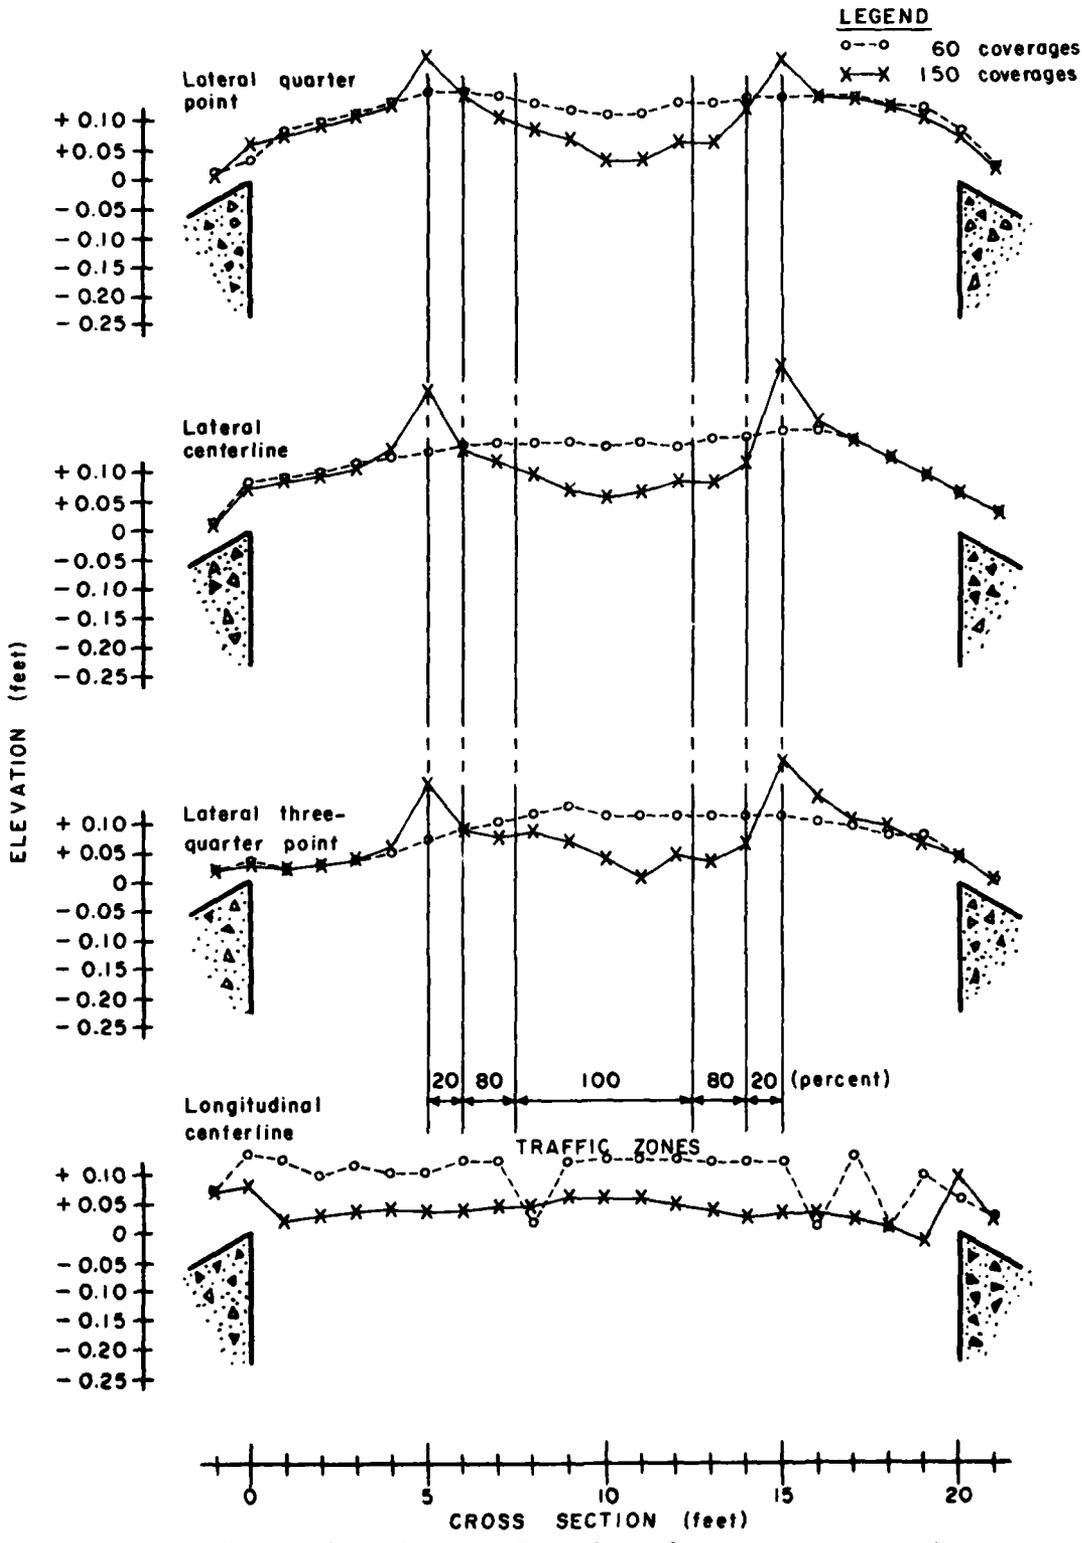
Figure 49. Surface Profiles After Repair, Item 32

The overlapped base course was placed back into the traffic lane, and the ridges leveled down after 80 coverages (Figure 47). After 120 coverages, the limestone appeared to be too dry. A hand pump was used to pump water onto half of the test surface. Trafficking resumed until 150 coverages were completed (Figure 48). The added moisture appeared to help stabilize the base course and reduced the amount of surface repairs required. Profiles (Figure 49) and density readings (Table 12) were taken for specified coverages. CBR tests were conducted, and a CBR of 80 was obtained in the in-traffic lane and a CBR of 110+ in the out-of-traffic lane. The subgrade showed a maximum consolidation of 0.24 inch along the center of the traffic lane.

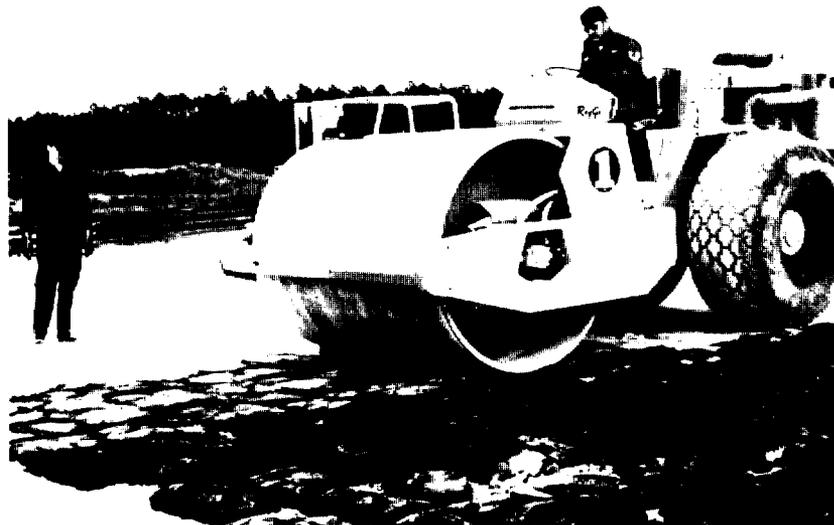
Figure 50. Compaction of Amalgapave®, Item 20

Shoving under the roller was occurring, and numerous cracks appeared on the surface of the asphalt due to the low adhesive ability.

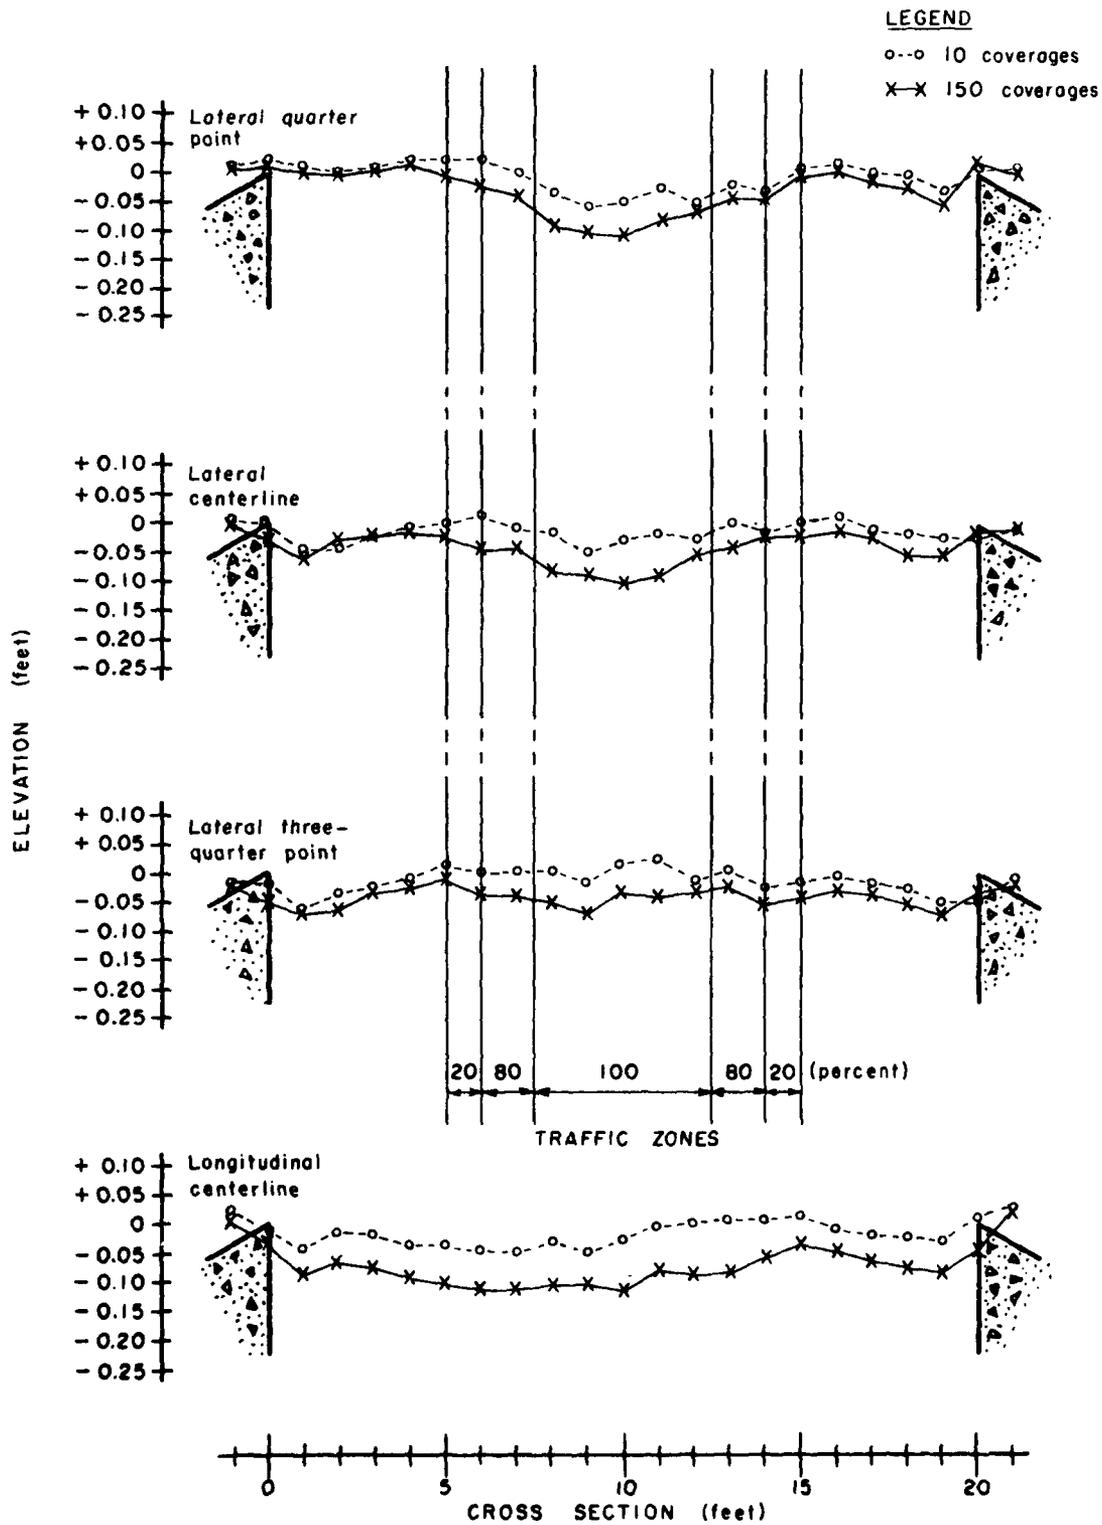
Figure 55. Surface Profiles, Item 23

Profiles of the surface (Figure 55) indicate a consolidation of approximately 0.5 inch. Results of test item 23 support previous data which had shown that after approximately 40 coverages the amount of consolidation of the limestone base course is minimal.

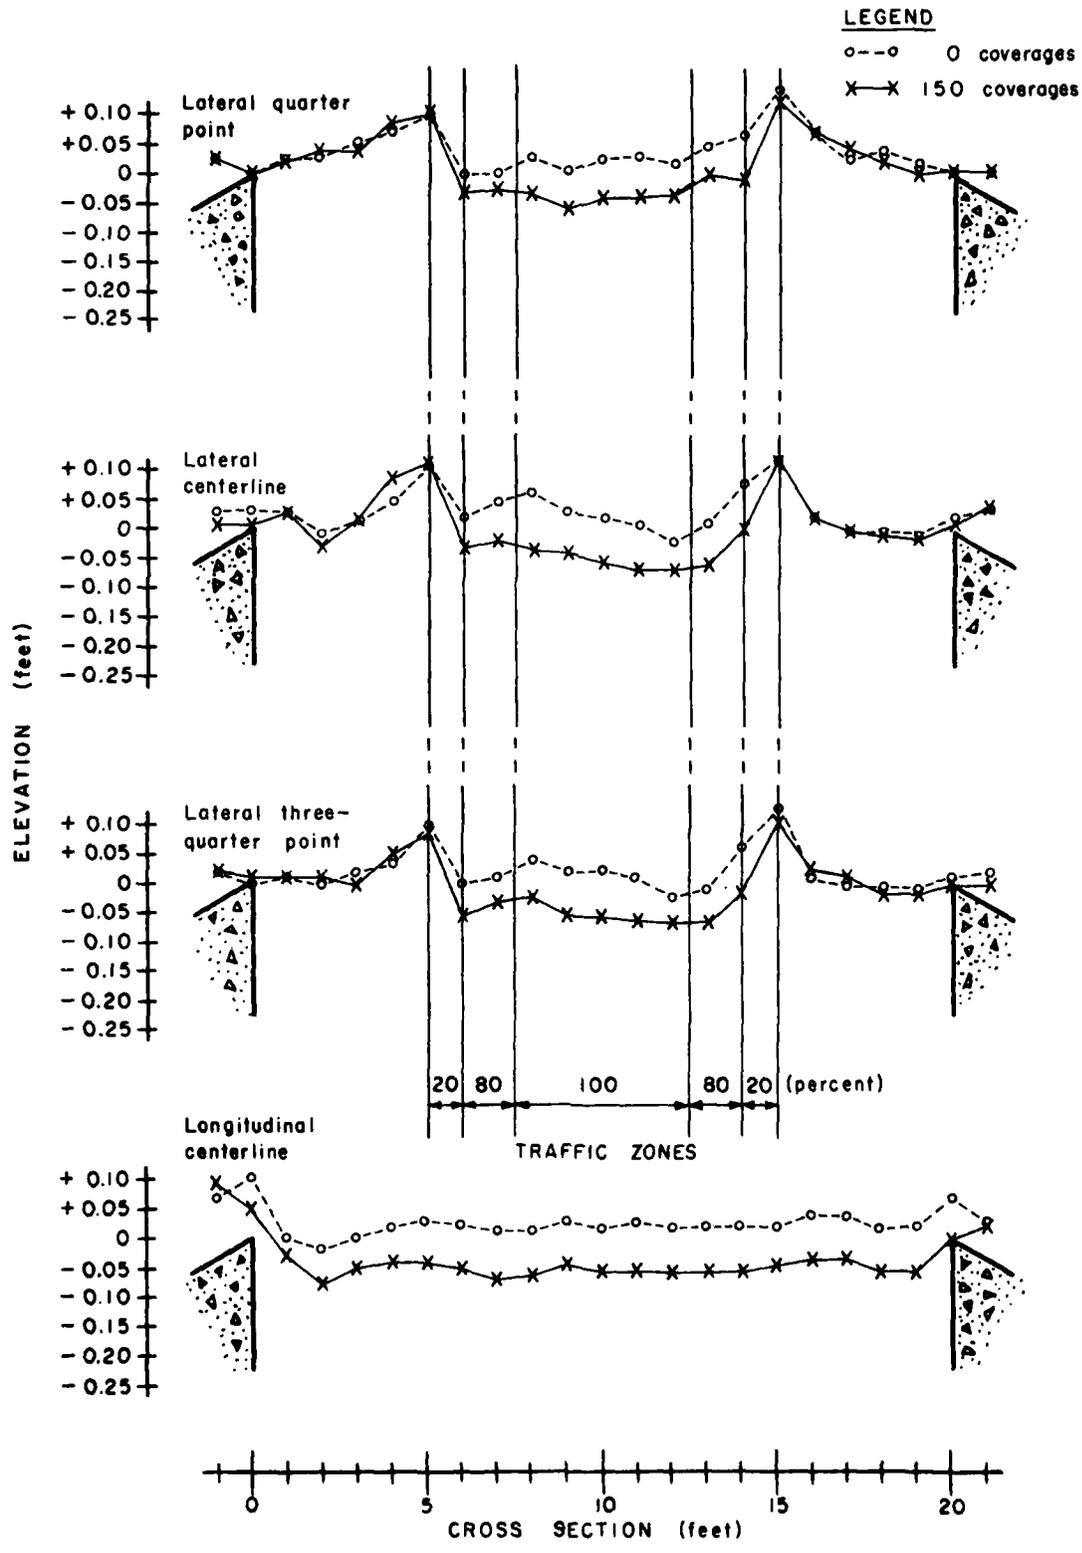
Figure 58. Surface Profiles, Item 31

The pivoting of the load cart wheels caused much of the wear previously described. The small test section using the flat steel tie-downs held firmly and showed no unusual wear; however, it did not receive the full load cart traffic to which the larger test item was exposed. Profiles of the test surface are illustrated in Figure 58; moisture and density readings are recorded in Table 17.

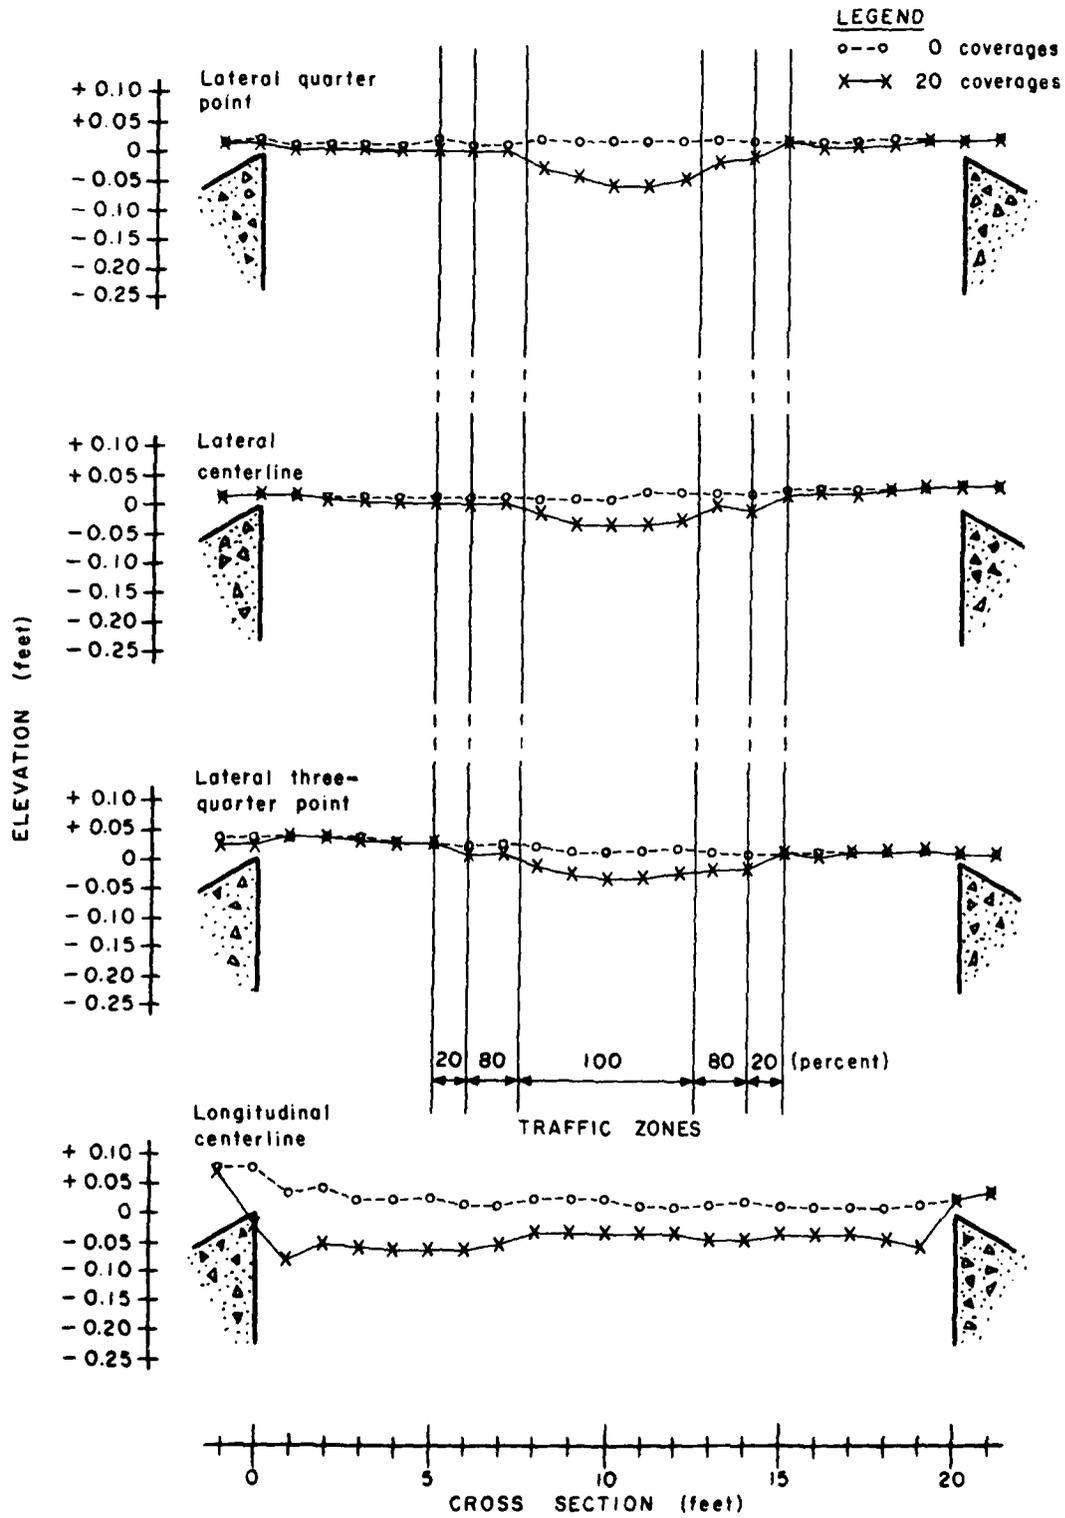
Figure 60. Surface Profiles Prior to Trafficking and After 20 Coverages, Item 34

The test surface was profiled after 20 coverages (Figure 60). After 40 coverages, a small hairline crack developed along the edge of the traffic lane. A deflection of 0.25 inch was recorded after 60 coverages but did not increase during the remainder of the test; however, several longitudinal hairline cracks had developed. Profiles obtained at the conclusion of trafficking are shown in Figure 61.
