MISCELLANEOUS PAPER SL-81-16

# STRUCTURAL STABILITY EVALUATION GULL LAKE DAM

June 1981

Final Report

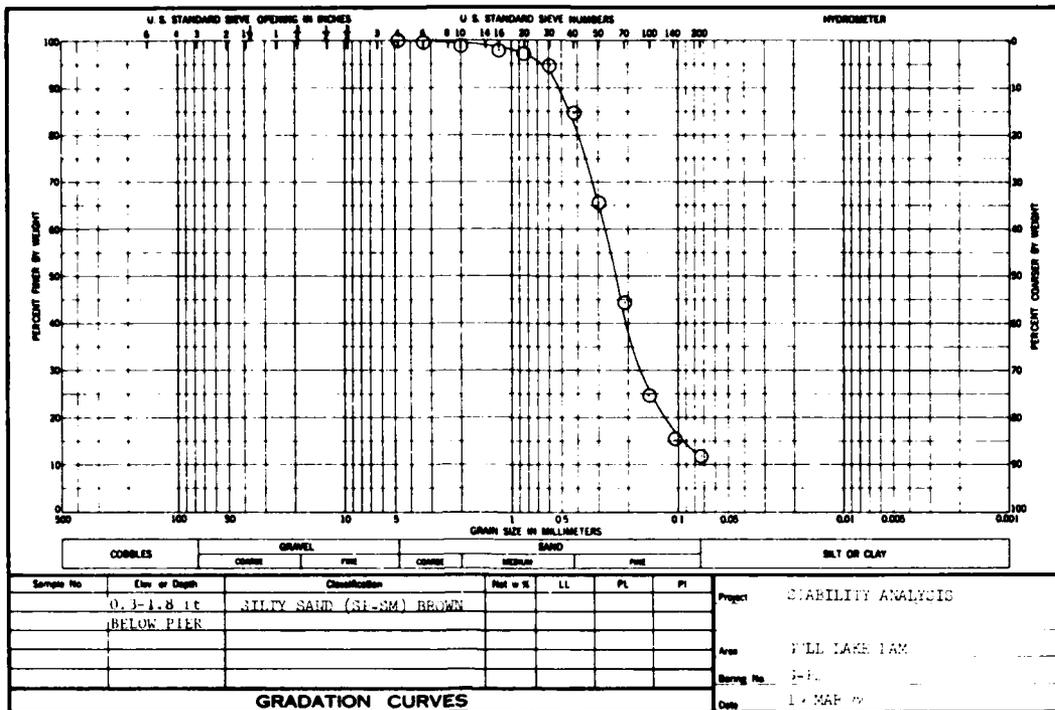
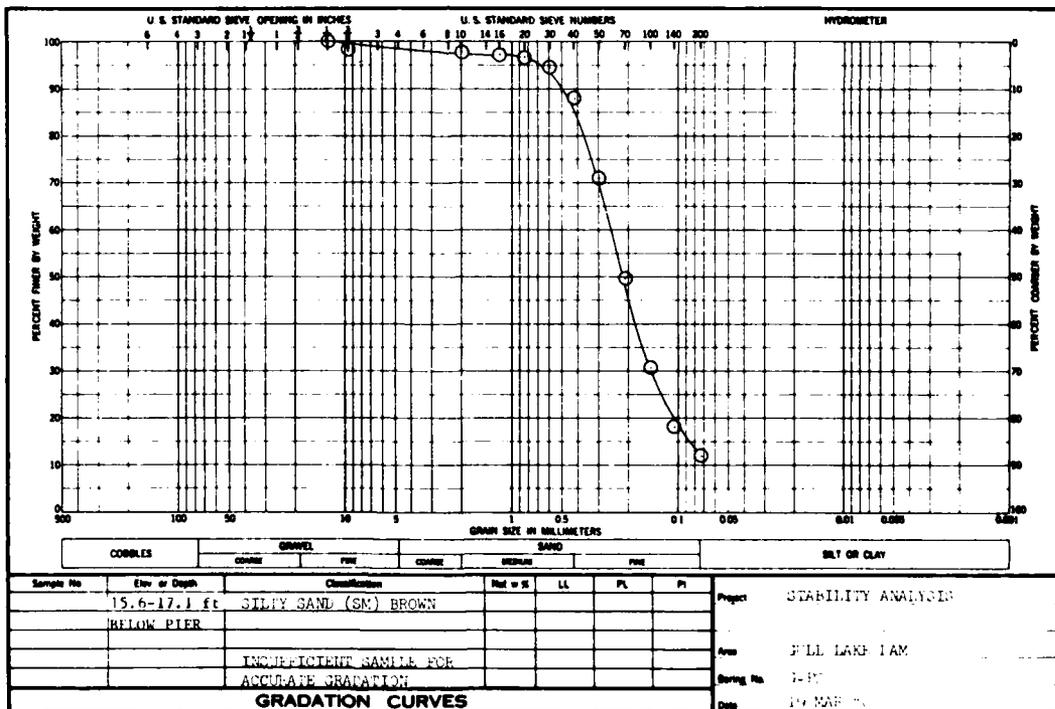
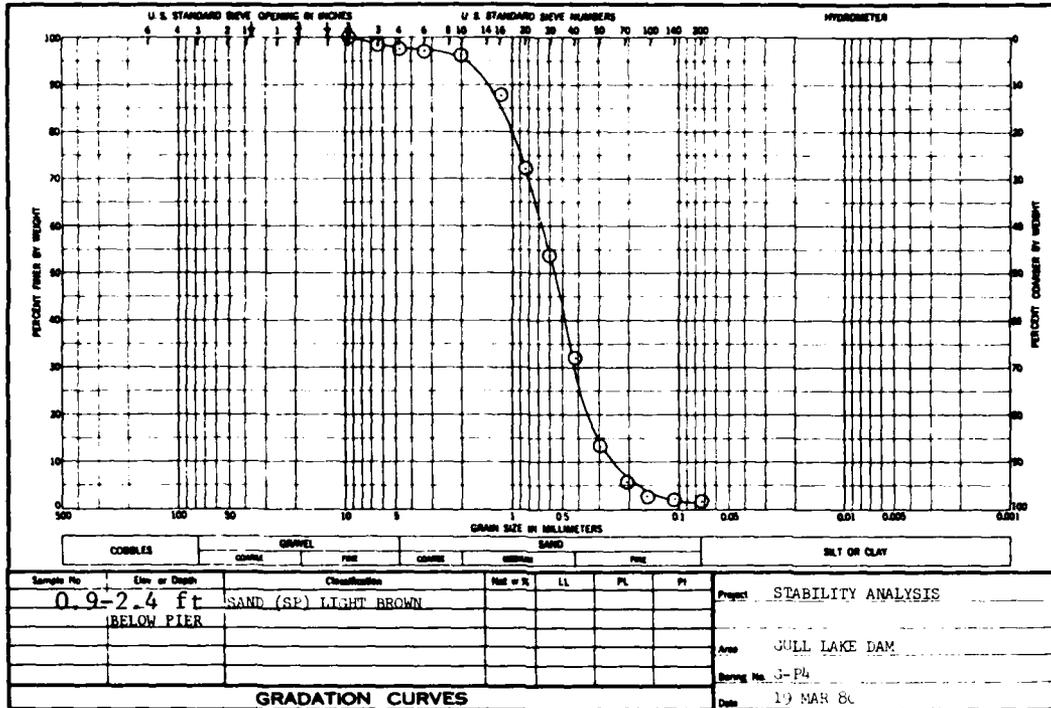
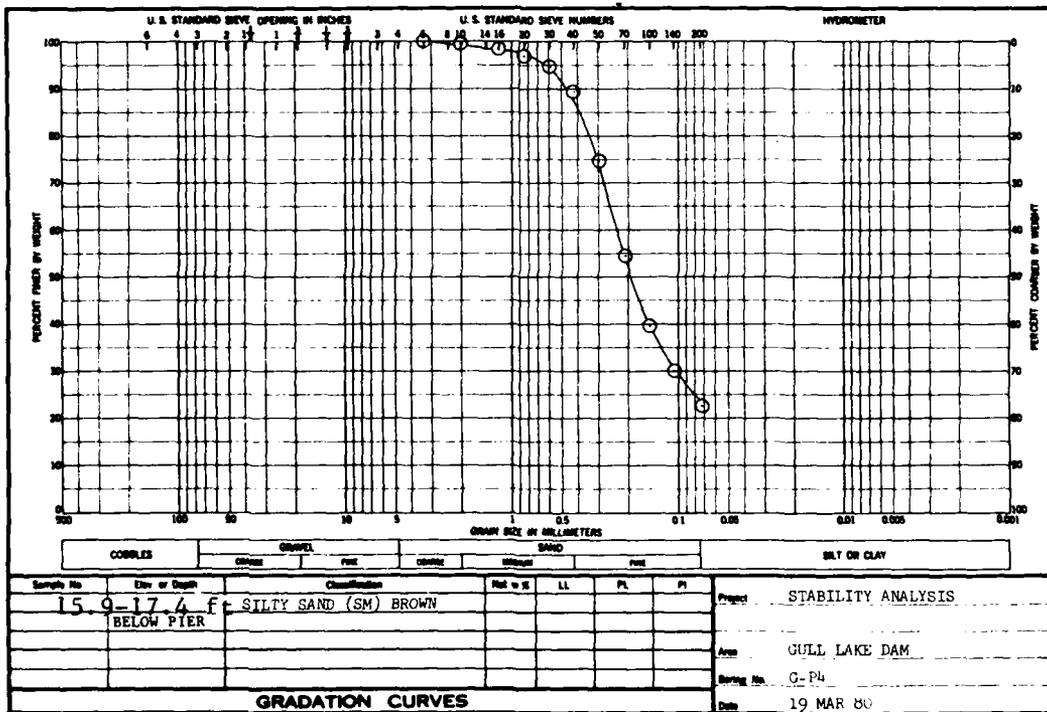
30. Disturbed samples of the foundation material were obtained and transported to the laboratory for classification. The foundation material under Gull Lake Dam is mainly a silty sand (Figures 9 through 12).

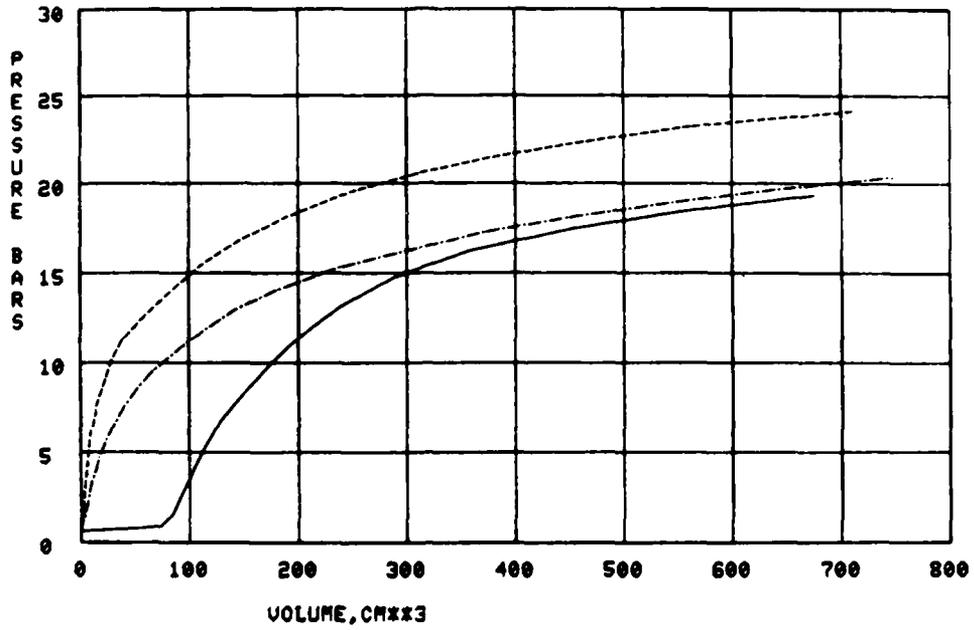
32. The actual pressure which is applied to the probe is higher than that which is read at the control unit due to the hydrostatic pressure of the water in the tubing. On the other hand, the pressure applied to the soil is less than the probe pressure due to the resistance of the rubber membrane. The corrected pressure curves are presented in Figures 13, 14, and 15 for hole G-P2 and in Figures 20, 21, and 22 for hole G-P4.

Figure 13. Pressure versus volume, Gull Lake Dam, hole G-P2

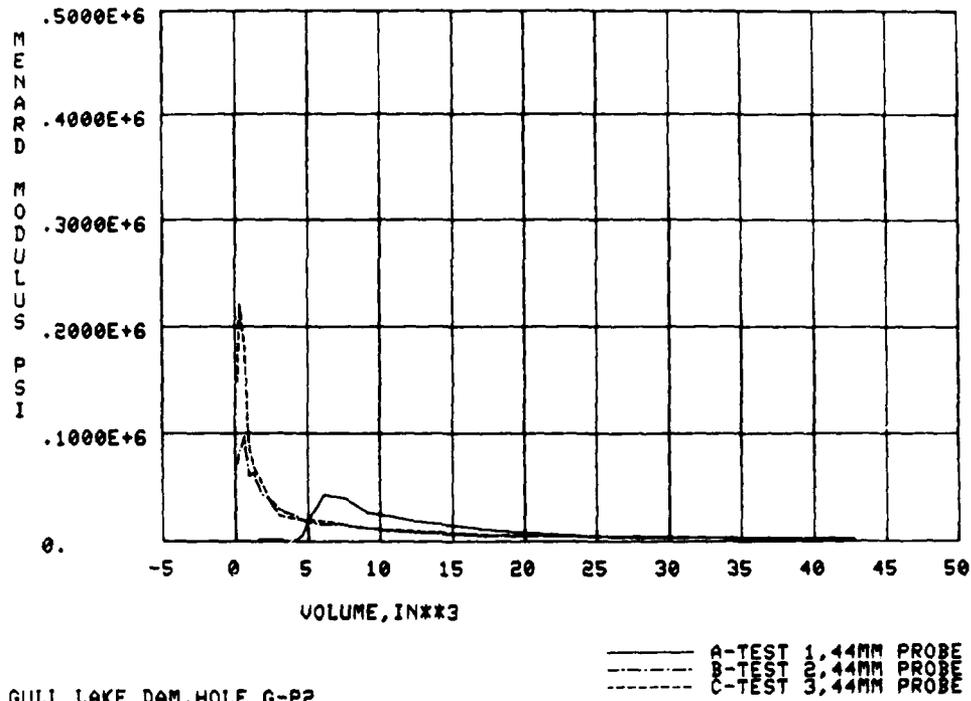
The Ménard modulus is presented in Figures 17 and 24 for hole G-P2 and G-P4, respectively.

Figure 17. Ménard modulus, Gull Lake Dam, hole G-P2

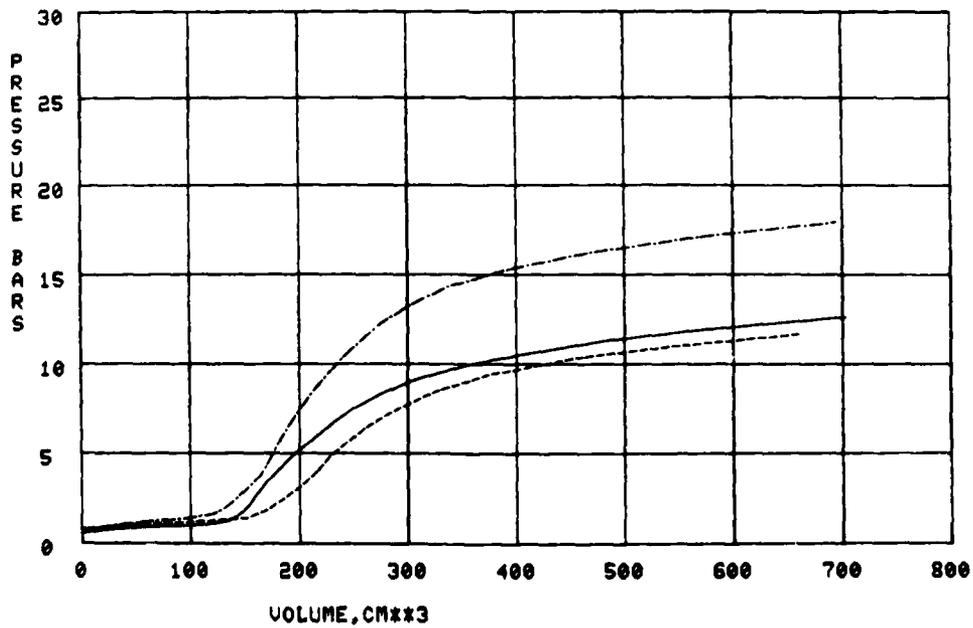
Figure 20. Pressure versus volume (metric units),  
Gull Lake Dam, hole G-P4

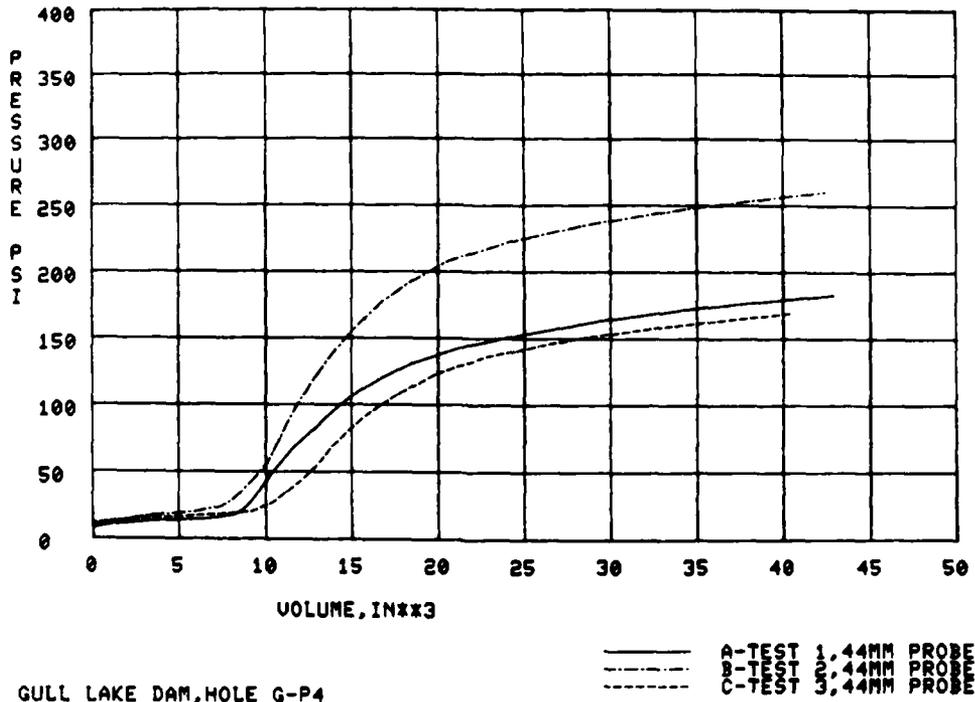
Figure 21. Pressure versus volume, Gull Lake Dam, hole G-P4

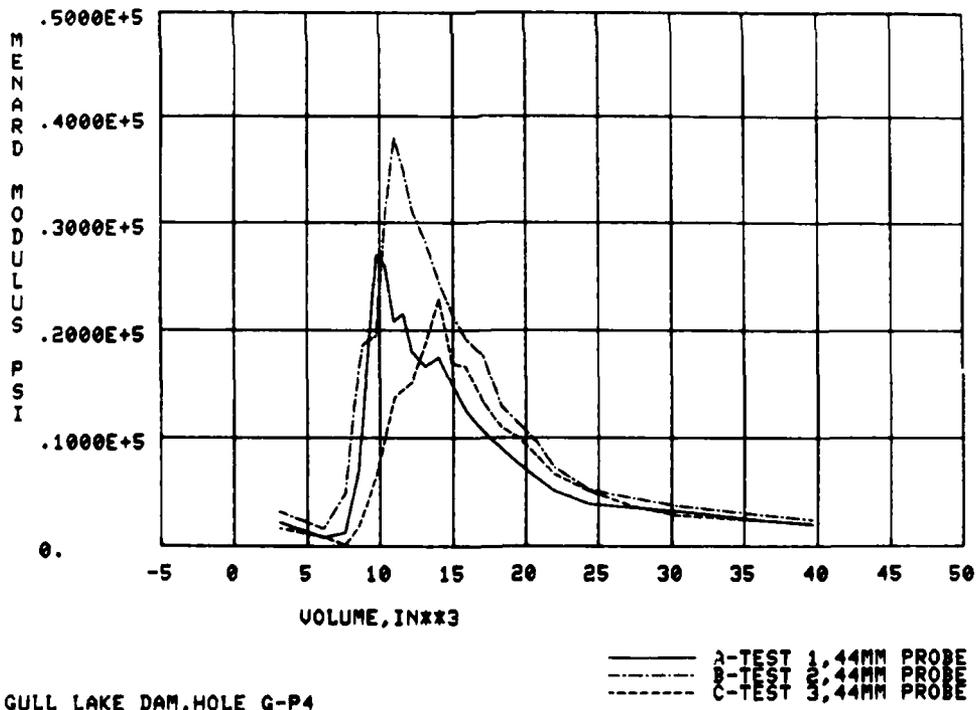
Figure 24. Ménard modulus, Gull Lake Dam, hole G-P4

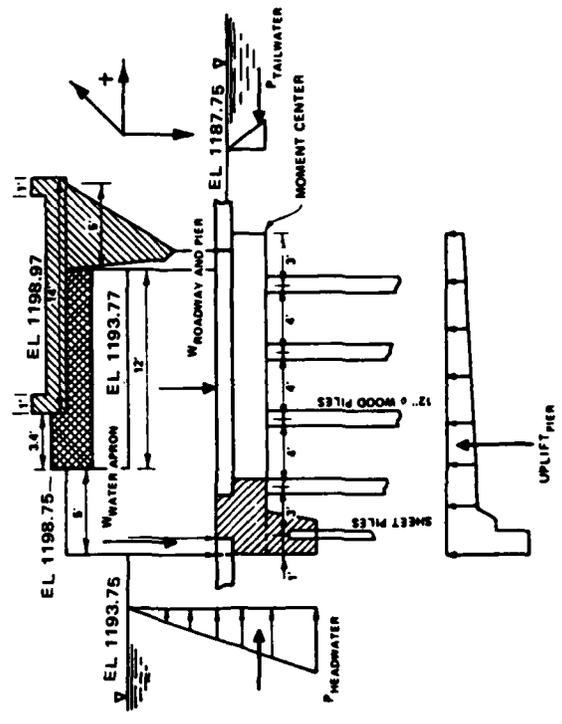
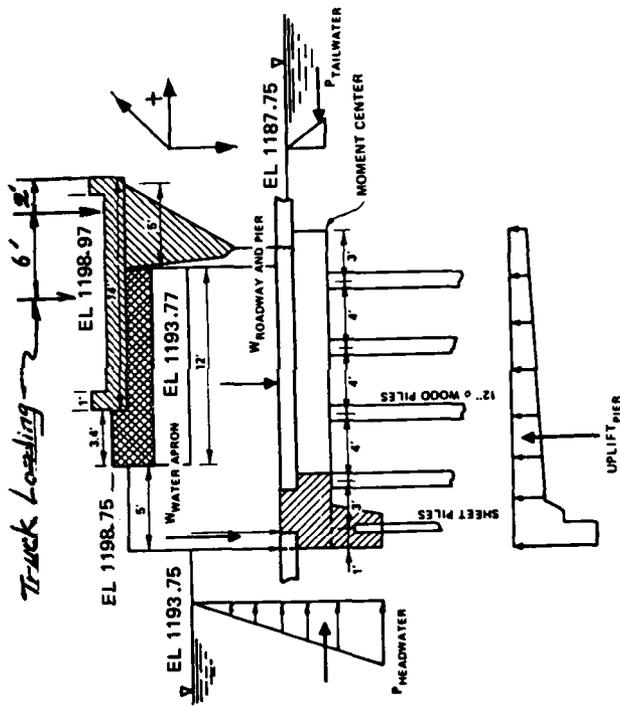
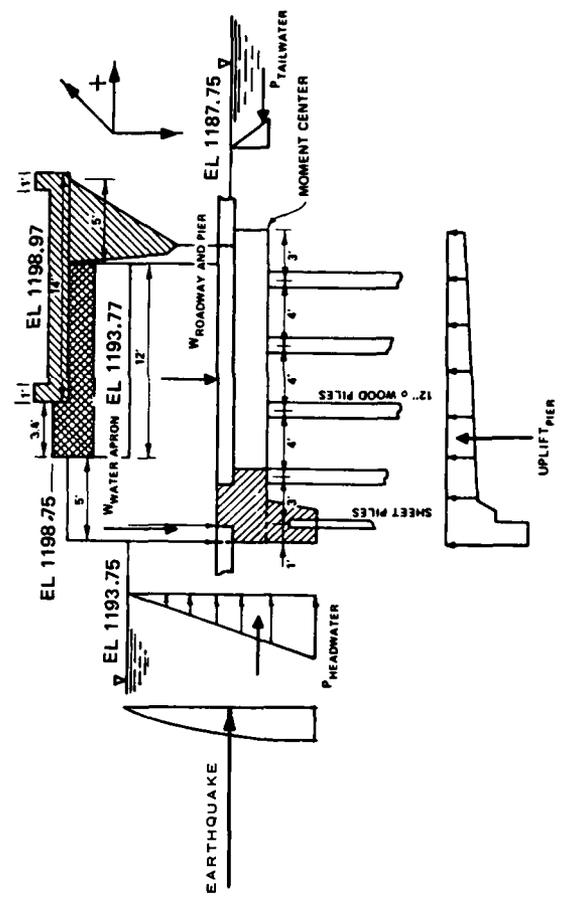
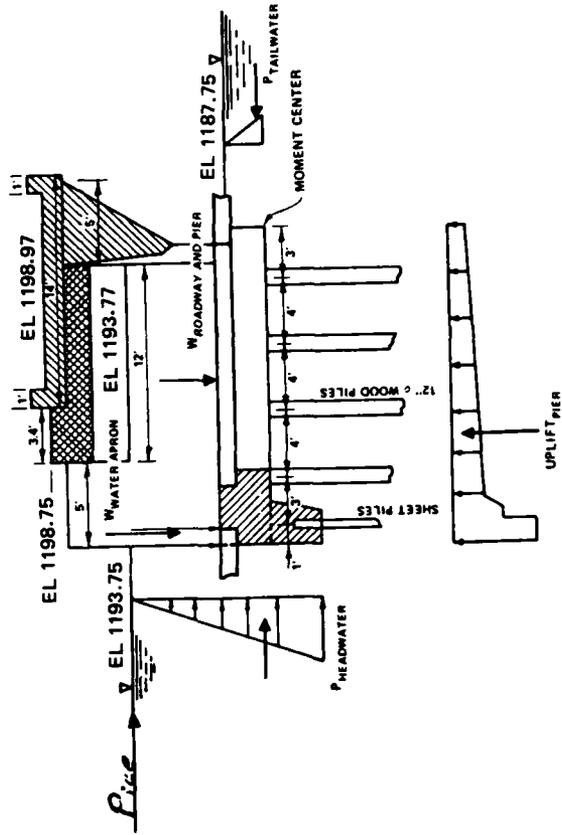
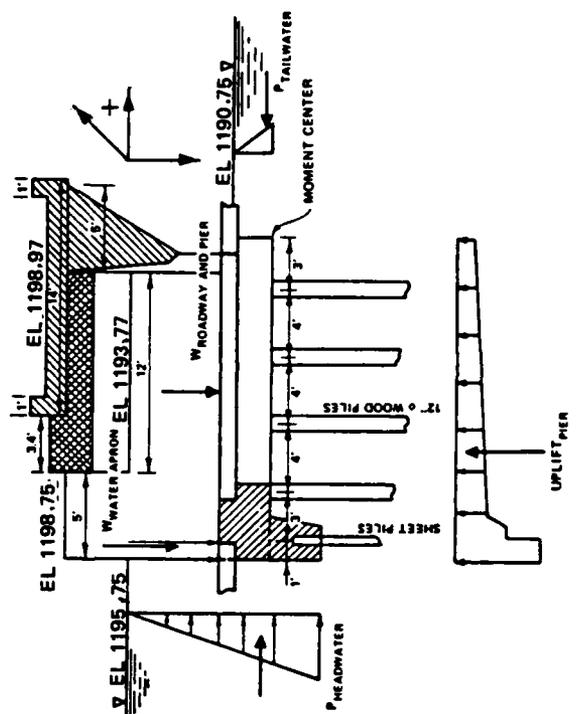
43. The geometry and loadings on a particular interior monolith of Gull Lake Dam are presented in Figures 27 through 31. Five load cases were analyzed:

The loading and analysis determining the applied forces and moments on the pile layout are also presented in Figures 27 through 31. The results of the conventional piling analysis are presented in Table 8.
