LAKE HARMONY DAM

MADISON COUNTY, MISSOURI

MO 30612

PHASE 1 INSPECTION REPORT
NATIONAL DAM SAFETY INSPECTION.

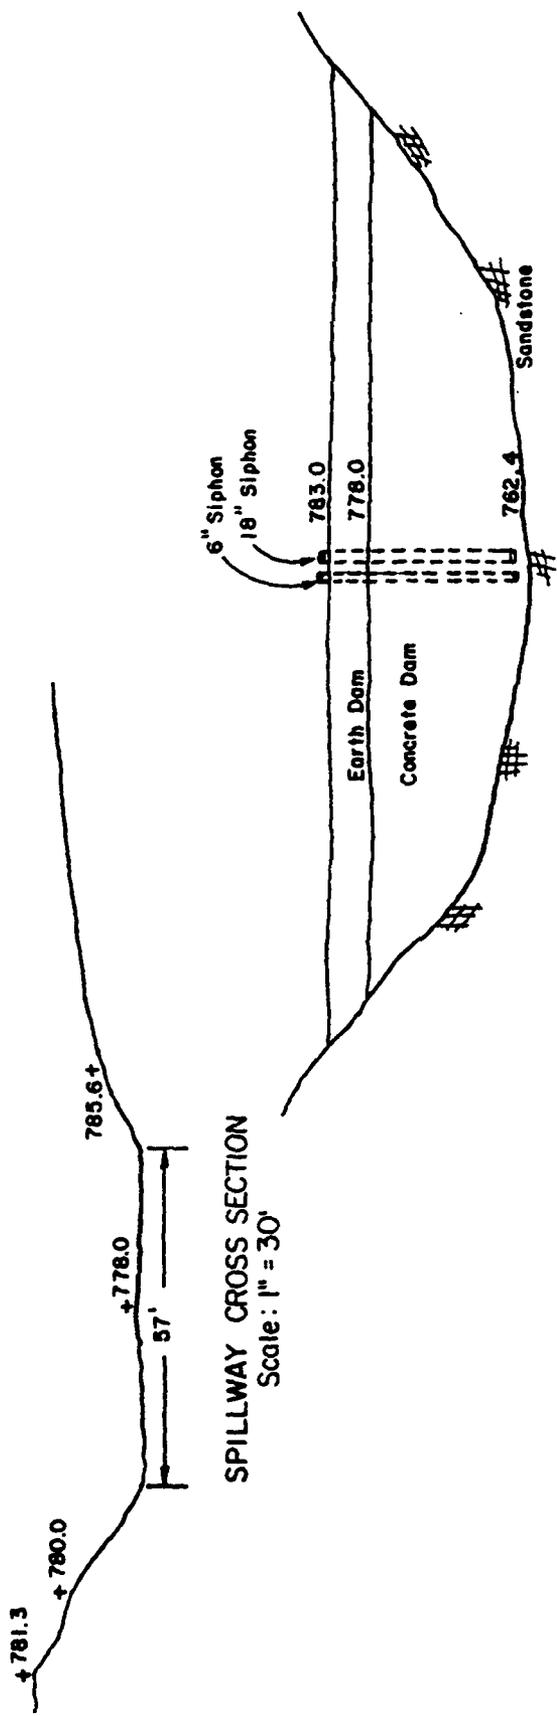
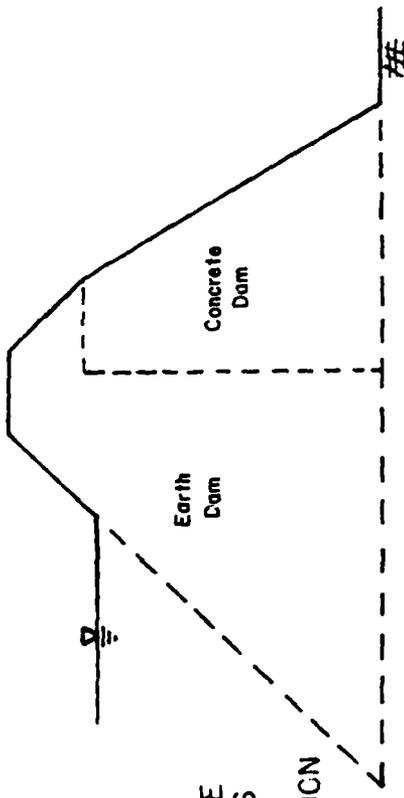
Figure 3

SPILLWAY CROSS SECTION
Scale: 1" = 30'

PROFILE OF DAM
Scale: 1" = 20' Vertical
1" = 40' Horizontal

CROSS SECTION OF DAM
Scale: 1" = 6'
