BROWN LAKE DAM

CAPE GIRARDEAU COUNTY, MISSOURI

MO 31223

PHASE 1 INSPECTION REPORT

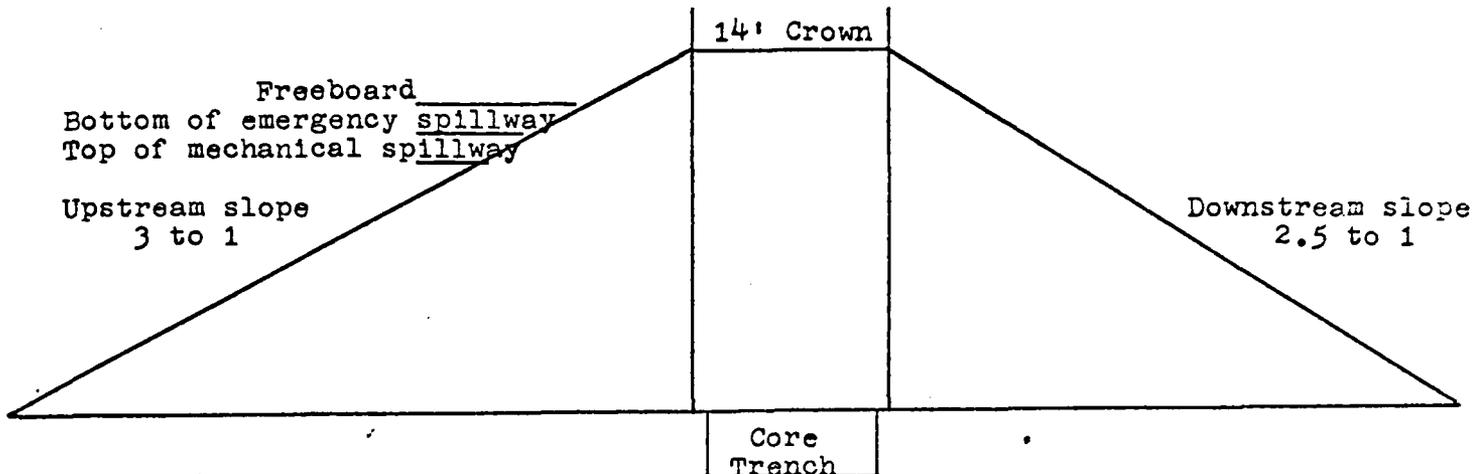
CROSS SECTION THRU THE LAKE DAM

1. All dams over 20' high should have a wider crown, therefore, I'm recommending a 14' crown. This will also make a better road since the crown is to be used for this purpose.

2. The freeboard should be 3 feet, this means the bottom of the emergency spillway should be 3 feet below the top of the dam.
3. The top of the mechanical spillway should be one (1) foot below the bottom of the emergency spillway or four (4) feet below the top of the dam. This would give acre feet of storage.
